# Archaeological Monitoring of Subsurface Electrical Lines at Fort McKavett State Historic Site (41MN2), Menard County, Texas

Texas Antiquities Committee Permit No. 5873

*Prepared by:*  
Center for Archaeological Research  
The University of Texas at San Antonio  
One UTSA Circle  
San Antonio, Texas 78249  
Technical Report, No. 30

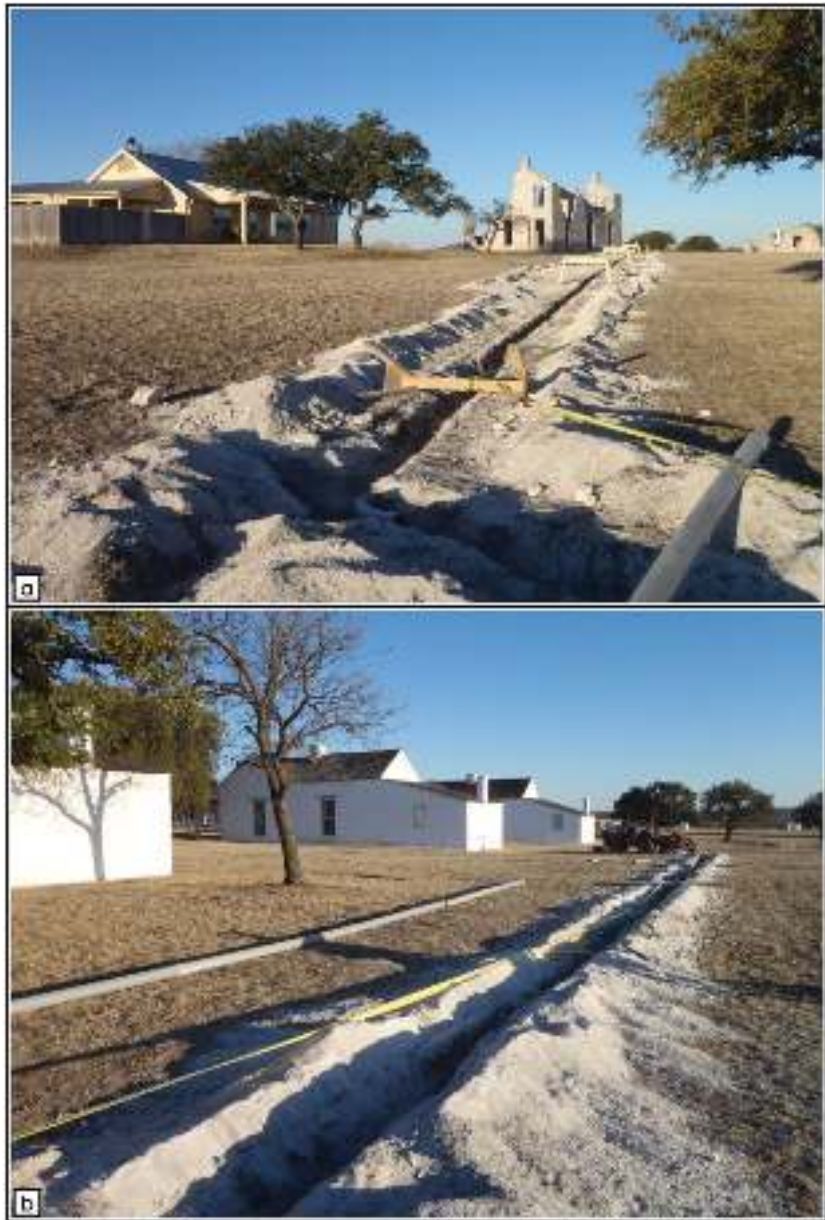
Figure 4-2. Photos of: a). Trench 1, east to west portion; b). Trench 1, north to south portion.

Two trenches were excavated to house the proposed electrical lines. Trenches were designated numerically as Trench 1 and Trench 2 (Figure 4-1). Trench 1 begins at the electrical access manhole located to the east of the ruins of the Commanding Officer’s Quarters (Figure 4-2a). It extends east between the Site Manager’s Quarters and Officer’s Quarters (OQ) #4 for

180 feet, then turns sharply north behind OQ’s #4 and #5 (Figure 4-2b). The trench continues another 120 feet before terminating at the proposed electrical box behind OQ #5.

Of the two trenches excavated, Trench 1 yielded the most cultural material. Soil in the trench varied, averaging approximately 5-10 centimeters in thickness above the limestone bedrock. Surface artifacts from the east-west portion of the trench included a single cut-nail and purpled bottle glass (Table 4-1). Artifacts from the back-dirt of this portion included a single cut-nail, a shard of brown bottle glass with embossed lettering, and a metal window latch.

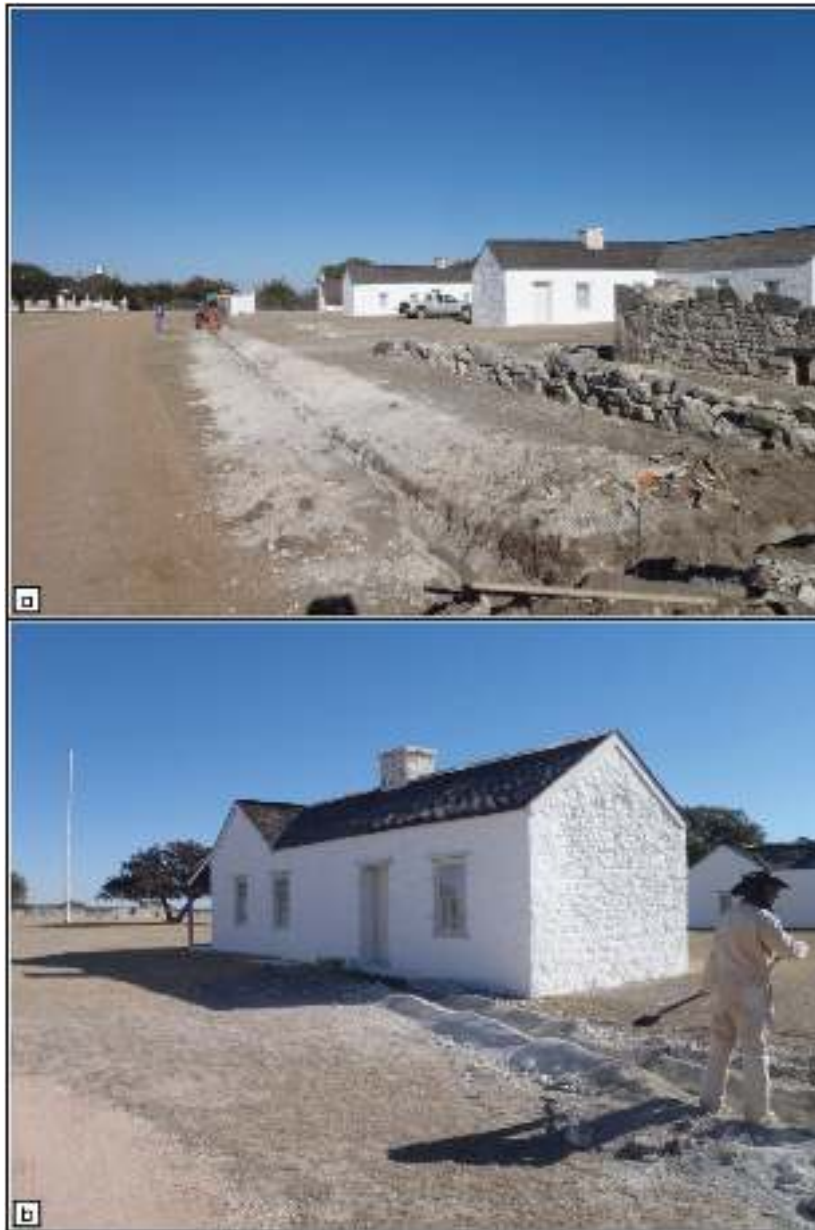
Figure 4-3. Photos of: a). Trench 2, east to west portion; b). Trench 2, north to south portion terminating at side door of OQ# 10.

and turns at a 90 degree angle, continuing for another 120 feet running behind OQ #9 and #10, parallel to the road (Figure 4-3a). It then turns at a 90 degree angle and heads north along the side of OQ #10 for 70 feet, where it terminates at the side door of OQ #10 at the proposed electrical box (Figure 4-3b).

Trench 2 yielded significantly fewer artifacts than Trench 1 (Table 4-1). The main concentration of artifacts was located

in a small area adjacent to the side door of OQ #10. Surface artifacts from the trench included a single cut nail, a piece of embossed purple bottle glass, and an embossed milk glass bowl fragment. All other artifacts came from the proposed electrical box area near the side door of OQ # 10. This area was unique in that it had soil down to the bottom of the trench. The soil in the rest of the trench was shallow and between 8 to 10cm. Glass recovered from this area featured a heavy patina. It is likely that artifacts from this area date to the civilian occupation of the fort when the old buildings were utilized as trash dumps. Artifacts from this area included: cut nails, a cast iron fragment, a bobby pin, two aqua bottle bases, an aqua drinking glass fragment, a ribbed aqua glass fragment; a piece of undecorated white earthenware, a piece of undecorated semi-porcelain, two porcelain plate bases—one gilded, the other undecorated; and, lastly, a bovine foot bone (Table 4-1).

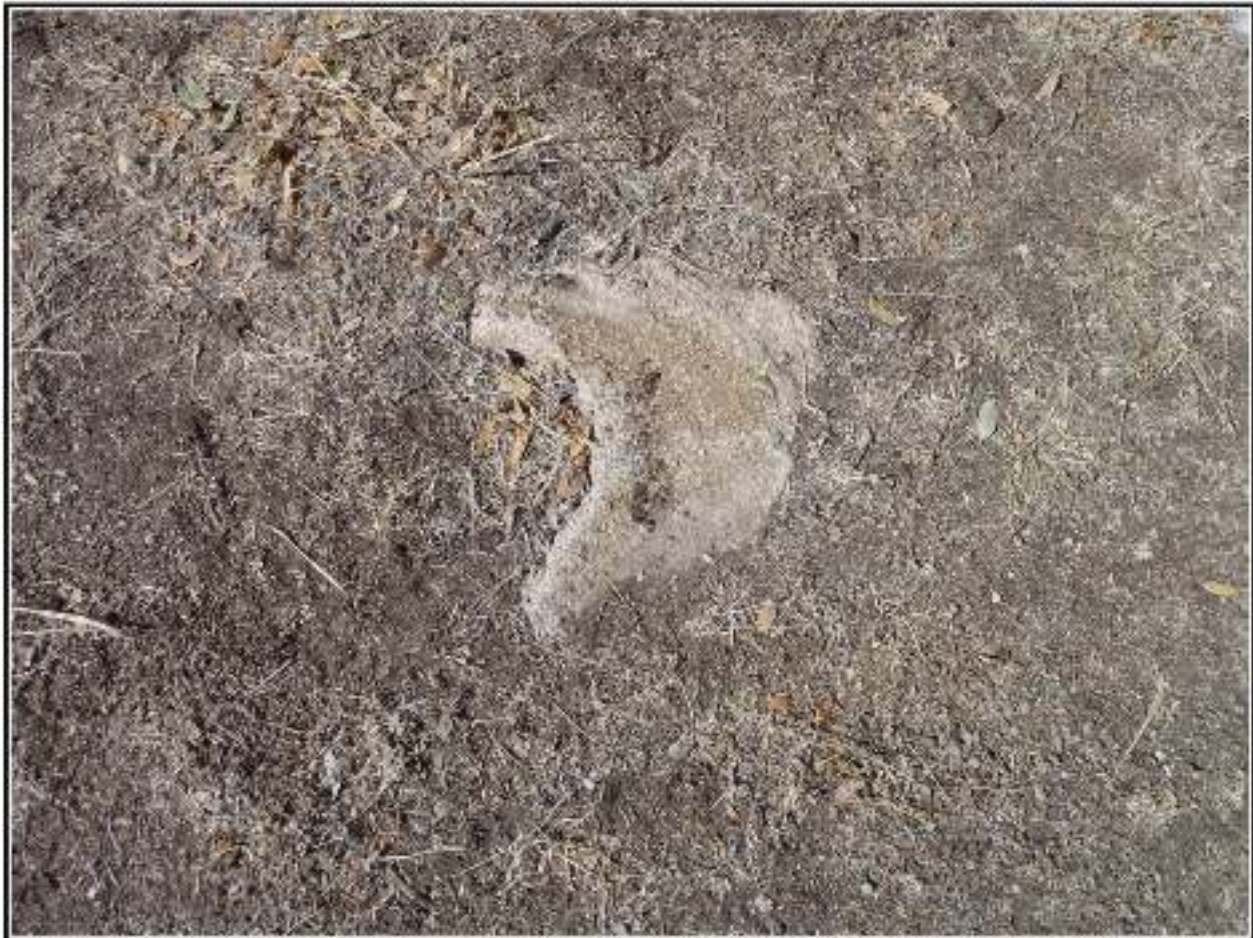
Figure 4-4. Photo of concrete post-hole feature.

The east-west running portion of Trench 1 had a series of six concrete post-holes that were set three on each side, forming a square. This grouping of post-holes was designated as Feature 1 (Figure 4-4). Close examination showed that the concrete used in the construction of the post-holes was composed of Portland cement and sand. It is surmised, based on both the layout and construction materials, that these post-holes were part of a support for a windmill. Since Portland cement was not widely available until the late 1800s, it is likely that this feature dates to the later part of the civilian occupation of the site. The date range for this feature

is estimated to be between 1920s-1968, with the later decade being the more likely. Because one post-hole was directly in the path of the trench, it was mechanically removed (Figure 4-4). However, the other five post-holes that make up the feature were located outside the path of excavation, and therefore, remain intact. Feature 1 was mapped using a GPS unit and photo-documented.

During the monitoring, one surface feature, Feature 1, was recorded. It consisted of six round concrete post holes which were arranged three on each side in a square. The post-holes appeared to form the footing for a modern windmill, corral or cistern built with Portland cement. This feature had relatively low research value and was likely associated with the civilian occupation of the site. It was photo-documented and its position mapped. Some diagnostic artifacts were collected from the surface of the electrical trenches and also from trench back-dirt. Artifacts ranged in date from the late 1800s to the mid 1900s.
