**Archaeological Investigations at the Lily Pond in
Brackenridge Park, San Antonio, Bexar County, Texas**

Texas Antiquities Permit No. 6021

Prepared by:
Center for Archaeological Research
The University of Texas at San Antonio
One UTSA Circle
San Antonio, Texas 78249
Technical Report, No. 35

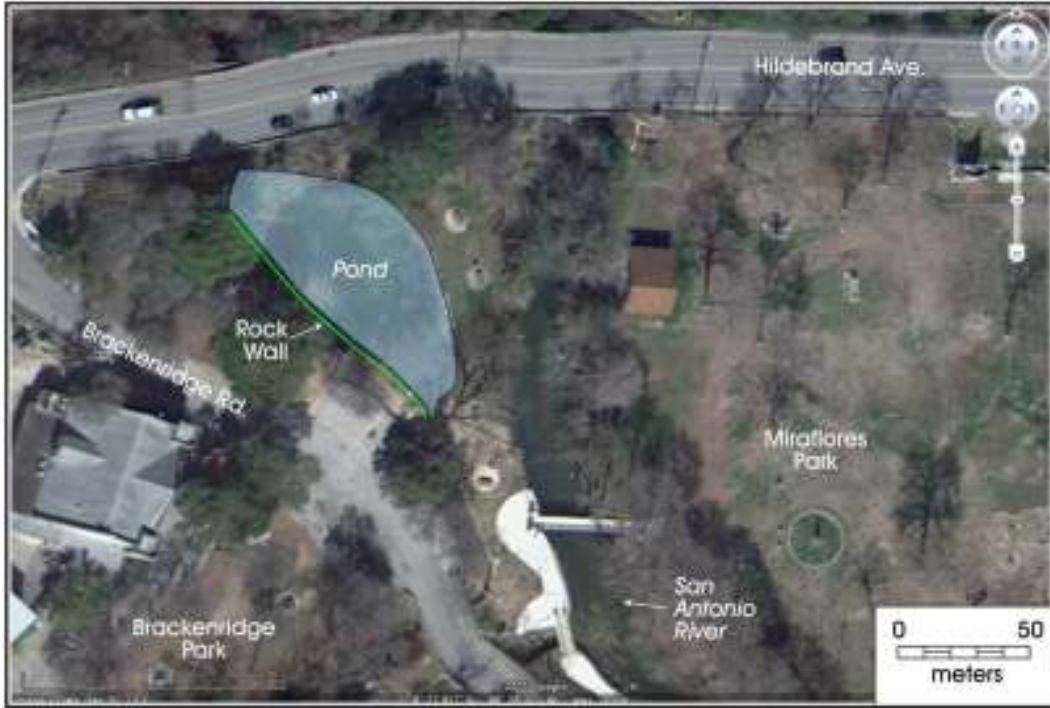
Figure 1-2. Aerial photo of the APE with the Lily Pond outlined.

Recent attempts by San Antonio Parks and Recreation Department to clean out silt that had accumulated in the Lily Pond immediately west of the Spanish Colonial Upper Labor Dam exposed an apparent rock alignment in the western portion of the pond paralleling the existing rock wall (Figure 1-2). This apparent alignment is located approximately 0.9-1.1 m (3-3.5 ft.) inside of the reconstructed rock wall that borders the Lily Pond along the western edge. The rock alignment appeared to consist of large cut limestone blocks. Prior to the beginning of the project, only the upper few inches of these blocks had been exposed. At the time, it appeared as if these blocks were held in place by cement-containing mortar. The wall segment appeared to be approximately 5.5-6.1 m (18-20 ft.) in length starting near the mouth of the reconstructed channel of the Upper Labor *Acequia* and running northward. Given the small amount that was exposed, it was not possible to establish the construction technique of the wall or its possible relationship to the Upper Labor Dam that is located on the east bank of the Lily Pond.

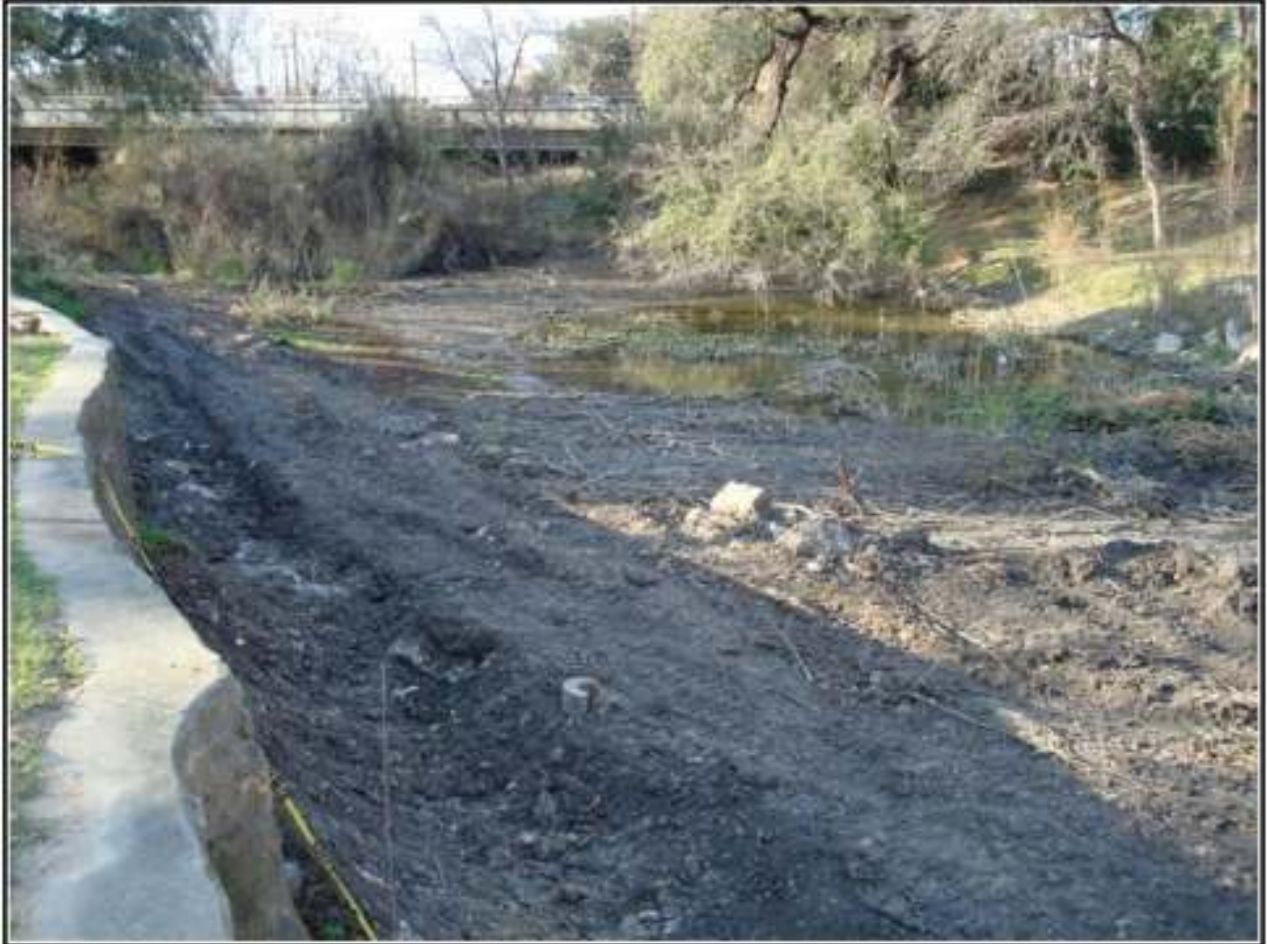
Figure 1-3. Possible rock alignment as it appeared shortly after being exposed.

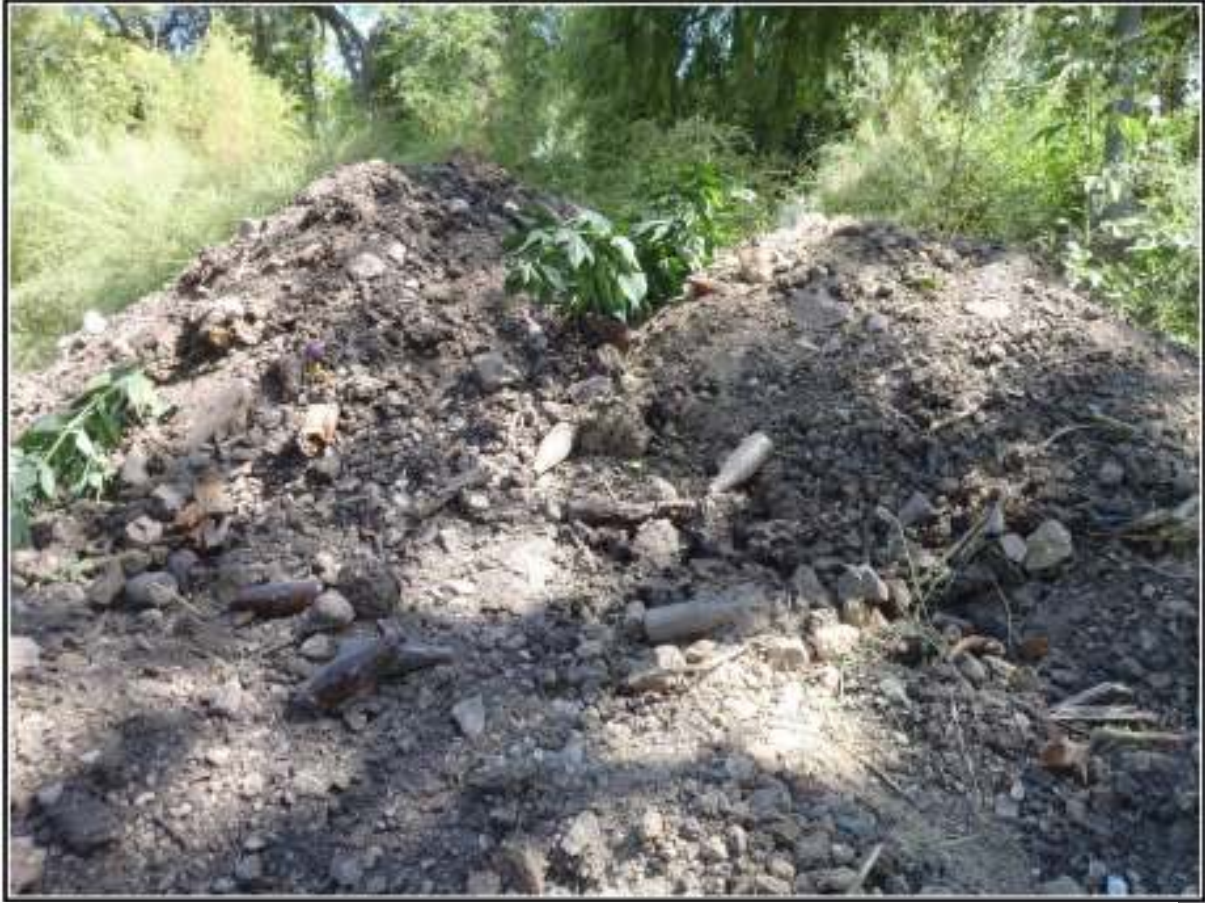
The project archaeologist asked the backhoe operator to stop work in the northern portion of the trench and open what would be the southern end of the trench. Large limestone blocks were noted on the surface in the southern portion adjacent to the southern wall of the pond, and the trench was opened up approximately 30 cm (12 in.) east of the stones. No evidence was noted in the profile of the trench that would indicate a dam or rock alignment. The soil in the southern portion of the trench consisted of fill material that had many glass bottles (Figure 5-1). The bottles dated to the 1970s and 1980s and consisted of soda (Pepsi, RC Cola, Sprite, Mountain Dew, and other varieties) and beer bottles (Michelob). Several pull tab cans were noted as well (Pepsi and Budweiser). The project archaeologist then had the trench expanded to the west to see if stones were present, but none were noted that were adjoined to one another.

Figure 5-1. *Bottles and modern material encountered in the southern portion of the trench.*

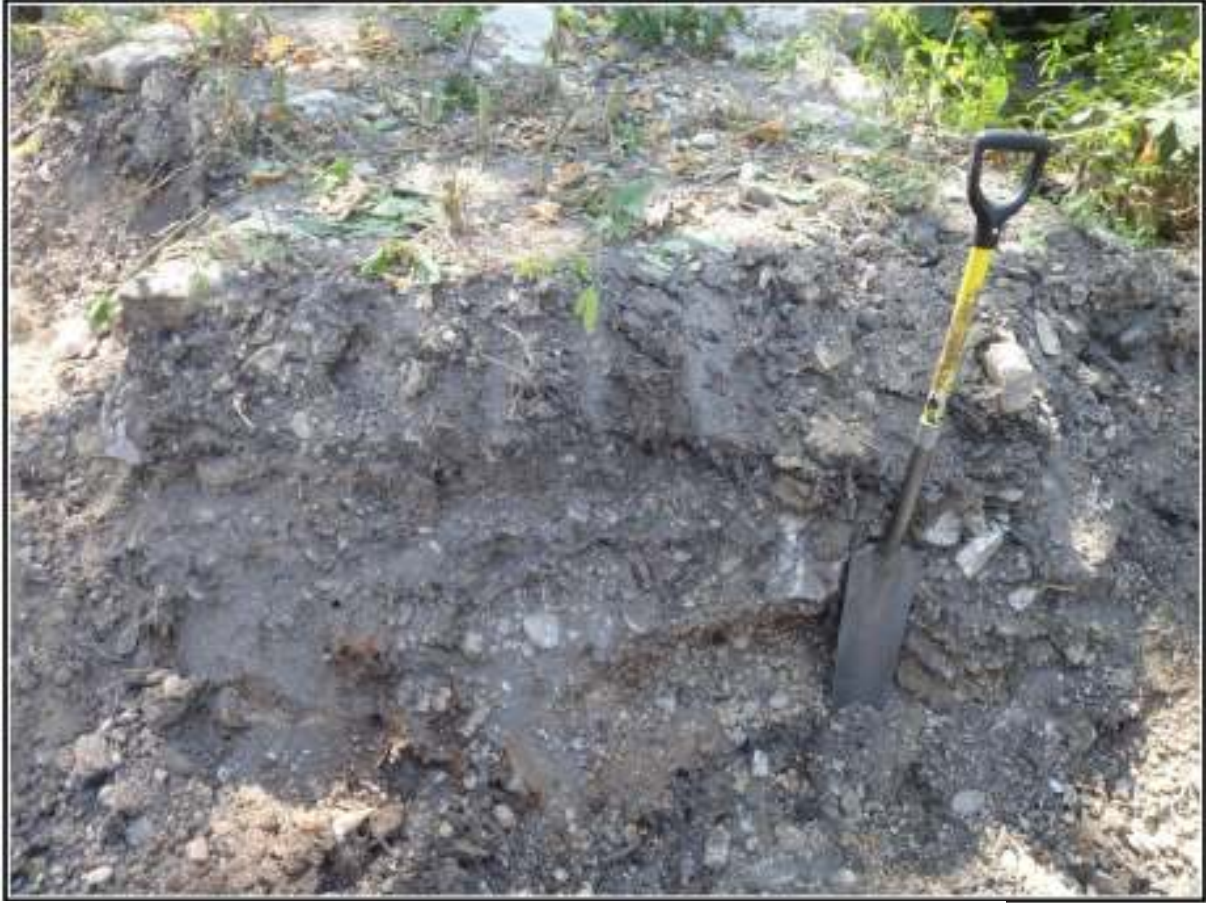
Since both the northern and southern portion of the trench appeared to have no evidence of a systemic alignment, the project archaeologist opted to cross-section the area that was believed to contain an alignment. This east-west running trench was located approximately 5 m (16 ft.) north of the south wall of the pond. The trench did not reveal any rock alignment (Figure 5-2). The fill noted in the southern portion of the initial north-south trench extended well into this area.

Figure 5-2. *Southern profile of the cross-section of the backhoe trench.*

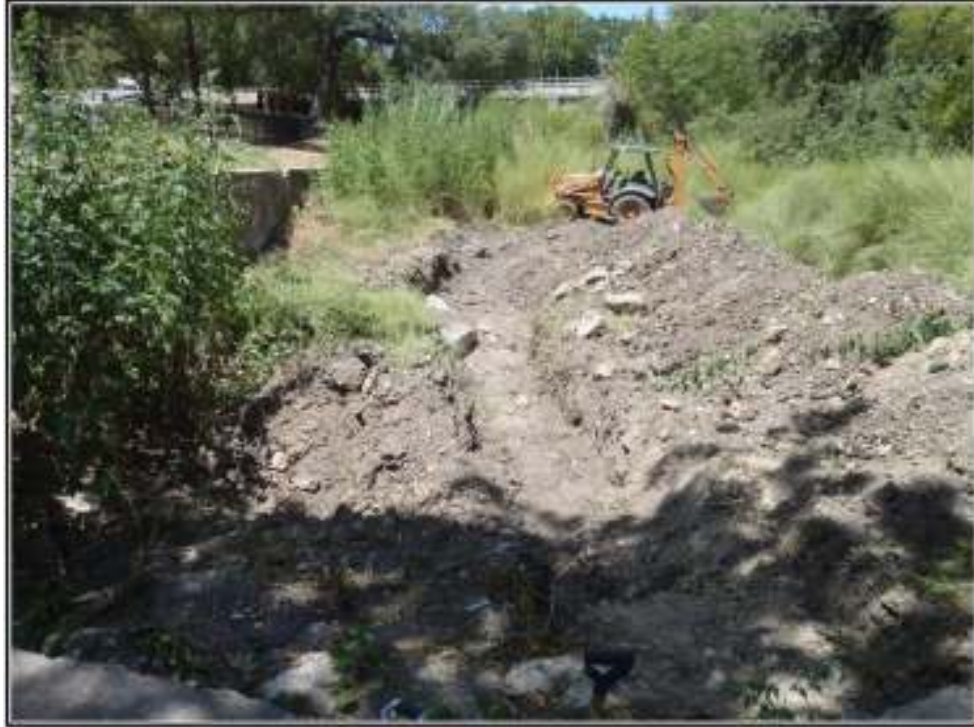
In a final attempt to search for any buried rock alignment, it was decided to connect the two ends of the trench (Figure 5-3). In the process, two remnants of the original Lily Pond wall were encountered in the mid-portion of the trench. The larger fragment was approximately 2.05 m (6.7 ft.) in length (Figure 5-4). Approximately 1.75 m (5.7 ft.) of the second fragment was uncovered in the trench (Figure 5-5). Both fragments appear to have fallen into the pond (Figure 5-6). The wall is 30 cm (11.8 in.) in thickness, which is the same as the currently standing reconstructed portion running around the pond today. The location of the wall fragments within the pond coincides with areas of the wall that show cracks and repairs. These wall fragments are related to the original rock wall that, in all likelihood, was constructed during the WPA era.

Figure 5-3. Entirety of the backhoe trench excavated within the Lily Pond. Rock wall fragments were encountered in the mid-portion of the trench.

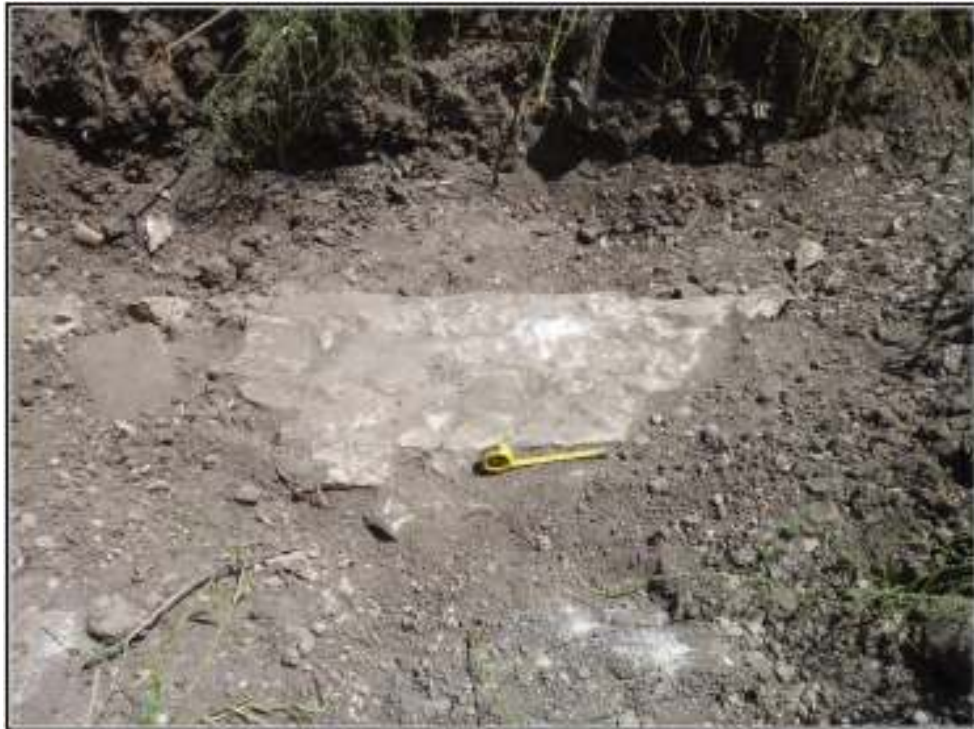
Figure 5-4. Fragment of the 1930s reconstructed Lily Pond rock wall encountered during backhoe trenching.

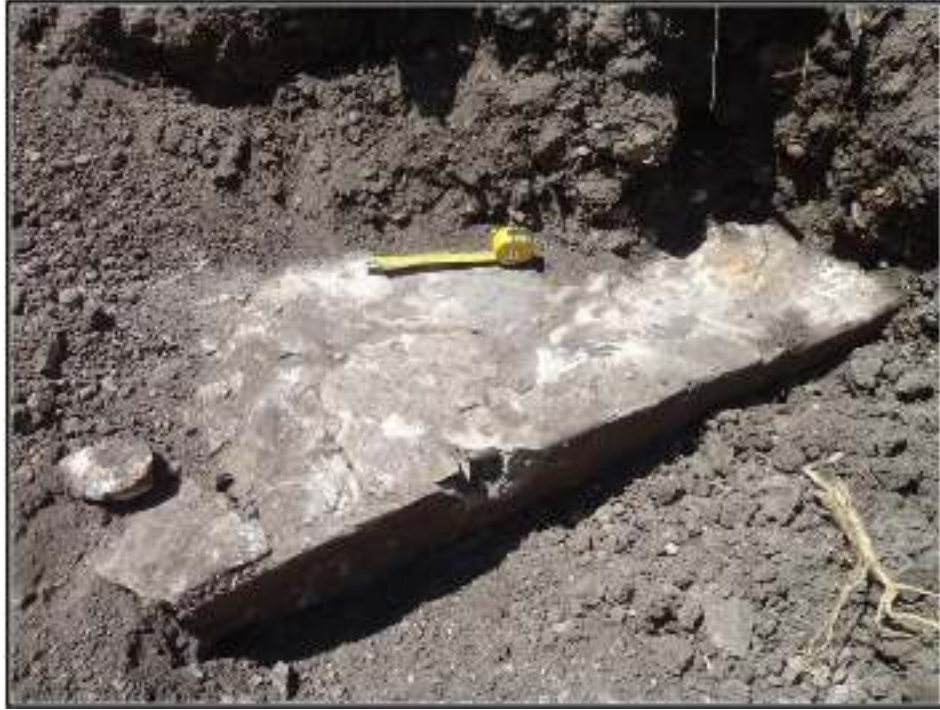
Figure 5-5. *Second fragment of the rock wall encountered while backhoe trenching in the Lily Pond.*

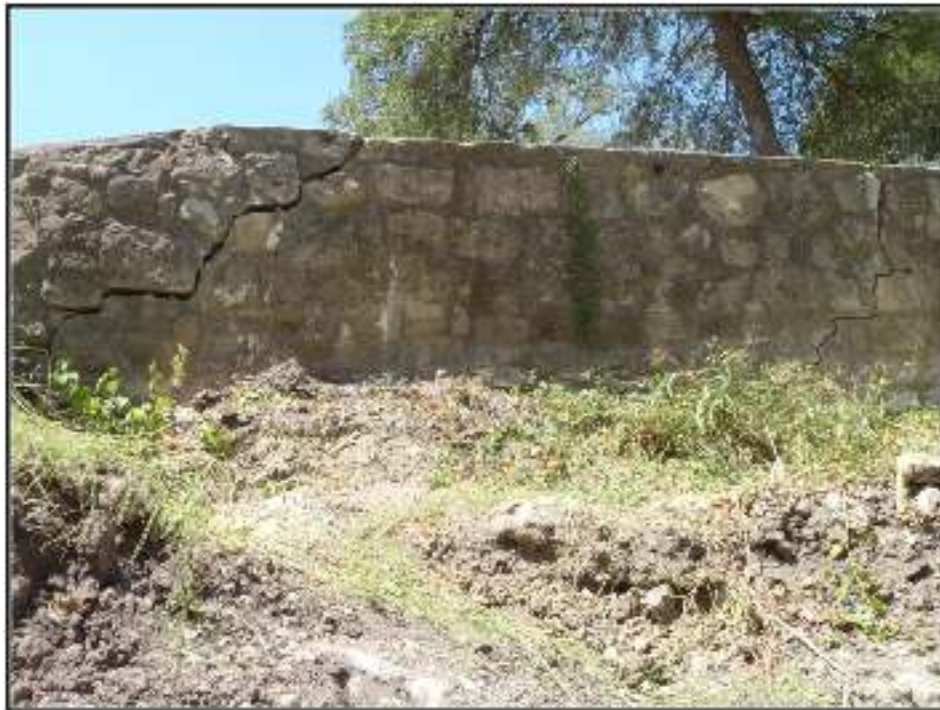
Figure 5-6. *Portion of the currently standing Lily Pond wall near the fragments that were encountered in the backhoe trench. Note the cracks that indicate the unstable nature of the current wall.*

The trench was backfilled at the completion of the project. No signs of a dam or rock alignment were noted during the course of the project. The rocks noted on the surface consisted of two styles. One resembled that which is similar to the rock wall that surrounds the pond. The second style was cut limestone block adjoined with mortar. These appear to not belong to the WPA era wall, but similar stones were noted in the base of the wall nearest the mouth of the *acequia*. They were not in situ and not associated with any feature. Due to the lack of a rock feature within the Lily Pond, CAR does not recommend any further investigations. The presence of the fallen rock wall was documented, and it should be noted that it likely represents the WPA-era construction within Brackenridge Park. All documents and photos associated with the project have been permanently curated at the Center for Archaeological Research. Besides two samples of mortar, no other cultural material was collected during the project.
