**A Historic Standing Structure
Survey of a Portion of the
San Antonio Zoo, Bexar County, Texas**

Prepared by:
Center for Archaeological Research
The University of Texas at San Antonio
One UTSA Circle
San Antonio, Texas 78249-1644
Technical Report, No. 37

As part of the Standing Structure Survey, 12 Historic Resources were recorded. Four of the resources were constructed as part of the Children's Zoo that opened in 1982. Seven resources were likely constructed between 1941 and 1960. One appears to have been constructed during the late 1930s.

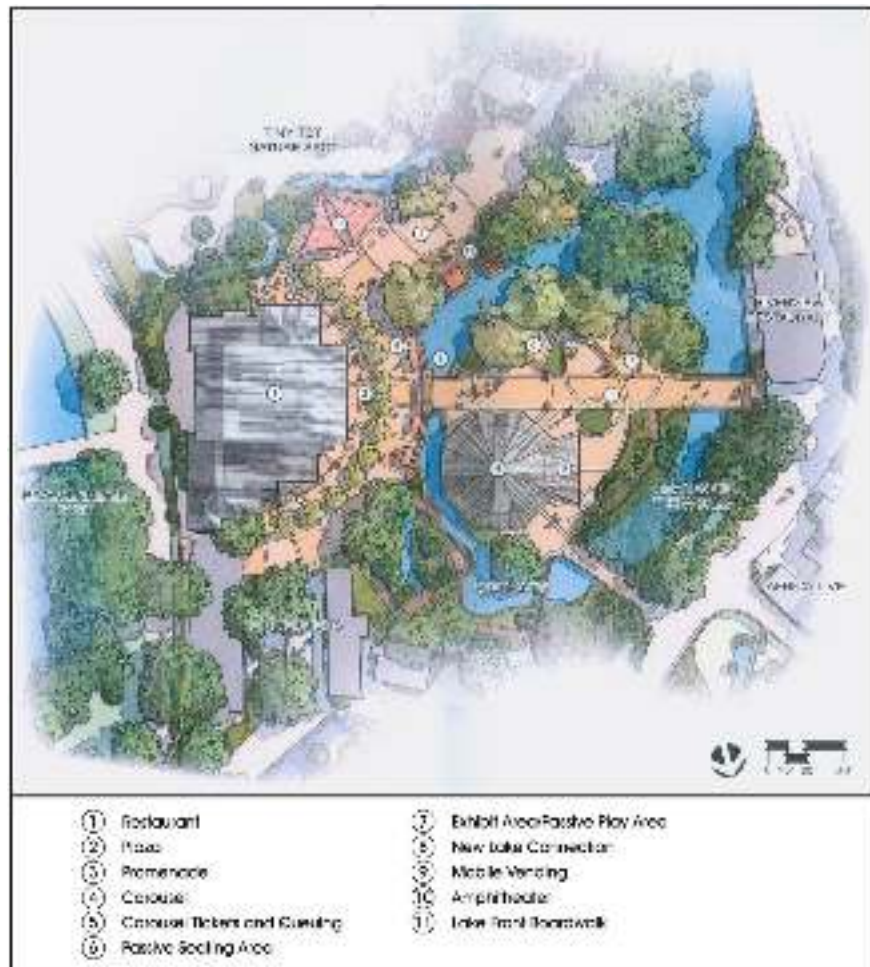
Figure 1-2. Planned improvements at the San Antonio Zoo.

The proposed project consists of the renovation of a significant portion of the Zoo grounds and facilities, scheduled to be completed in celebration of the Zoo's 100th birthday in 2014 (Figure 1-2). The APE is sandwiched between the Cranes of the World exhibit to its northwest and the Tiny Tots Nature Spot exhibit on its south (Figure 1-3); these exhibit areas will remain intact. The bridge located adjacent to the Cranes of the World exhibit leading to the Riverview Restaurant is located outside of the current APE and will not be affected.

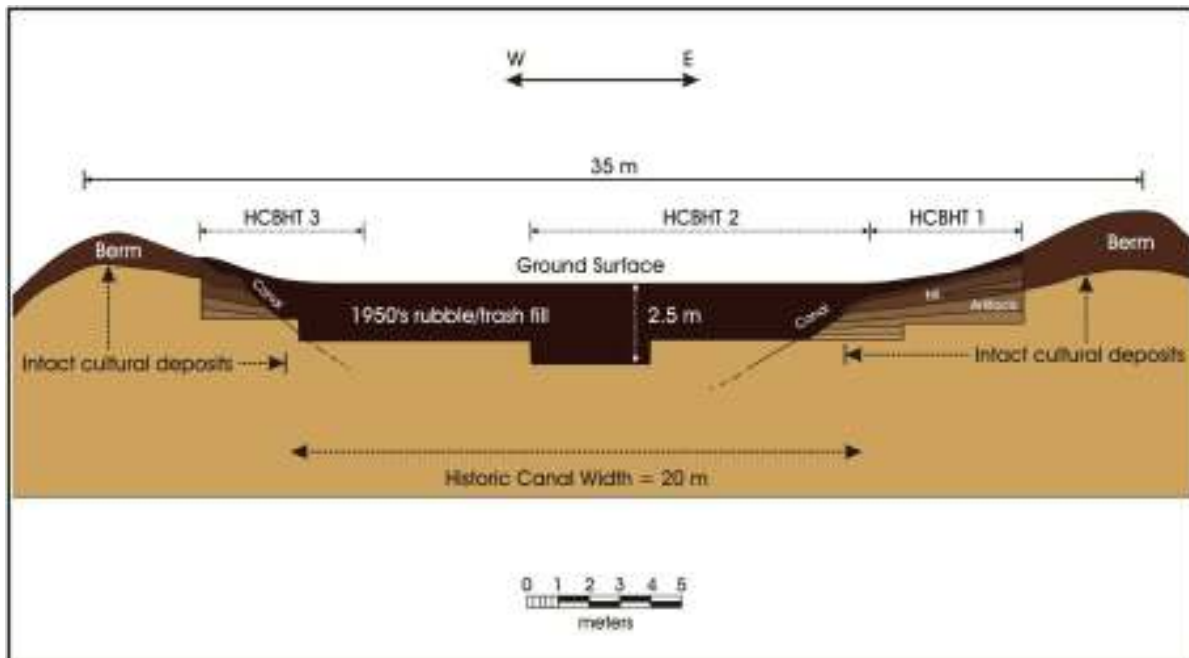
Figure 3-7. *Water works canal cross-section, north of the APE as recorded by Miller et al. 1999.*

SWCA conducted archaeological investigations of the Second Water Works Canal in 1997 (Miller et al. 1999). This was to record the structure and to assess its preservation. Three backhoe trenches were excavated in the northern end of the canal near its juncture with the San Antonio River. Two more trenches were placed near Mulberry Avenue. These provided a cross-section view of the canal and berms between Mulberry Avenue and Tuleta (Figure 3-8). Miller et al. (1999:43) reported the canal narrows from 20-10 m (65.6-32.8 ft.) as it approaches Mulberry and reaches depths below 2.5 m (8.2 ft.). The ground surface on which the berms were constructed was evident in the berm profiles as were intact prehistoric deposits beneath the berms along the canal (Miller et al. 1999:43). They found the canal was filled in the 1950s or 1960s with modern concrete, limestone blocks, asphalt, gravel, and recent trash (Miller et al. 1999:45).

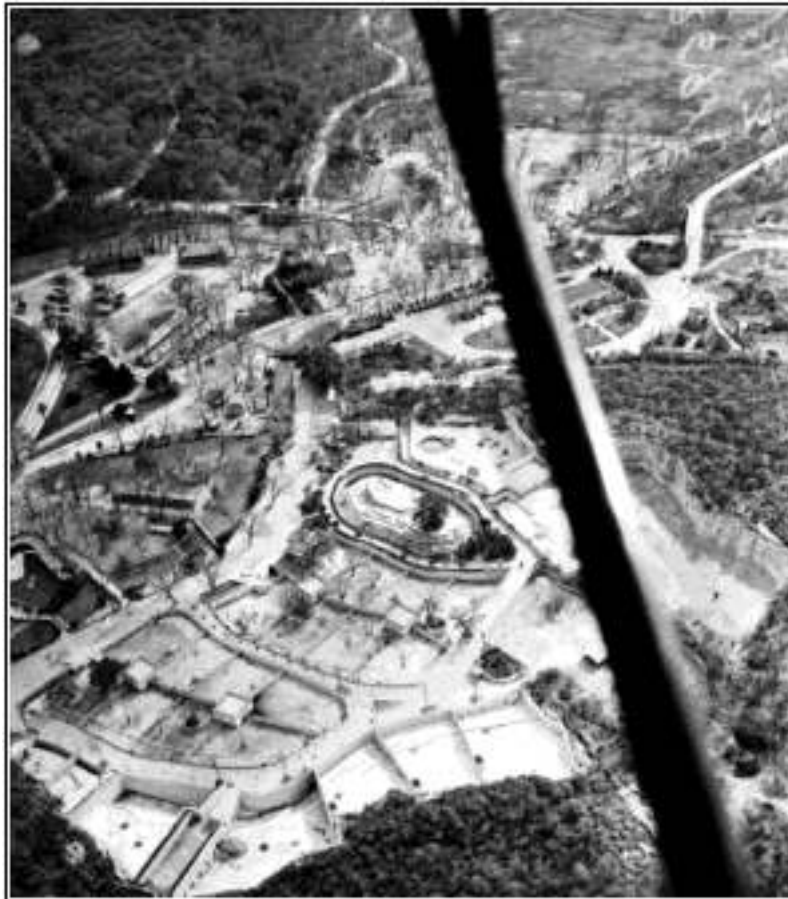
Figure 4-2. Aerial of the San Antonio Zoo taken in 1941 after the completion of new additions to the Zoo.

With funds from the Works Progress Administration (WPA), additional barless exhibits were constructed to house elephants and other large mammals. The new enclosures constructed by the WPA showed the skill and craftsmanship of the individuals. Stonemasons carved faces of humans and animals into the limestone as they shaped the walls (Meffert 1994). The first exhibit finished through the work of the WPA was an area for the impalas and gazelles located in the northern reaches of the Zoo. The WPA also did extensive work on the camel, dik-dik, and crane enclosures (Matthews 1991). In addition to the craftsmen, in 1938 the National Youth Administration (NYA) was employed to paint the signs for many of the exhibits (Figure 4-1). Between 1938 and 1940, the WPA constructed a large Bird of Prey Aviary. This enclosure is still standing, located just north of the current project's APE. A plaque on the structure indicates that it was constructed by the WPA between 1938 and 1940. By 1941, the additions and new exhibit areas constructed during this period were open to the public (Figure 4-2).

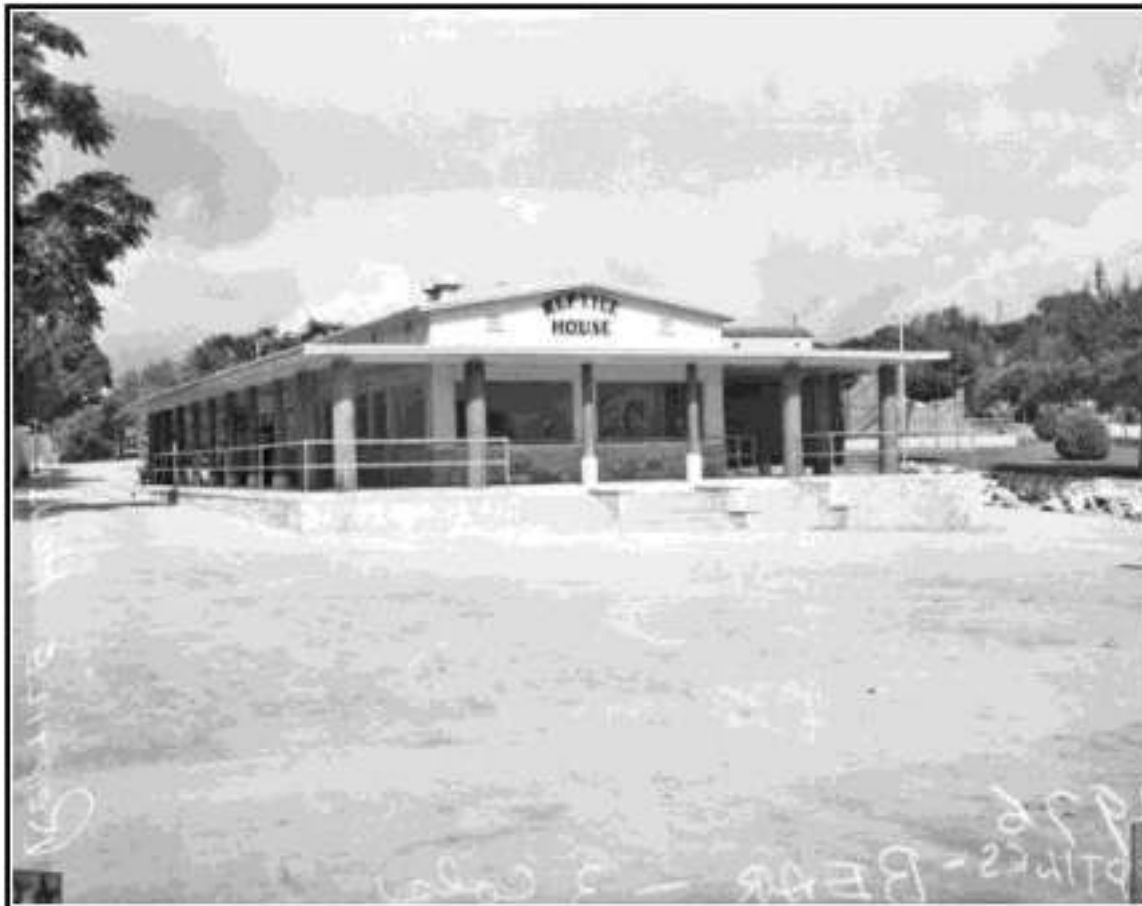
Figure 4-4. *Reptile House at its completion in 1942.*

Unlike it is today, when the Reptile House opened in June 1942, it was an open-air exhibit that contained up to 150 reptiles. Guests could view the animals while walking under the covered porch of the structure (Figure 4-4). The inhabitants of the Reptile House were representative of the over 100 varieties that had been collected over the years at the Reptile Garden located adjacent to the Witte Museum (Matthews 1991).

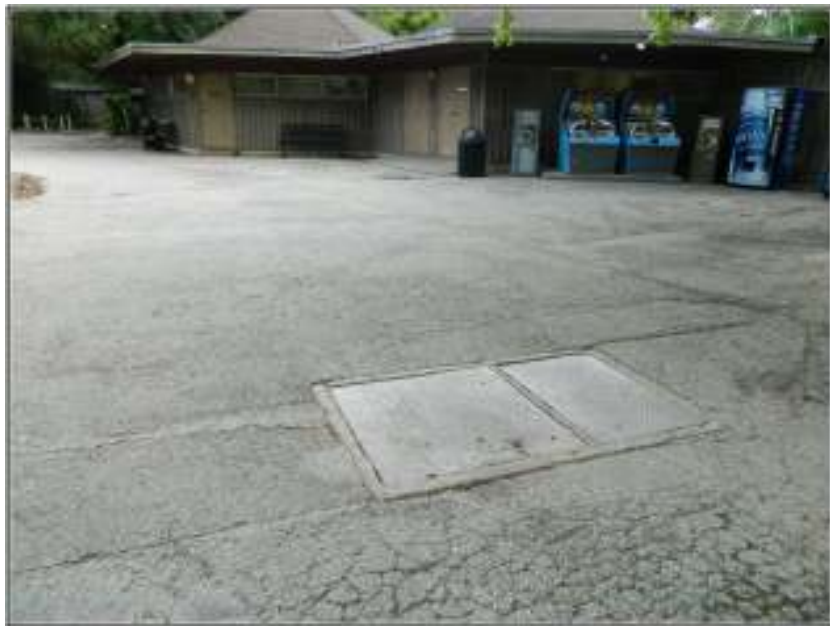
Figure 4-11. *Subsurface electrical conduit box.*

The previously reviewed history of the zoo indicates that extensive construction activities have occurred within the San Antonio Zoo and have impacted the APE under consideration here. CAR's inspection of the project area also identified signs of several subsurface disturbances. These disturbances were a result of the installation of sewer lines and electrical conduits and have impacted deposits to a depth of 1.2-1.8 m (4-6 ft.) below the surface (see Figures 4-11 and 4-12). These factors in combination with the shallow water table in the project area reduce the potential of the APE to contain intact cultural deposits.

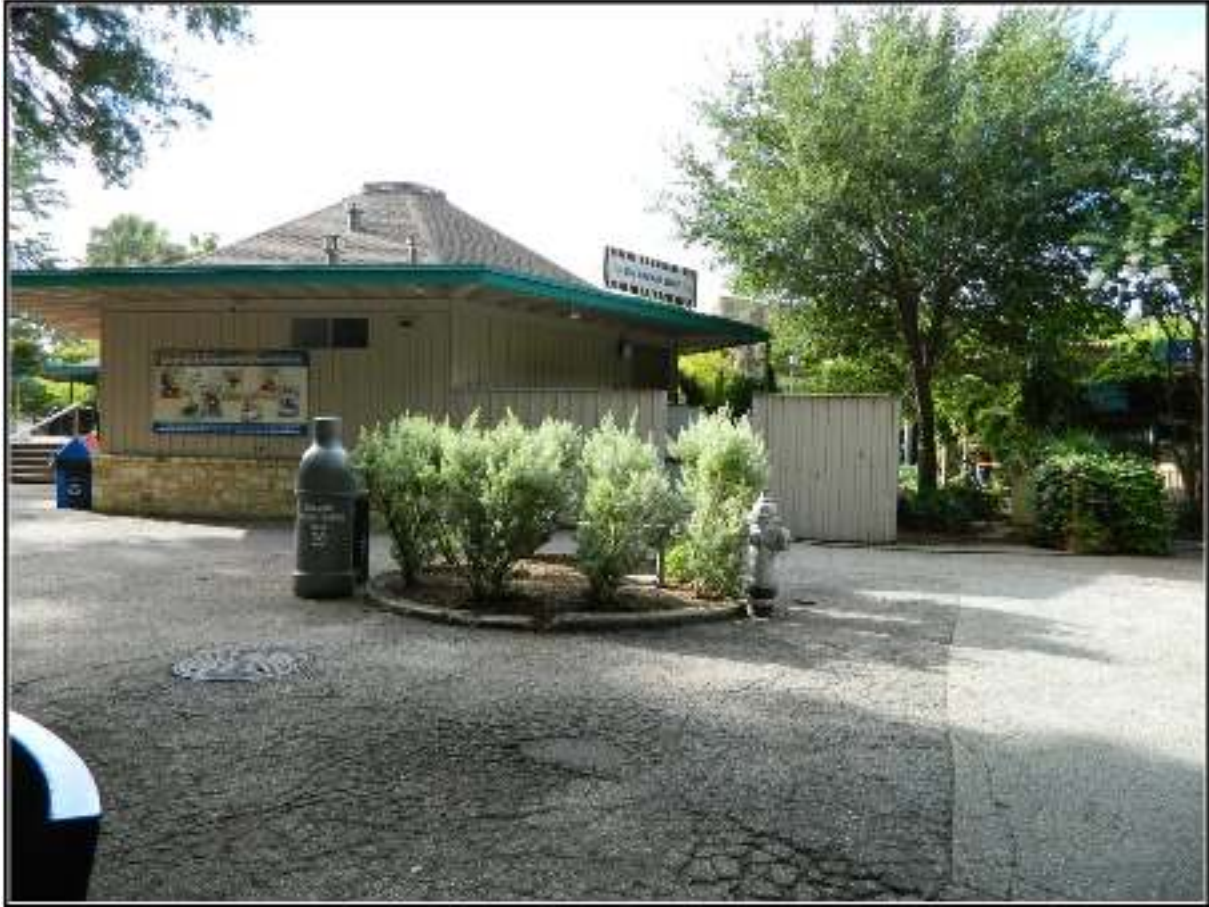
Figure 4-12. Culvert connecting sewer lines in the vicinity of the Ice Cream Shop.

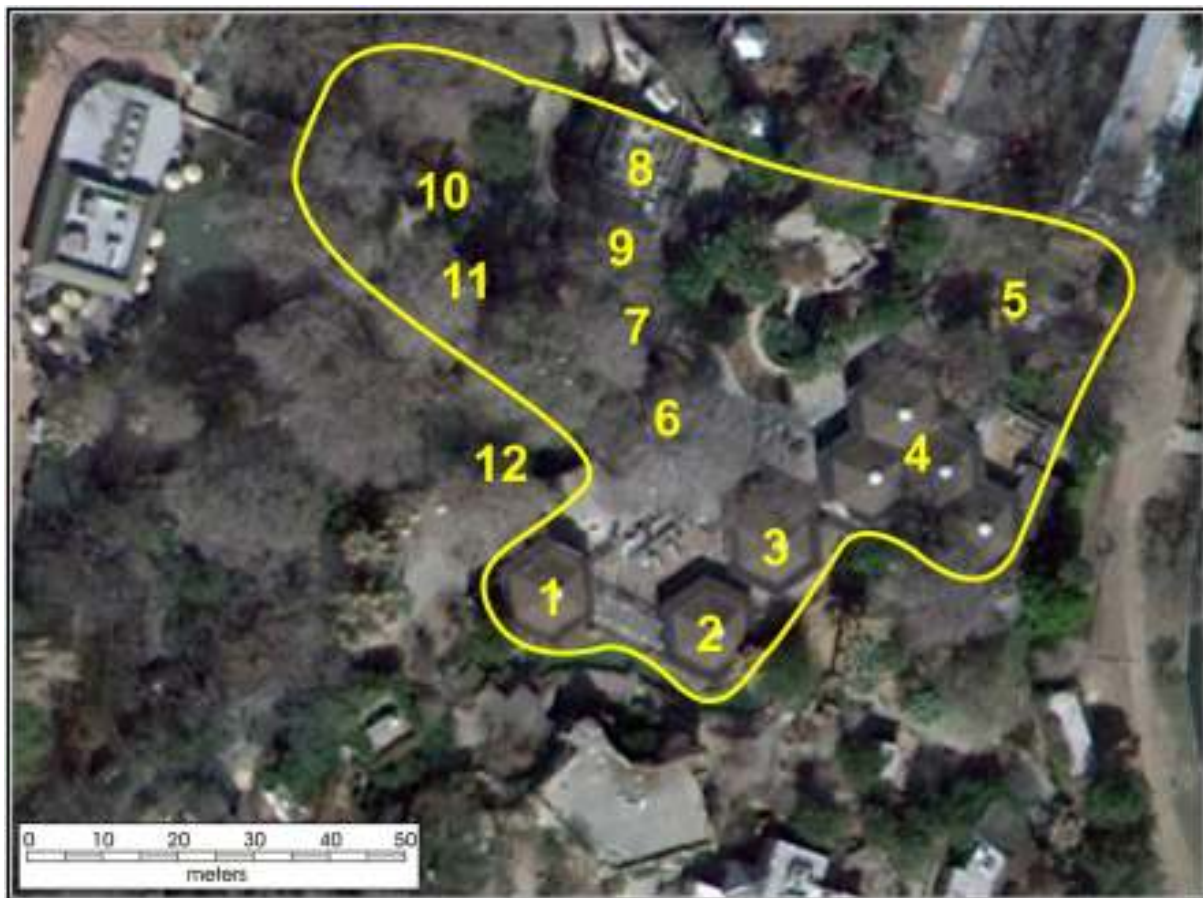
Figure 6-1. Historic Resource locations within the current APE.

Field visits were made to the Zoo on November 27, January 20, and February 29. The structures to be affected by the improvements to the Zoo were documented on February 29, 2012. Documentation included the photography of the structures and features as well as the completion of the Standing Structure Survey Form. The CAR archaeologist met with the Superintendent of Maintenance at the Zoo to be shown the boundaries of the APE. Armed with this information, aerials, and a master plan map, the archaeologist identified 11 Standing Structures within the APE needing documentation. All 11 resources were located in an area of the Zoo to the northeast of the Tiny Tot Nature Spot, to the southeast of the Riverview Restaurant, and to the south of the Wetlands exhibit (Figure 6-1). The bridge leading to the Riverview Restaurant is located outside of the current APE and will not be affected by construction. It was not included in the current survey.

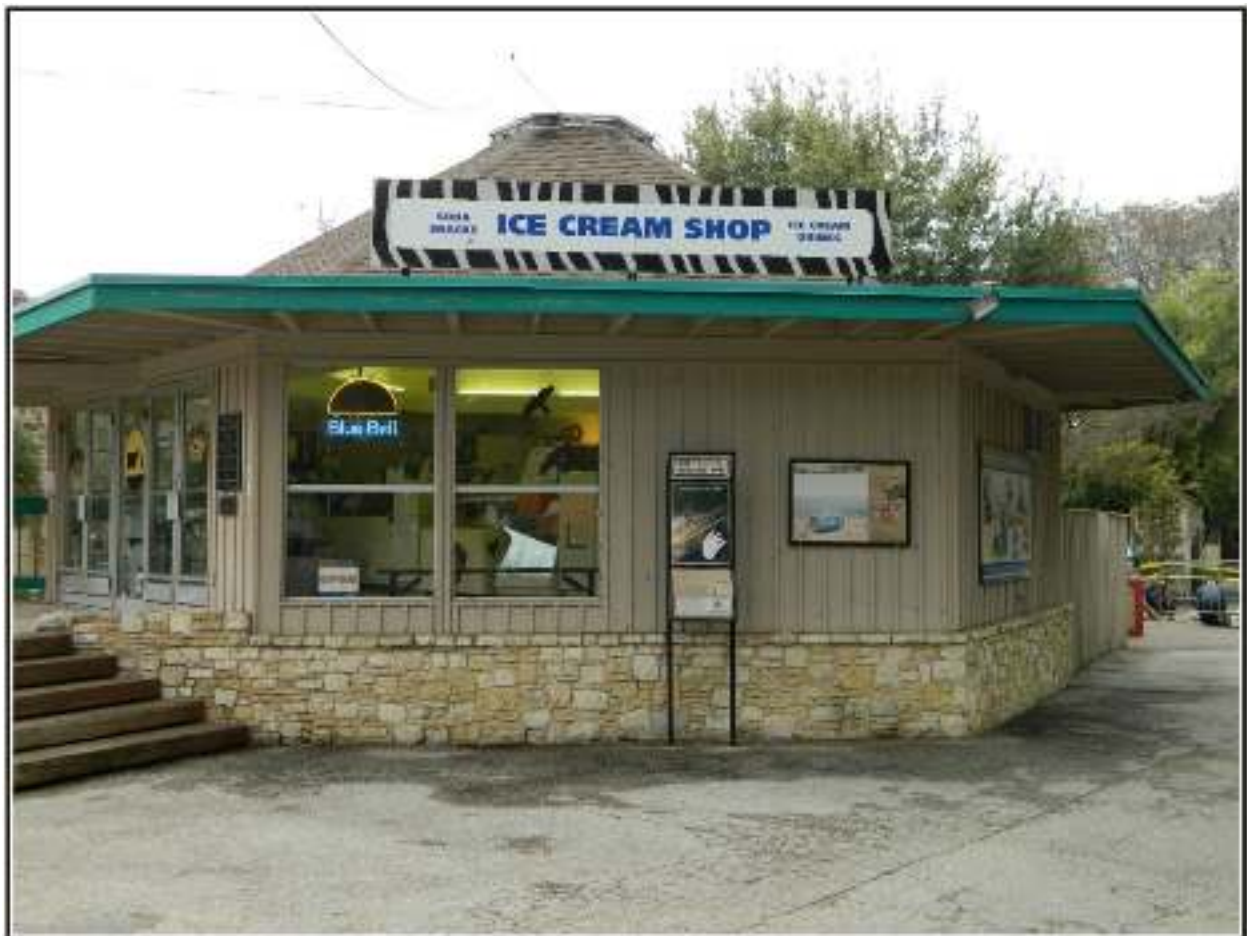
This structure was built as part of the Children's Zoo in the 1980s. It shows up on the 1979 master plan of the area but appears to not have opened to the public until 1982. A plaque on the front of the structure indicates that it was the Hixon Visitor Center. It is likely that it has always served as an ice cream shop.

Figure 6-2. *Historic Resource #1, the Ice Cream Shop located next to the Tiny Tot Nature Spot at the San Antonio Zoo.*

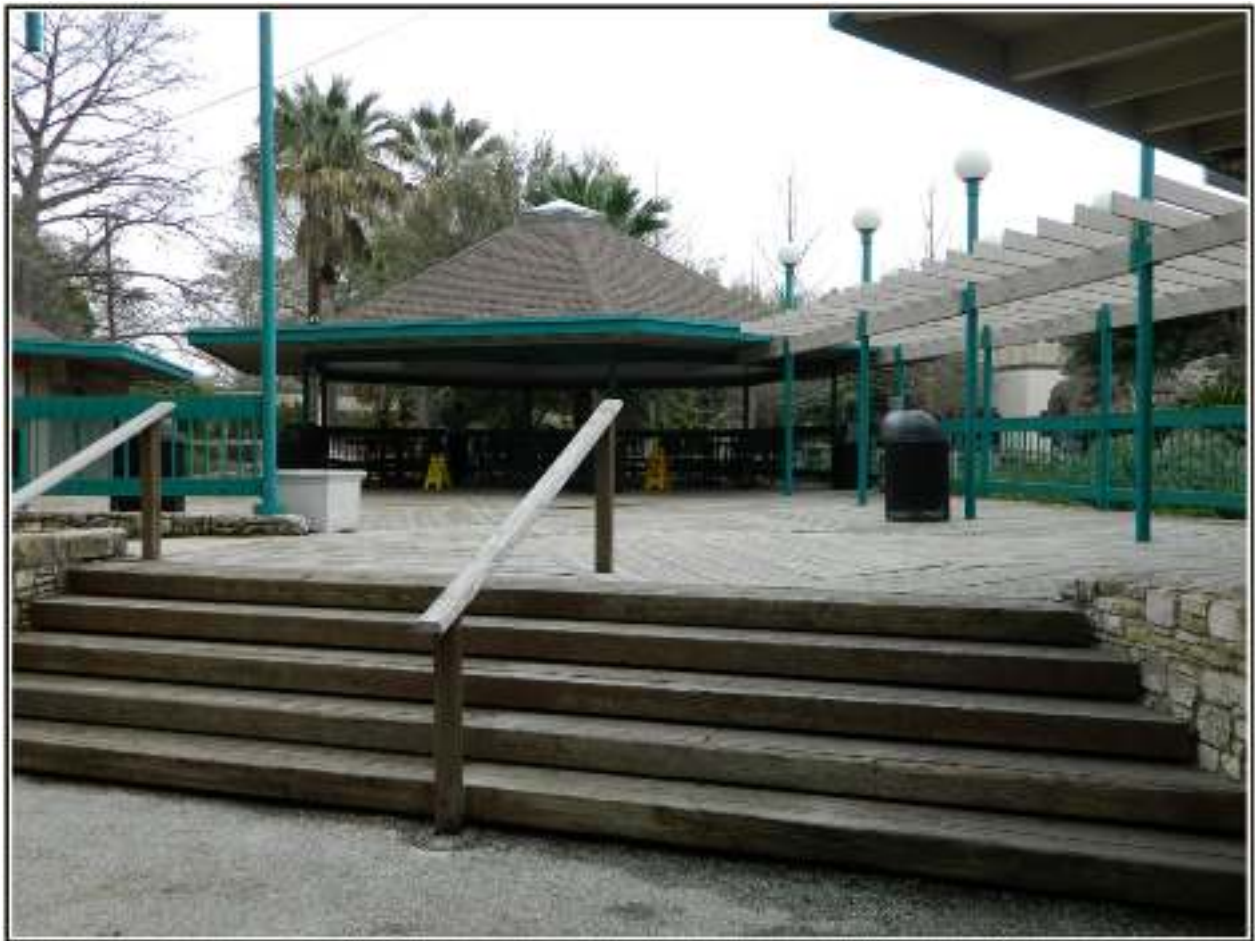
Similar to the Ice Cream Shop, this feature was part of the Children's Zoo expansion that was completed in the 1980s. It also appears on the 1979 master plan of the new addition but likely did not open to the public until 1982. Today, the wood of the boardwalk and railings shows some deterioration, but it is still in good condition. Many groups use the pavilion for lunch and party gatherings.

Figure 6-3. *Historic Resource #2, the Ice Cream Deck adjacent to the Ice Cream Shop at the San Antonio Zoo.*

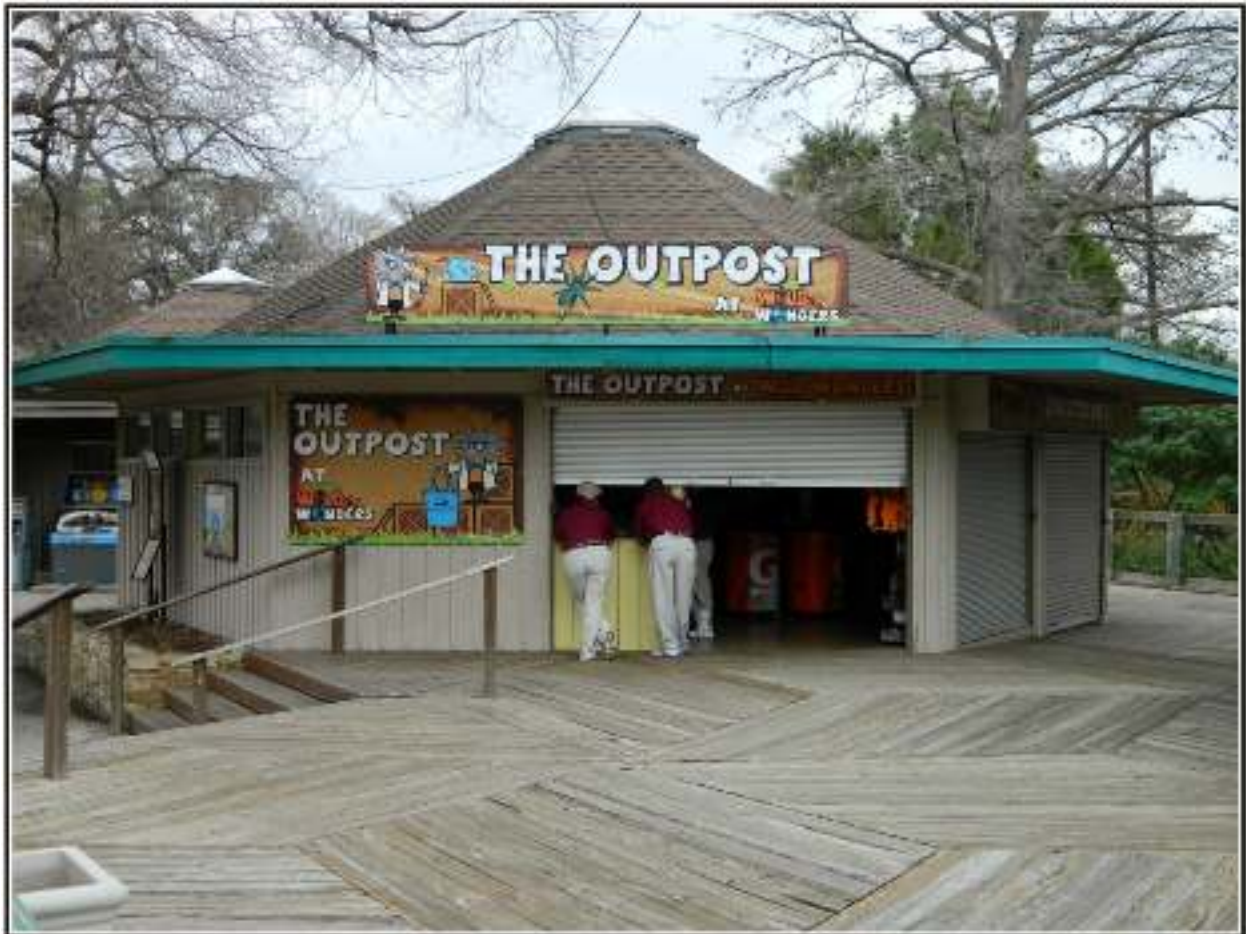
This is another building that was constructed during the early 1980s. The same shape and construction techniques were used in these three Historic Resources. Newspaper articles and old maps of the Zoo place these near the entrance of the Children's Zoo addition.

Figure 6-4. *Historic Resource #3, The Outpost, a gift shop and restroom facility at the San Antonio Zoo.*

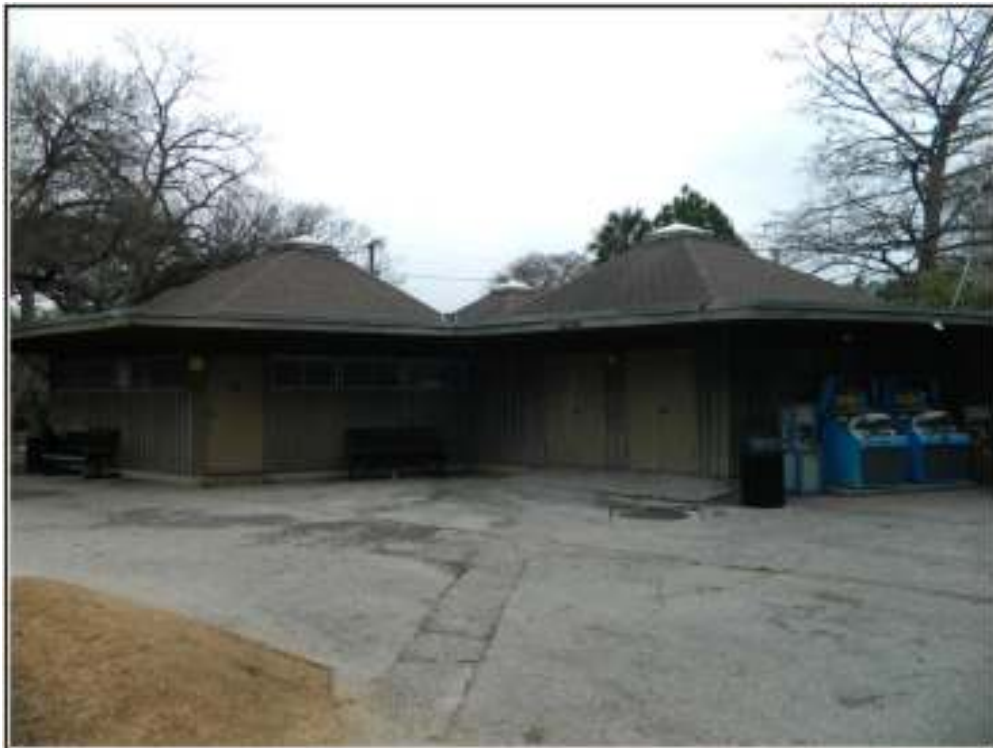
A fenced area to the north of Historic Resource #4 has a few small hutches and sheds. It is likely that these provide additional room for animals and the storage of tools and supplies.

Figure 6-5. *Historic Resource #4, larger building that houses the Wild Wonders exhibit.*

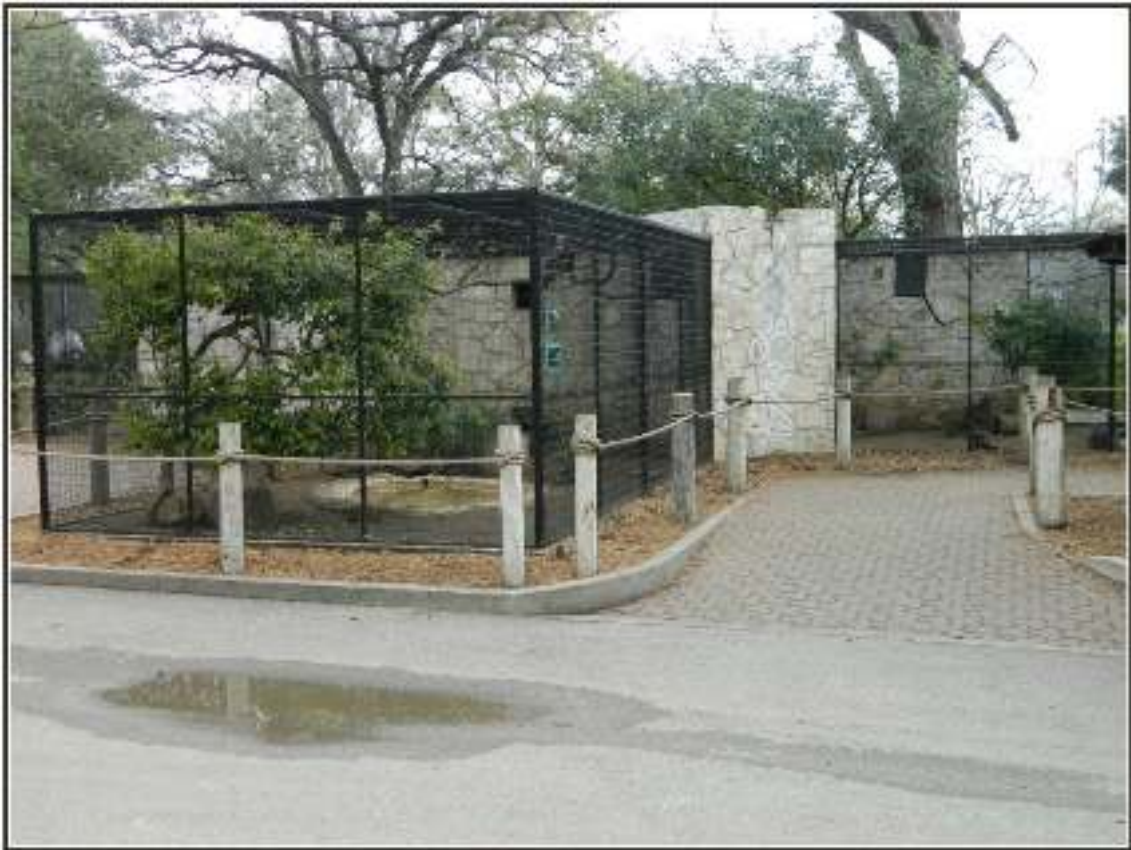
The structure sits on a concrete slab and is aligned like an “X”. Since the roof is flat, the construction materials cannot be determined from the ground. A brick pathway allows visitors to walk around the building and see each of the birds housed in the exhibit.

Figure 6-6. *Historic Resource #5, a bird enclosure located to the north of the Wild Wonders exhibit.*

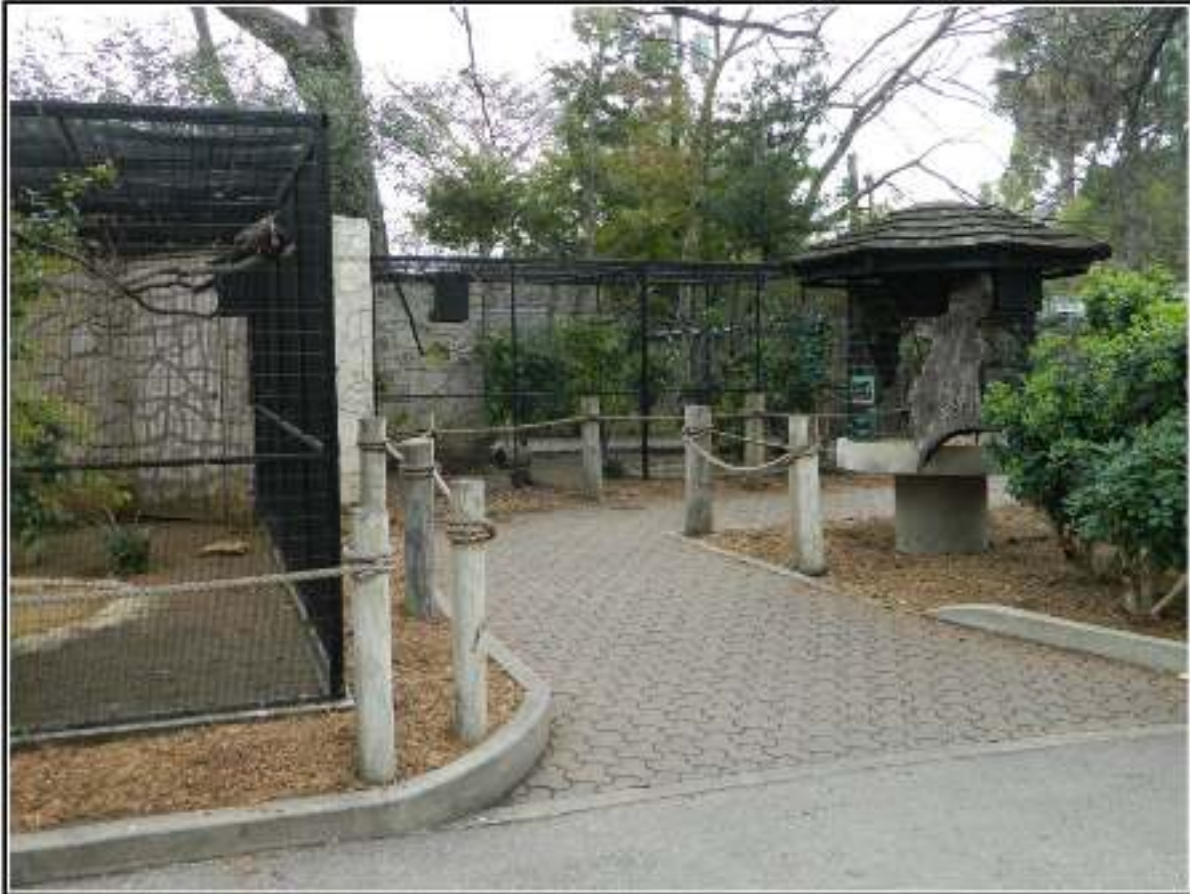
Adjacent to the structure is a round birdcage with a shingle roof. The small, round cage sits on a concrete pedestal (Figure 6-7). The date of construction is unknown for this cage, but it could be contemporaneous with Historic Resource #5.

Figure 6-7. Round birdcage associated with Historic Resource #5.

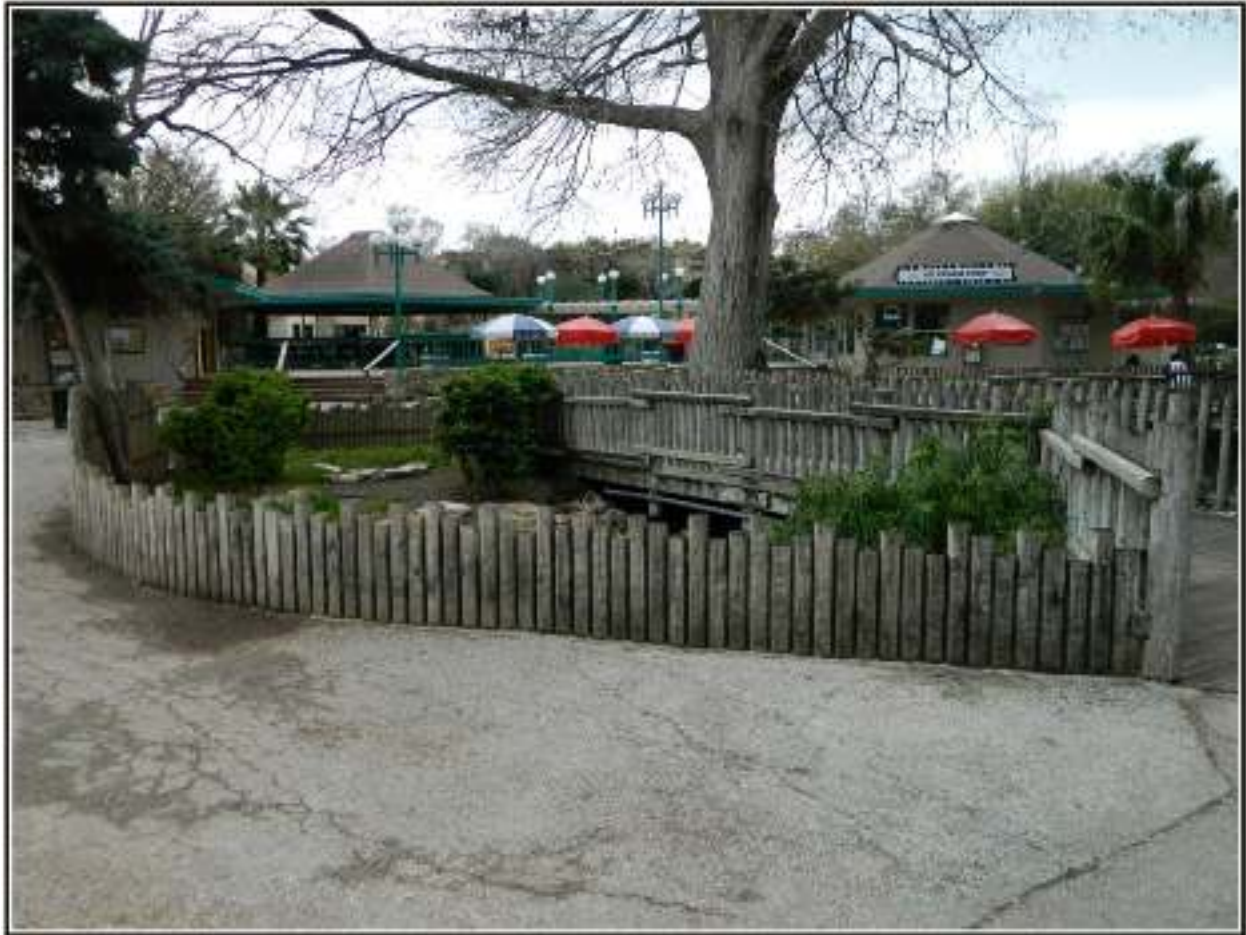
noted on any map of the Zoo. The Waterfowl pond connects into the Upper Labor *Acequia*, although the *acequia* appears to run closer to the western portion of the waterway.

Figure 6-8. *Historic Resource #6, turtle enclosure located on the edge of the Waterfowl pond at the San Antonio Zoo.*

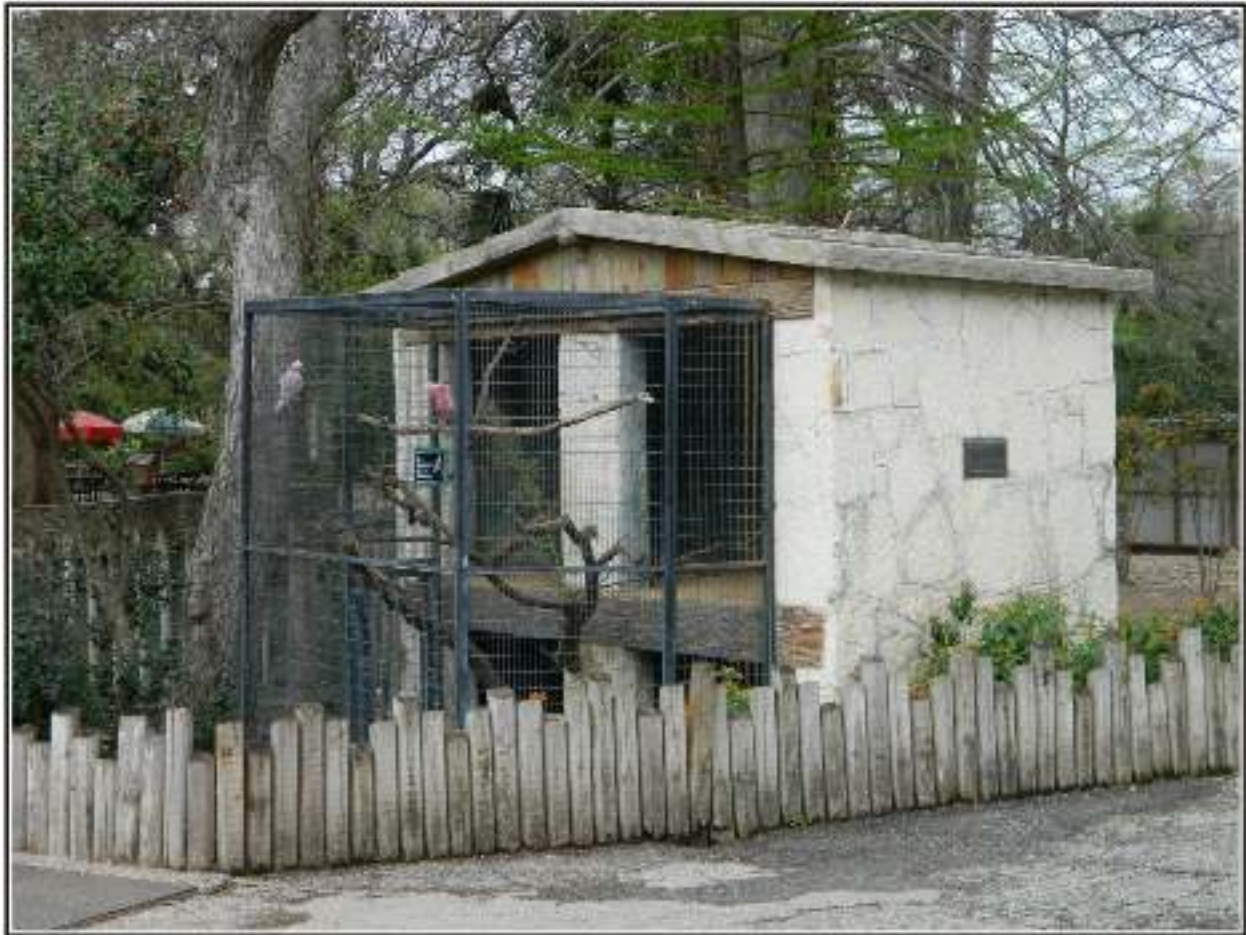
The structure does not show up on any of the Zoo maps perhaps because it is so small. A date of construction is unknown, though it may be contemporaneous with another Historic Resources (Historic Resource #10) exhibiting the *faux bois* style.

Figure 6-9. *Historic Resource #7, a bird cage located at the edge of the Waterfowl pond at the San Antonio Zoo.*

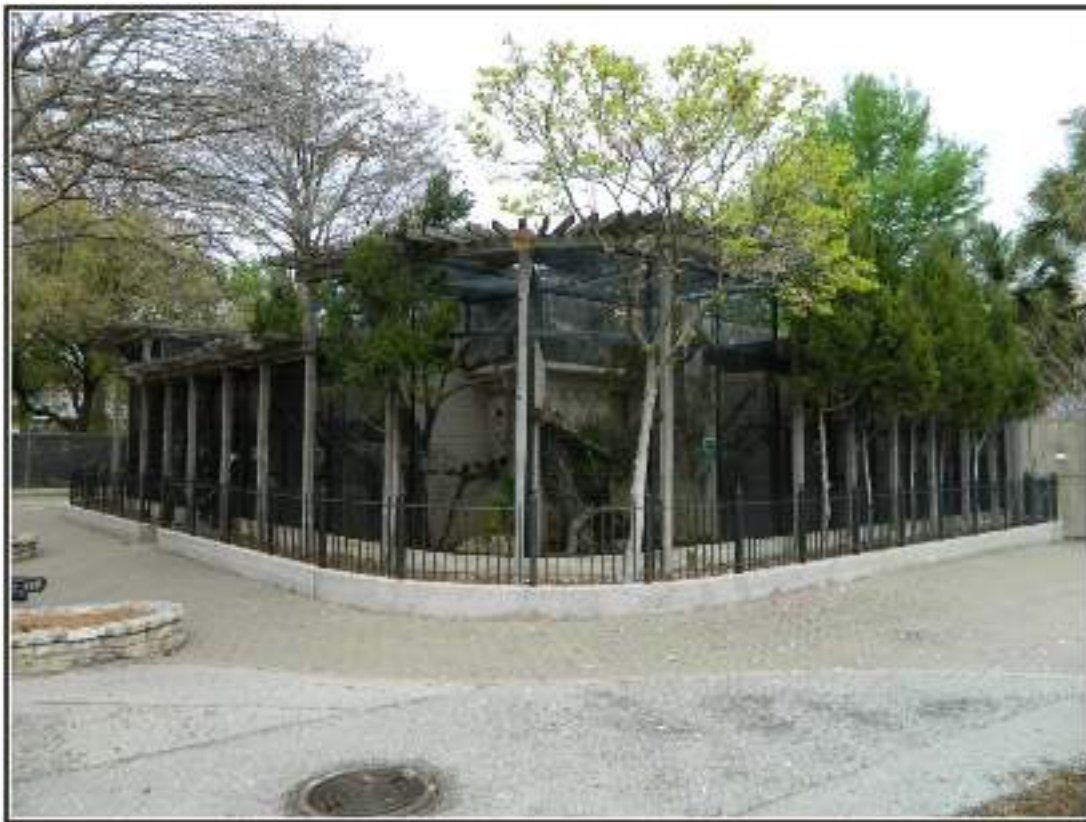
Modern additions to the structure are evident in the form of metal casement windows on the rear elevation and the additions to the front and side for the bird enclosures. It appears that glazed brick has been used in the construction of the bird enclosure additions to the structure. The wrought iron fencing and the wood shade covering are also elements that have been added after the initial construction of the structure.

Figure 6-10. *Historic Resource #8, Parrots of the World exhibit located just north of the Waterfowl pond at the San Antonio Zoo.*

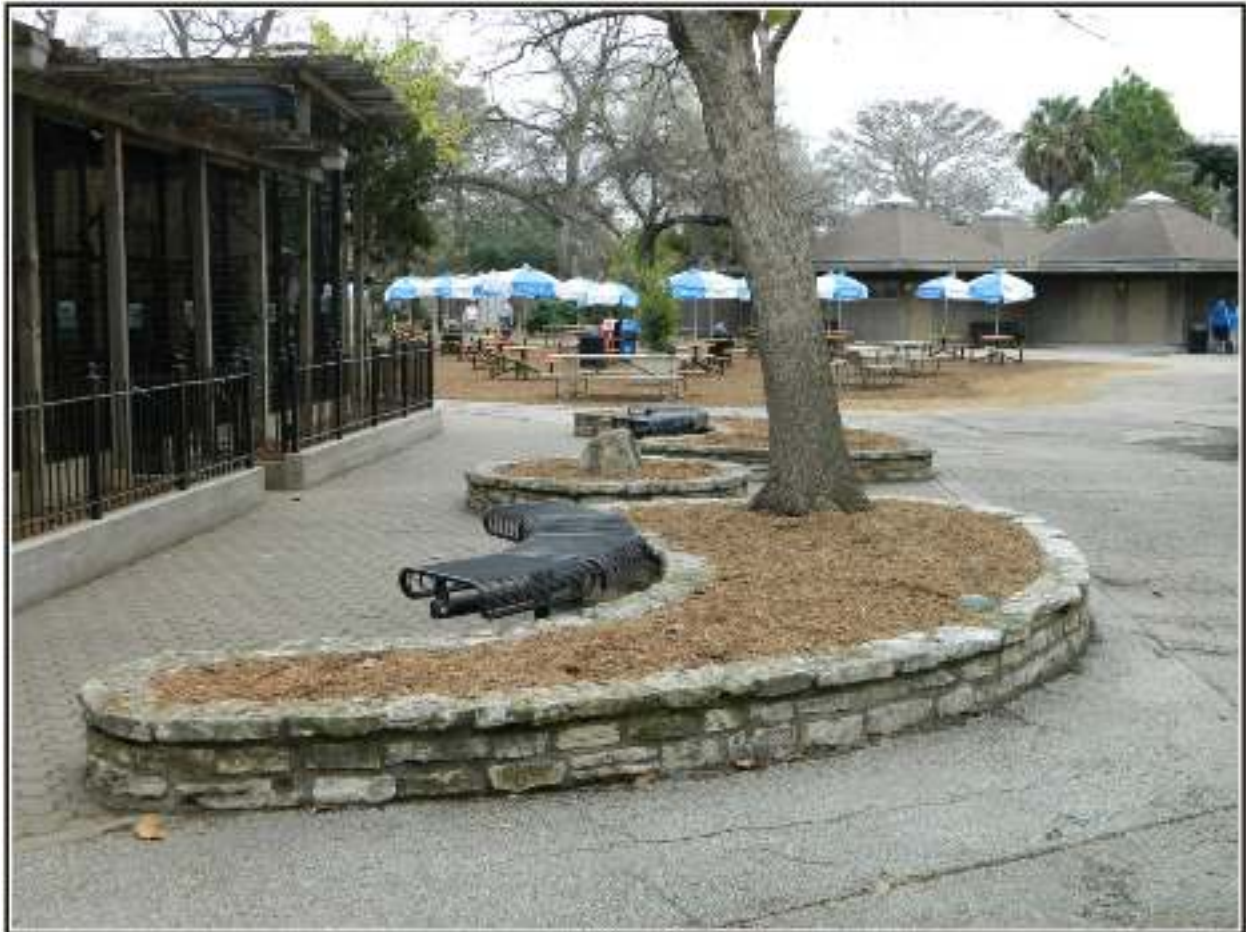
together. The limestone blocks used in these planters are uniform in size and shape. Metal benches are situated in the curves of the two outer planters. The inner circular planter contains a stone with a plaque that reads, “Parrots of the World Sponsored by Betty and Bob Kelso in appreciation for the beauty and diversity of this family of birds 1990.”

Figure 6-11. *Historic Resource #9, planters located in front of the Parrots of the World exhibit.*

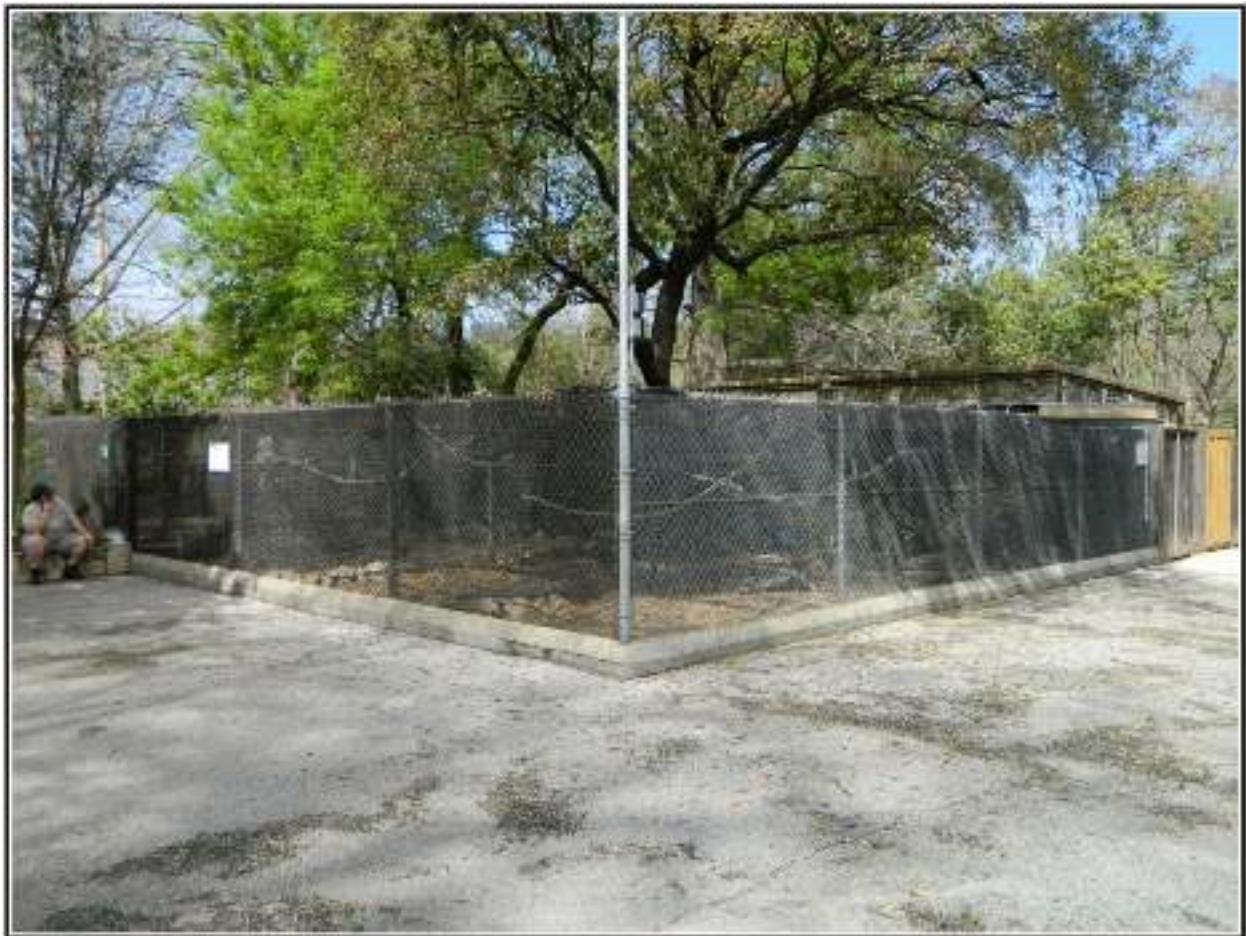
Similar to Historic Resource #7, this structure exhibits *faux bois* accents. The roof is composed of *faux bois* shingles. Along the east side, a *faux bois* lintel is present above a doorway into the structure. Along the west side, a *faux bois* timber is seen above the “cubbies”. It appears that this resource was constructed approximately at the same time as Historic Resource #7, although the chain-link fencing and enclosures are more recent additions. The structure does not appear on the map of the Zoo dated to 1960s, but an exhibit area specified for storks and cranes appears on the ca. 1980s map. The structure may have been built prior to 1960, although none of the Zoo maps show these buildings.

Figure 6-12. *Historic Resource #10, a bird enclosure located to the west of the Parrots of the World exhibit, note that the fenced area is attached to a stone building.*

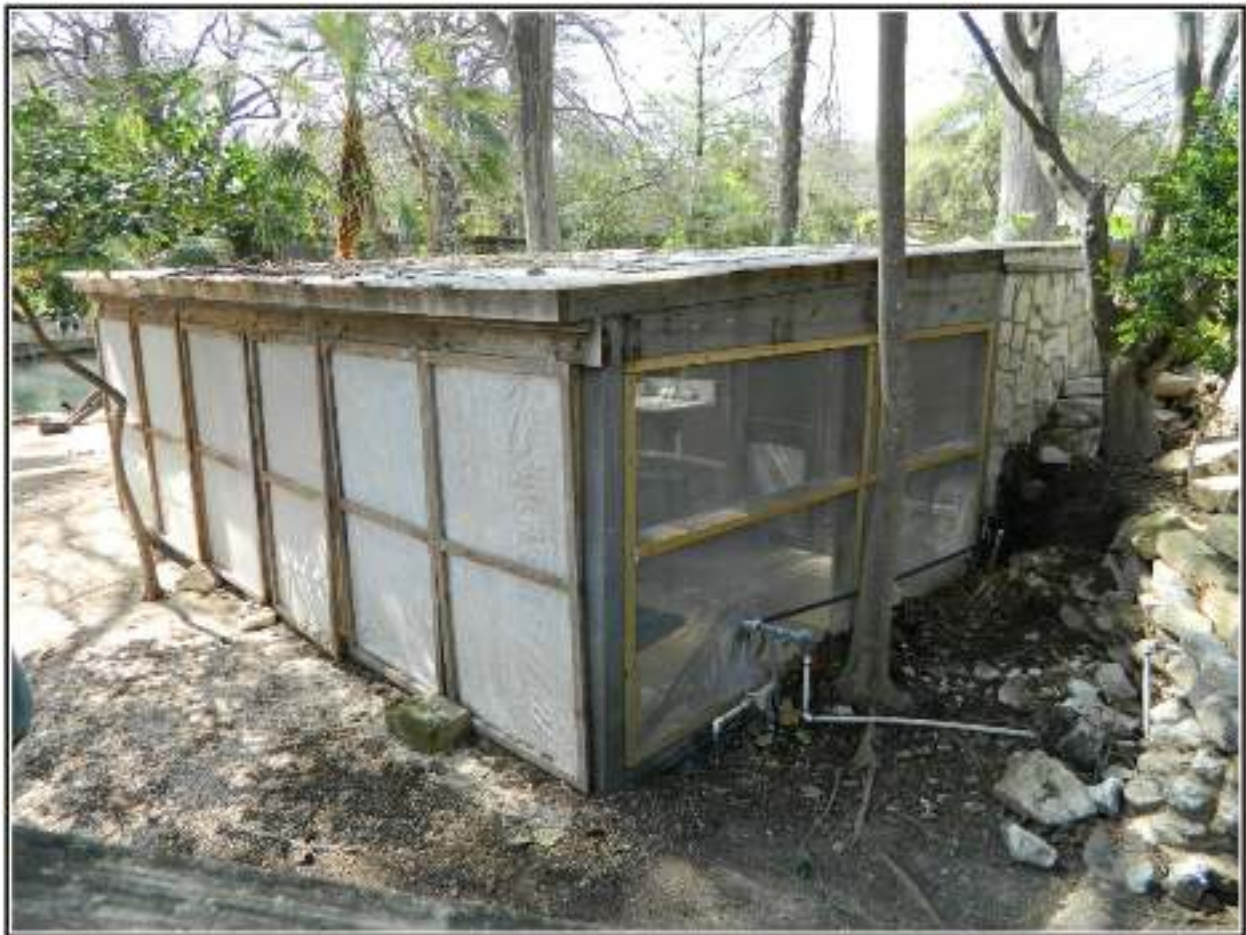
house some geese and goslings. The screened patio is a wood frame construction with wire mesh screen and a corrugated flat plastic roof. The structure is on a concrete slab while the patio is on the ground. The stone structure is divided into at least two rooms. It appears that the north wall of the stone structure has two construction styles (Figure 6-14). The eastern half of the north wall consists of small to medium limestone rocks mortared together. The attached western half of the north wall consists of larger stones. The western section appears to have the *faux bois* shingles. The southern wall of the stone structure has large stones and *faux bois* roof. The western portion of the structure also appears to be incorporated into a water feature that consists of a small waterfall and pool (Figure 6-14).

Figure 6-13. *Historic Resource #11, bird enclosure located at the edge of the Waterfowl pond at the San Antonio Zoo.*
