**A Historic Standing Structure
Survey of a Portion of the
San Antonio Zoo, Bexar County, Texas**

Prepared by:
Center for Archaeological Research
The University of Texas at San Antonio
One UTSA Circle
San Antonio, Texas 78249-1644
Technical Report, No. 37

As part of the Standing Structure Survey, 12 Historic Resources were recorded. Four of the resources were constructed as part of the Children's Zoo that opened in 1982. Seven resources were likely constructed between 1941 and 1960. One appears to have been constructed during the late 1930s.

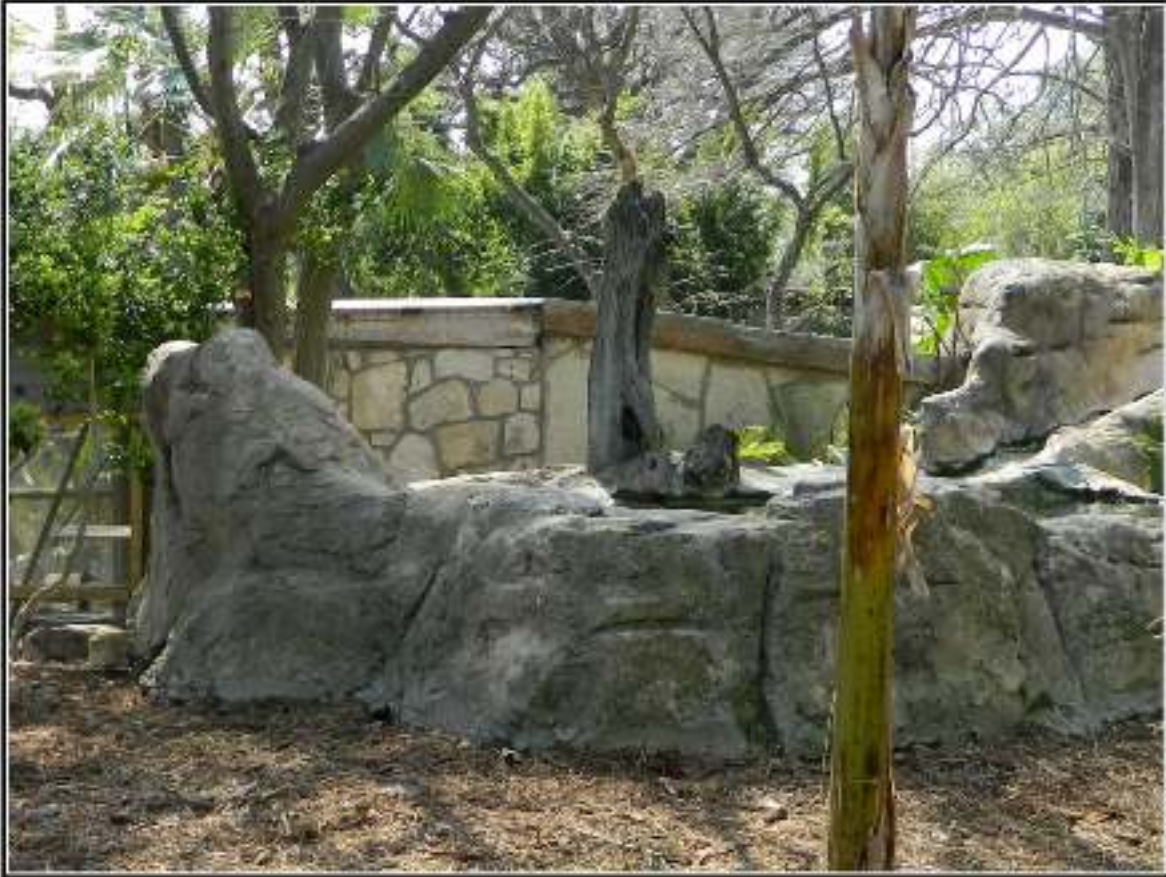
Figure 6-14. *Historic Resource #11, note the difference in the stones used.*

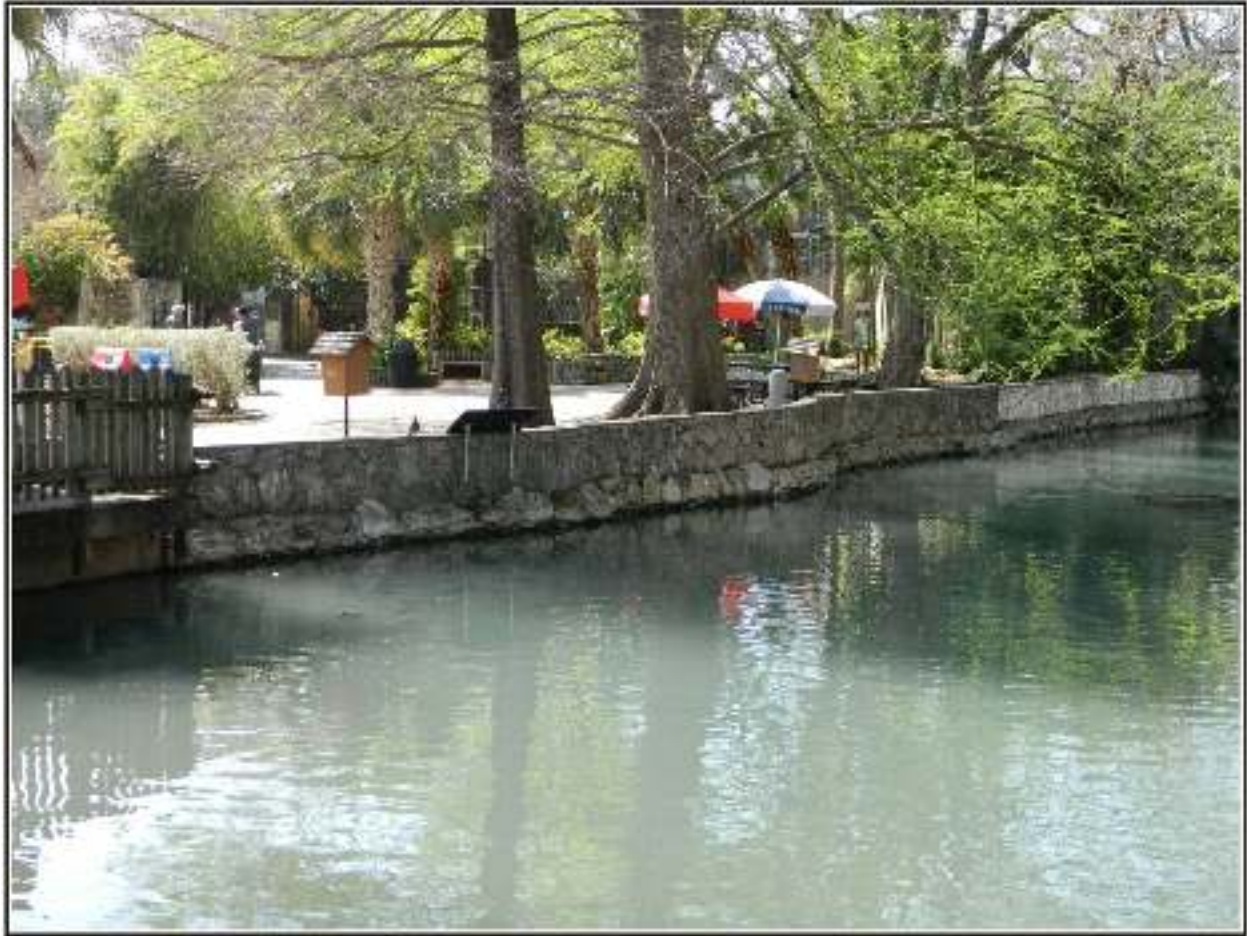
Although Historic Resource #12 is located within the project APE, it will not to be affected by any of the improvement activities. Contractors will be given very clear instructions to avoid disturbing the wall.

Figure 6-15. *Historic Resource #12, stone wall located along the eastern edge of the Waterfowl pond.*

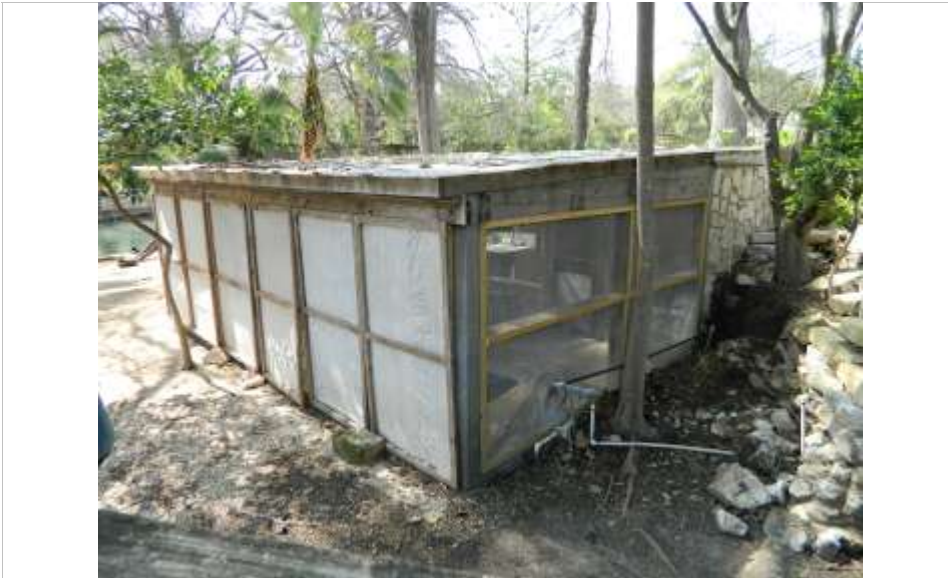
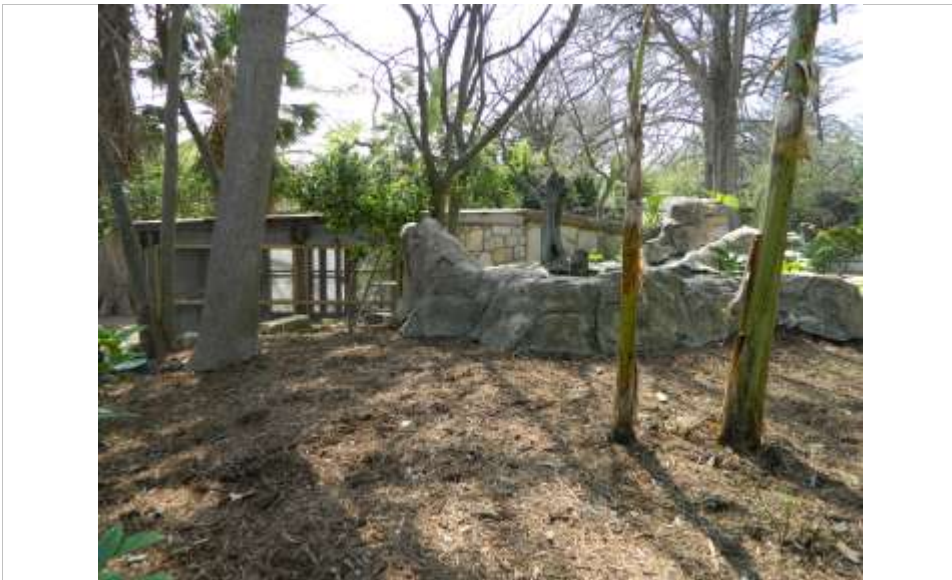
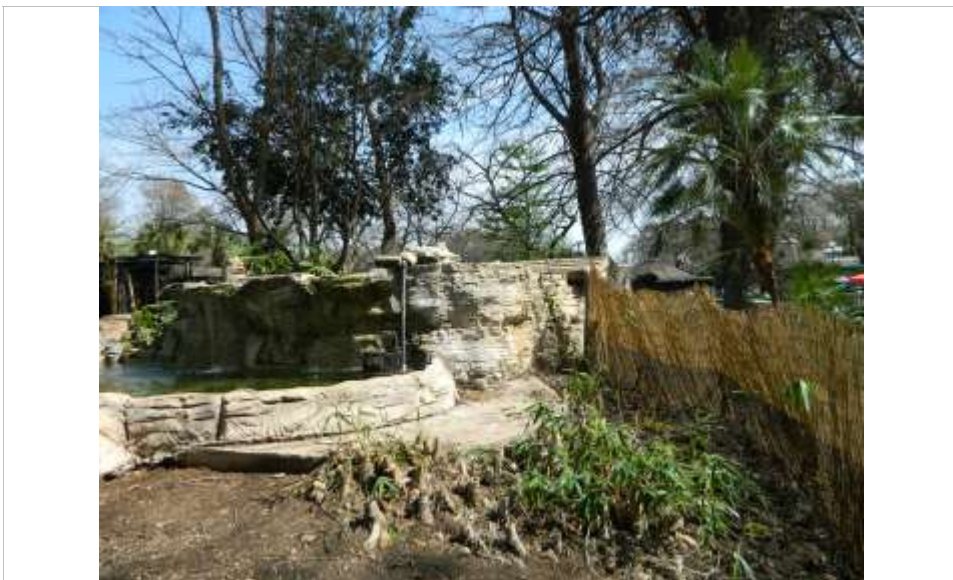
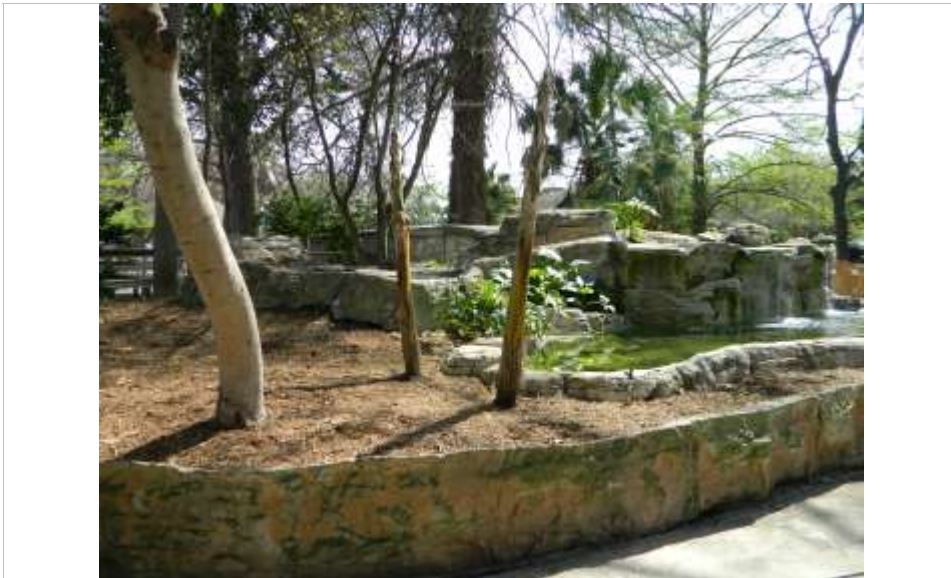
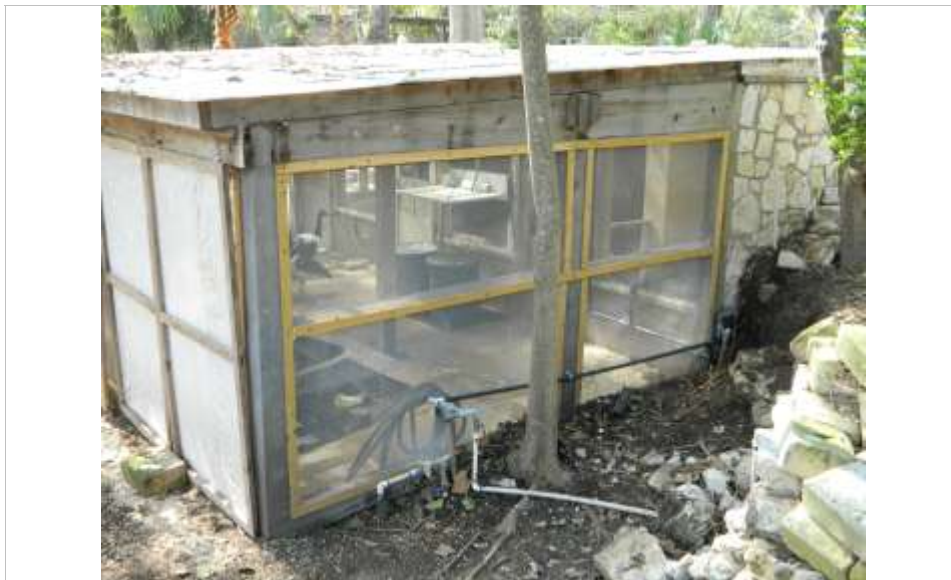
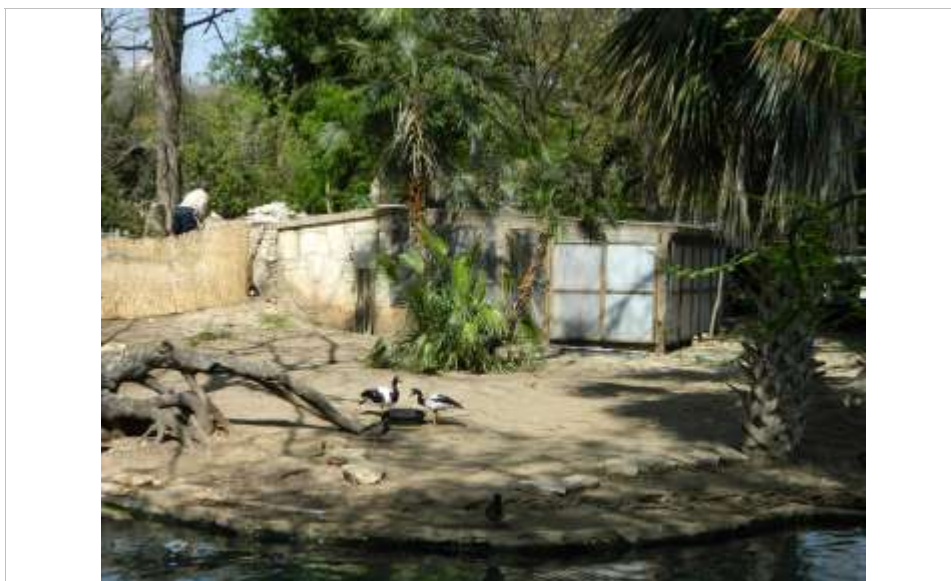
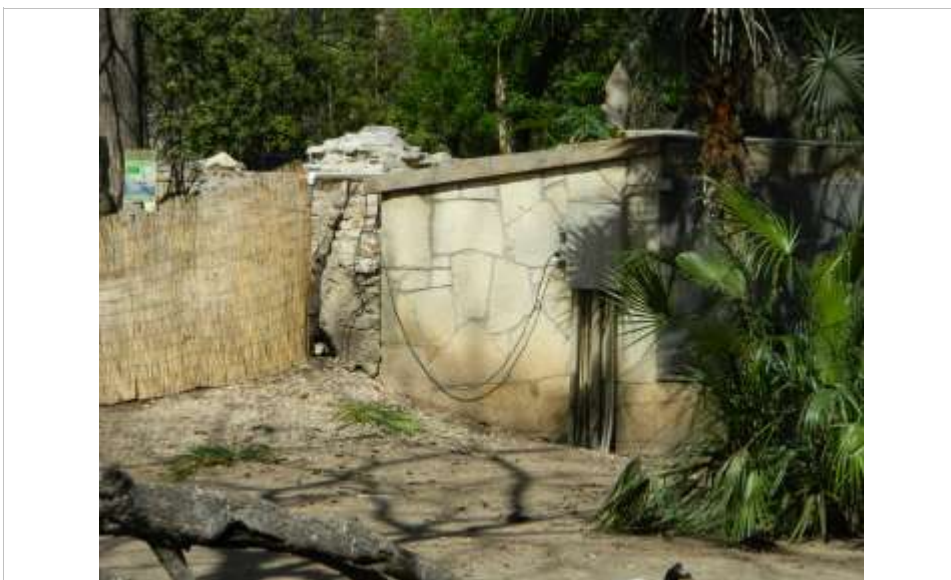
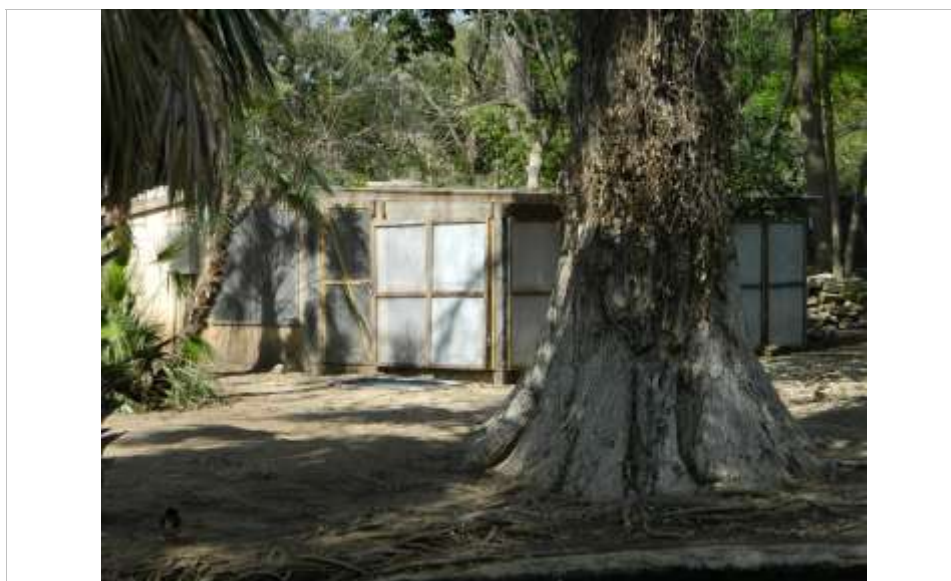
City San Antonio County Bexar Inventory # 11

A stone and concrete structure with a wood frame addition. Wood frame is enclosed with screen and plastic. Being used for geese and gosslings. The back part of the structure (stone part) is connected into the water feature. It resembles WPA-era construction, but not so finely done. Cannot get entire structure. Appears to be three different building styles, and can see a seam in the permanent portion of the small structure. A water feature is attached to the rear elevation of the structure. Faux bois elements are noted on the roof.

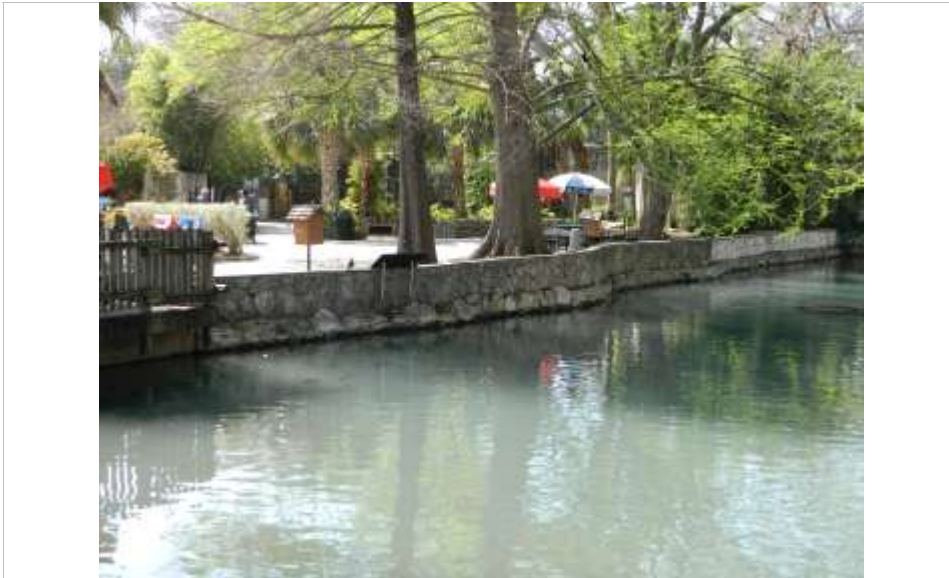
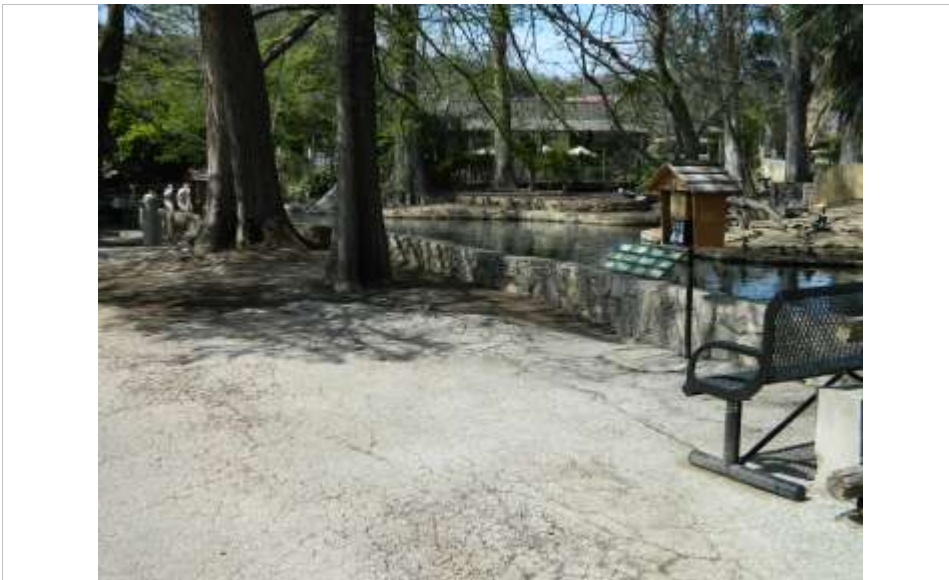
City San Antonio County Bexar Inventory # 12
Historic Name Complex/Site Name Waterway

Wall Façade rock and cement Foundation rock

Historic Resource #12 is a stone wall located along the water fowl pond at the San Antonio Zoo (Figure 6-15). The wall is constructed of limestone rock held together by Portland cement. The wall portion located on the opposite bank from Historic Resource #11 is in line with the old path of the *acequia*. It is likely that the stone wall was constructed during the early development of the Zoo when the water fowl pond was created. The style and stones that were used in the construction are consistent with the walls that are found outside of the Zoo grounds along the San Antonio River. The waterway is visible on both the 1941 aerial and the 1941 map of the San Antonio Zoo. Although it is not possible to tell if this wall was present on either the maps or the aerial, it is very likely that the wall was constructed prior to 1941 because the pond has not changed in shape. This would place construction likely during the late 1930s, and it may be contemporaneous with the WPA-era work that was done in 1938.

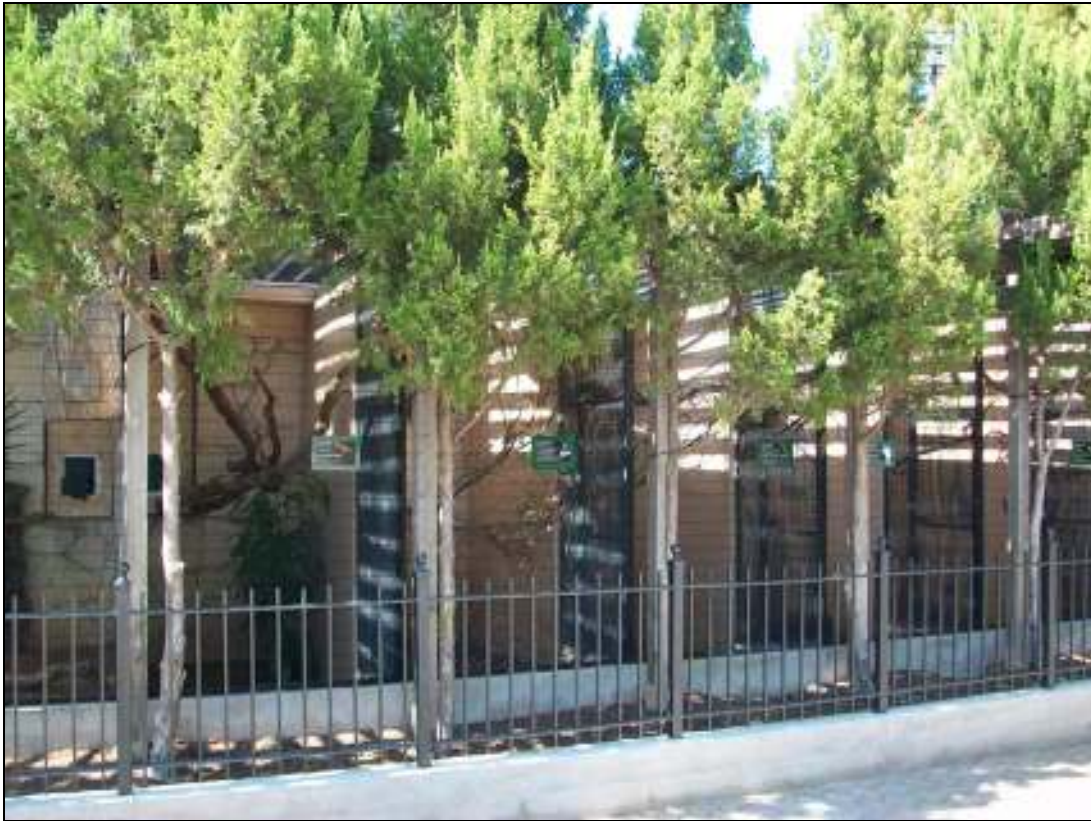
Resource #8 – detail of façade with exterior cages

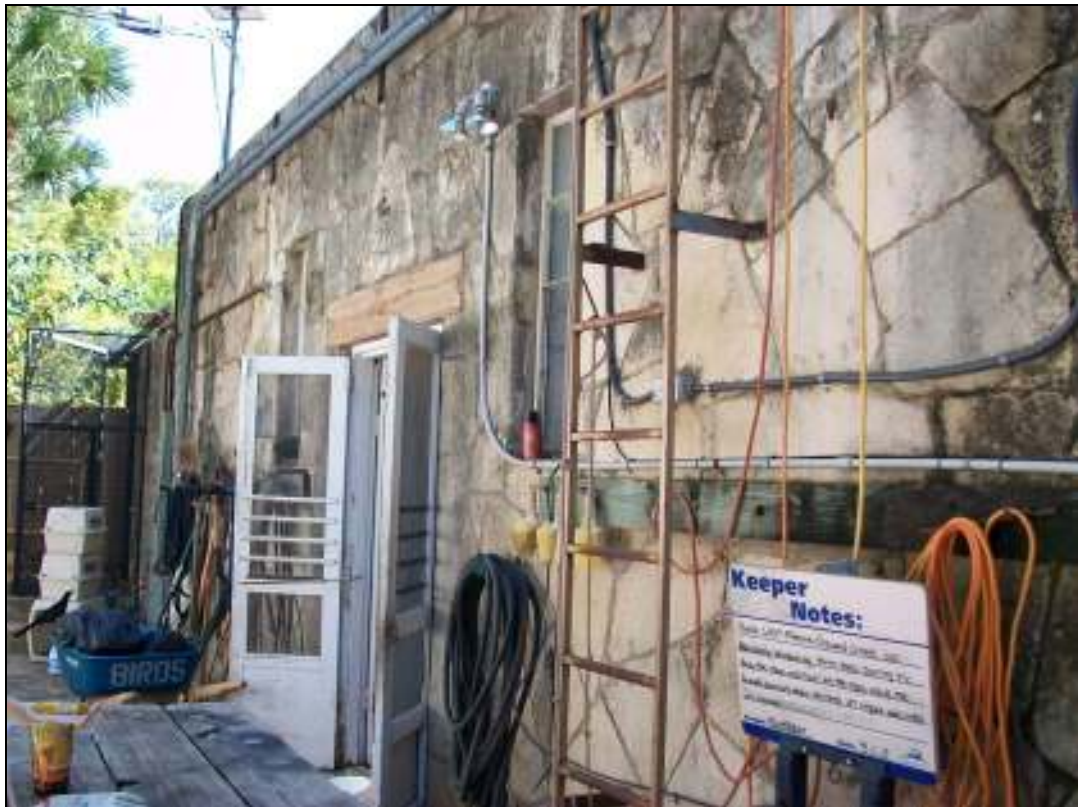
Resource #8 – rear elevation with casements and *faux bois* lintel

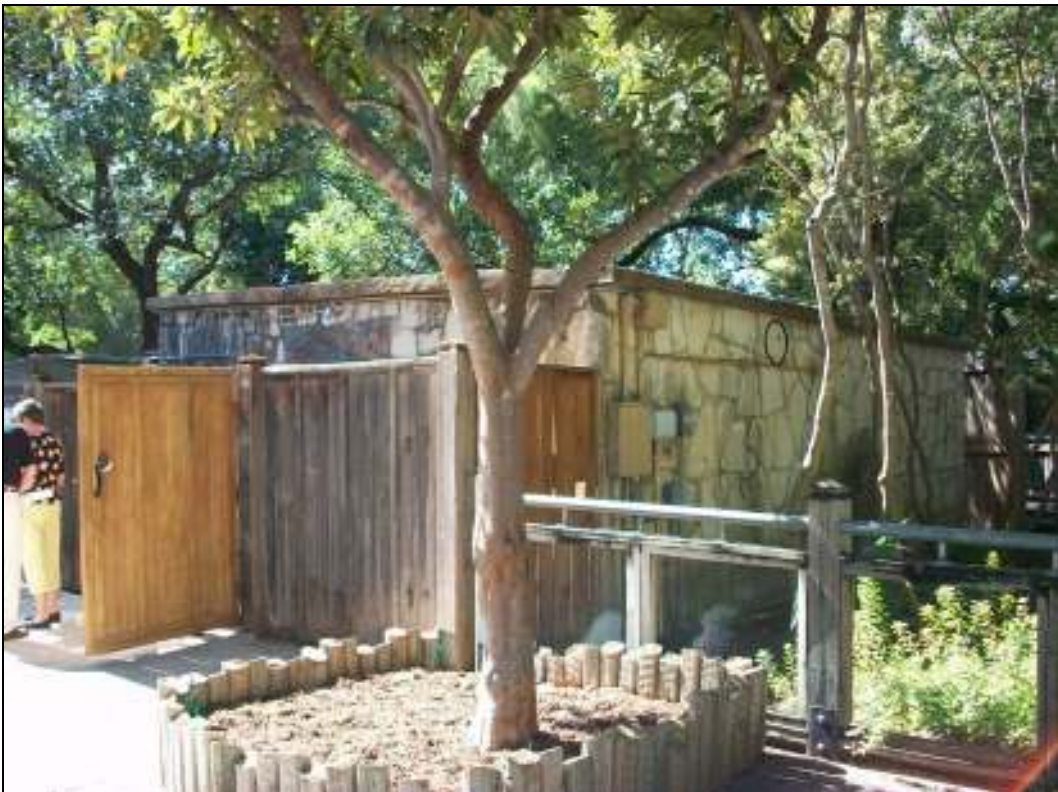
Resource #10 side and rear elevations

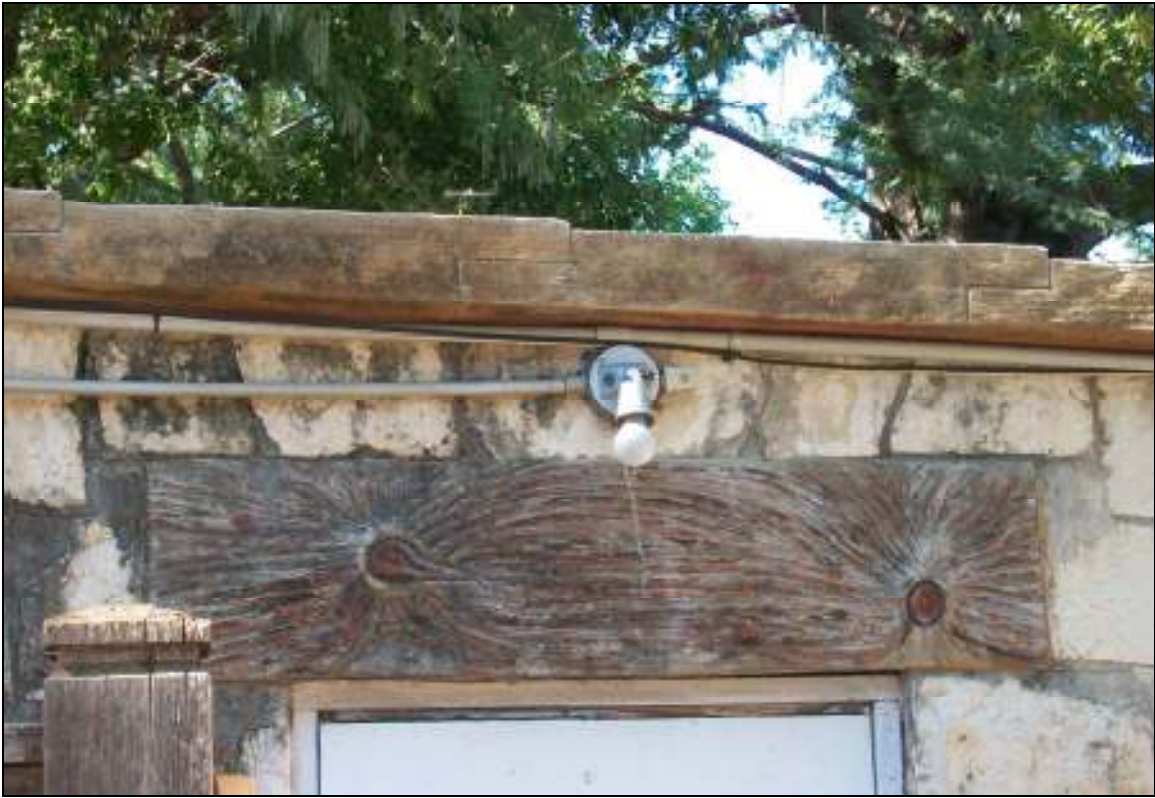
Resource #10 detail of *faux bois* lintel and “shingles”
