Texas Antiquities Permit No. 5859

Prepared by:
Center for Archaeological Research
The University of Texas at San Antonio
One UTSA Blvd.
San Antonio, Texas 78249
Technical Report, No. 39

Archaeological Monitoring of the Construction of Two CPS Vaults in Central San Antonio, Bexar County, Texas

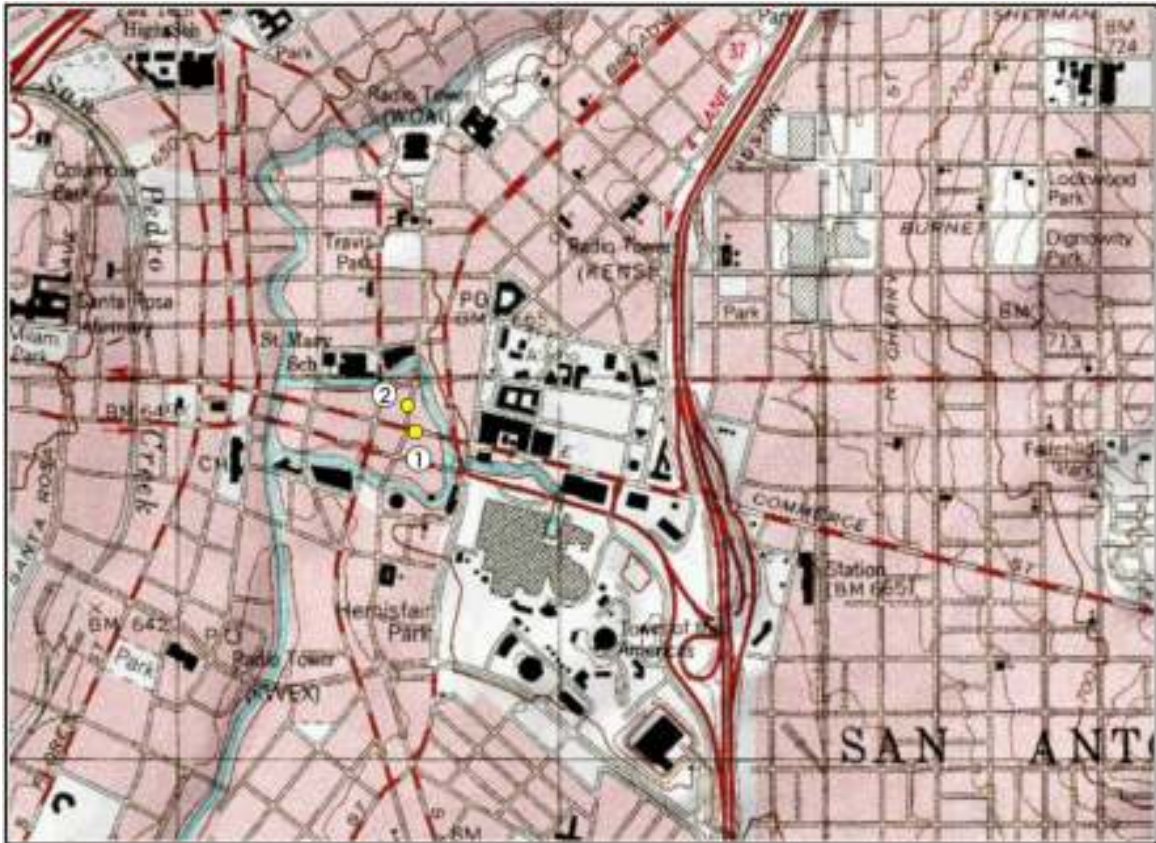
Figure 1-1. The Areas of Potential Effect on the Southton 7.5-minute USGS quadrangle map.

The Center for Archaeological Research at The University of Texas at San Antonio (CAR-UTSA) was contracted by City Public Services (CPS) to conduct archaeological monitoring of excavation associated with two proposed underground electrical vaults. The Areas of Potential Effect (APEs) are shown on the Southton 7.5-minute series USGS quadrangle map in Figure 1-1 and on a current aerial of downtown San Antonio (Figure 1-2).

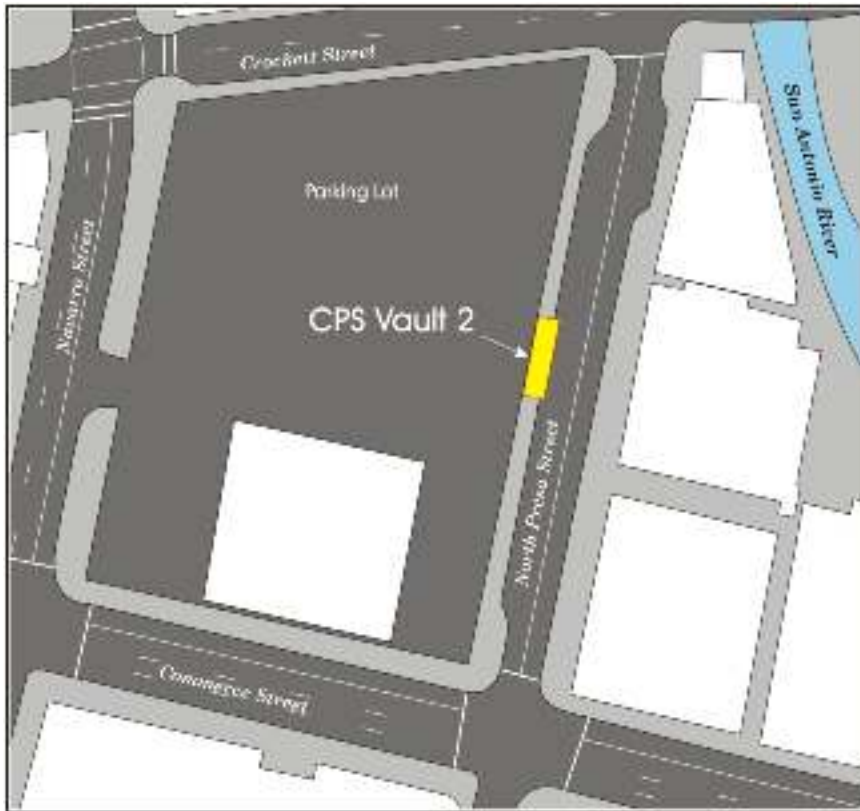
Figure 1-4. Location of CPS Vault 2 along North Presa Street.

Vault 1 is located on Commerce Street near its junction with North Presa Street (Figure 1-3). It is under the sidewalk fronting the Riverbend Parking Garage. Vault 2 is located along North Presa Street, midway between Commerce and Crockett Streets. It is under the western edge of the street (Figure 1-4).

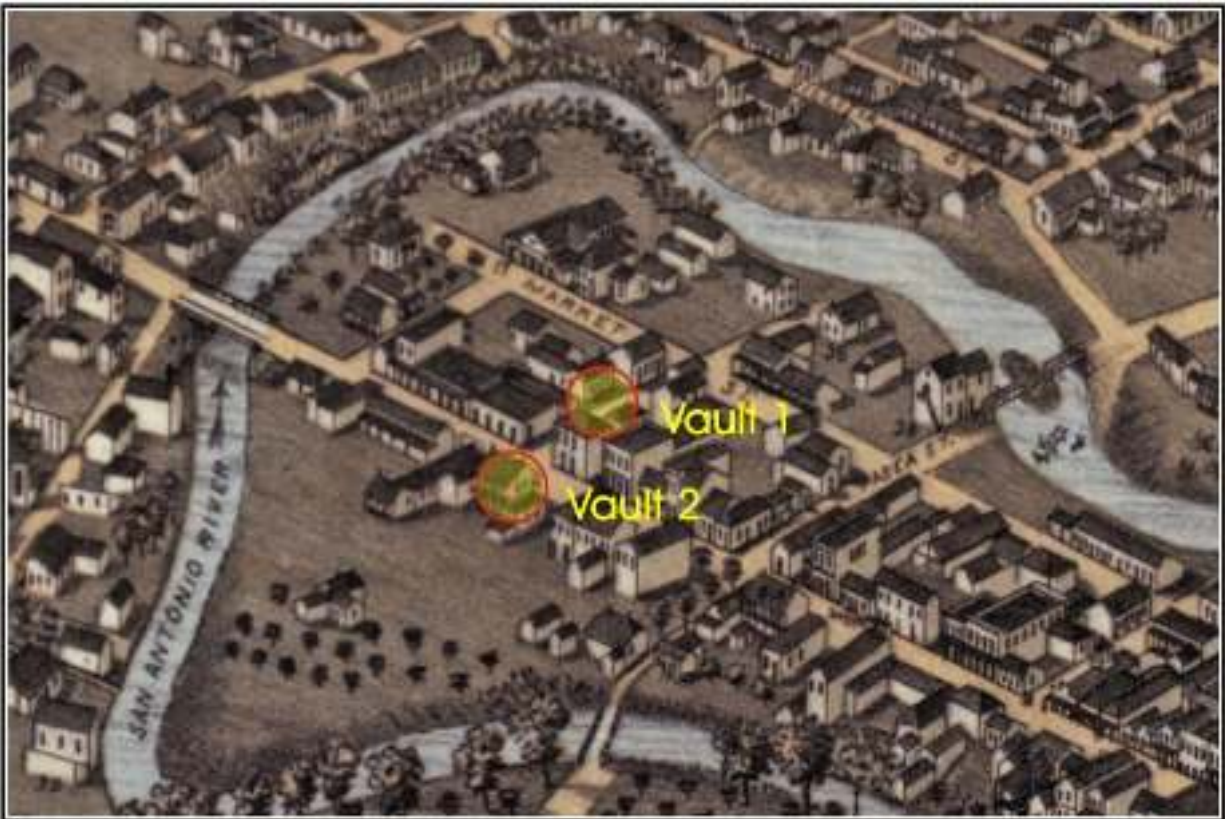
Figure 2-1. Koch's 1873 Bird's Eye View of San Antonio showing the approximate locations of Vaults 1 and 2.

The 1873 Koch's Bird's Eye View of San Antonio shows a large building in the area of Vault 1 (Figure 2-1). With the exception of the James Homestead, this area of town was a commercial district and consisted of many businesses. In 1879, Rummel sold his interest in the partnership, including claims to the property, to Wagner (BCDR 13:172). The earliest Sanborn Fire Insurance Map consulted (1885) indicates that there was a crockery warehouse, the Bazaar House Furnishing store, and a store specializing in stoves, hardware, and paints in the area where the vault was excavated (Figure 2-2).

It is highly likely that the dwelling shown on the 1885 Sanborn Fire Insurance Map as a stone two-story structure with a detached kitchen is the James Homestead (Figure 2-2). The house is drawn on Koch's Bird's Eye View of San Antonio 1873 (Figure 2-1), although there is no kitchen. While the scale is much

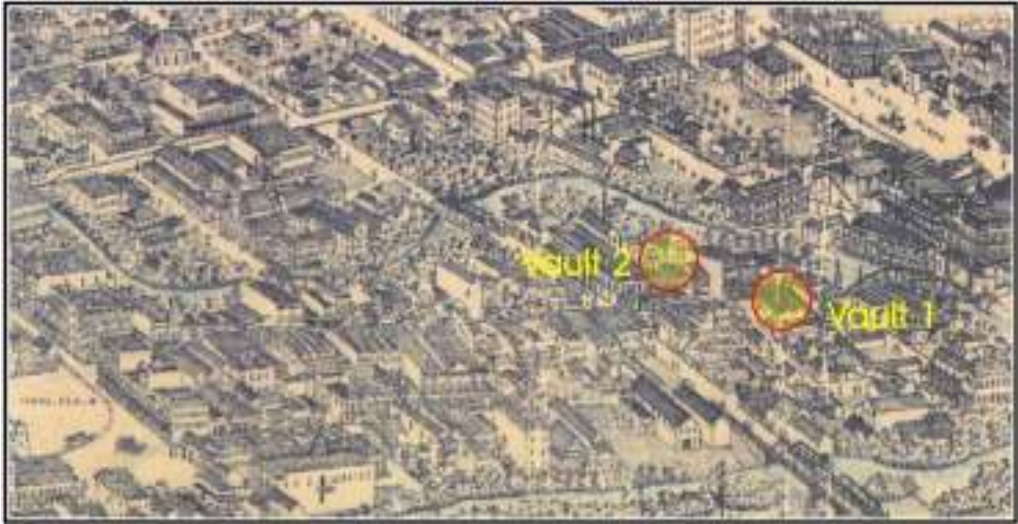
Figure 2-3. Koch's 1886 Bird's Eye View of San Antonio showing the approximate locations of Vaults 1 and 2.

The 1886 Koch's Bird's Eye View of San Antonio also depicts the structures at the corner. Due to the perspective, only the roof tops of the structures are shown, and Commerce Street is hard to see (Figure 2-3). The 1888 Sanborn Fire Insurance Map also shows the same structures and businesses at that location (Figure 2-4).

smaller and it is difficult to determine all of the details of the lot, the structure is also present on the 1886 Bird's Eye View of the City (Figure 2-3). There is definitely a two story structure depicted on the map in the area surrounded by more commercial buildings. The house has been noted as being one of the first two-story houses in San Antonio (Jennings 1998). Additionally, many of the visitors to the James homestead went on to be high ranking military leaders, including Robert E. Lee, William Worth, Albert Sydney Johnson, S.B. Holabird, John Bell Hood, and John L. Bullis (Jennings 1998, Strong 2012). The property remained within the family until 1910. James passed away on November 26, 1877. At that time the house was passed to his wife and first son, John Herndon James.

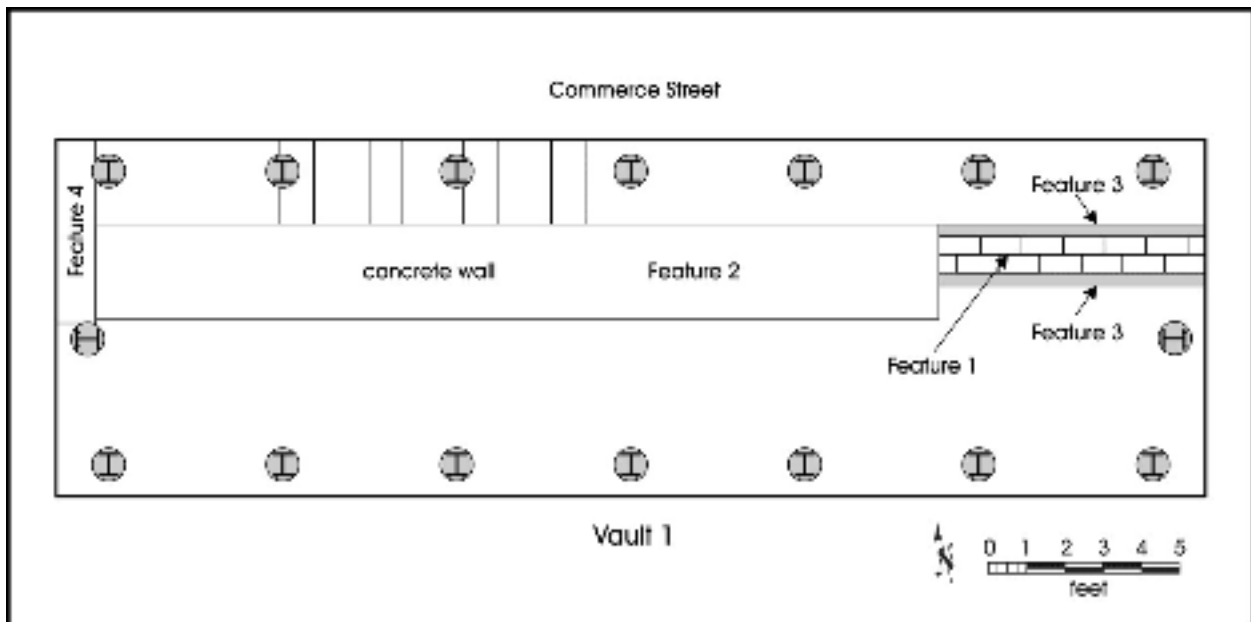
Figure 4-1. Layout of Vault 1 and features noted during the monitoring.

Three trenches (Ts) and 16 auger bores (ABs) were excavated to explore the area for buried features prior to installing the I-beam supports for the steel reinforcement plates around the perimeter of the vault (Figure 4-1). The excavation of CPS Vault 1 began with sidewalk and curb removal (Figure 4-2). Approximately 28 cm (11 in.) of deposits were removed using a John Deere 410J backhoe with alternating uses of an applied demolition-bit.

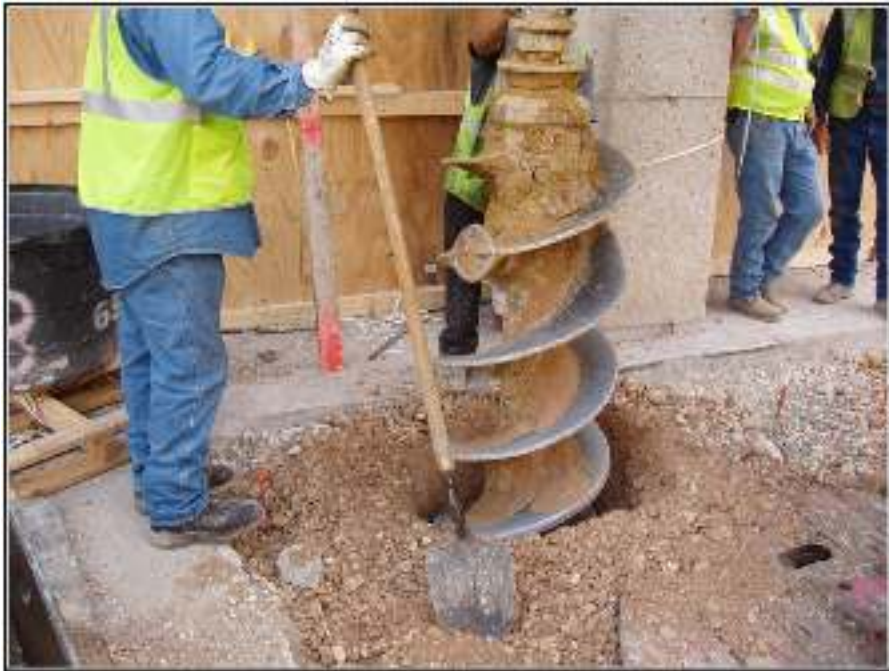
Figure 4-3. *Auger bore excavation to determine the nature of the substrate.*

After the removal of the sidewalk, A.H. Beck Drilling personnel excavated a 0.9 m (3 ft.) diameter auger bore hole (AB-1) near the northeast corner of the vault (Figure 4-3) to determine the nature of the substrate. An impenetrable obstacle was encountered at a depth of 2.4 m (8 ft.) below the surface.

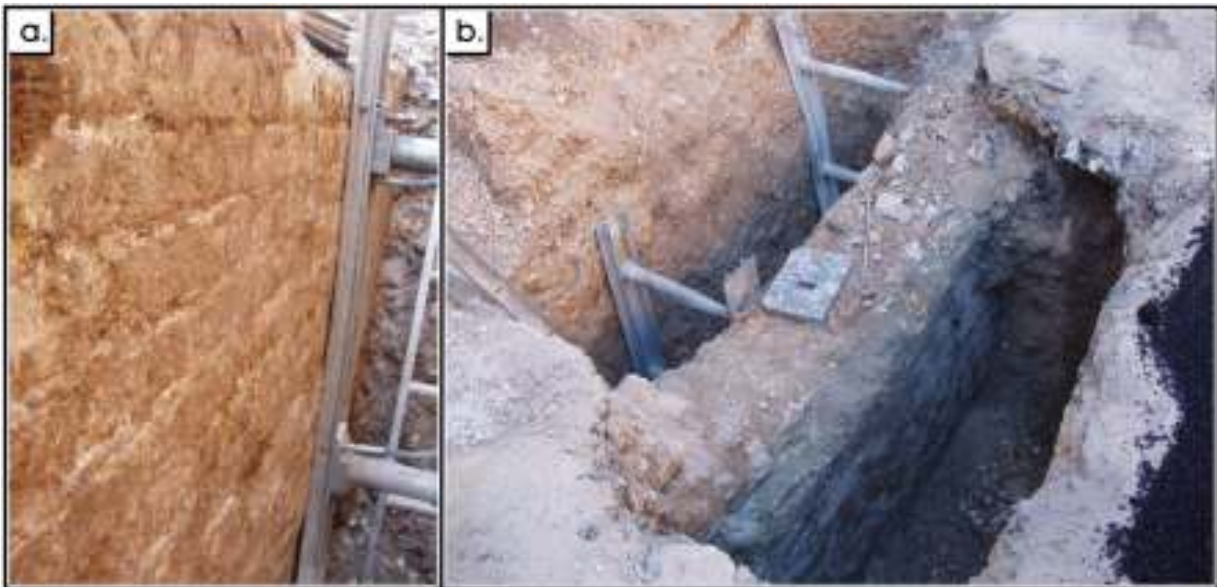
Figure 4-4. *a) Yellow brick wall exposed by backhoe trench; b) T-1 is on the left, and T-2 is on the right of wall.*

To help determine the nature of the obstacle encountered in AB 1, Zachry personnel excavated a 0.6 m (2 ft.) wide and 2.4 m (8 ft.) long trench (T-1) immediately to the south of the auger hole. This trench exposed a yellow sandstone brick wall running in an E-W direction along the south edge of the trench (Feature 1; Figure 4-4a). In addition, a concrete wall (Feature 2) was exposed along the northern edge of the trench in line with and abutting the brick wall. A second trench (T-2) was excavated to expose the south side of the wall (Figure 4-4b) and to establish whether or not other walls were present in the southern half of the vault's footprint.

Feature 1 was a yellow brick wall identified near the northeast corner of the vault. It was exposed by T-1 and T-2, which were excavated on either side of the wall (Figure 4-4a, b). It was oriented in an E-W direction and was 63 cm (24.8 in.) wide. The brick wall rested on a concrete foundation. The foundation is 30 cm (11.8 in.) high and rested on a concrete slab (Feature 3). The bricks had a very sandy texture, and the mortar contains Portland Cement. The height of the wall was 2.4 m (8 ft.). The brick wall abutted a reinforced concrete wall (Feature 2).

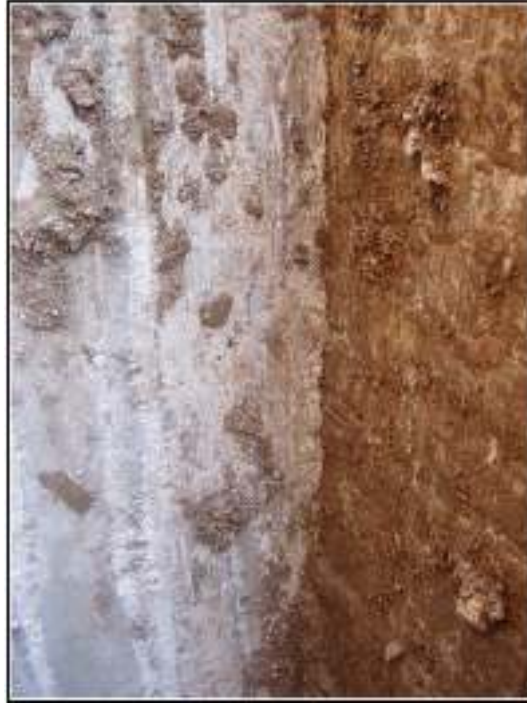
Figure 4-5. *Concrete wall abutting brick wall at the west end of T-2.*

Trench 2 (T-2) measured 83.5 cm (32.9 in.) in maximum width, exposed the southern face of the yellow brick wall (Feature 1), and abutted the concrete wall at the southern end of the trench (Figure 4-5).

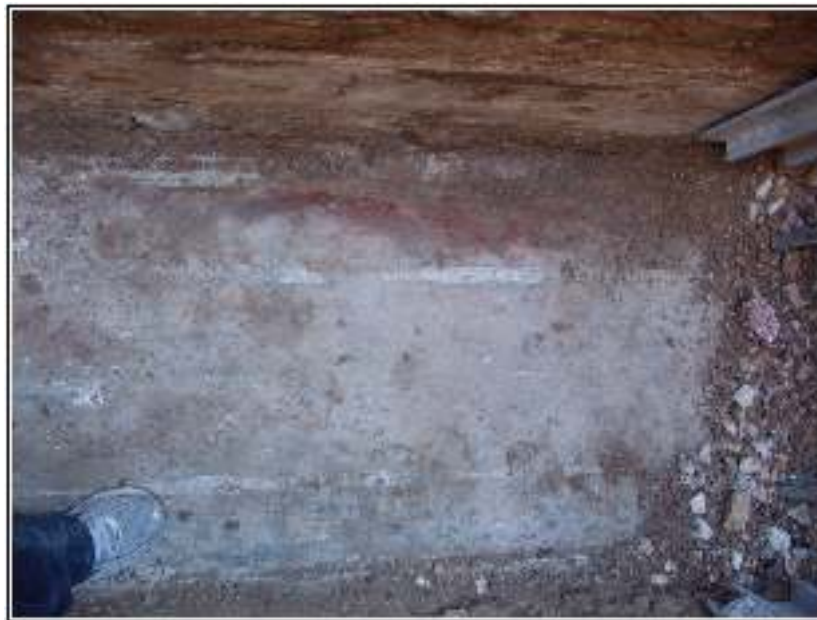
Figure 4-6. *Concrete slab at the base of backhoe trench.*

At the base of T-1, some 2.4 m (8 ft.) below the ground surface, a flat concrete slab was exposed (Feature 3; Figure 4-6). Several attempts were made to break through the concrete slab. When finally successful, the layer proved to be roughly 14 cm (5.5 in.) thick and appeared to have been poured to cap an underlying clay horizon.

Feature 3 is a concrete slab found 2.4 m (8 ft.) below the surface. It provided a footing for the foundation of the yellow brick wall, Feature 1. The feature was noted during the excavation of T-1, but not in T-2, which was located on the south side of the yellow brick wall. The concrete slab was cleared and exhibited red and blue paint. A portion of Feature 3 was removed, revealing that the slab was roughly 14 cm (5.5 in.) thick. Groundwater began seeping into the vault area immediately after the removal of the slab suggesting that it had been poured to cap an underlying clay horizon and also provide a stable footing for the wall and foundation of Feature 1. It extended the length of Feature 1 but did not extend under Feature 2, the long concrete wall along the north face of the vault.

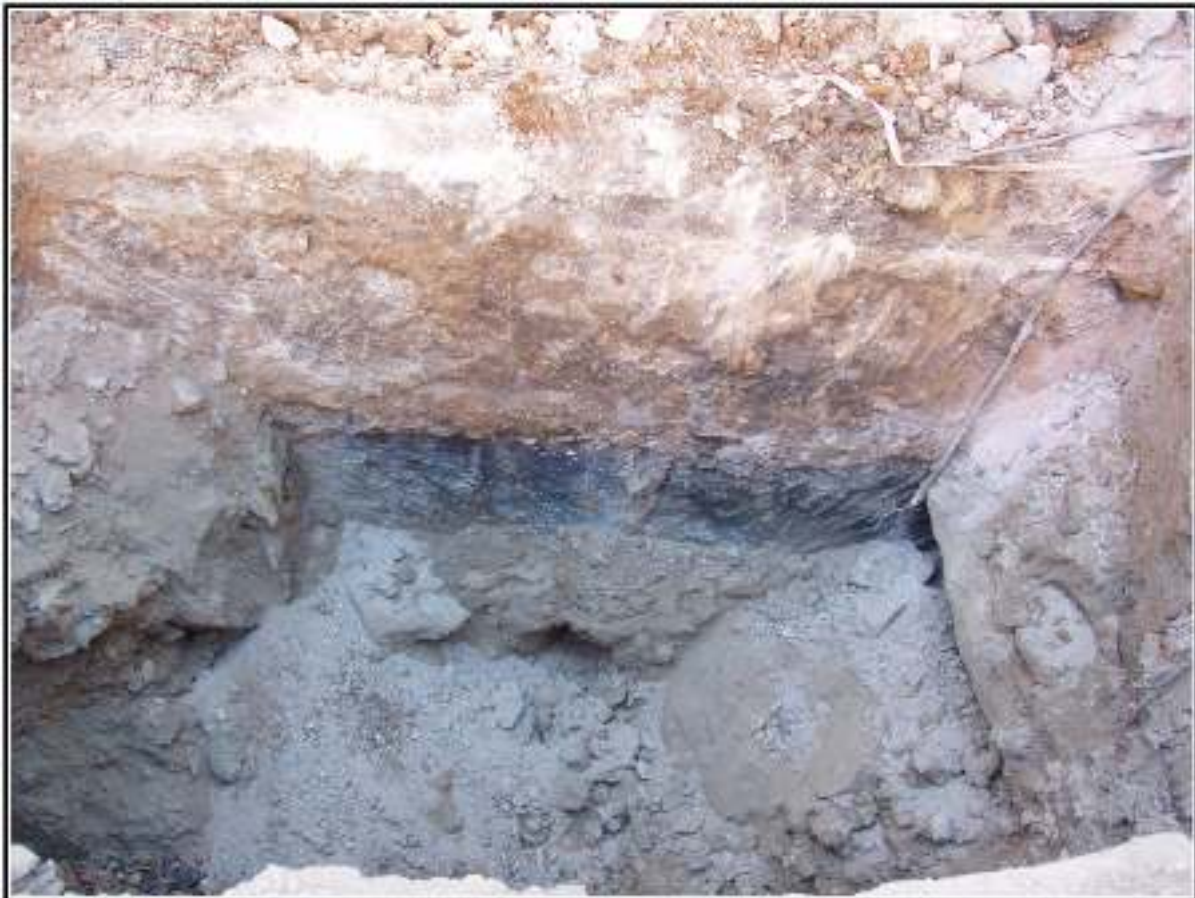
Figure 4-7. Wall uncovered in T-3 near western edge of the vault.

AB-4 was excavated in the northwest corner of the vault. After encountering the concrete slab, a third trench (T-3) was excavated to delineate the extent of the slab at this location. The trench exposed a yellow sandstone wall (Feature 4; Figure 4-7) running perpendicular to the trench. The southern edge of the trench exposed the reinforced concrete wall that abutted a stacked limestone block wall (Feature 5; Figure 4-8a, b). The project monitor was told that four similar stacked limestone wall segments were noted along the length of the vault but had been removed to expose the concrete wall (Figure 4-1).

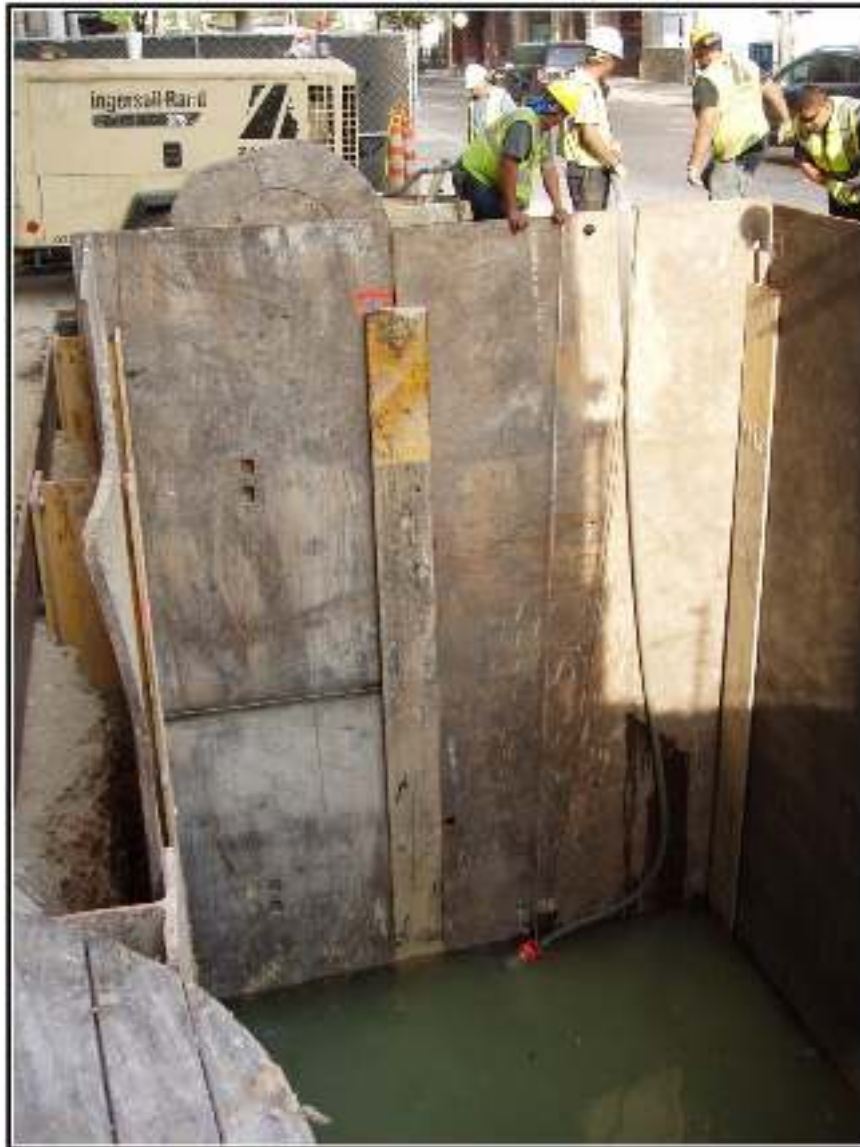
Figure 4-9. I-beams and steel plates at south end of vault.

After the installation of the I-beams and steel plates (Figure 4-9), Zachry personnel began removing the matrix from within the vault space. Digging began on the southern perimeter to a depth of 7.3 m (24 ft.) and progressed northward over the course of several days. As soil was cleared past each successive I-beam, steel support plates measuring 2.4-x-1.8 m (8-x-6 ft.) were lowered between the slots. Sixteen plates and I-beams were placed within the perimeter space of the vault.

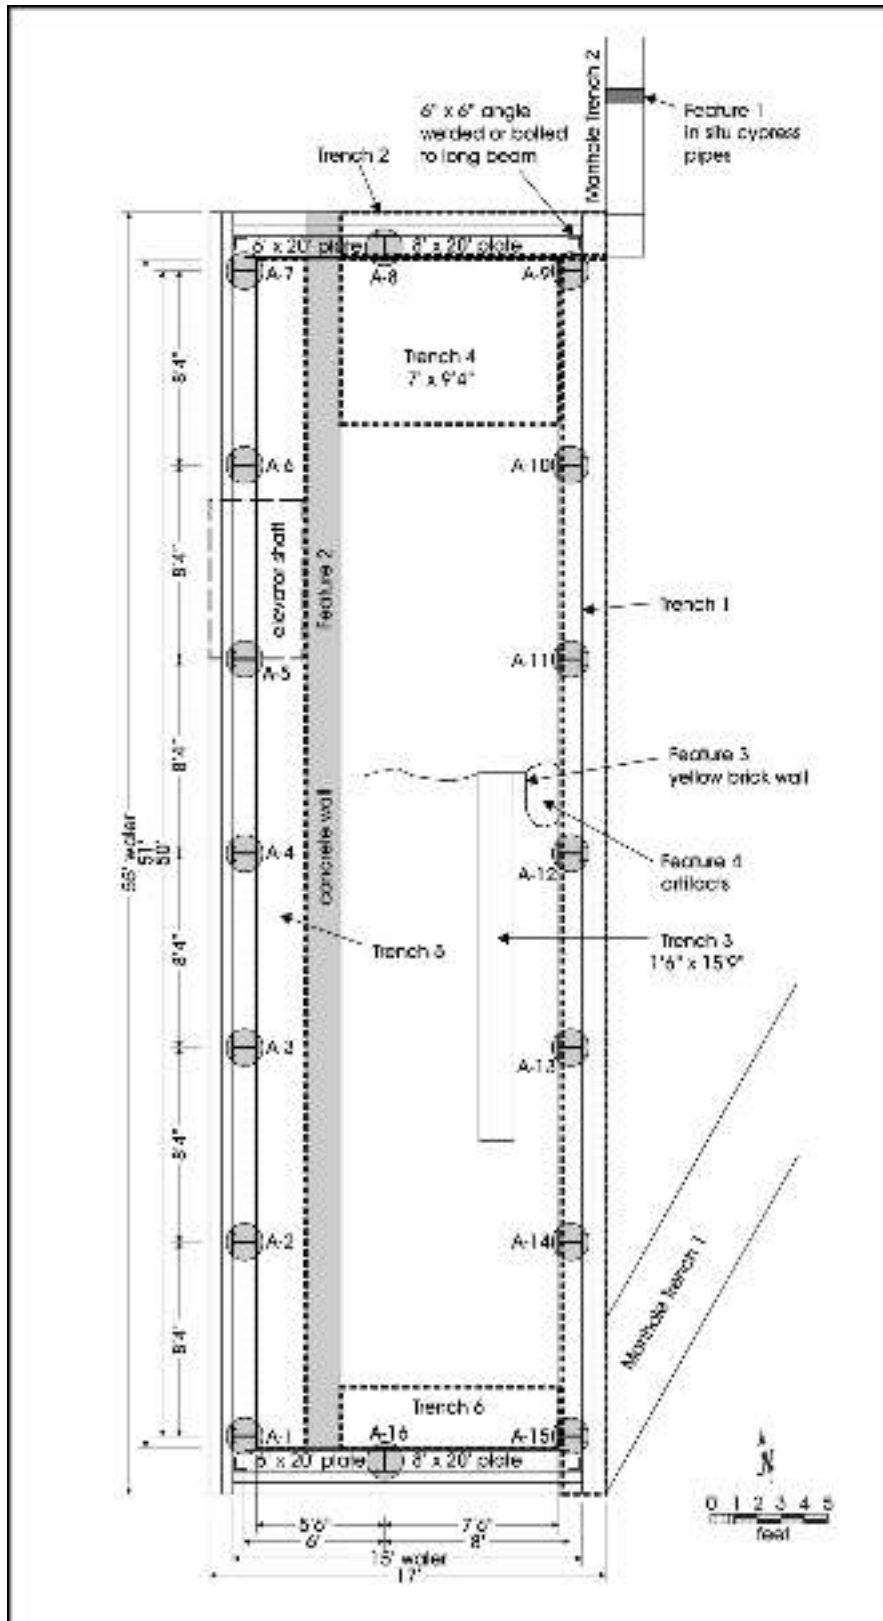
Figure 4-10. Schematic of the trenches and auger bores excavated during the construction of Vault 2.

The construction of City Public Service's Vault 2 began with a different approach than that of Vault 1. A total of six trenches and 16 auger bores were excavated during the construction of Vault 2 (Figure 4-10). In addition, to connect electrical wiring to the vault, two additional backhoe trenches were excavated to nearby manholes (Figure 4-11).

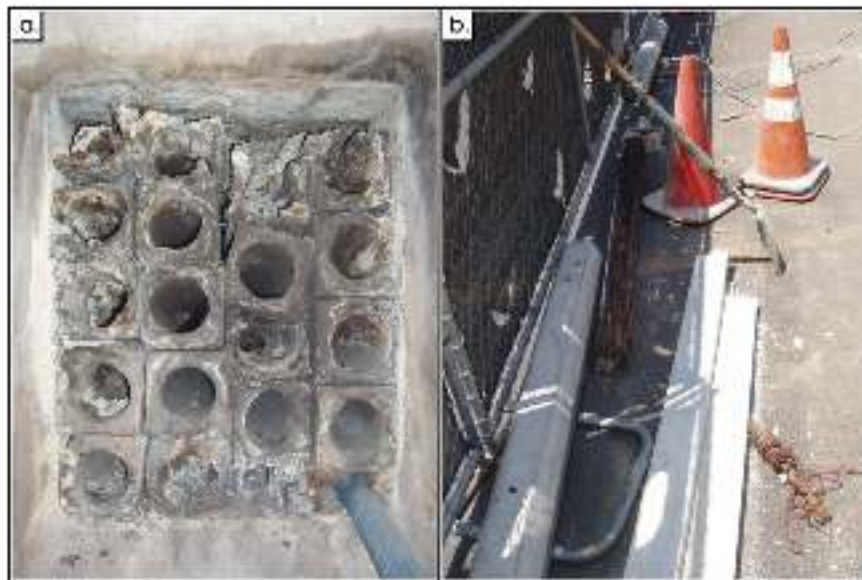
Figure 4-12. Wooden electrical conduit housing: a.) bank of cypress pipes buried under street level; b.) close-up of individual segment.

Zachry Construction personnel removed the blacktop and curb along the northern perimeter of the vault and mechanically excavated a 15.5 m (51 ft.) long E-W oriented trench. The width of T-1 was 61 cm (2 ft.), and the depth was approximately 1.8 m (6 ft.). A bank of cypress pipes (Feature 1; Figures 4-10 and Figure 4-12a, b) was encountered at 1.4 m (4.5 ft.) below the surface in the east portion of this trench, running westward towards the midpoint of the North Presa Street City Block. Four cypress pipes measuring 45.7 cm (18 in.) across were lying horizontally and parallel to the street with a total of five stacked above each of these (20 all together). These were removed using a John Deere 410J Trackhoe bucket. A 0.6 m (2 ft.) sample was retained and returned to the CAR laboratory for study and curation. The trench space was then filled with Global-fill cement.

Feature 1 consists of a series of cypress wooden conduits (Figure 4-12a, b). It was encountered at 1.4 m (4.5 ft.) below the surface in the east portion of T-1 within the footprint of Vault 2, running westward towards the midpoint of the North Presa Street City Block. The area where the wooden pipes are best preserved is in a portion of a concrete manhole located about 1.5 m (5 ft.) from the northwest corner of the vault. The manhole measures approximately 2.4-x-3 m (8-x-10 ft.), and in its north wall, 1.4 m (4.5 ft.) above the floor, is a bank of stacked cypress conduits lying horizontally next to each other oriented E-W and parallel to the street. The stack contains four conduits placed on top of five others forming a bank of closely spaced cedar pipes containing a total of 20 conduits (Figure 4-18). Each of the pipes measures 3.7 m (12 ft.) in length and has a square cross-section and rounded inner conduit. A cypress plug was noted in the ends of some of the conduits.

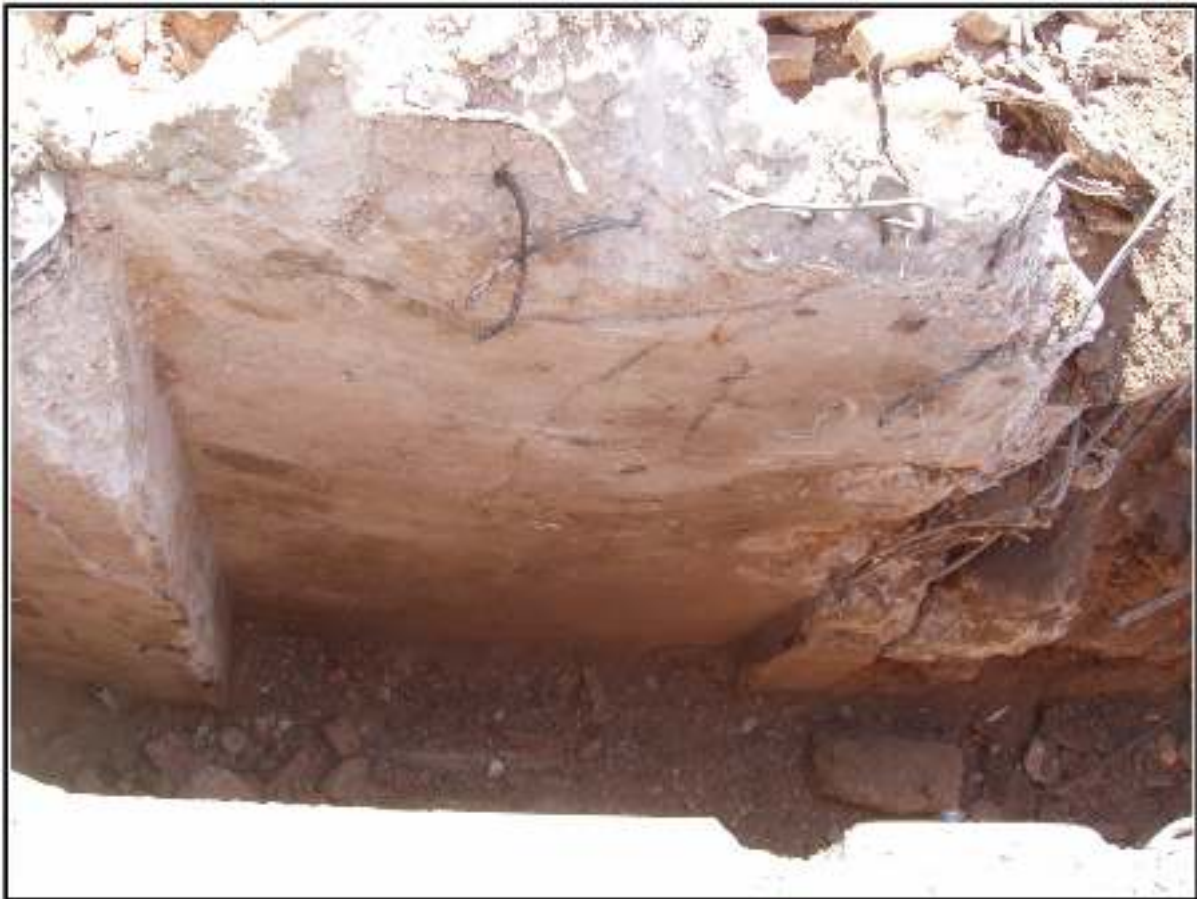
Figure 4-13. Reinforced concrete wall encountered in T-2.

Next, a 1.8-x-0.6 m (6-x-2 ft.) short trench (T-2) was excavated at the western end of T-1 and perpendicular to the first trench. At 20 cm (7.9 in.) below the surface, a reinforced concrete wall (Feature 2; Figure 4-13) was encountered 185 cm (72.8 in.) south of the north wall of the vault. This wall extended to a depth of 3.7 meters (12 ft.) below the surface. The trench in this area was dug to a depth of 4.4 m (14.5 ft.) below surface before excavations stopped to allow for CPS and Zachry consultation.

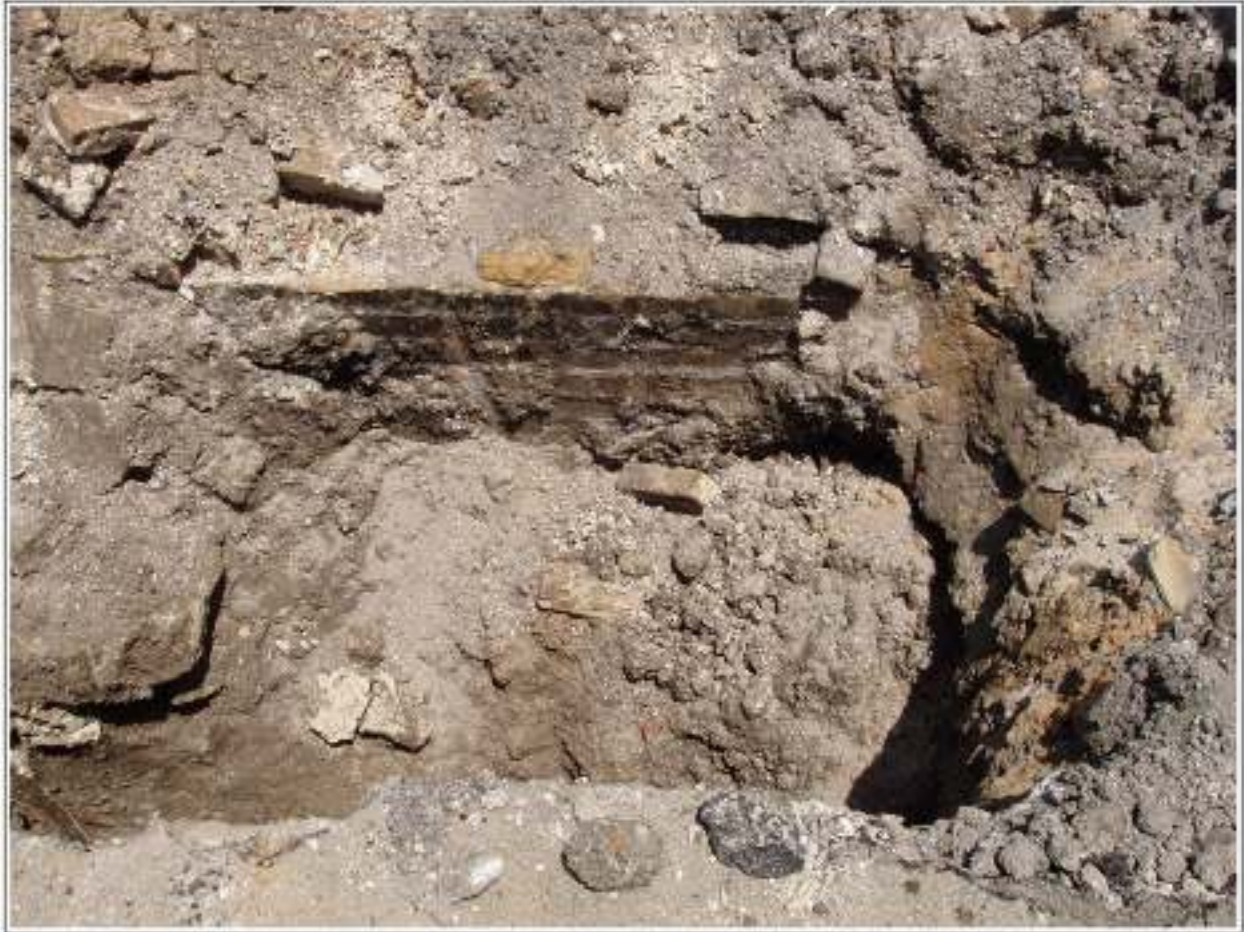
Figure 4-14. *Short yellow brick wall segment in T-3.*

After moving the trackhoe back to an approximate mid-point of the vault, another trench (T-3) was excavated parallel to T-1. This trench was oriented E-W and was 0.6 m (2 ft.) wide and 1.4 m (4.5 ft.) deep. A reinforced concrete wall (Feature 2) was encountered at roughly 0.6 m (2 ft.) below the surface in the south wall of the trench. In addition, a segment of yellow brick wall (Feature 3; Figure 4-14) was exposed in the north wall of the trench at around 0.9 m (3 ft.) below the surface. A dense cluster of artifacts was noted in the vicinity (Feature 4).

Feature 3 was a segment of yellow brick wall (Figure 4-14) that was exposed in the north wall of the trench (T-3). The wall was oriented in an E-W direction, and its top was uncovered approximately 0.9 m (3 ft.) below the surface. Five perpendicular (i.e., oriented N-S) interior brick walls were seen dividing the space along the original wall. These walls could potentially represent the remains of an outbuilding to the James Homestead that is noted on the 1885 and 1888 Sanborn Fire Insurance Maps.

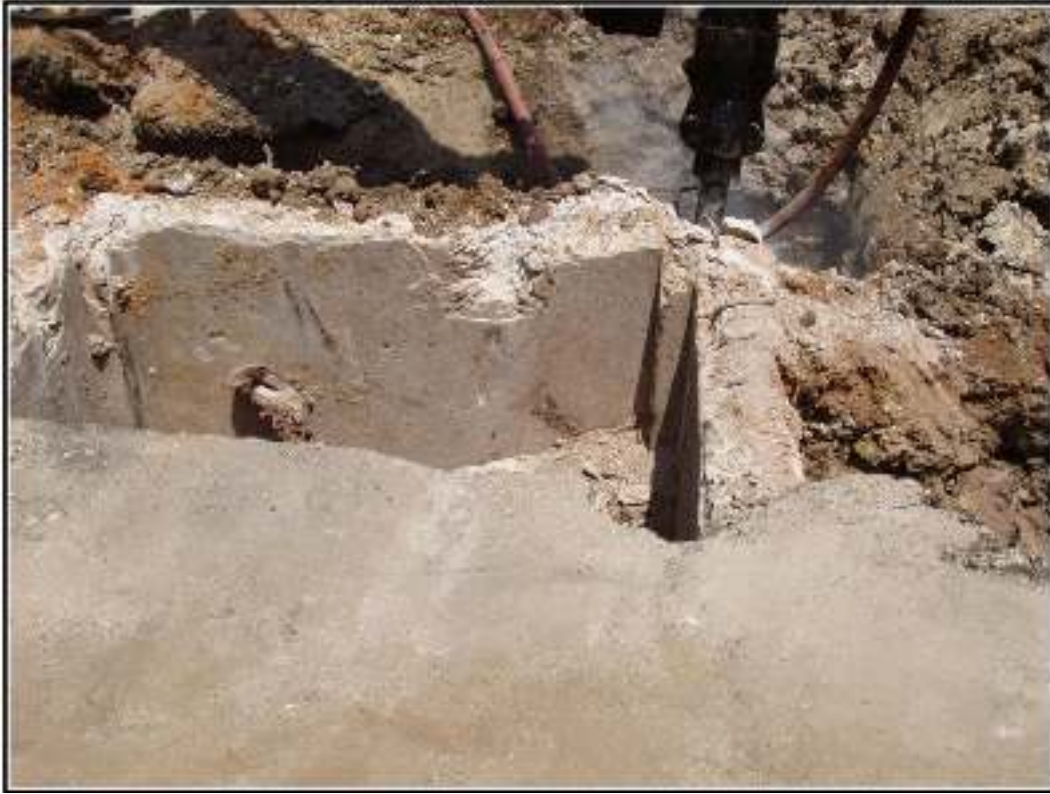
Figure 4-15. *Elevator shaft exposed in T-5.*

Once the north facing concrete wall was revealed, a fifth trench (T-5) was begun along the south side of the wall. Starting at the southwest corner of the proposed vault and running eastward, a 1.8 m (6 ft.) wide trench was excavated to a depth of 4.4 m (14.5 ft.). This trench showed that the concrete wall was associated with an old elevator shaft (Feature 5; Figure 4-15). Trench 5 continued along the concrete wall to the far east end of the vault pit.

Feature 5 was identified as the remnant of an old elevator shaft. The elevator shaft was located in the northwestern portion of the CPS Vault 2. The elevator shaft was removed, and there were no significant cultural remains noted. Cables were located in the vicinity of the feature, but these were cut as the elevator shaft was removed.

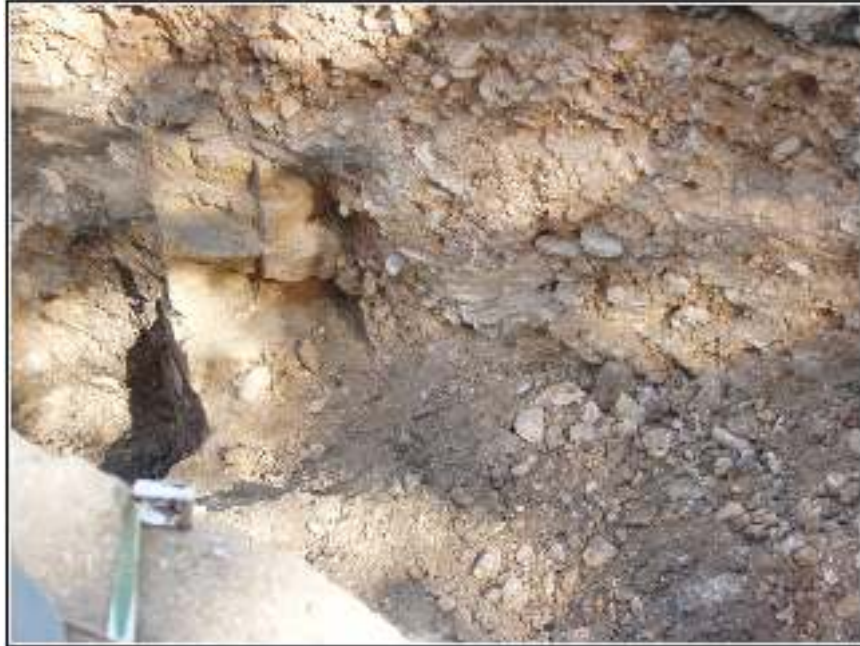
Figure 4-16. *Sandstone wall in Manhole Trench 1.*

Two manholes were excavated in association with Vault 2. Each necessitated the excavation of trenches connecting the manholes to the vault. The first manhole was situated on the north side of the street directly across from the vault, roughly 10.7 m (35 ft.) north of the vault. The second manhole was also on the north side of the street, 18.3 m (60 ft.) west of the vault along the northern curb of North Presa Street. Each trench was one backhoe bucket wide and approximately 2.1 m (7 ft.). Manhole Trench 1 (MT-1) cross-cut a two-bricks-wide (40.6 cm; 16 in.) yellow sandstone wall (Feature 6) measuring 25.4 cm (10in.) in width (Figure 4-16). This wall was encountered 1.5 m (5 ft.) from the southeast corner of the vault at a depth of 1.2 m (4 ft.) below the ground surface.

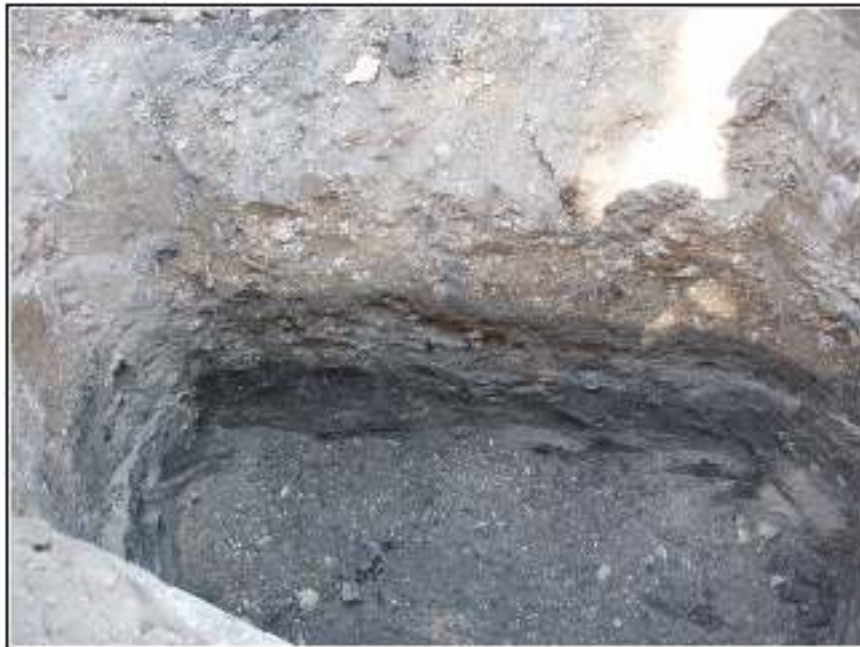
Figure 4-17. *Midden deposit in Manhole Trench 1, adjacent to sandstone wall.*

A midden deposit (Feature 7) containing a mixture of historic artifacts was noted on the northwest side of the narrow brick wall (Figure 4-17). The materials were in a silty, ashy, dark gray lens that was approximately 15.2-20.3 cm (6-8 in.) thick.

Feature 7 appears to be a continuation of the Feature 4 midden but was located in Manhole Trench 1 extending from the northeast corner of the vault toward the north-northeast. On the northeast side of the yellow sandstone brick wall (Feature 6), the soil was ashy. Artifacts encountered in this area included burnt oyster shell, animal bone, several types of ceramics, various colors and shapes of bottle glass, window glass, metal objects, and coal. A sample of artifacts was collected for further analysis at the CAR laboratory. A detailed description of the faunal remains is provided in a later section of this report.
