Background Research and Historic Standing Structure Survey for the New Alamo Colleges Office Complex and Veterans Outreach and Transition Center

**Background Research and Historic Standing Structure
Survey for the New Alamo Colleges Office Complex
and Veterans Outreach and Transition Center,
San Antonio, Bexar County, Texas**

Prepared by:
Center for Archaeological Research
The University of Texas at San Antonio
One UTSA Circle
San Antonio, Texas 78249
Technical Report, No. 40

Management Summary:

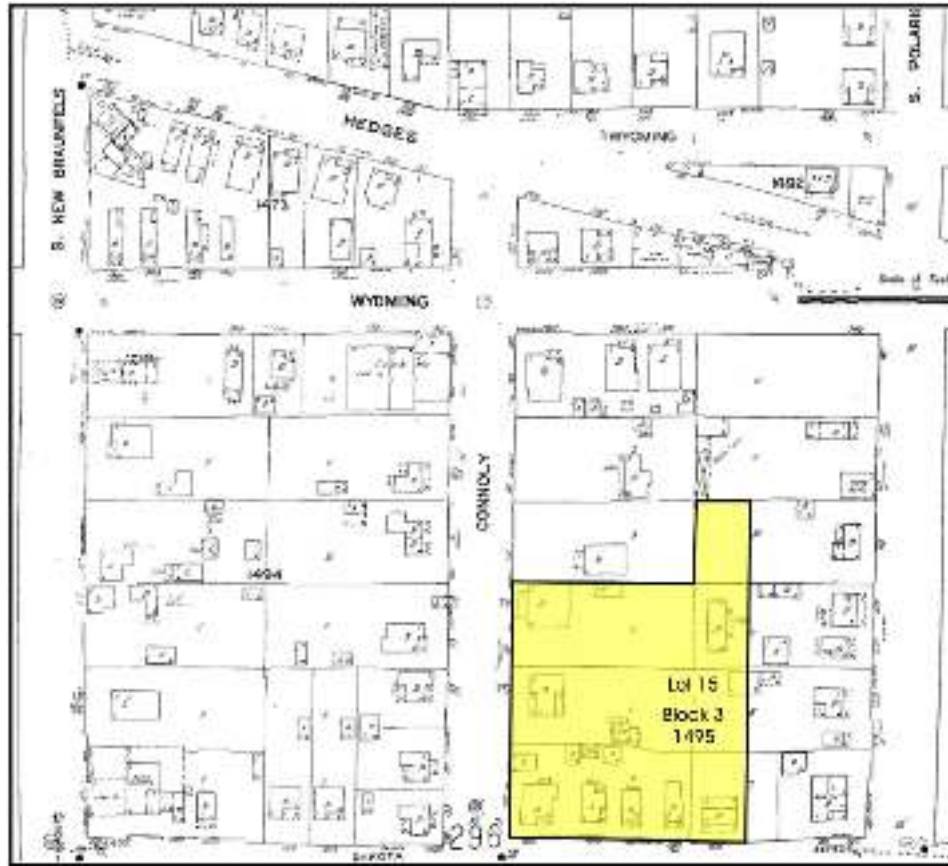
Figure 4-4. A portion of the APE on the 1911-1951 Sanborn Fire Insurance Map.

The property within the APE that is located to the north of Dakota Street is depicted on page 291 in Volume 3 of the 1911-1951 Sanborn Fire Insurance Maps (Figure 4-4). What had been six structures that fronted Dakota Street had become five in 1951. The map shows a much larger structure at 1601 Dakota, and 1603 is absent, suggesting that the two were absorbed into each other. Some alteration is evident on both 1605 and 1607 Dakota Street as well, but 1609 Dakota Street appears to be in much of the same shape as it was in 1912. The difference that is noted is that the address is listed as 1609 and 1611 on the 1951 map. In addition, 1619 Dakota retained the same footprint as depicted on the earlier map.

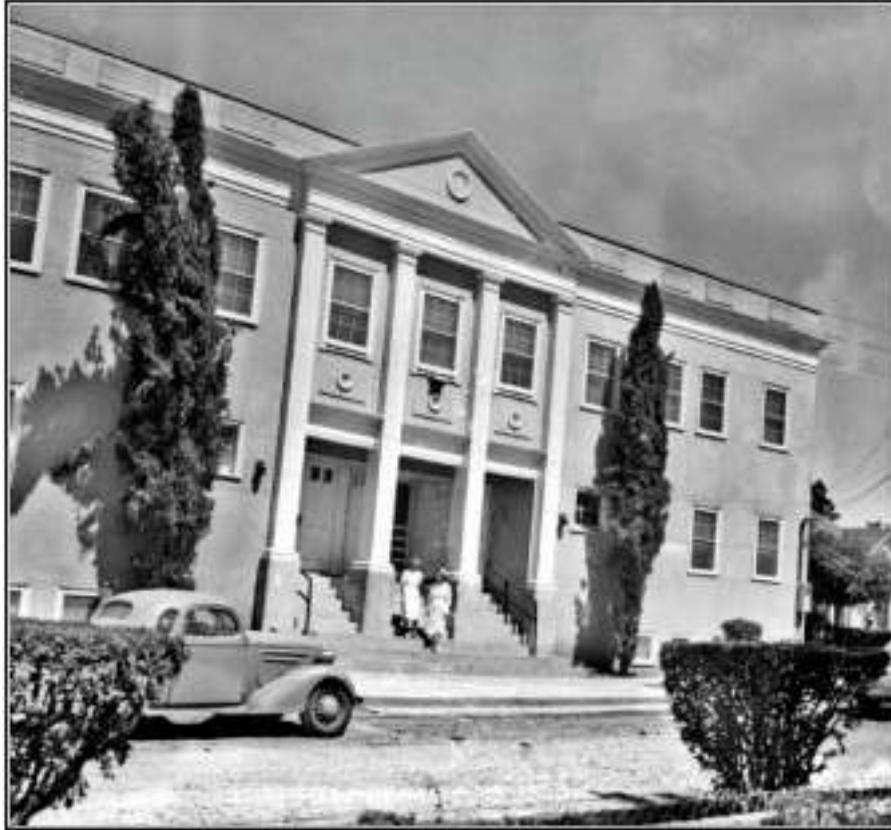
Figure 4-5. *Photograph of the Good Samaritan Hospital at its opening in 1948. San Antonio Light Photograph collection, MS 359, University of Texas San Antonio Libraries Special Collections from the Institute of Texan Cultures.*

The Good Samaritan Hospital was built on the property that had once housed the East End Baptist Church. Located in the area that was predominately populated by African Americans, the Good Samaritan Hospital allowed for the members of the surrounding community to have easier access to health care. Construction on the Good Samaritan Hospital was started in the late 1940s and was completed in 1948 (Figure 4-5).

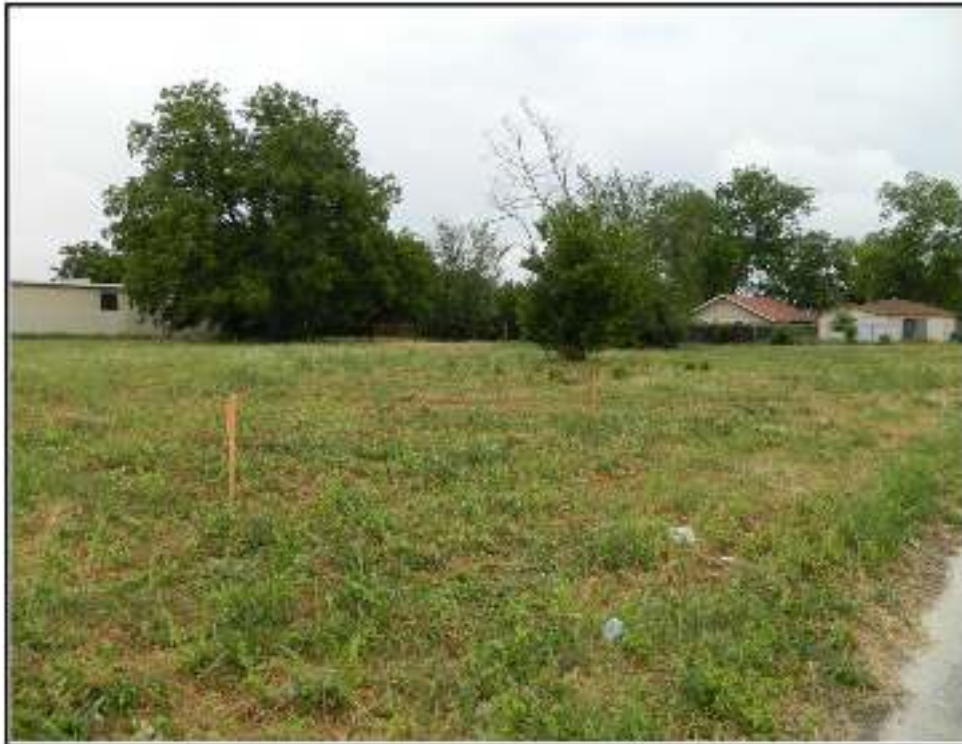
Figure 6-1. Vacant lot located to the north of the Good Samaritan Hospital. The vacant lot is Lot 15, Block 3, NCB 1495.

Although there were several lots that were researched in the background history of the project area, only three structures remain standing. The area located to the north of the hospital was a vacant field at the time the report was written (Figure 6-1). In addition, the lot located to the west of the hospital was also vacant, the house having been demolished years ago (Figure 6-2). Each of the three structures was documented according to the guidelines set out in the previous chapter. All three properties were vacant at the time of documentation, although evidence of squatters living in the hospital was found. The three properties were located in NCB 1508 and included Lots 1, 2A, and 3.

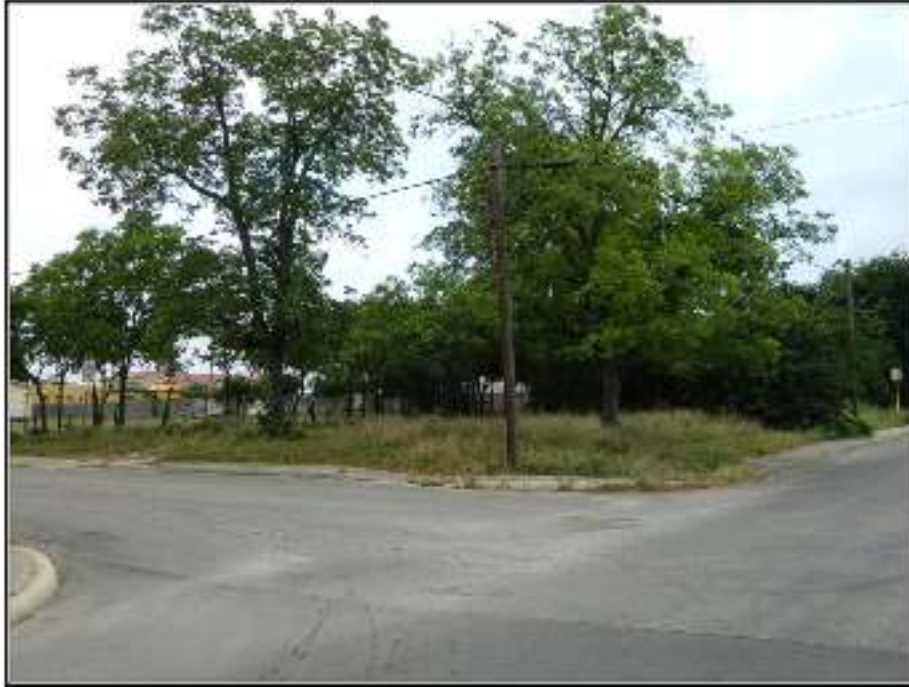
Figure 6-2. *Vacant lot located to the west of the Good Samaritan Hospital. The lot is Lot 12, Block 9, NCB 1509.*

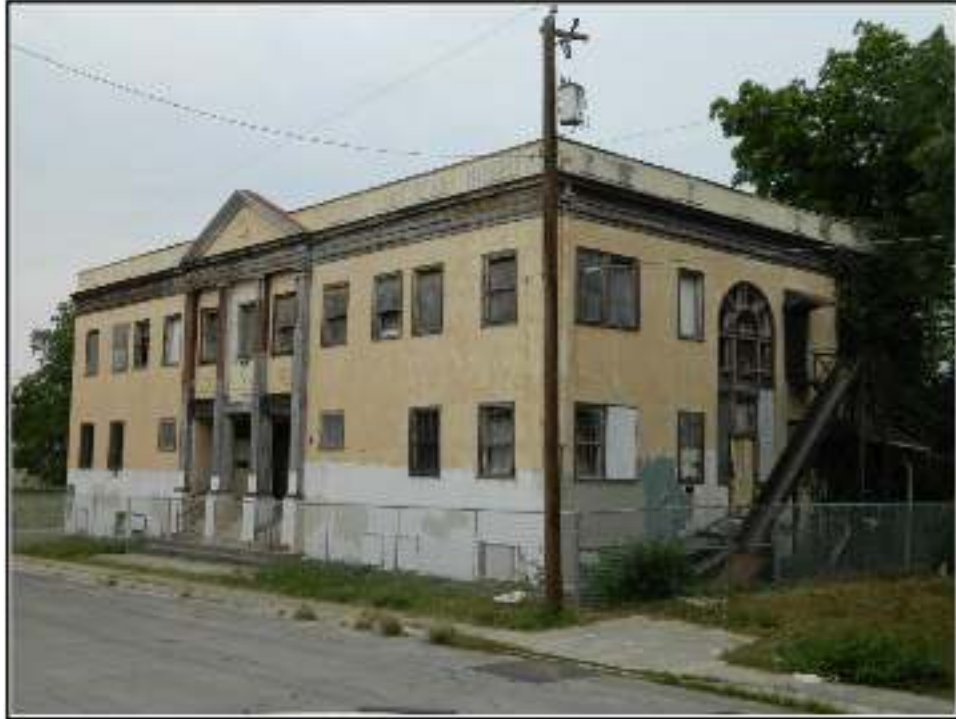
Historic Resource 1, the Good Samaritan Hospital, is located at the corner of Dakota and Connelly Streets (Figure 6-3) on Lot 1, Block 8, NCB 1508. At the time of documentation, the hospital was boarded up and a chain-link fence surrounded the building along the north, west, and south elevations. The Good Samaritan Hospital is a designated City of San Antonio local historic landmark. The structure is a two-story, flat-roofed, rectangular building on a raised basement with a few architectural styles exhibited, including Classical Revival and Greek Revival elements. The west and east elevations of the building are symmetrical to each other and so are the north and south elevations. There is a main floor, a second floor, and a basement. The entire structure has a stucco façade. At the top of the building, on the parapet, the words “GOOD SAMARITAN HOSPITAL” are stenciled on either side of the pediment (Figure 6-4).

Figure 6-3. *Historic Resource 1, the Good Samaritan Hospital.*

Saving the structure will require much work, but the architectural assessment indicates that barring any unforeseen impacts it is possible. Excavation around the perimeter of the structure would be necessary to install a foundation drain and add waterproofing. Removal of the concrete slab of the basement floor is proposed to investigate the foundation construction. It would be replaced with a slab that meets current standards. Bringing everything up to code will be a major undertaking. Due to the designation as a local historic landmark, coordination with the City's Office of Historic Preservation will be required prior to any exterior modifications or alterations.

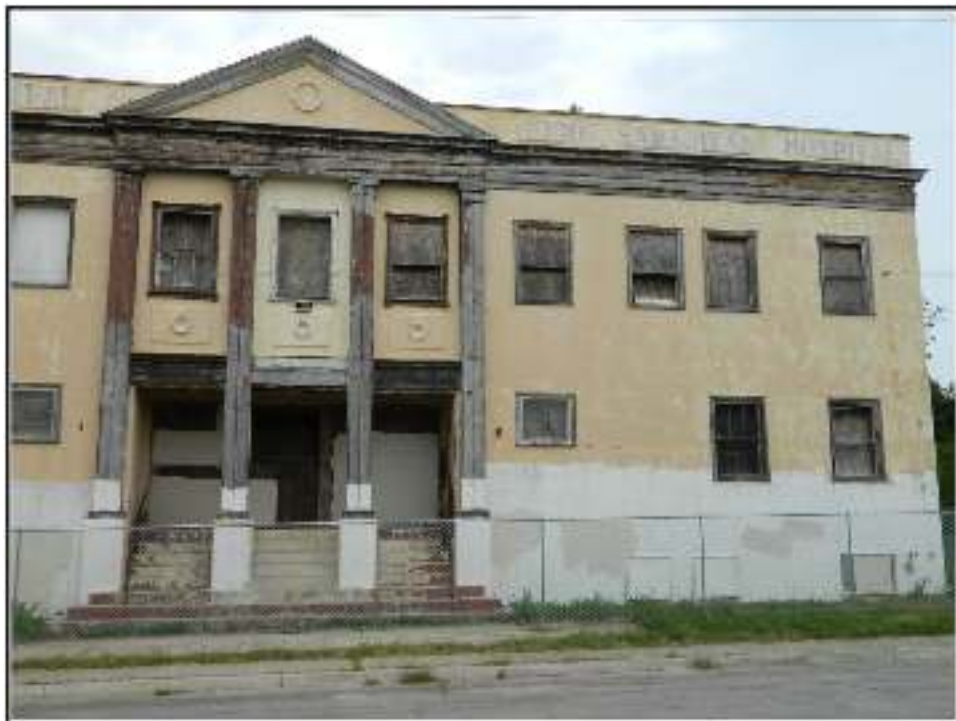
Figure 6-4. *"GOOD SAMARITAN HOSPITAL" is still seen on the front façade.*

The square columns at the front of the building exhibit wood capitals and shafts, but the columns are sitting on concrete bases (Figure 6-4). The square column is loosely based on Greek and Roman style, but square prototypes do not exist. These types of columns are considered to be vernacular Doric simplifications that are commonly used in the Greek Revival architectural style. The wood appears to be fairly weathered. In addition to the wood columns, a wooden architrave is present near the top of the building. A very thin cornice, also made of wood, is at the top of the building.

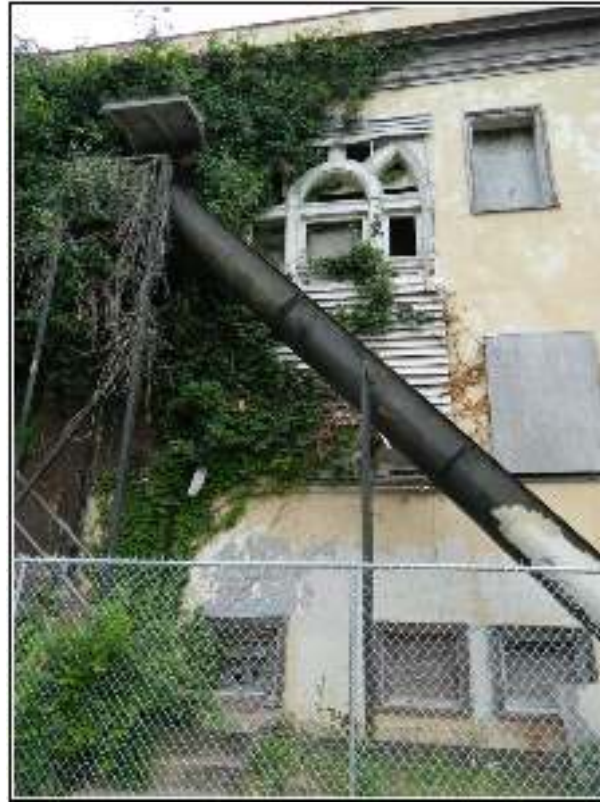
basement. An ornate arched window is located on this side of the building as well. The window exhibits a Classical Revival architectural feel with a Palladian style to the feature. This window appears to have been boarded up with clapboard covering. Approximately half of the boards are now missing, and it is unknown if the covering was added after the building was vacated to protect the window (Figure 6-5).

Figure 6-5. *Window located on the north side of Historic Resource 1.*

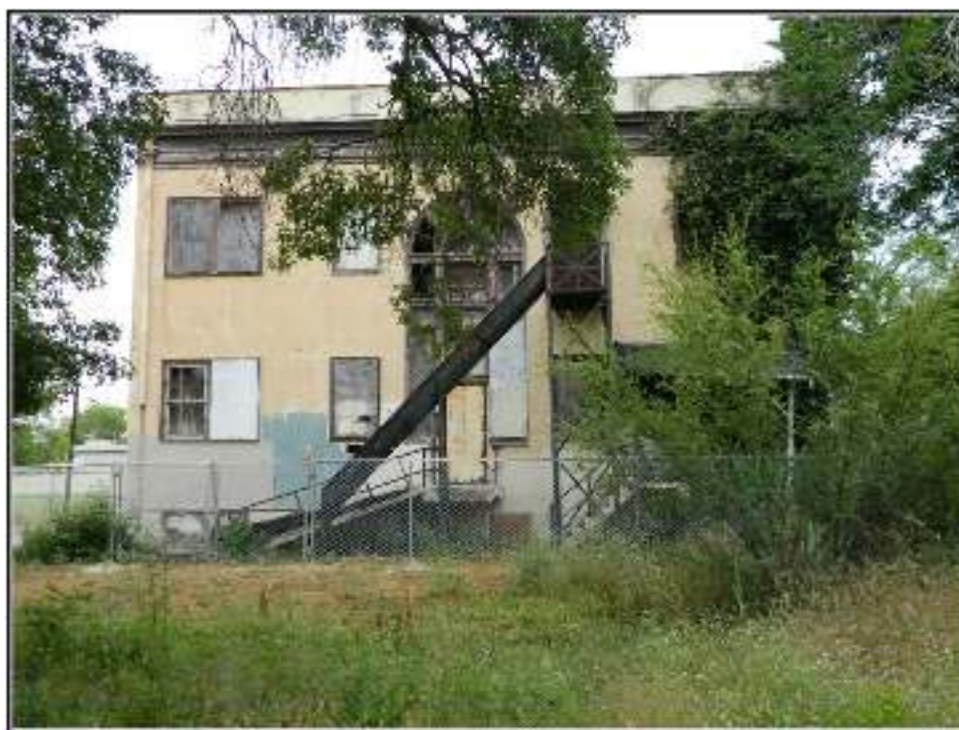
Figure 6-6. *Metal fire escape slide located on the south side of Historic Resource 1.*

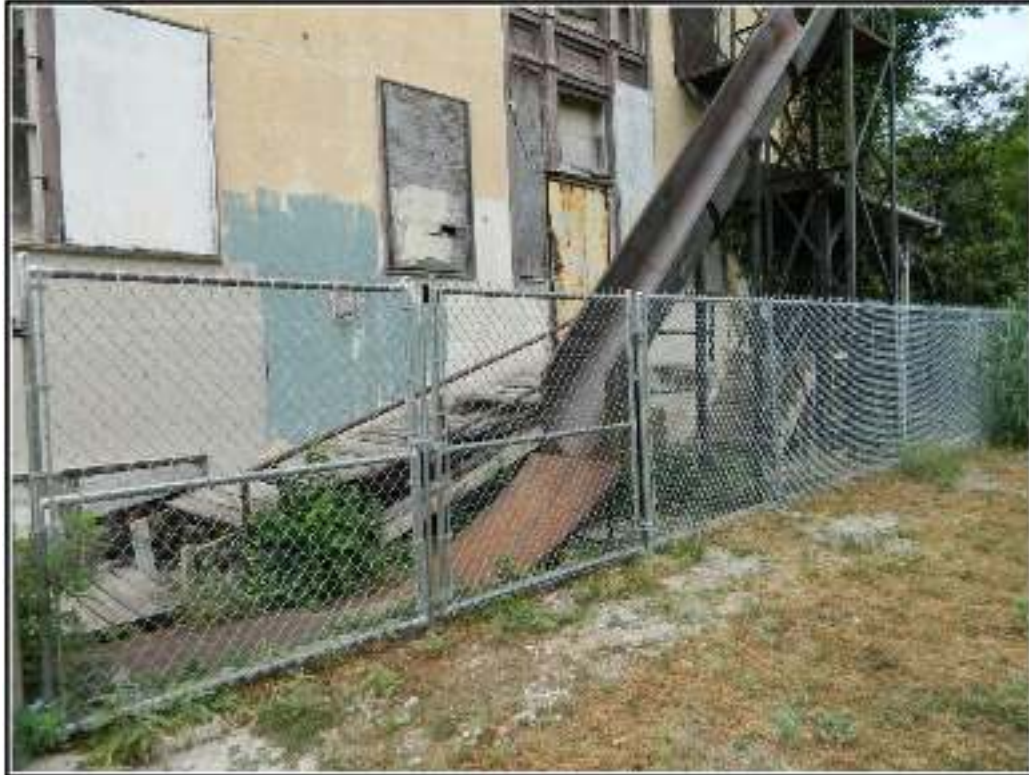
Figure 6-7. *Stairways leading to the entrances on the south side of Historic Resource 1.*

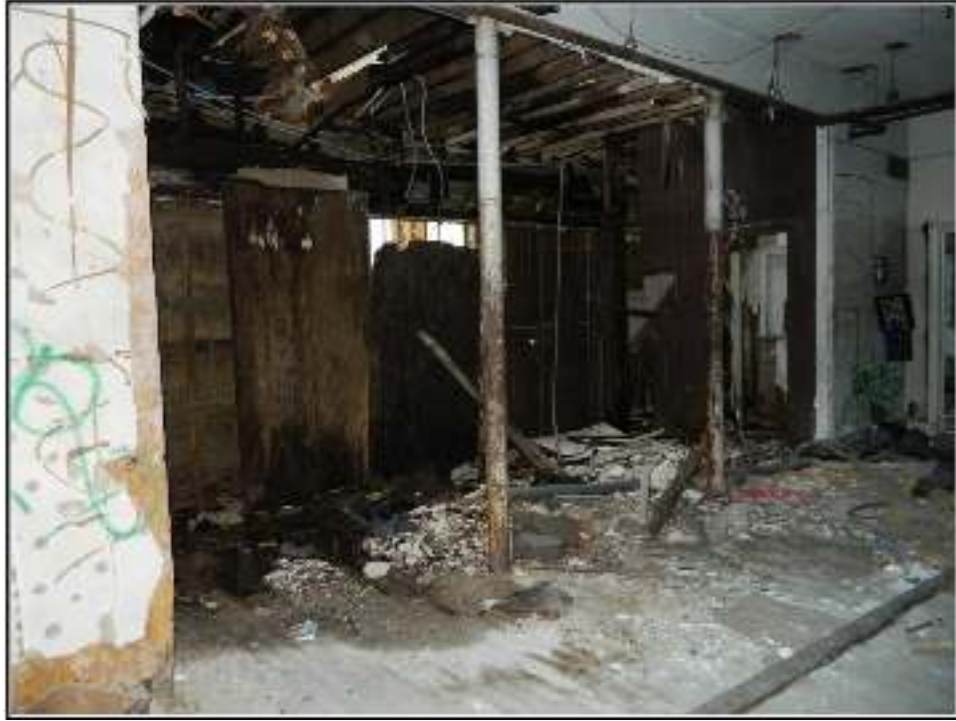
The floors of the first floor were wood with wooden joists and a few steel beams. Both the joists and steel beams were visible in areas that the wood flooring was missing. The wood is decaying due to water damage, and there were areas where the floor was no longer intact (Figure 6-8). A portion of the second floor had fallen into the first and exposed the basement of the structure. The main hallway was still intact, but the northwestern room floors were not present. The flooring along a portion of the east wall was also missing on the first floor.

Figure 6-8. *The interior of the Good Samaritan Hospital at the main entryway to the first floor.*

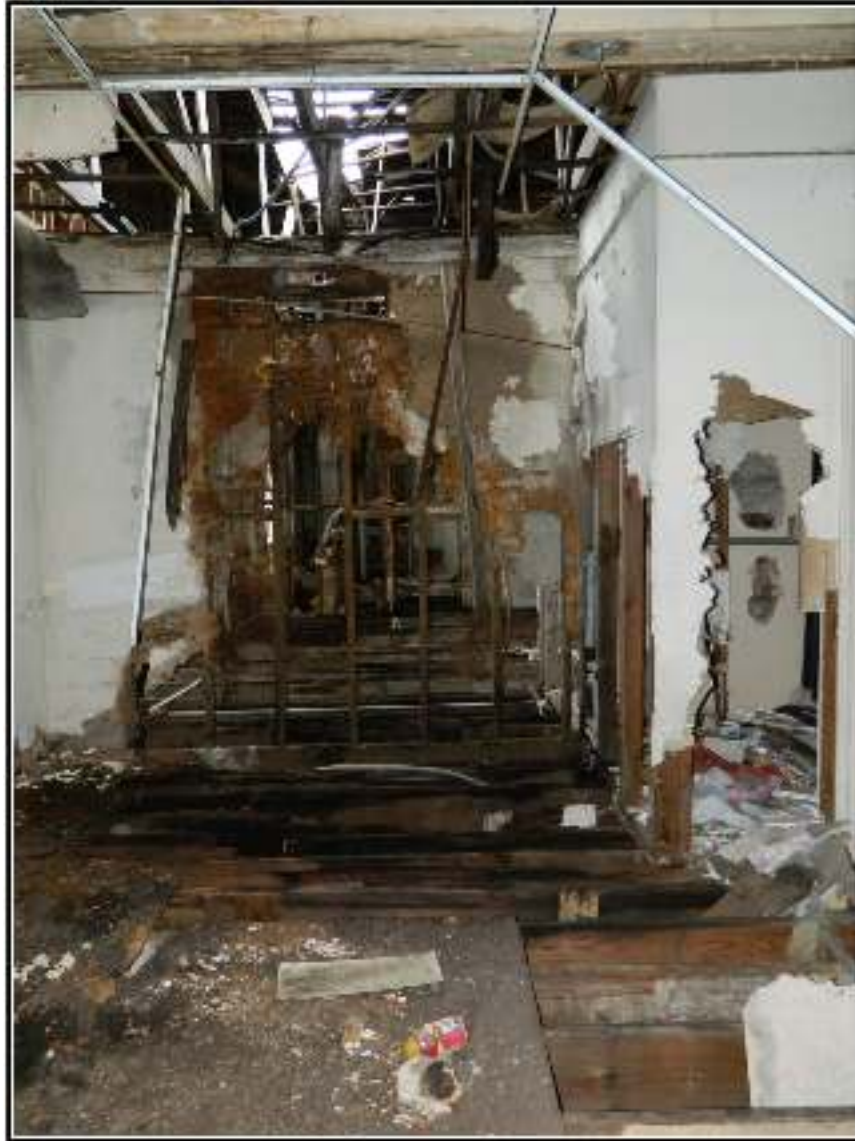
The second floor was missing a good portion of its wood flooring (Figure 6-9). Stairs leading to the second floor from the main foyer were missing, but remnants of the frame were still visible. Access to the second floor was obtained through a smaller stairwell southeast of the main entrance. These stairwells would have mirrored each other. The missing stairwell was removed at one time due to the damage resulting from the fallen roof and ensuing exposure to the elements. Two stair treads were missing in the remaining stairwell. The flooring at the head of the stairs on the second floor was extremely waterlogged and weakened. What appears to be a door was laid across missing flooring to allow for access to a portion of the second floor. The main hallway of the second floor was intact. The area above the foyer was missing floor boards as well as portions of the floor in each corner of the second floor.

Figure 6-9. *The interior of the Good Samaritan Hospital on the second floor above the main entryway.*

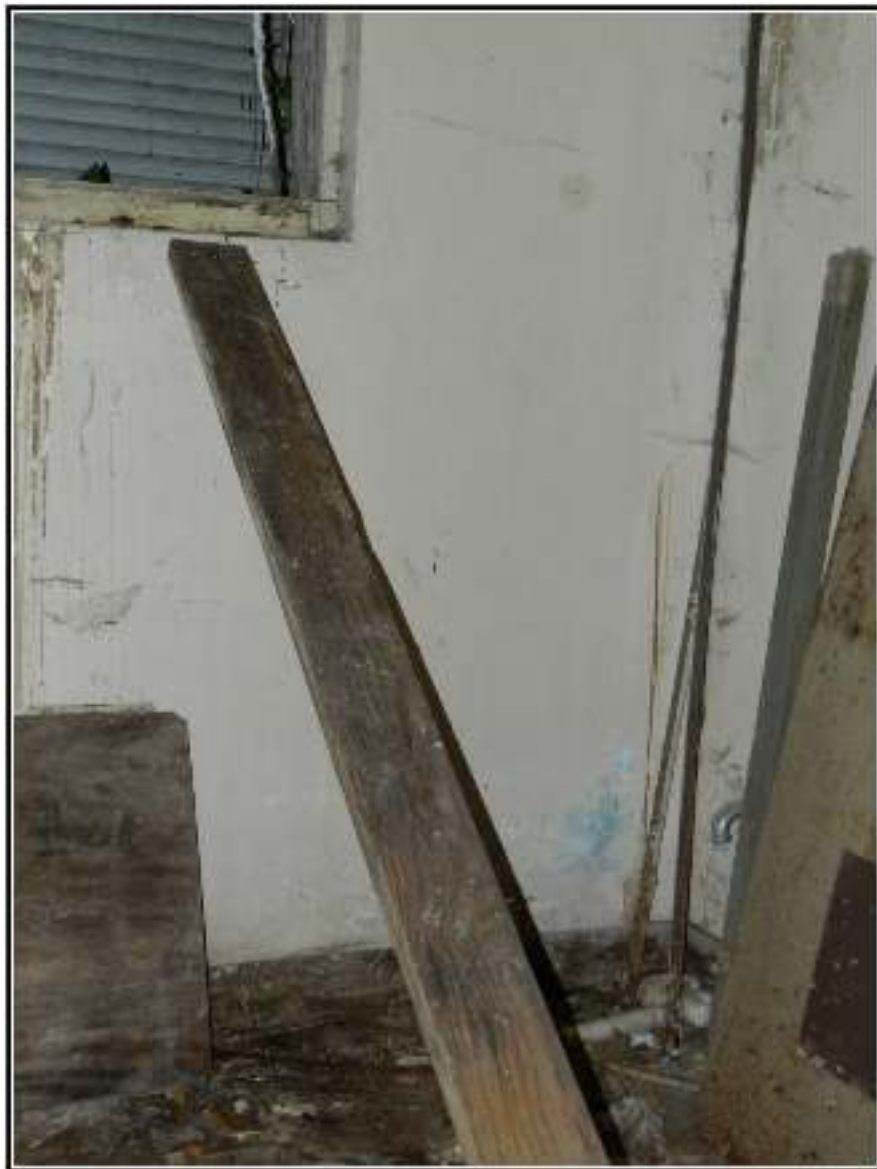
Figure 6-10. Room at the Good Samaritan Hospital in the basement that had an open window and plank.

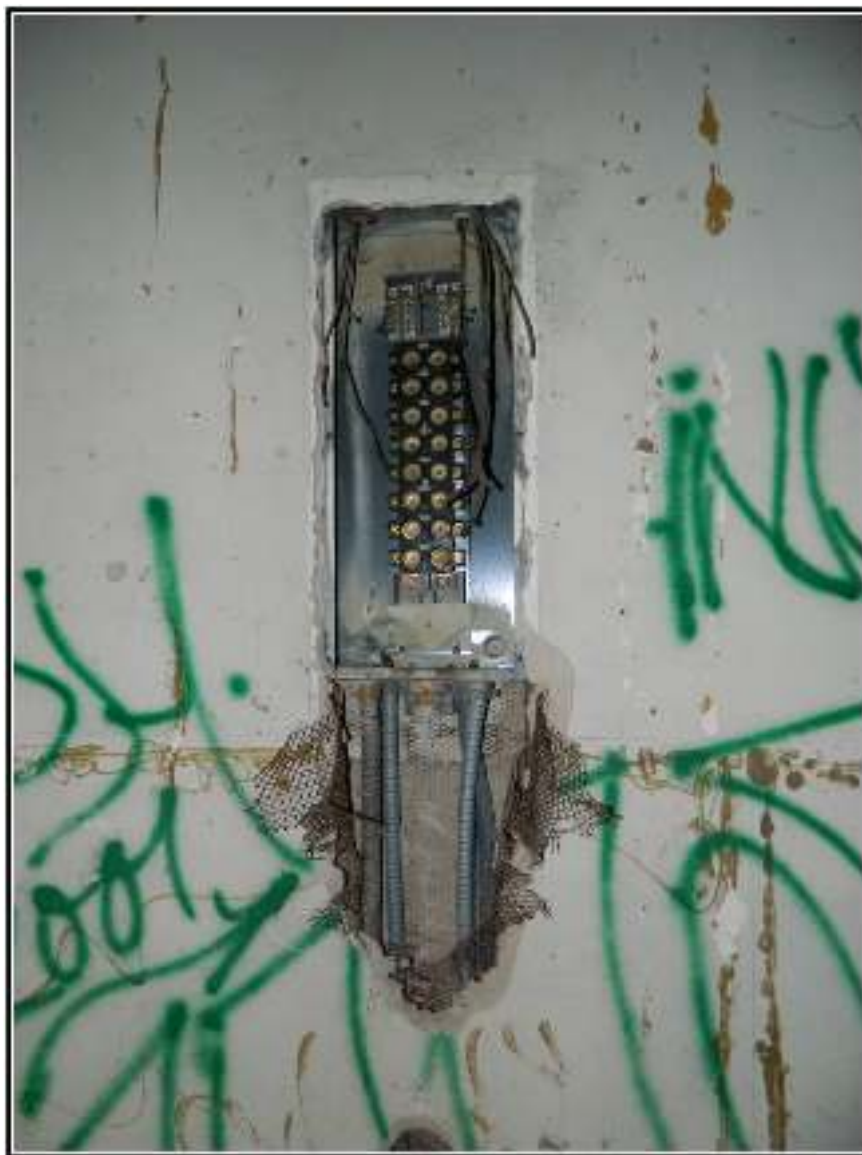
All fixtures have been removed from the structure. Each of the fuse boxes has been opened, and the fuses and wiring have been torn out (Figure 6-11). In many of the bathrooms the toilets and showers have been smashed. There are no switches, doors, door knobs, glass window panes, or any decorative pieces. The air ducts have been ripped open. Only three things with ties to the original construction were noted in the building. One is the sprinkler system. The lines are still present and can be seen throughout the building (Figure 6-12). The second is a water valve located in the northwestern room on the first floor (Figure 6-13). The date on the piece is 1948. The third is located in the basement and is likely connected to the water system (Figure 6-14). It is a control valve that appears to have been part of the original construction.

Figure 6-11. Fuse box noted on the main floor of the hospital.

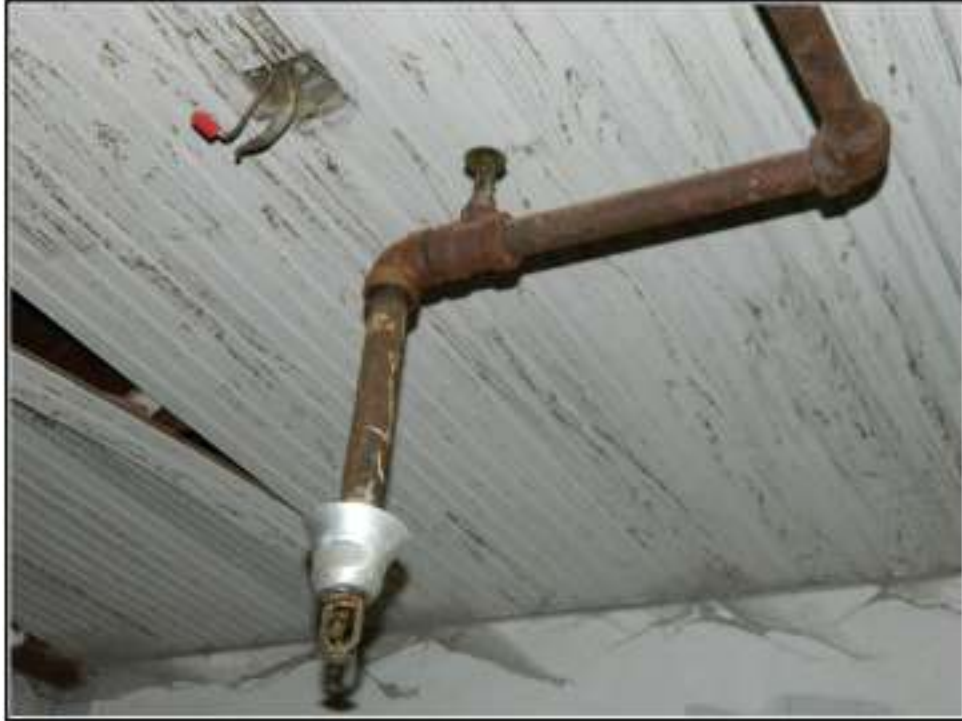
Figure 6-12. Example of the sprinkler system present throughout the hospital.

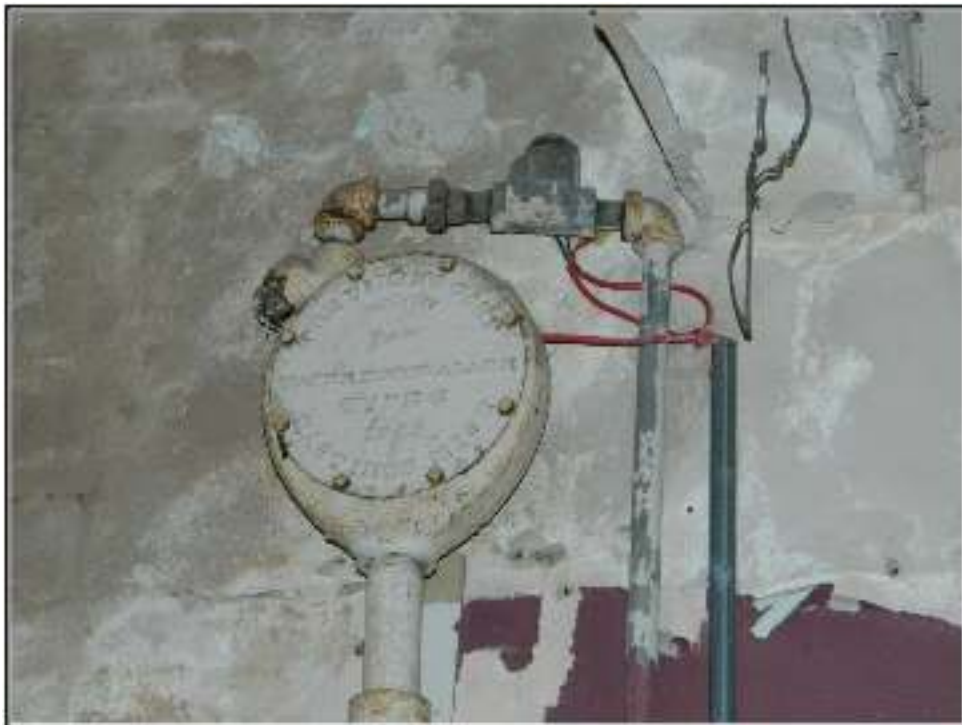
Figure 6-13. Water valve noted on the main floor of the northwestern room in the hospital.

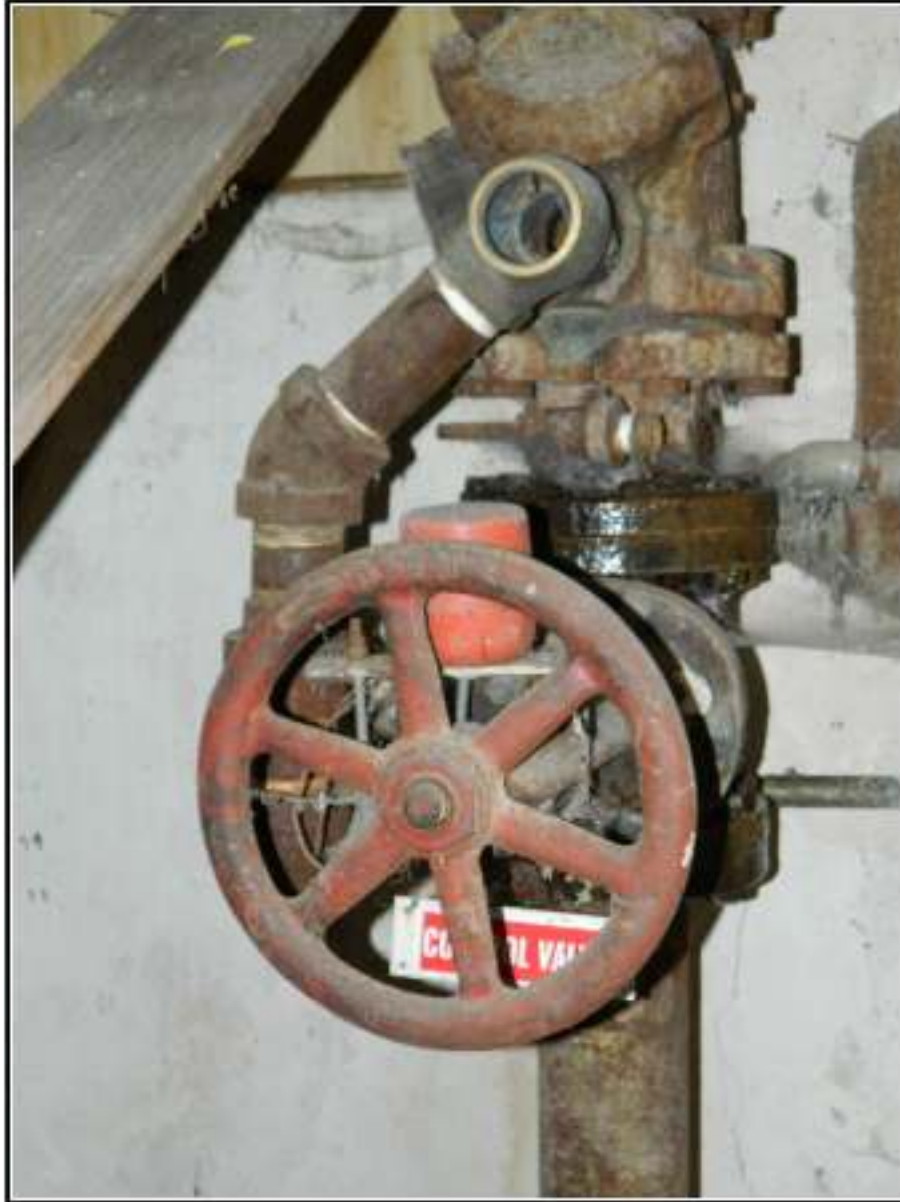
Figure 6-14. *Water line and valve located in the northern room in the basement.*

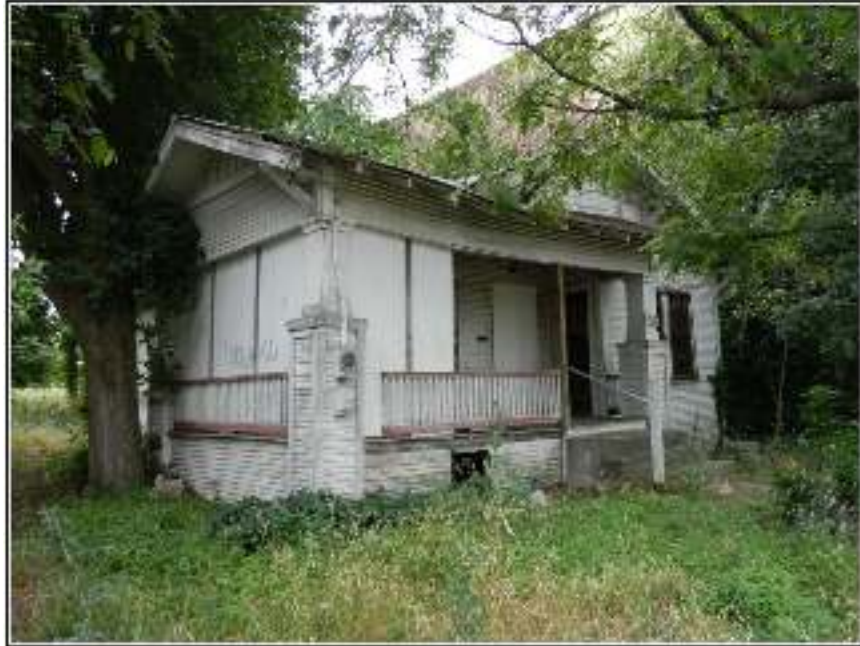
Historic Resource 2 is a one-story Craftsman bungalow located at 1604 Connelly Street on Lot 2A, Block 8, NCB 1508 (Figure 6-15). It is a wood frame, wood siding, clapboard dwelling that rests on a pier-and-beam foundation. The low roof line, wide overhanging eaves, and exposed rafter ends add visual interest as do the decorative brackets supporting the overhanging eaves. The roof is covered with fiberglass shingles. Craftsman-influenced square boxed piers topped with square box columns support an attached front- and side-gabled porch.

Figure 6-15. *Historic Resource 2, facing southwest.*

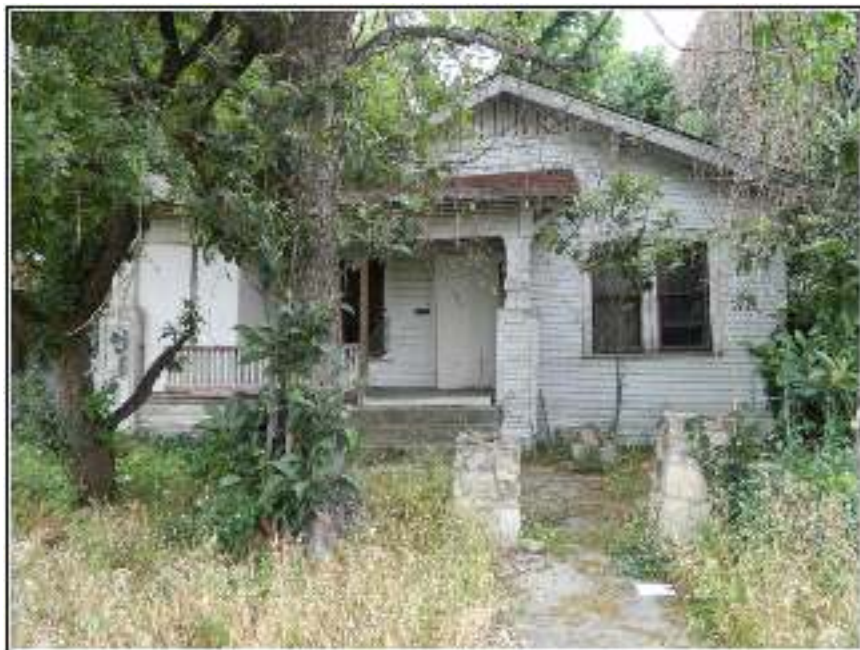
The porch has rails and a clapboard skirt below the railing. Concrete steps provide access to the porch level of the dwelling off the concrete sidewalk that is framed by two stone columns offset from the curb (Figure 6-16). The north elevation, the front of the dwelling, has one 1/1 wood sash window centered under the space defined by the covered porch, and two doorways provided entry into the dwelling, one facing the stairway and the other to right of it. A double set of 1/1 wood sash windows are centered in the façade.

Figure 6-16. *Historic Resource 2, north elevation.*

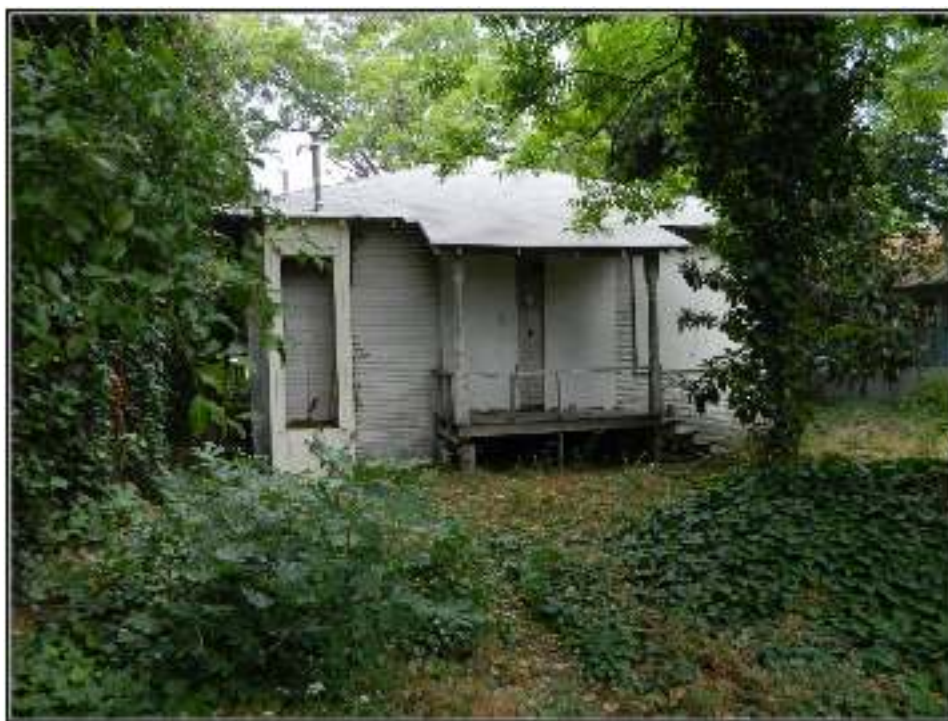
The south elevation, or back façade of the dwelling, has two boarded doors that open onto a covered porch (Figure 6-17). Turned spindle columns support a shingled roof, and the floor of the porch is supported by a combination of milled dimensional lumber and logs. The railing frames the porch on two sides, and the entire porch is a later construction possibly having replaced a previous porch given the doorways that opened to the back of the house. A double-hung wood sash window overlooked the backyard prior to having been boarded up. A narrow sheet-rock-framed addition at the southwestern corner of the back of the dwelling, and given the chimney pipe extending from it through the roof of the house, the addition may have housed the water heater.

Figure 6-17. *Rear of Historic Resource 2, facing northeast.*

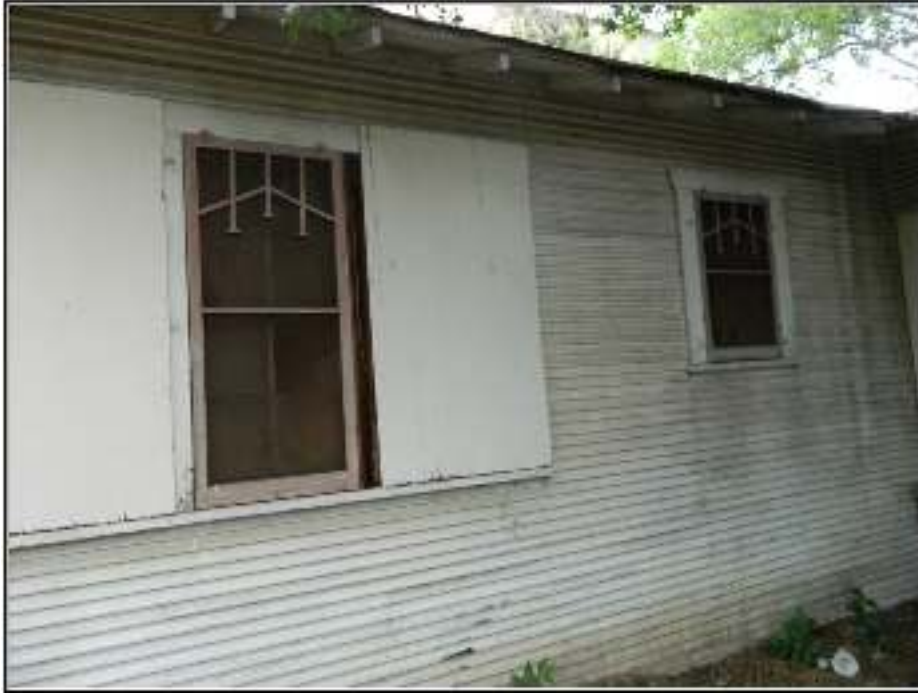
The windows that are not boarded up on the house exhibit decorative screens (Figure 6-18). The screens were hinged to the top of the window frame. The front windows of the house also have decorative wrought iron bars. One window on the side had shutters on the interior of the house that could be seen through the screen.

Figure 6-18. *Decorative screens covering the windows of the eastern side of the house.*

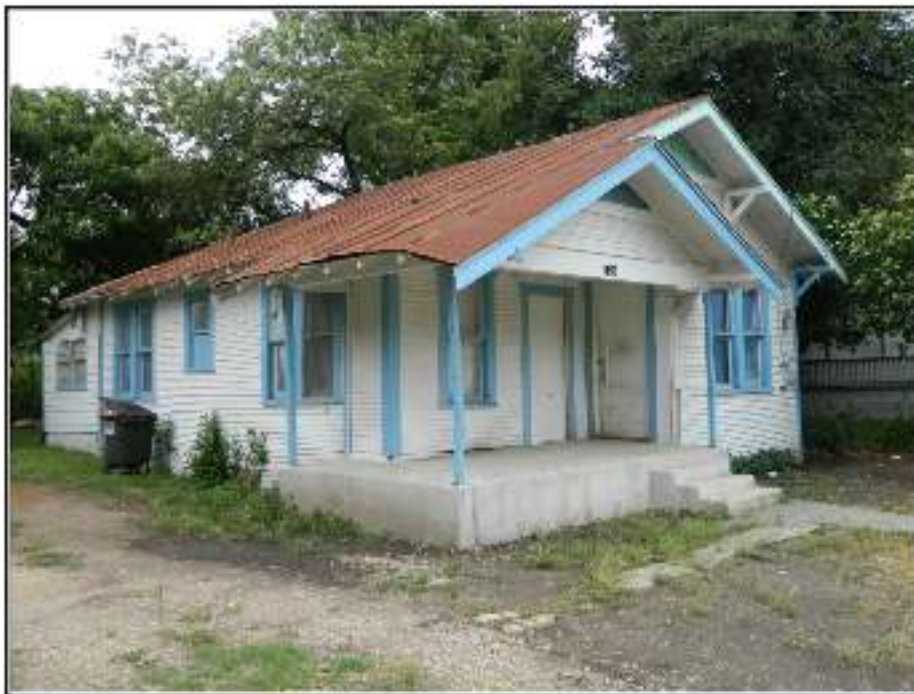
Historic Resource 3 is located to the east of Historic Resource 2 at 1610 Connelly Street on Lot 3, Block 8, NCB 1508. It is a one-story wood frame, wood siding, clapboard dwelling that rests on a pier-and-beam foundation (Figure 6-19). The dwelling has double front-facing gables. The moderate roof line, wide overhanging eaves, and exposed rafters are Craftsman style elements. Decorative brackets support the overhanging eaves. The pinnacles under the eaves exhibit decorative lattice details. The porch is supported by metal posts rather than wooden columns. The floor plan appears to be a variation on that employed in Historic Resource 2 with entry to the dwelling provided through two doors that open on the front porch. The structure exhibits a standing-seam metal roof.

Figure 6-19. *Historic Resource 3, facing southwest.*

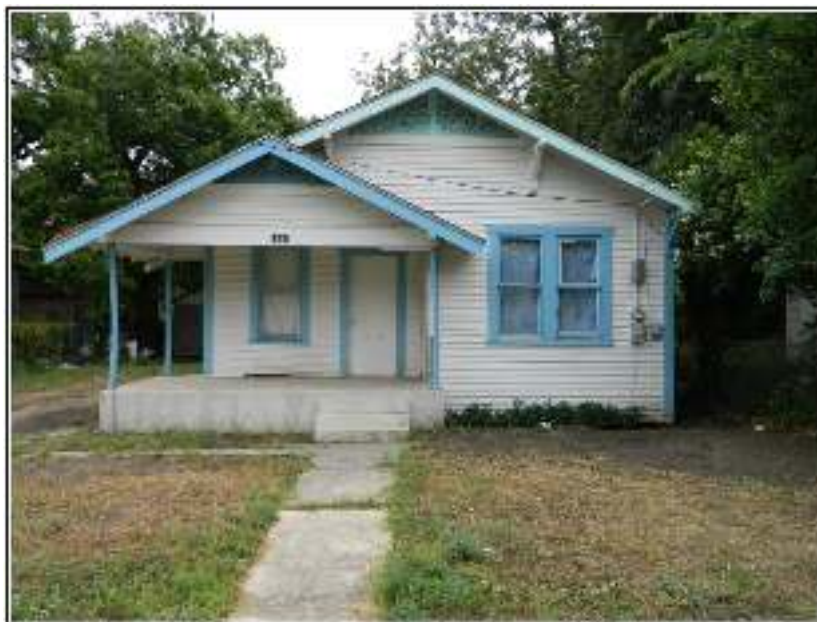
doorways provided entry into the dwelling, one facing the stairway and the other to right of it. A double set of 1/1 wood sash windows are centered in the façade. Flat board moldings frame each of the windows.

Figure 6-20. *Historic Resource 3, north elevation.*

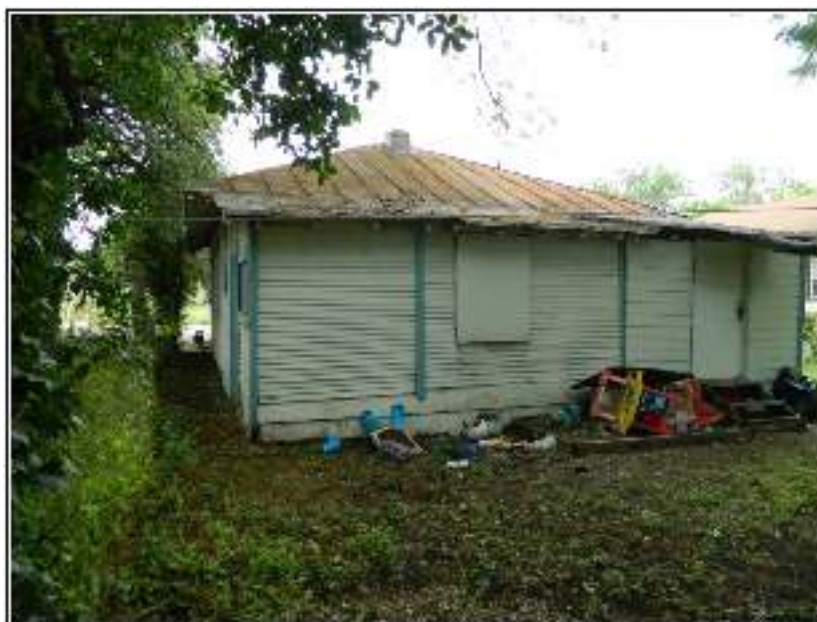
The south elevation of the dwelling has a wood framed door that opens onto wooden steps providing access to the backyard (Figure 6-21). A window, which is now boarded up, overlooked the backyard.

Figure 6-21. *Historic Resource 3, south elevation.*

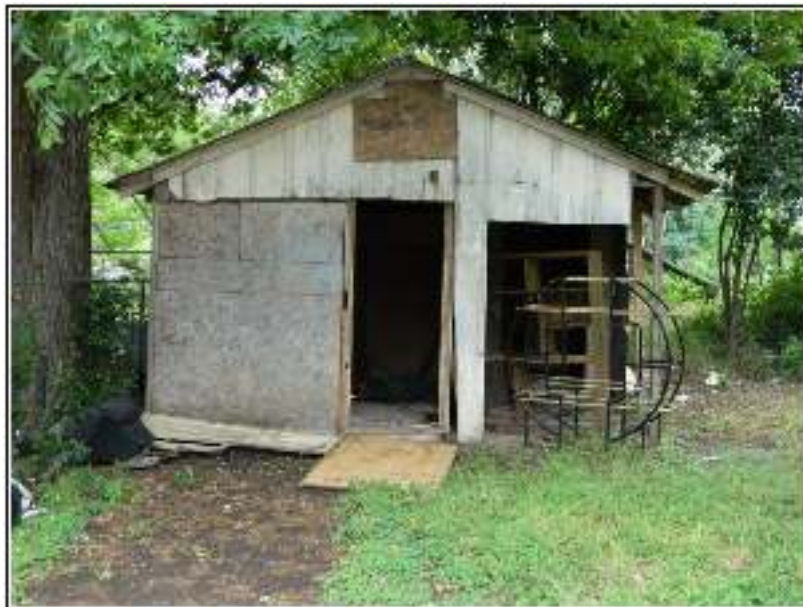
At the back of the property is a small outbuilding that appears to have more recently been used as a workshop or shed (Figure 6-22). The outbuilding may be contemporaneous with the main house, likely built between 1912 and 1952 as evident on the Sanborn maps. The roof is of the same material (tin sheets) as that used on the main portion of the house. The structure exhibits a house number on the front, suggesting that it was used as a residence at one point. If this is the case, the structure has not been used in many years as the siding and door has been removed.

Figure 6-22. *Associated structure located at the rear of the lot, Historic Resource 3.*
