Archaeological Monitoring of Electrical Conduit and Drainage Pipe Trenching at Mission San José y San Miguel de Aguayo, San Antonio, Bexar County, Texas

Texas Antiquities Permit No. 6295

Prepared by:
Center for Archaeological Research
The University of Texas at San Antonio
One UTSA Circle
San Antonio, Texas 78249-1644
Technical Report, No. 47

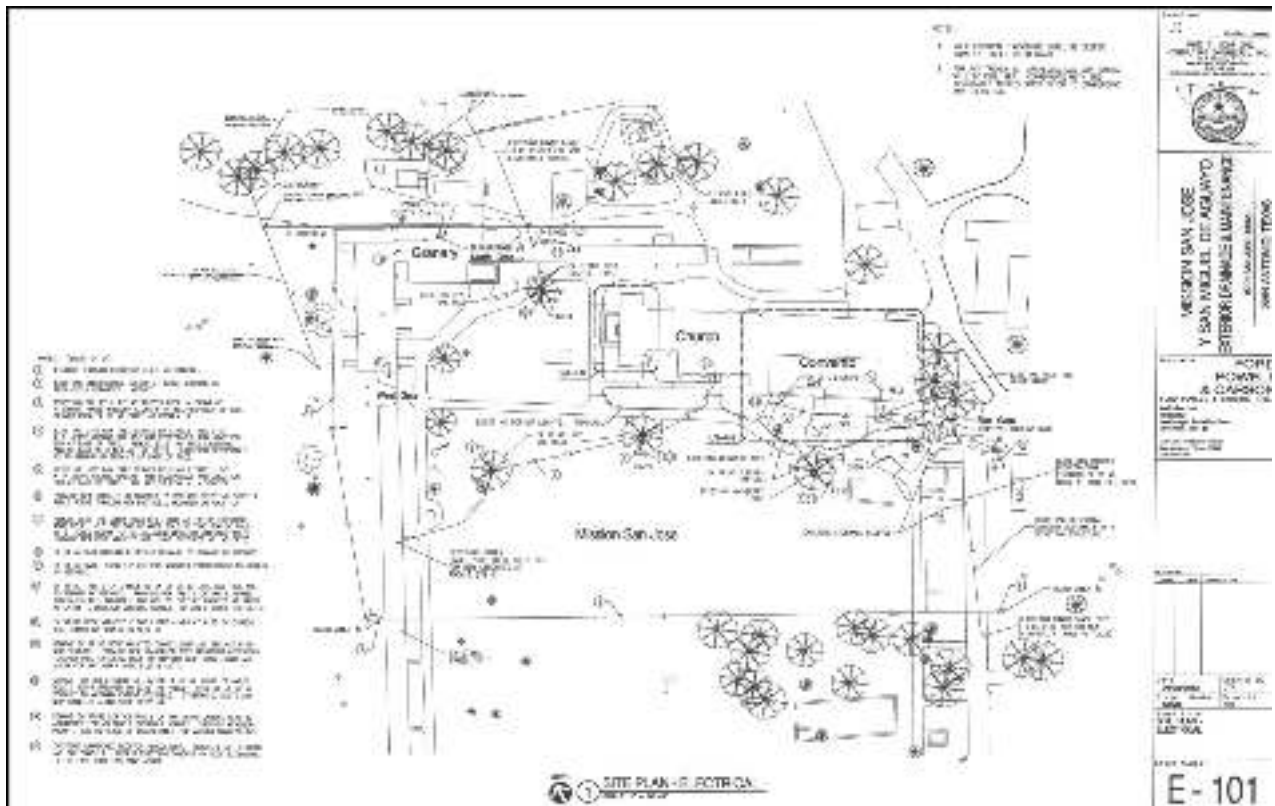
The Area of Potential Effect (APE) consists of the entryway to the church at Mission San José y San Miguel de Aguayo and a portion of the *convento* (Figure 1-2). The planned improvements, sponsored by the Archdiocese of San Antonio, consist of the installation of electrical conduits (Figure 1-2) in the vicinity of the *convento* and church entryway at Mission San José. The electrical conduits were to be installed in hand-excavated trenches. In addition, a new drainage pipe was to be installed if the existing pipe could not be freed of obstructions.

Figure 1-2. The location of the conduits to be installed at Mission San José.

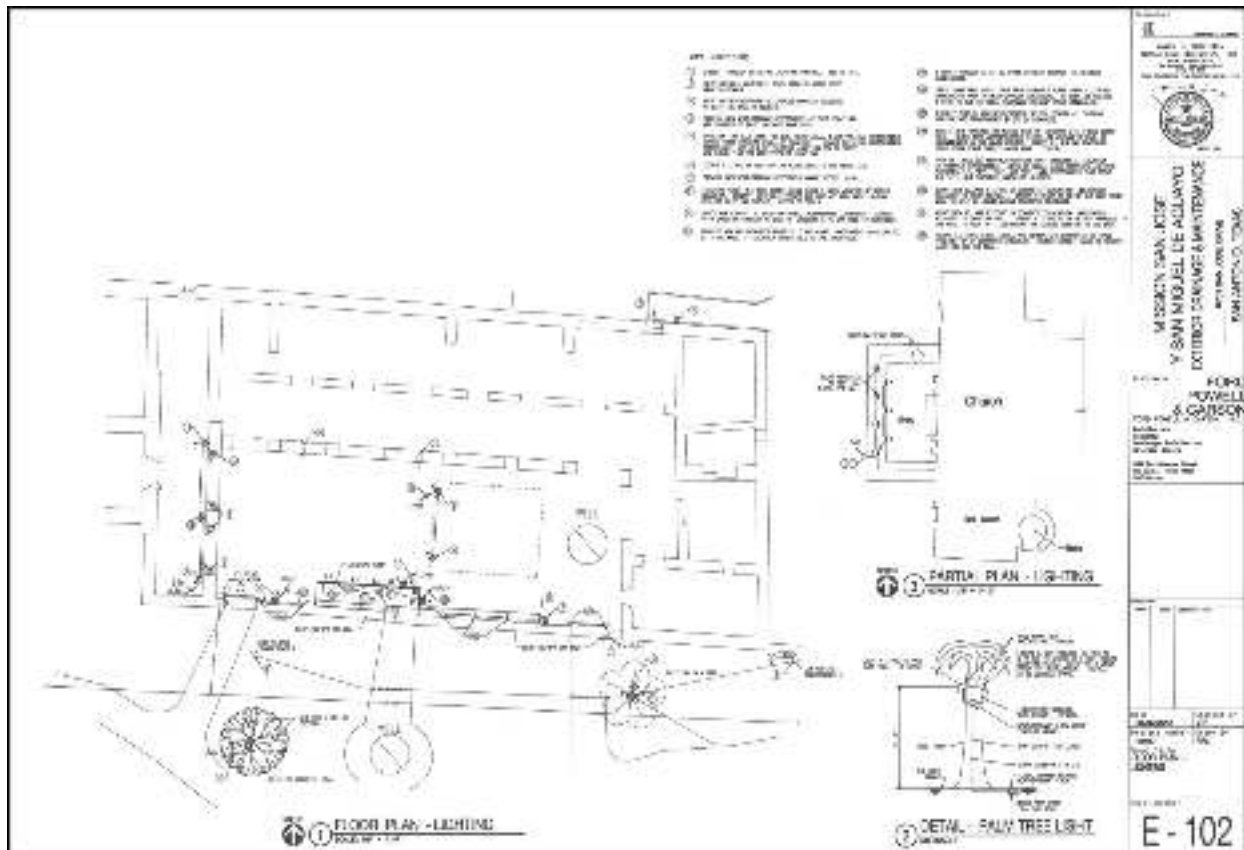
Figure 1-3. The location of the conduits to be installed at Mission San José around the convento.

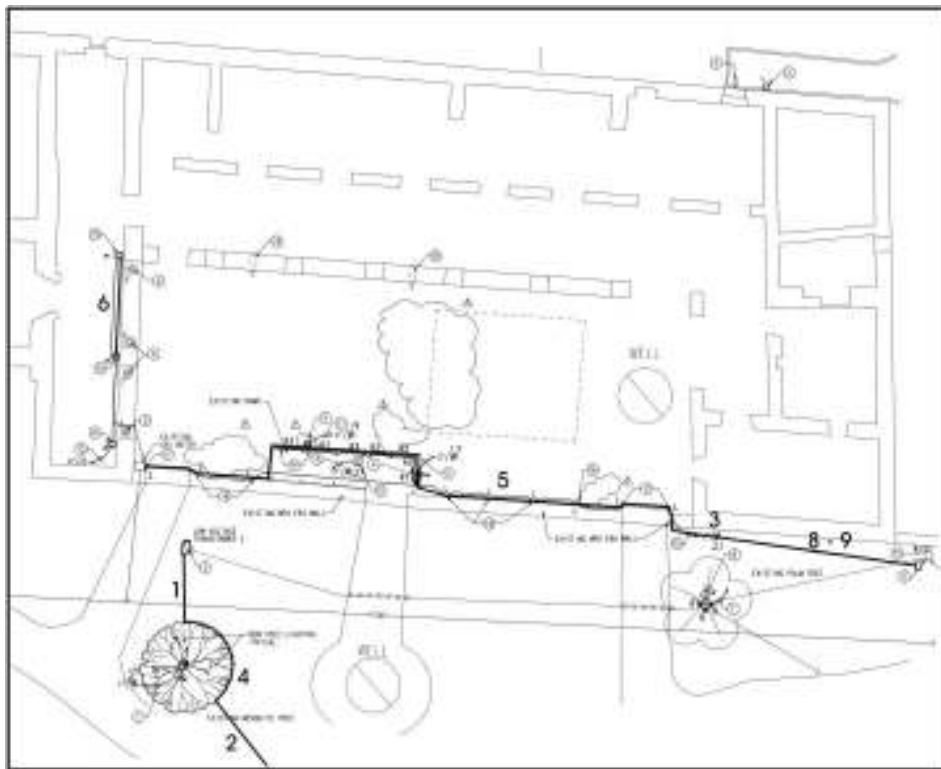
Nine trenches were excavated for the installation of electrical conduits along the south side of the *convento*. Their locations are shown on Figure 4-1 below.

Figure 4-1. Close-up of “as-built” installation of utility lines in the vicinity of the convento. Bold numbers indicate trenches.

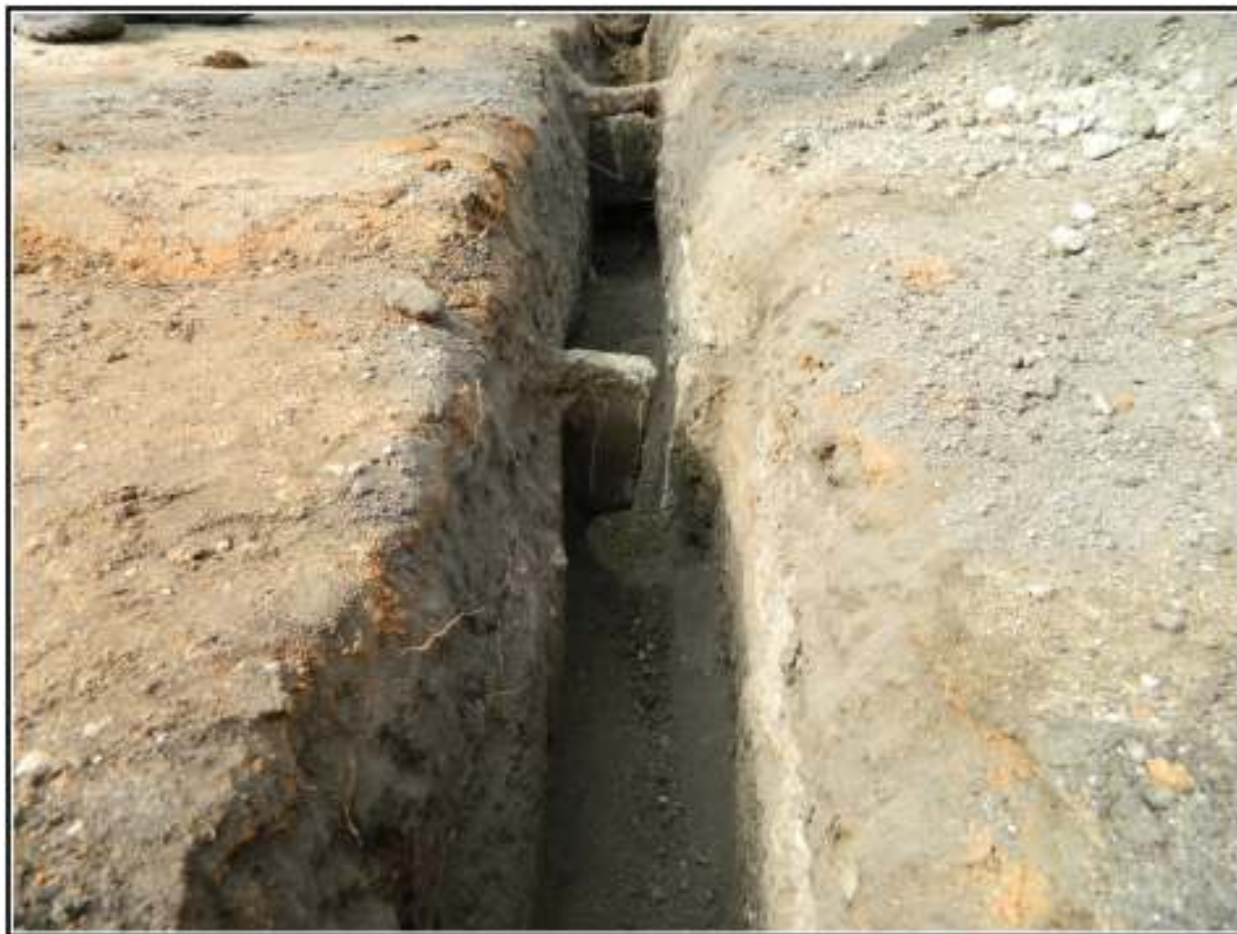
Trench 1 (TR-1) was excavated between a low voltage transformer and an existing light fixture on a hackberry tree (Figure 4-1). It was approximately 15.24 cm (6 in.) wide, 30.5 cm (12 in.) deep, and 7.62 m (25 ft.) long. At about 6 m (20 ft.) along this trench, two vertical stones that may have served as edging along a sidewalk were encountered, and another stone was encountered roughly 1.2 m (4 ft.) north of these stones. Few pieces of ceramic and animal bone were noted during the excavation of this trench.

Figure 4-2. *Vertically laid sandstone pieces noted in Trench 1.*

Trenching associated with electrical line installations near the *convento* identified no intact cultural deposits. Vertically positioned tabular limestone rocks in one portion of Trench 1 suggest that a sidewalk may have been present in the area paralleling the current concrete sidewalk.

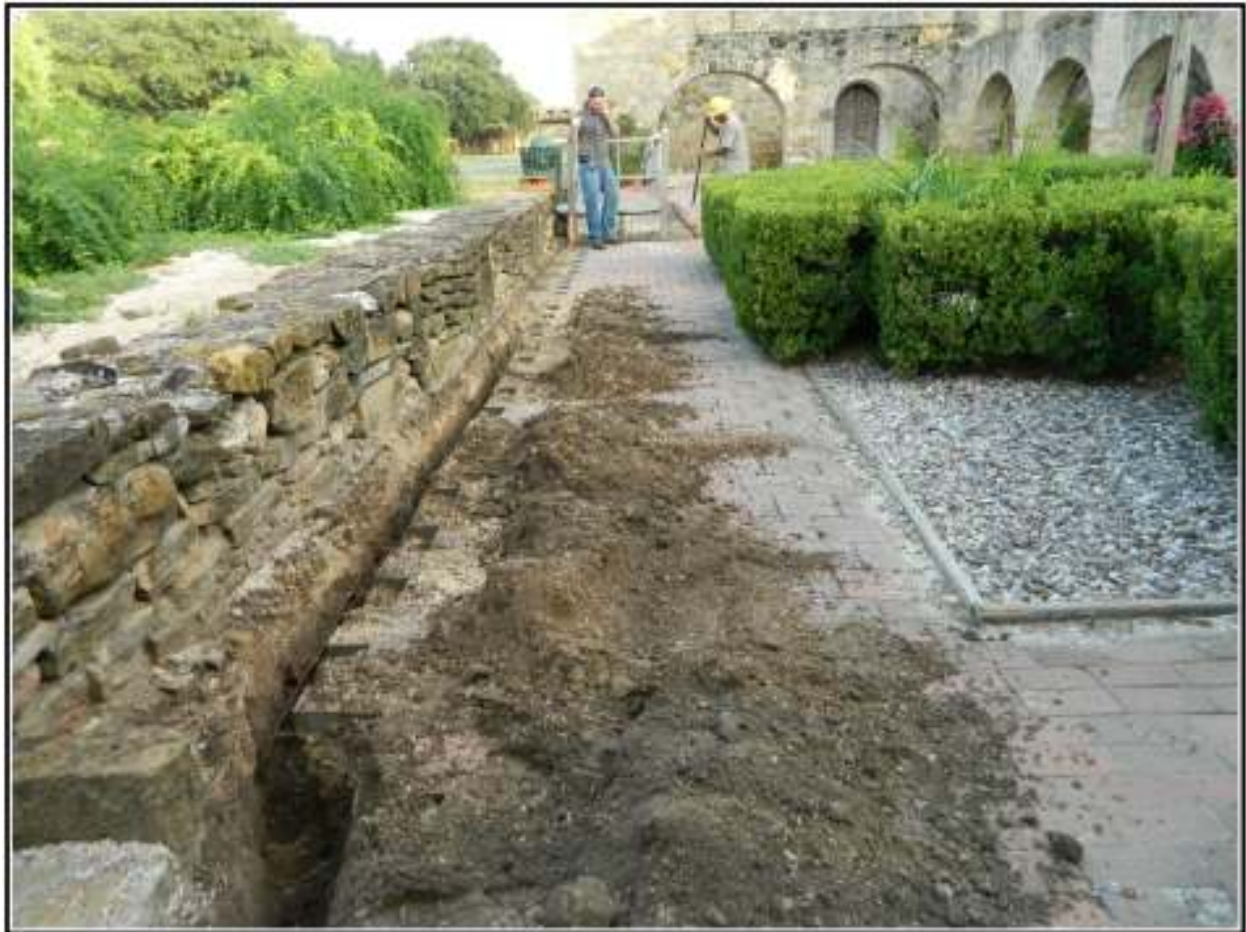
Figure 4-3. Excavation of Trench 5 along the inside of the retaining wall bordering the convento.

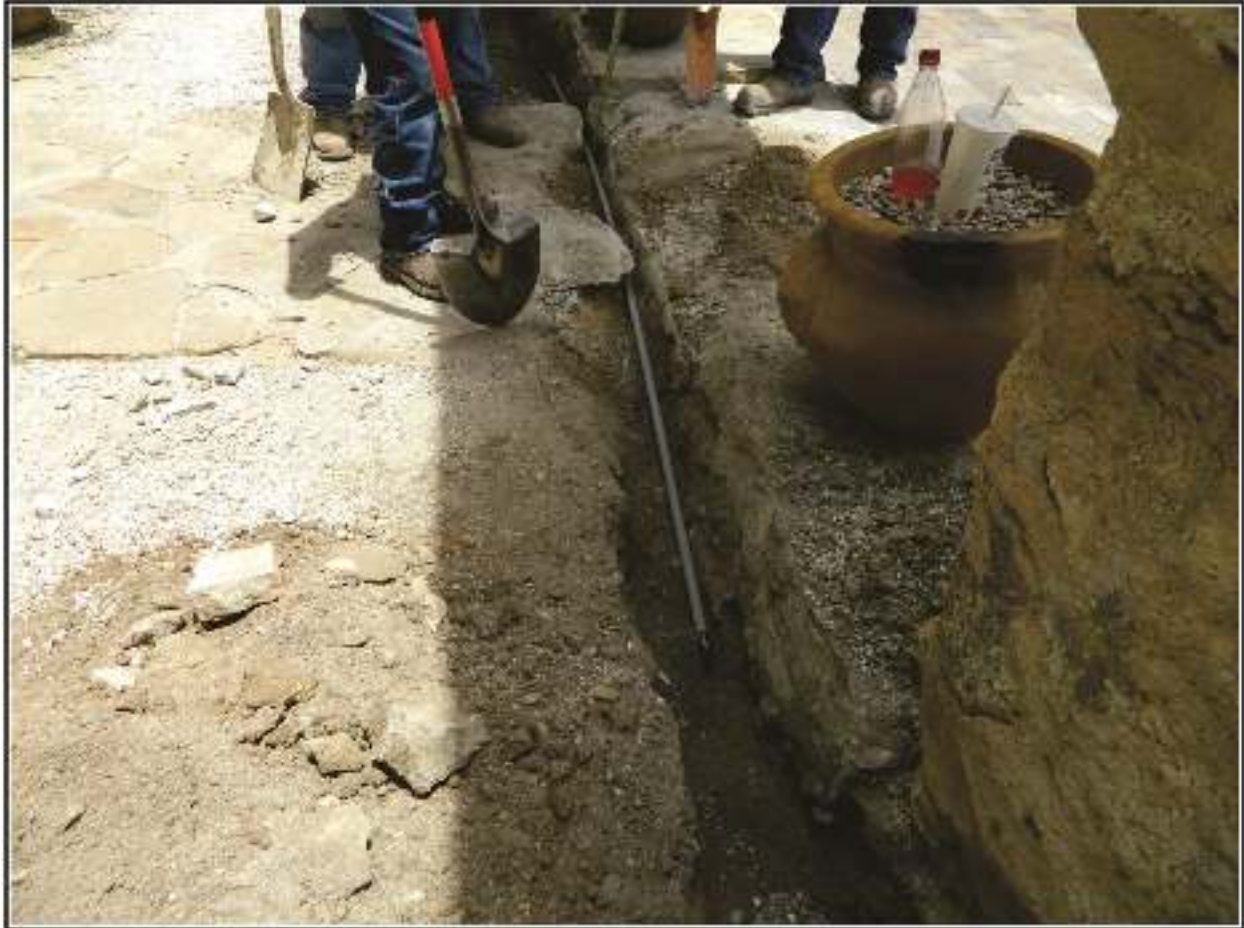
Figure 4-4. Trench 7 on the inside of stone foundation near back entrance to church.

Trench 7 (TR-7) was excavated south of a sidewalk that leads past the *convento* (Figure 4-4). It connected the conduit in TR-2 to a lighting fixture attached to a nearby tree. No artifacts were noted during the monitoring of this excavation. The last two trenches (TR-8 and TR-9) were excavated near the southeast corner of the *convento* to connect conduits to a junction box in the area. Ceramic, glass, and metal were present within both trenches, and a cartridge case was encountered in TR-9.

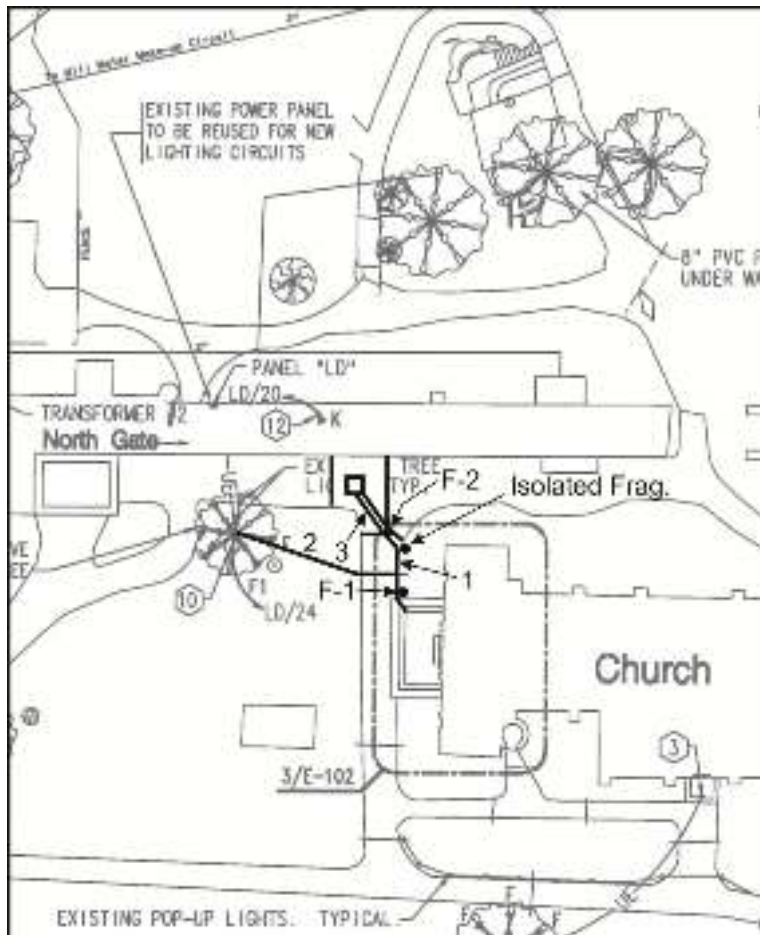
While trenches around and within the *convento* were being excavated, a second CAR archaeologist monitored the excavation of two trenches in front of the church (Figure 4-5).

Figure 4-5. Close-up of “as-built” installation of utility lines in the vicinity of the church. Bold numbers and lettering refer to trenches. F-1 and F-2 are features.

One of these trenches was intended for a new drainage pipe along the church entryway. This trench, designated as Trench 1 (TR-1), began at the northeast edge of the sunken flagstone entryway at the front of the church. Approximately 91 cm (3 ft.) from the northwest corner of this sunken entryway, trenching exposed the very edge of a shallow pit filled with fine sterile sand (Figure 4-5). The shallow pit was designated as Feature 1. The top of the feature was encountered at 15.24 cm (6 in.) below the surface. Because the trench skirted the feature without impacting and exposing its contents, it was not investigated beyond photo-documenting and mapping the location. Subsequently, the trench was reoriented to provide an additional buffer away from the feature, and the trench excavations resumed. The trench continued north-northwest of the church towards the second portal of the servants’ quarters. At a distance of approximately 2.74 m (9 ft.) from the northeast corner of the sunken entryway (Figure 4-5), an isolated bone fragment, a portion of the skull cap, was encountered in the matrix removed from the trench. The fragment was temporarily retained for further examination to determine whether it was human. The

Excavations immediately north of the church entryway identified one feature (Feature 1), a pit filled with sand. Since the utilities trench did not disturb the feature, it was not investigated in detail. The alignment of the trench was changed so as not to disturb the feature, and trenching was allowed to continue. An isolated skull cap fragment was encountered a few feet away within the same trench. At the time of the initial recovery, it was unclear whether the remains were human, and the fragment was temporarily retained for closer inspection. Once it was established that indeed the fragment was a human skeletal fragment, it was presented to Susan Snow and subsequently reintroduced in the same trench where it was encountered.

The second feature (Feature 2) was identified during the excavation of a tunnel linking the ends of Trench 1 and 3 under the sidewalk near the church entrance. This feature consisted of small unidentifiable fragments of bone. Given their location within a tunnel under the sidewalk, the context of the finds could not be properly assessed. Rather than removing the sidewalk to allow for the investigation of the feature, the tunnel was realigned, and the few pieces of bone were covered with matrix and left in place.

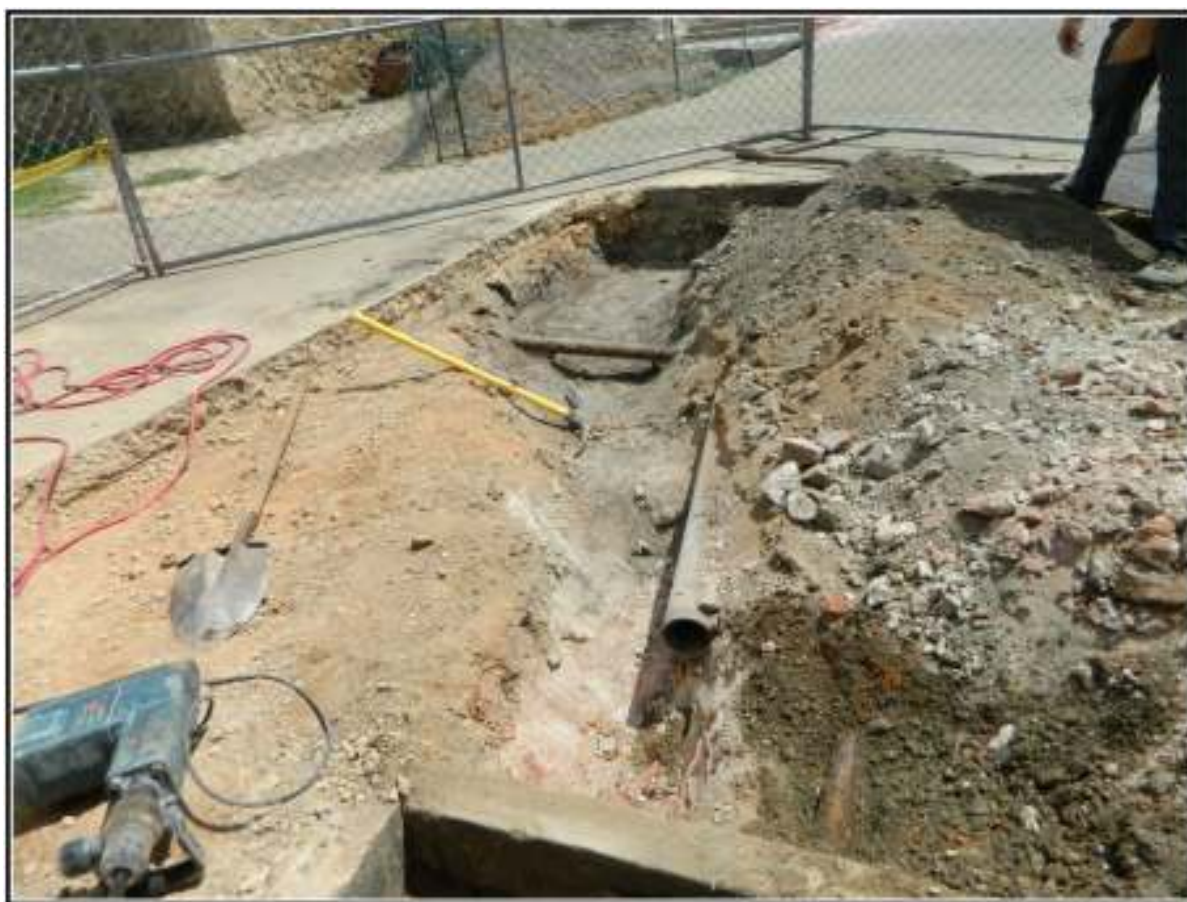
Since T-1 connected to a drain that was in the center of the east-west running sidewalk in front of the servants' quarters, a portion of the sidewalk had to be sawed and removed from around the drain. Subsequently, Trench 3 (T-3) was begun at the drain and continued southward to the edge of the cut sidewalk. At this point it was to run under the sidewalk to connect to TR-1 (Figure 4-6).

Figure 4-6. Trench 3 near the church entrance. Trench 1 is seen on the opposite side of the sidewalk.

Several pipes as well concrete and brick from what appeared to be a previous sidewalk in the area were encountered during the excavation of T-3. An abundance of faunal remains were encountered in this area. Some unidentified metal and glass fragments also were present.

Tunneling under the sidewalk to connect the two trenches (T-1 and T-3) was a slow process accomplished by hand and with the assistance of a pneumatic hammer with a chisel attachment. The dirt removed from under the sidewalk was inspected by the monitor, and intermittently, the monitor would lie in the trench and peer into the tunnel. It was during one of these episodes that a cluster of fragmented bones was noted in the wall and on the floor of the tunnel (Feature 2; Figure 4-5). Due to the poor lighting conditions, it was not possible to discern the context of the remains. Nonetheless, the small number of bone fragments that had fallen out of the matrix were clumped together at the end of the tunnel and covered with matrix. Additional work in this portion of the tunnel was suspended, and the area was photographed. The examination of the photographs revealed a rectangular trench-like outline under the sidewalk. Due to the limited space and small area exposed, it was not feasible to determine whether this outline represented a burial pit or a utility trench that had been excavated in the area during prior improvements. Nonetheless, the excavator was instructed to change the angle of the tunneling so that it would miss the feature. The tunneling resumed and monitoring continued without identifying any additional remains under the sidewalk.

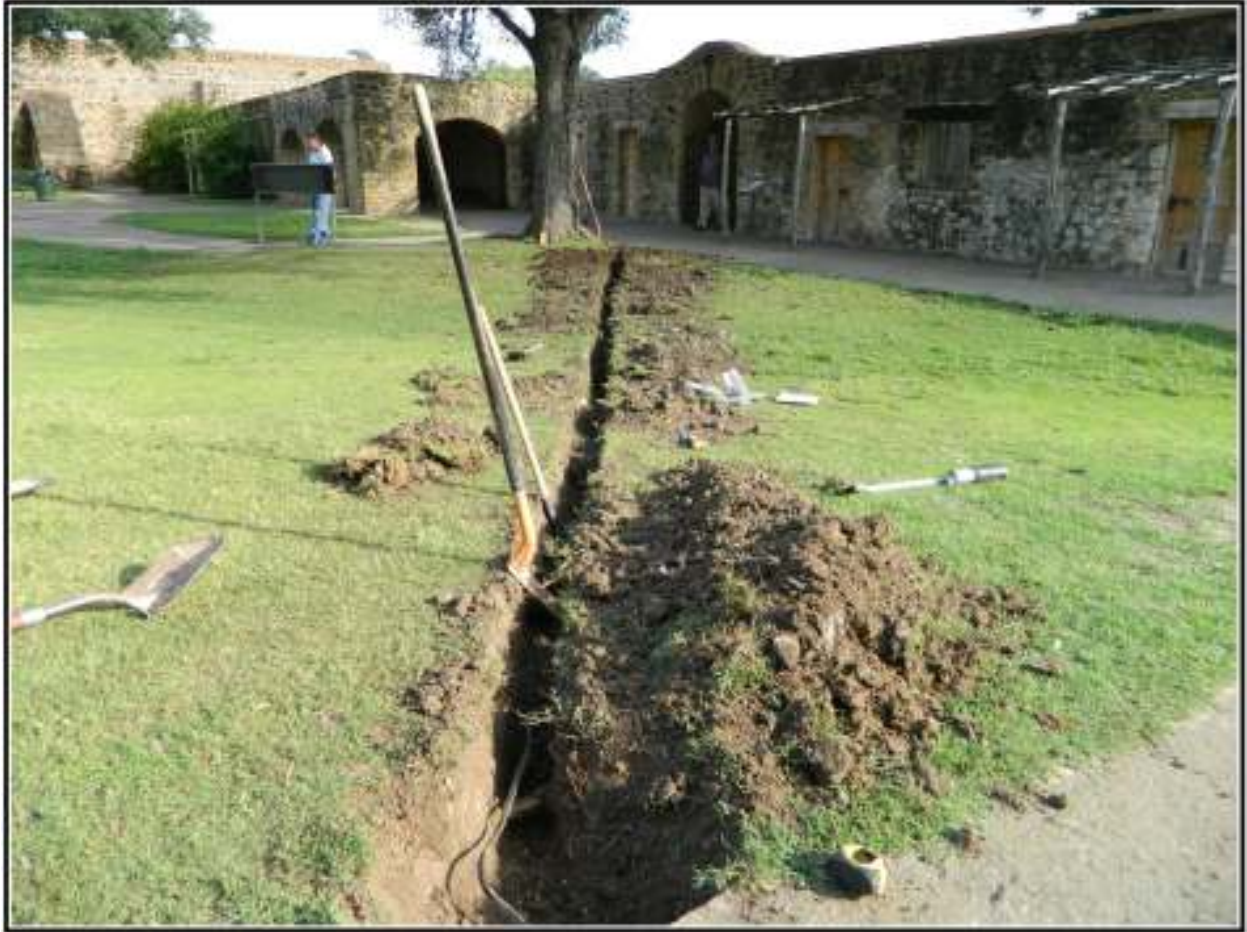
Trench 2 (TR-2) was excavated for the installation of electrical conduit in the grassy area in front of the church (Figure 4-7). This trench extended northwest of the church from the walkway to a junction box next to a live oak tree. The soil from this trench appeared to have been undisturbed. Many pieces of animal bone and three pieces of ceramics were noted in the backdirt. Two of these pieces of ceramic were native-made Goliad wares and were therefore collected.

Figure 4-7. Trench 2 running from in front of the church to a junction box next to the tree.
