Standing Structure Survey of a Portion of San Pedro Creek, San Antonio, Bexar County, Texas

Prepared by:
Center for Archaeological Research
The University of Texas at San Antonio
One UTSA Circle
San Antonio, Texas 78249-1644
Technical Report, No. 51

Management Summary:

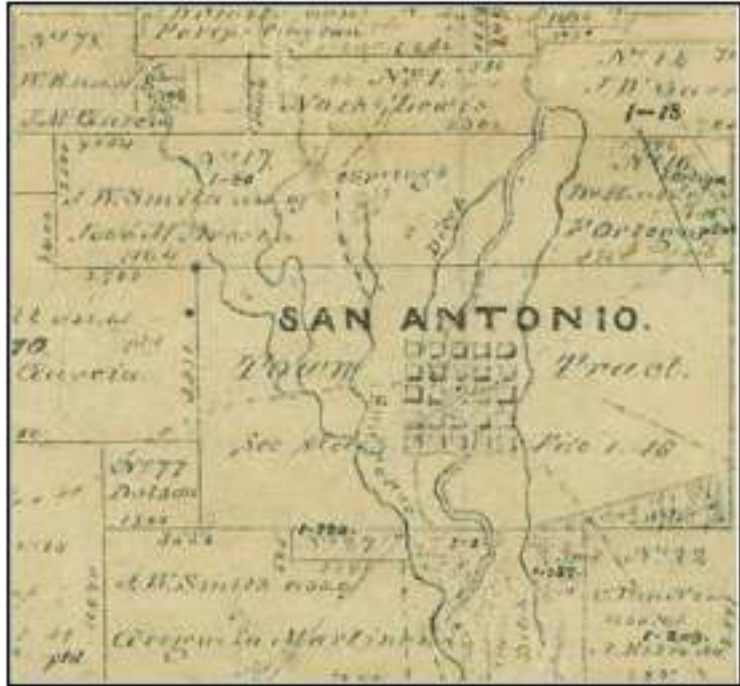
Figure 4-6. The San Antonio Town Tract depicted in 1845.

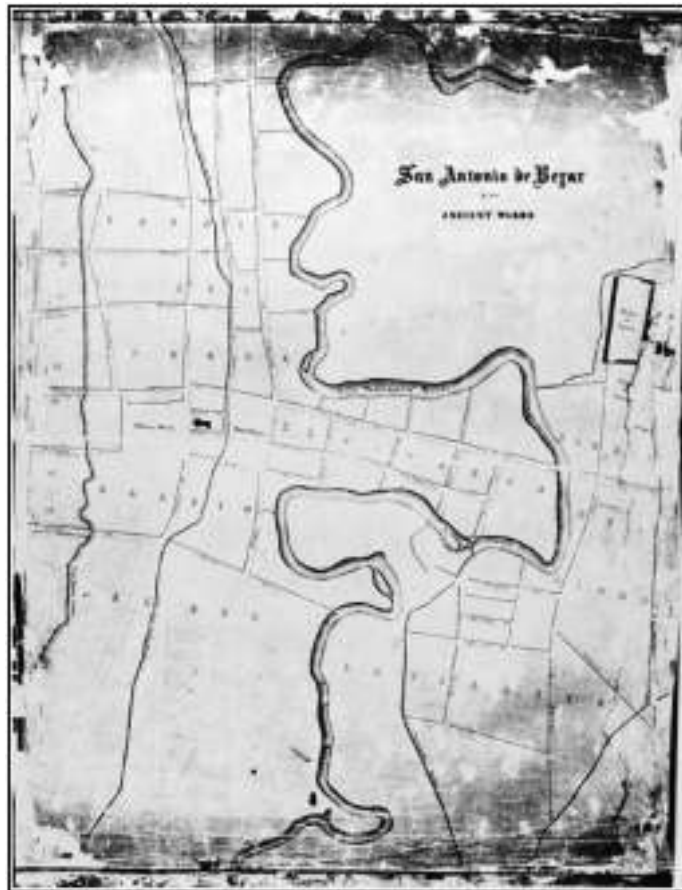
Figure 4-7. Map depicting big bend in San Antonio River and its vicinity, drawn by Frieslaben in 1845.

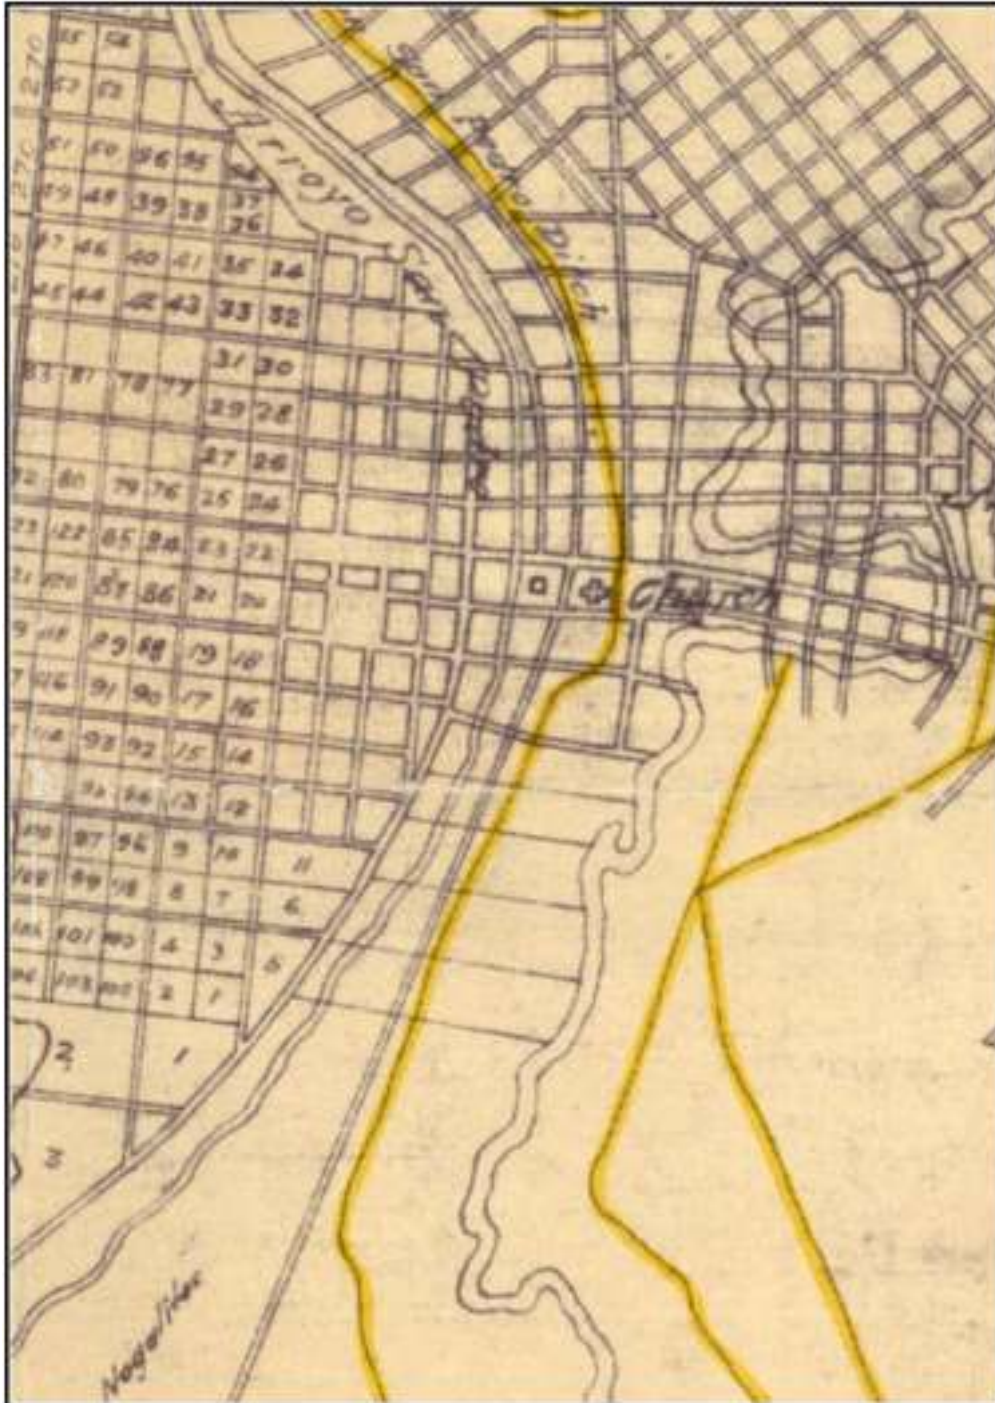
Figure 4-8. Central portion of San Pedro Creek drainage shown on 1852 map.

A plat map of city tracts drawn only seven years later in 1852 shows the upper portion of the project area from roughly Kingsbury Street to Arsenal Street although the latter is not depicted on the map (Figure 4-8). Development appears to have reached to Frio Street west of San Pedro Creek, but parcels further west appear not to have been sold at this time. Eight roadways appear to cross the San Pedro Arroyo as it is identified on the map.

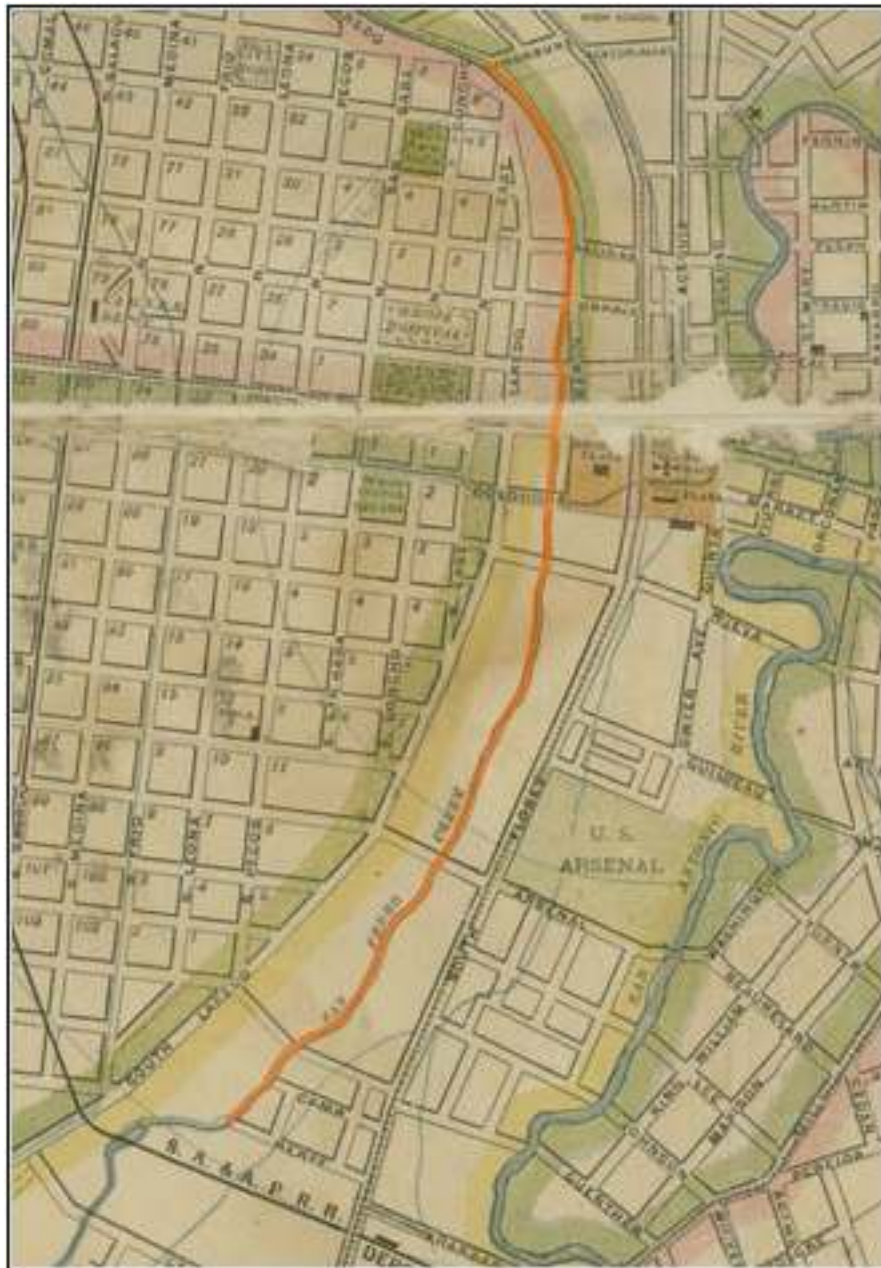
Figure 4-12. A portion of the 1889 J.J. Olsen and Son map of San Antonio showing the project area. The orange line highlights the project area.

The 1889 color map of the city published by J.J. Olsen and Son of San Antonio provides additional details regarding the growth of the city during the late nineteenth century (Figure 4-12). The banks of San Pedro Creek are drawn as if they are natural stream banks rather than contained within retaining walls. This would contradict the interpretation of the 1885 Sanborn Map that suggested, at least between W. Houston and Dolorosa Streets, the west bank of San Pedro Creek was formed by a retaining wall. For much of its course, between Kingsbury and Camp Streets, the creek flowed along a relatively broad and undeveloped stretch of floodplain between Laredo Street on the west and Flores Street on the east.

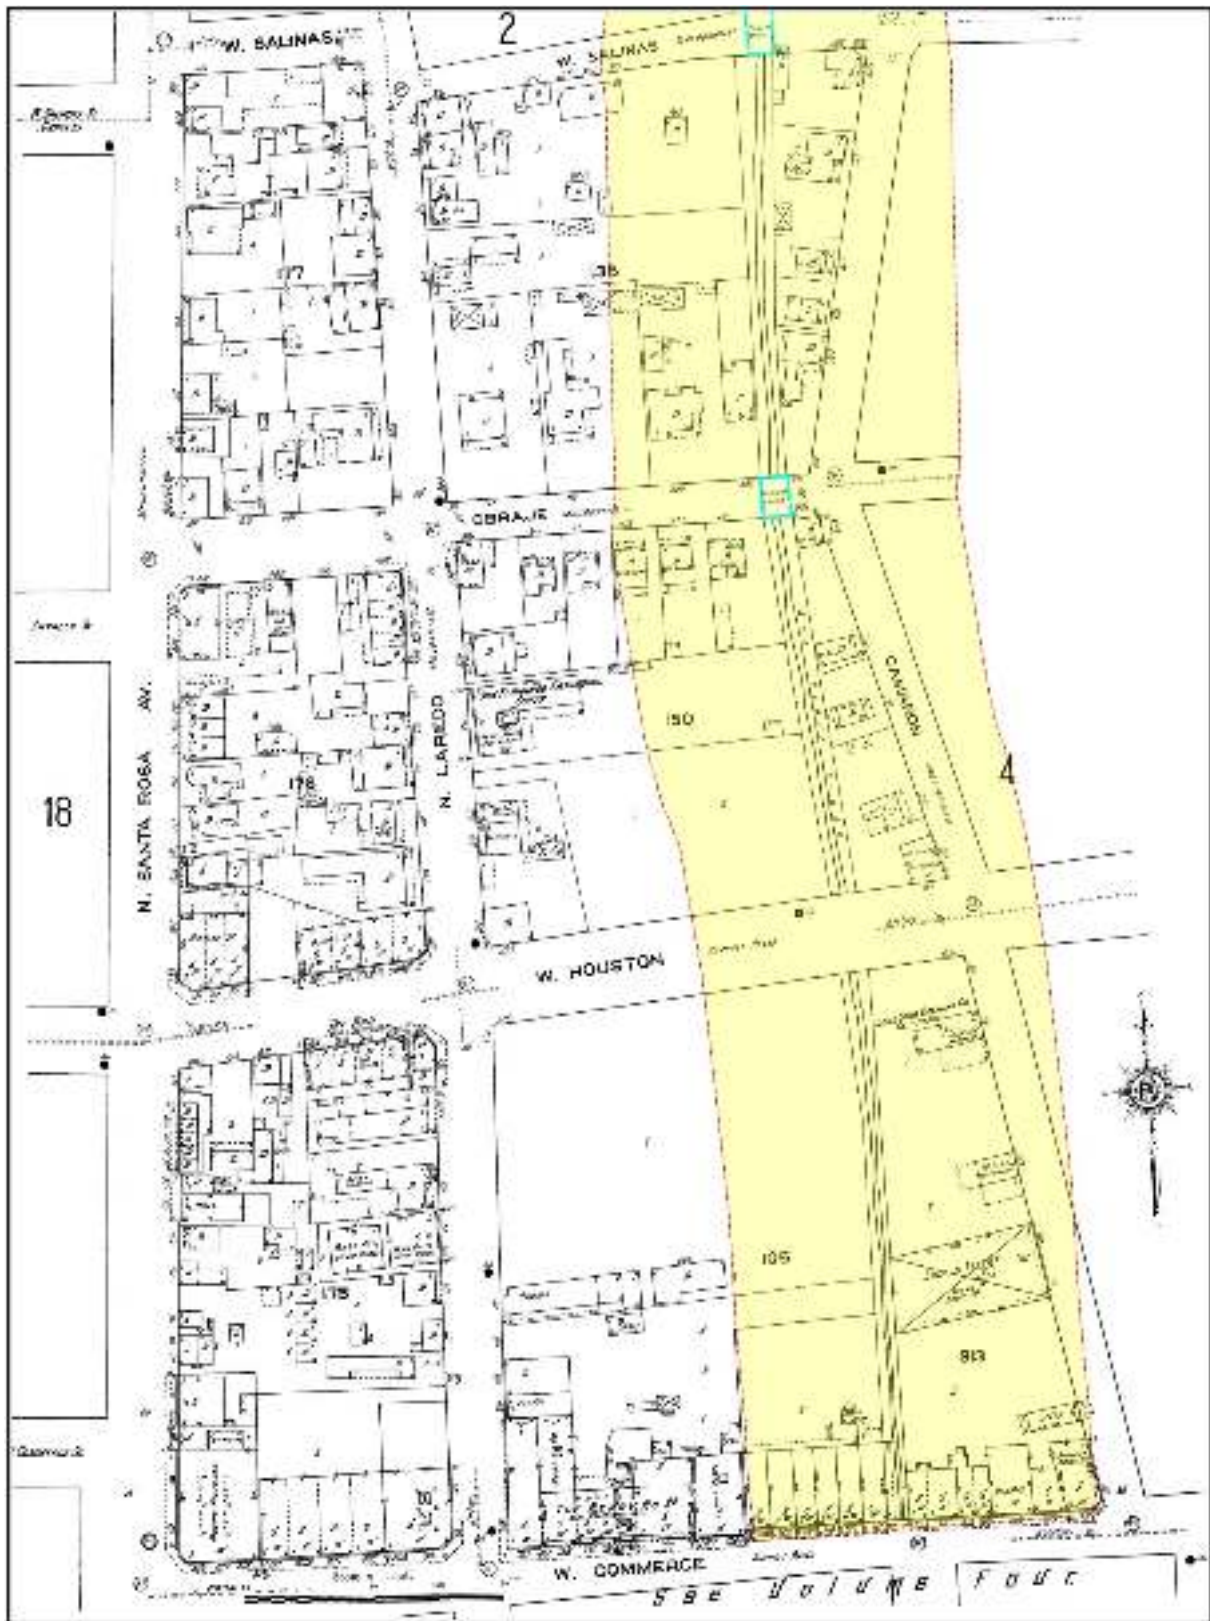
Figure 4-21. The 1911 to 1924 Sanborn Fire Insurance Map (Sheet 3). Wooden bridges are outlined in blue.

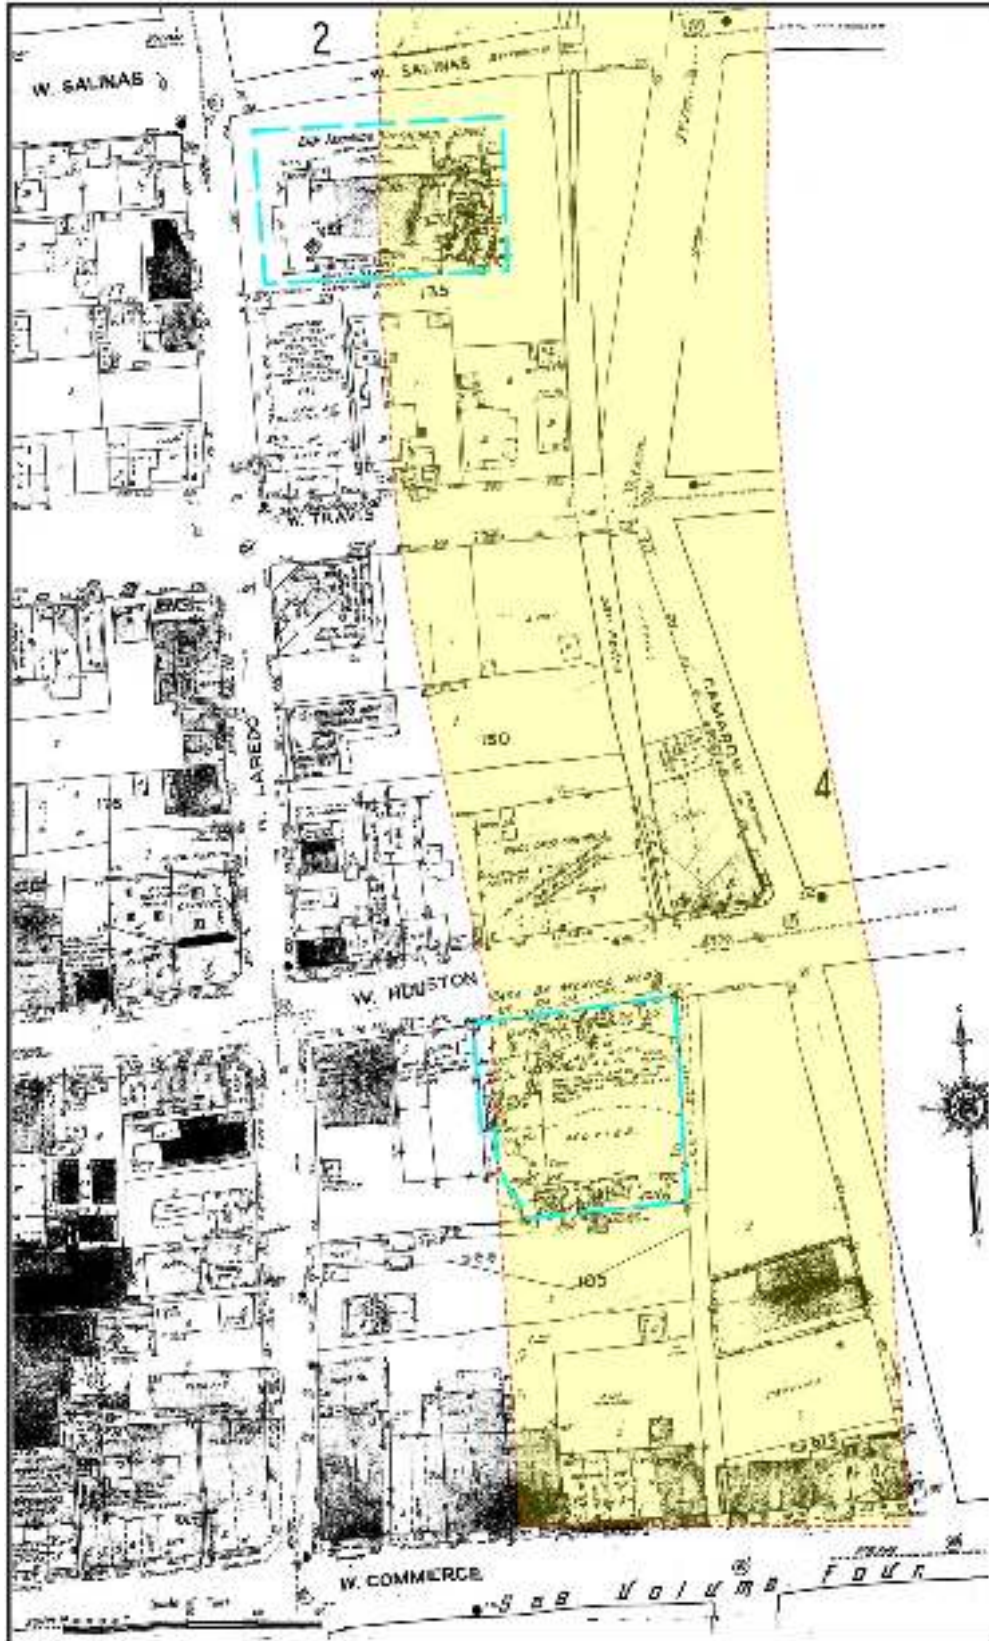
Figure 4-23. The December 1922 Sanborn Fire Insurance Map (Sheet 2). The San Fernando Cathedral School and the Casa de Mexico Building are outlined in blue.

In the 1922 Sanborn Fire Insurance Map (Sheet 2; Figure 4-22), the portion of the creek that runs from just north of W. Martin Street to W. Salinas Street shows several residences and an auto shop. More importantly, the bridge crossing the creek at W. Martin and Camaron Streets is depicted as being made of concrete. On Sheet 3 of the same year, the portion of the creek from W. Salinas to W. Commerce Streets is shown (Figure 4-23). The San Fernando Cathedral School is on the west bank of the creek just south of W. Salinas Street. The area occupied by the San Antonio Gas Company now depicts the location of the Casa de Mexico Building, and the location of the Lonestar Brewery Depot is now an empty lot.

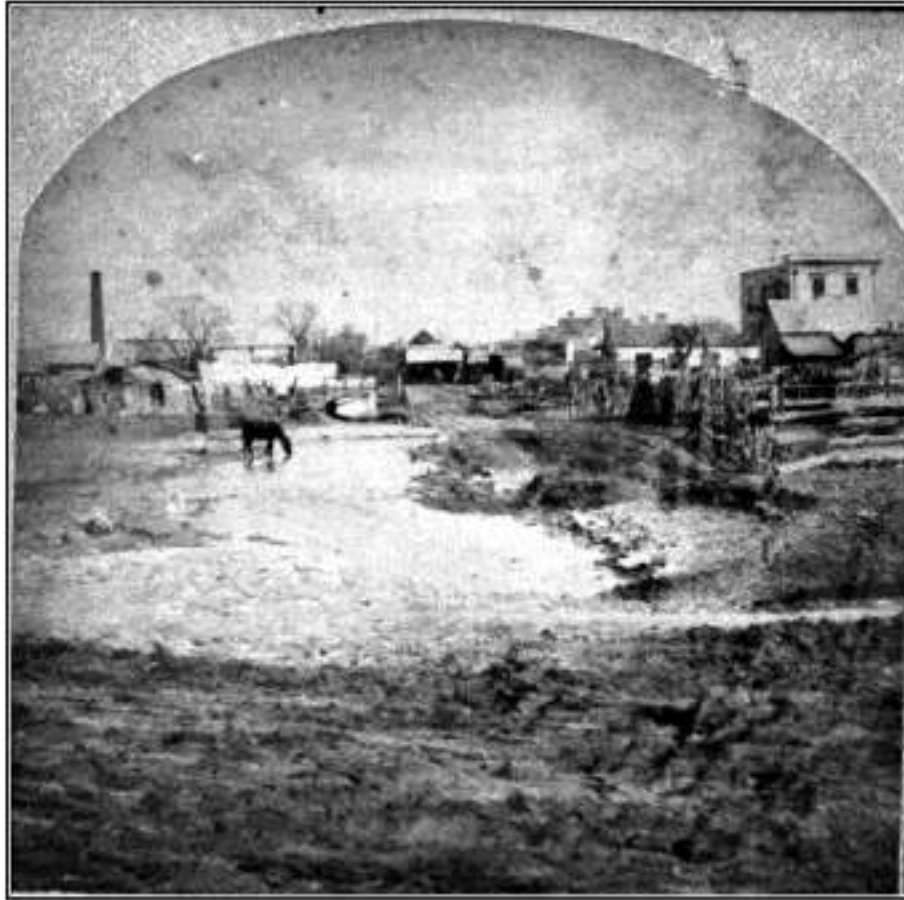
Figure 5-2. *An example of a low water crossing at Dolorosa Street (1870s, UTSA digital photo collection).*

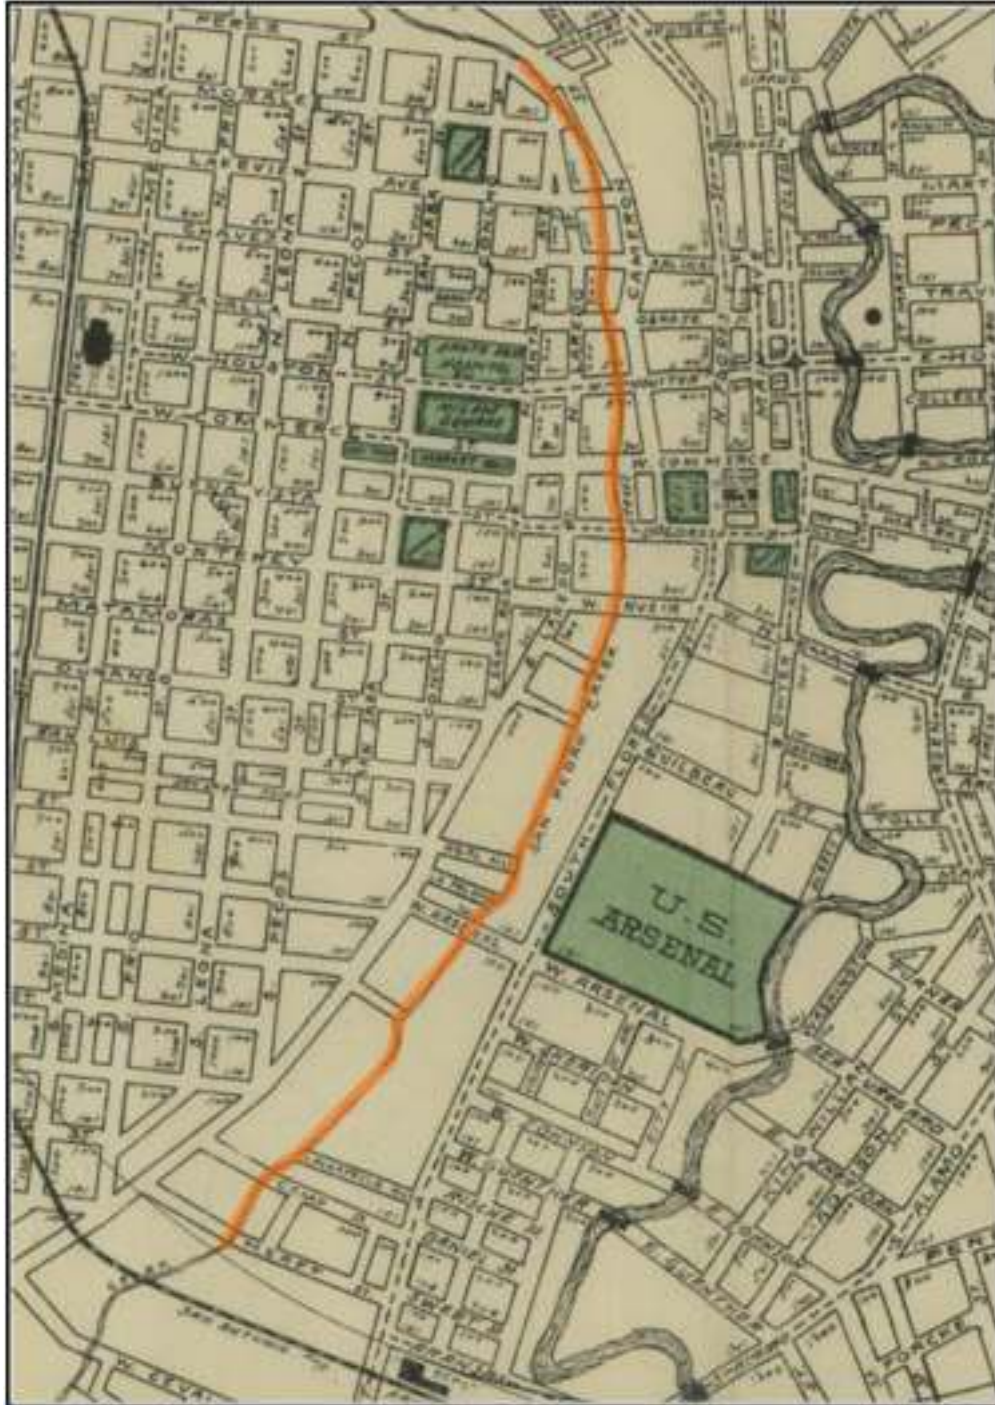
Figure 5-5. Jules Appler's 1909 map of San Antonio. Project area is highlighted in orange.

Examination of Figure 5-4 clearly shows that in 1886, the area south of Nueva Street is undivided, with orchards dominating the land on both sides of the creek. Appler's 1909 map (Figure 5-5) shows that this same area was not subdivided by this date, though a number of new streets are present, several of which dead-end into San Pedro Creek. The area to the north above Nueva Street has an increased density of lots, with crossings depicted at Lakeview Avenue, Salinas, Obraje, W. Houston, W. Commerce, Dolorosa, W. Nueva, W. Arsenal, Camp, and Herff Streets.

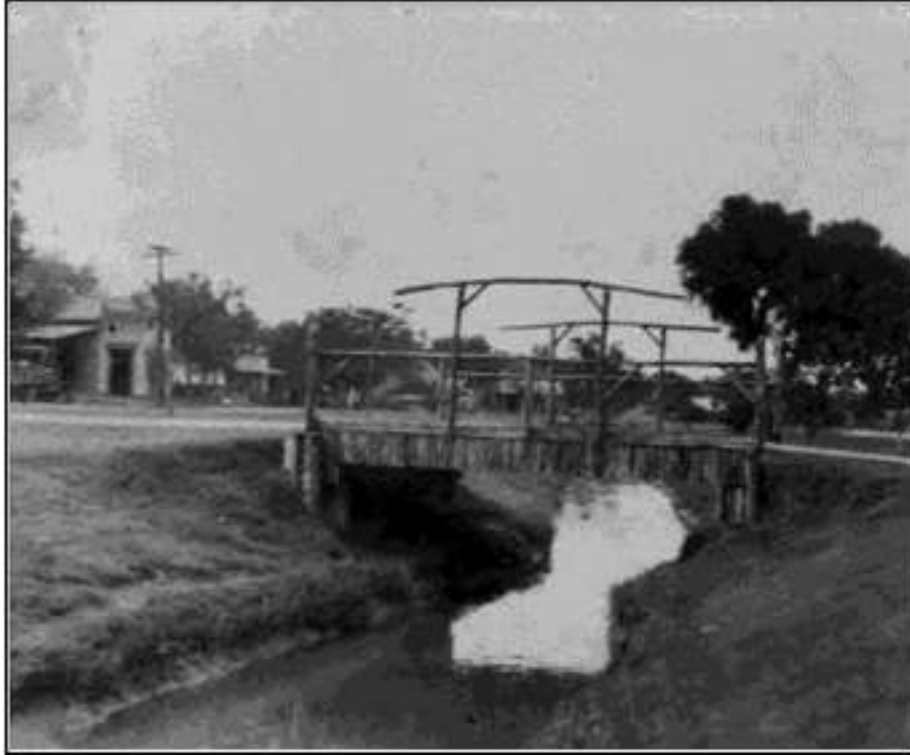
Based on notations present on Sanborn Fire Insurance Maps, many of these late nineteenth-century bridges were wooden plank construction. Some of these plank bridges were used until into the twentieth century. For example, Figure 5-6 shows a late 1920s photograph of the wooden bridge at Camaron Street.

Figure 5-6. *San Pedro Creek channel and wooden bridge at N. Laredo and Camaron Streets, ca. 1927-1931 (UTSA - digital photo collection).*

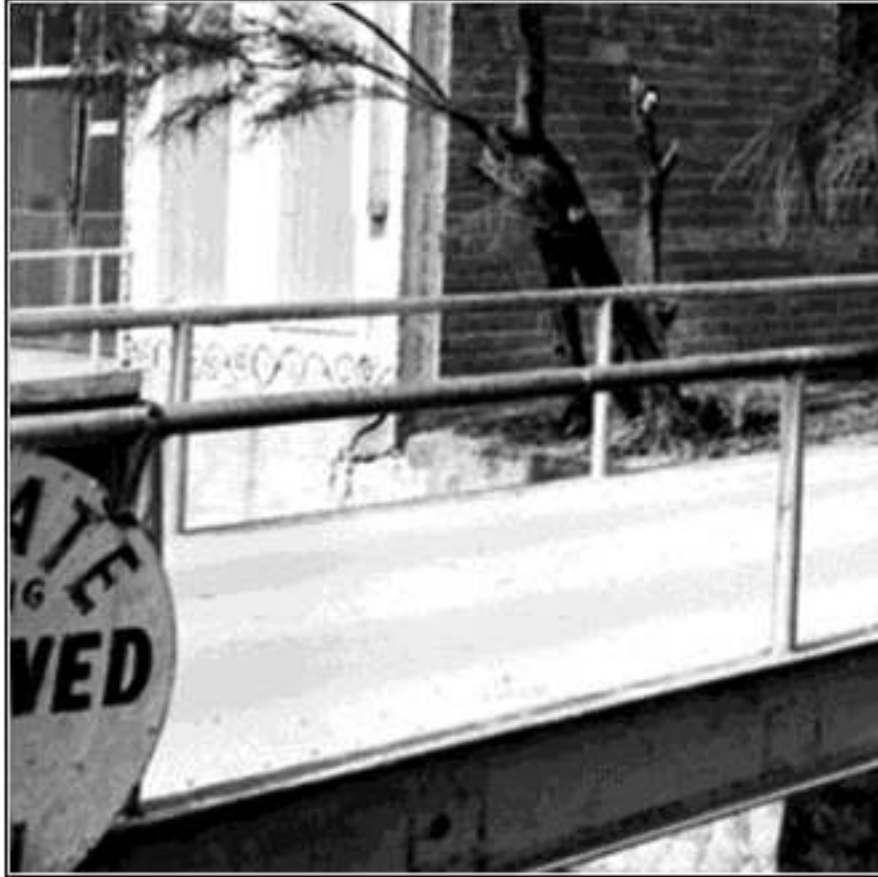
Concrete bridges spanned the channel of San Pedro Creek and were typically installed on top of the retaining walls of the creek. Steel I-beams supported the heavy concrete and asphalt road surface, and concrete sidewalks provided pedestrian access across the bridge (Figure 5-8). Railings were typically made of fitted steel pipes anchored to the sidewalk with bolts (Figure 5-9). If the railings suffered damage or deteriorated, they were replaced with welded steel pipes. Bridges constructed during the 1950s and later had welded, steel pipe railings, and the more recent bridges had decorative steel and wrought iron railings.

Figure 5-8. Construction detail of one of the bridges over San Pedro Creek, ca. 1968 (UTSA – digital photo collection).

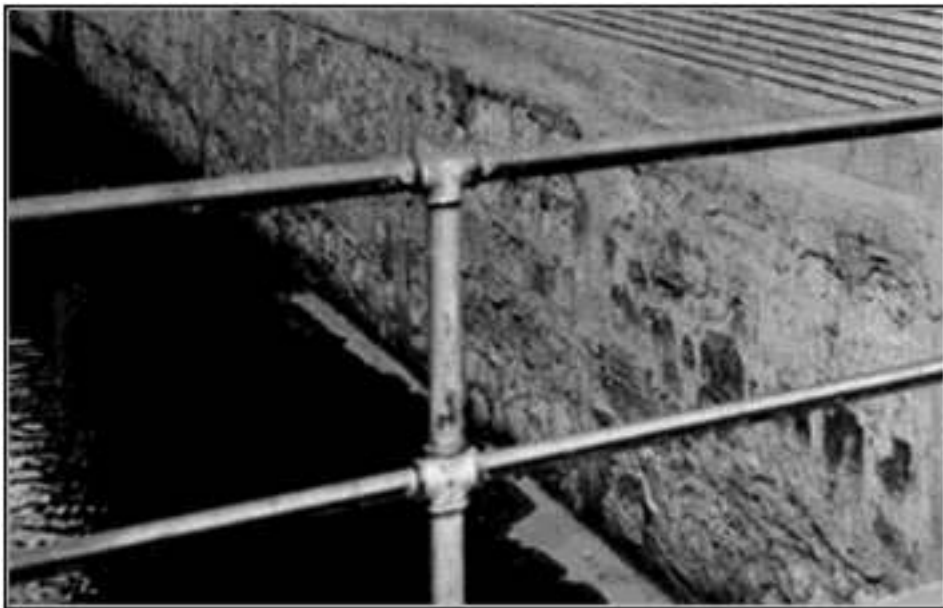
Figure 5-9. Detail of railing assembly of a footbridge over San Pedro Creek (UTSA – digital photo collection).

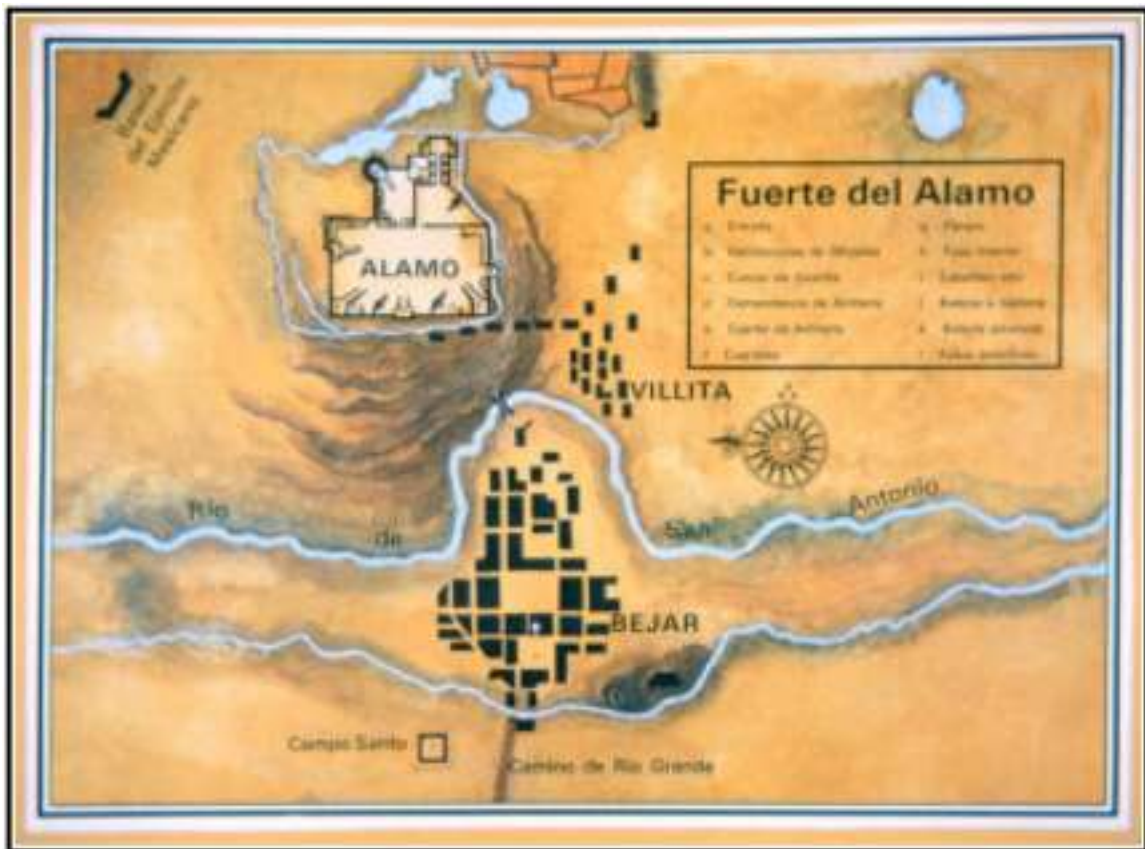
Figure 5-10. Map drawn in 1836 showing the Alamo and the surrounding area.

Two of the earliest maps showing the creek channel in reasonable detail are the 1836 maps of the Alamo and its surroundings (Figures 5-10 and 5-11). In both maps, San Pedro Creek has a large bend immediate west of the big bend in the San Antonio River, and several smaller bends also are depicted north and south of this larger bend in the creek channel.

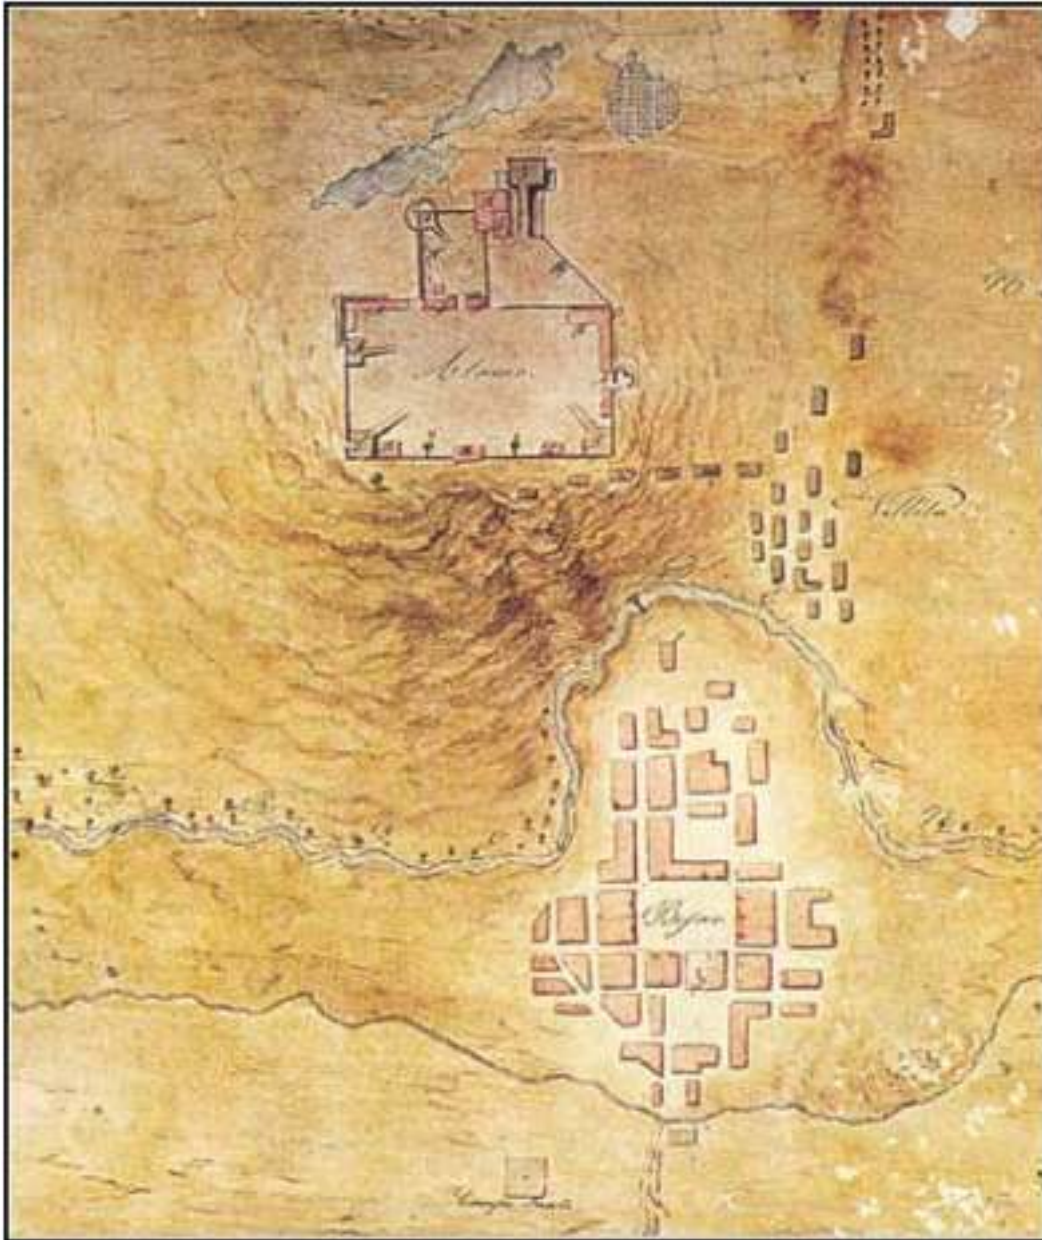
Figure 5-11. *Portion of the map drawn for Santa Anna in 1836 by Colonel Ygnacio de Labastida, Commander of Engineers, showing La Villita and the settlement of Villa de Béjar. Note westward curve in San Pedro Creek channel west of Villa de Béjar.*

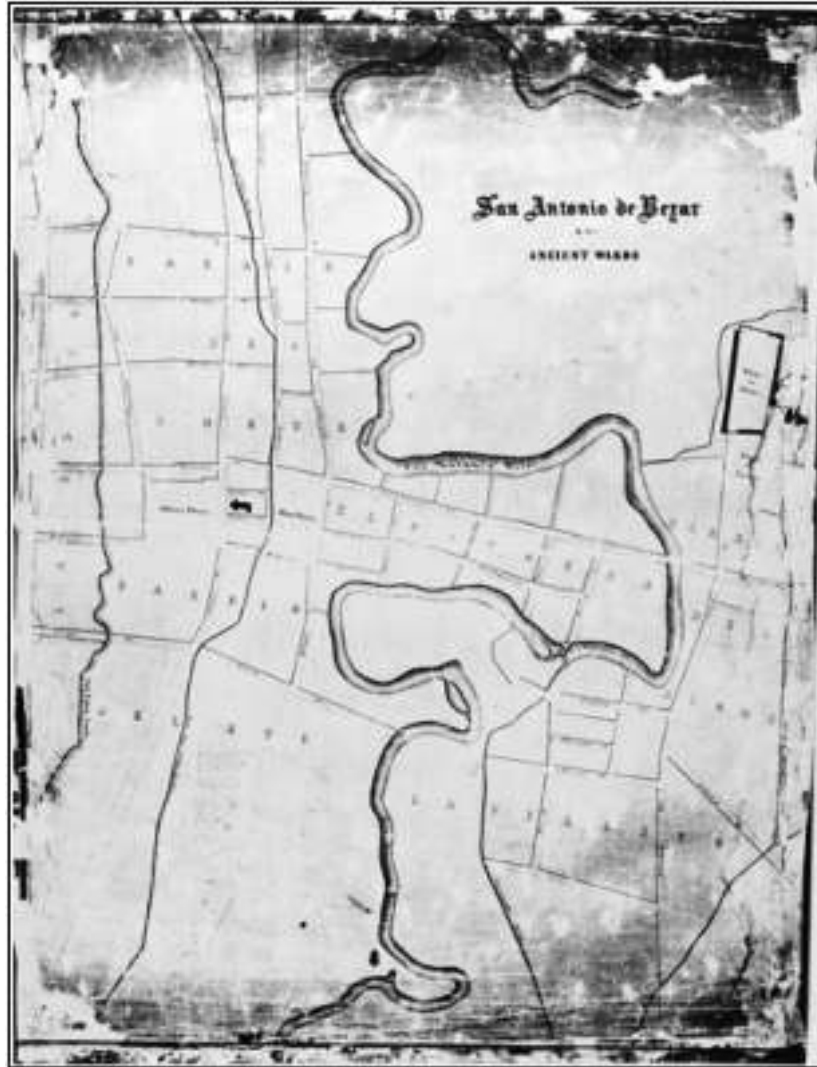
Figure 5-12. *In the Frieslaben 1845 map of the creek, the large bend west of the settlement is not depicted.*

The large bend west of the settlement is not depicted in the Frieslaben 1845 map of the creek (Figure 5-12). This portion of the creek channel, running from Salinas Street to Presidio Street, is straight. Its unlikely pattern suggests that the creek channel has been straightened between these streets sometime prior to the drawing of the 1845 map. This would, however, be an early date for modifications to the channel, and no independent corroboration exists for this modification.

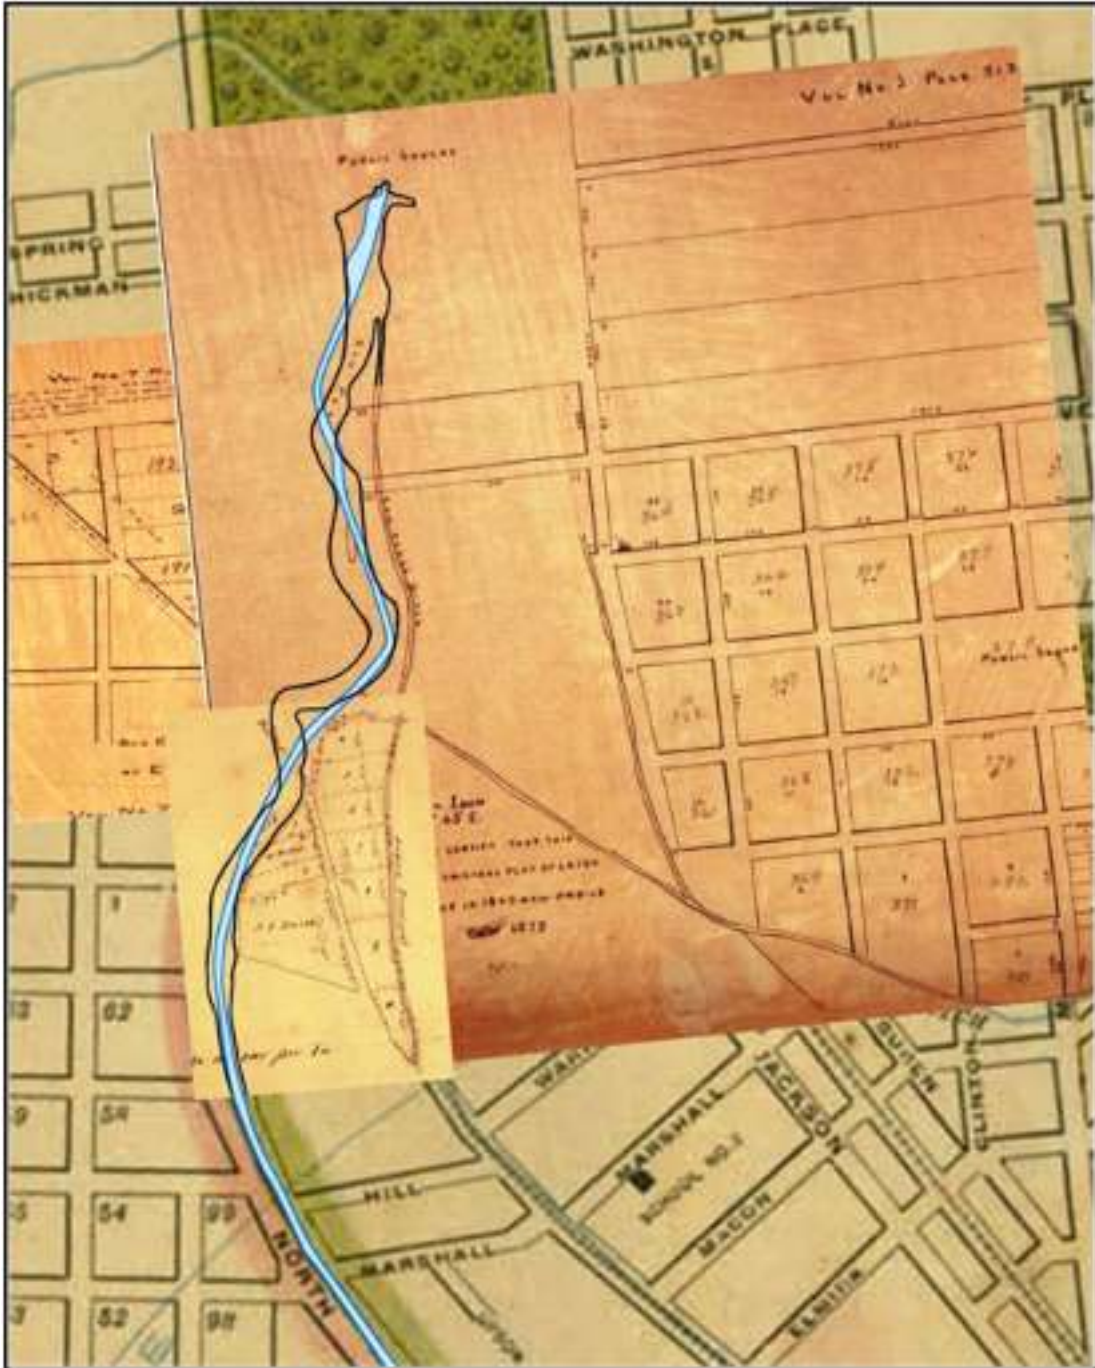
Figure 5-13. Composite map of San Pedro Creek channel near the headwaters of San Pedro Springs.

To ascertain the original orientation of the creek during the late nineteenth century, the CAR consulted the Municipal Archives for maps depicting properties situated along San Pedro Creek. We could locate historic maps of the creek channel for only a few segments. One set of maps covers the area near the spring itself, and a second series documents several sections to the south. We overlaid these maps onto the 1889 Olson and Sons map, allowing a comparison of the creek channel as depicted in these 1870s and 1889 maps. Figure 5-13 shows the overlay near the Springs, while Figure 5-14 shows an area to the south of the Springs, some of which is within the northern portion of the current project area. As noted regarding the 1836 map of the Alamo Mission (see Figure 5-10), the composite map depicts several small meanders along its course within the project area. The map comparisons suggest that early documentation of the creek was highly variable or that modification of the channel began very early.

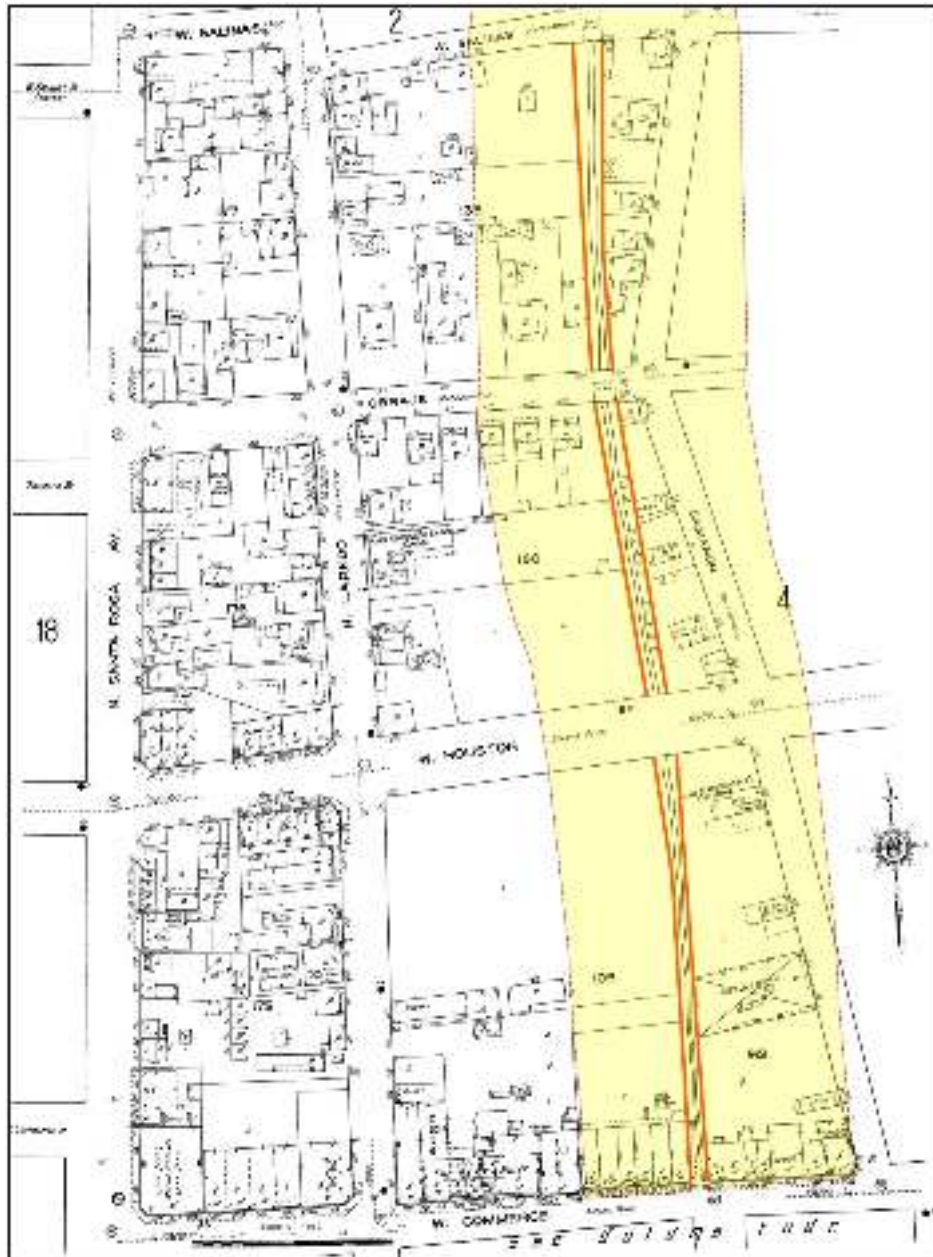
Figure 5-19. Sheet 3 of the 1911-24 Sanborn Fire Insurance Map, note the straight-line boundaries (highlighted in orange) of San Pedro Creek.

The depictions of the San Pedro Creek channel remains consistent through the 1904 Sanborn Fire Insurance Maps, suggesting that the western bank of the creek, and perhaps a short portion on the east bank just south of W. Houston Street, may have been lined with a wall. However, it may also be the case that the straight lines depict property boundaries rather than walls along the active channel. Sheet 3 of the 1911-1924 Sanborn Map depicts the portion of the creek from W. Salinas Street to Commerce Street. The undulating creek bottom is encompassed within straight lines depicting either a property boundary or walls lining the banks of the creek (Figure 5-19).

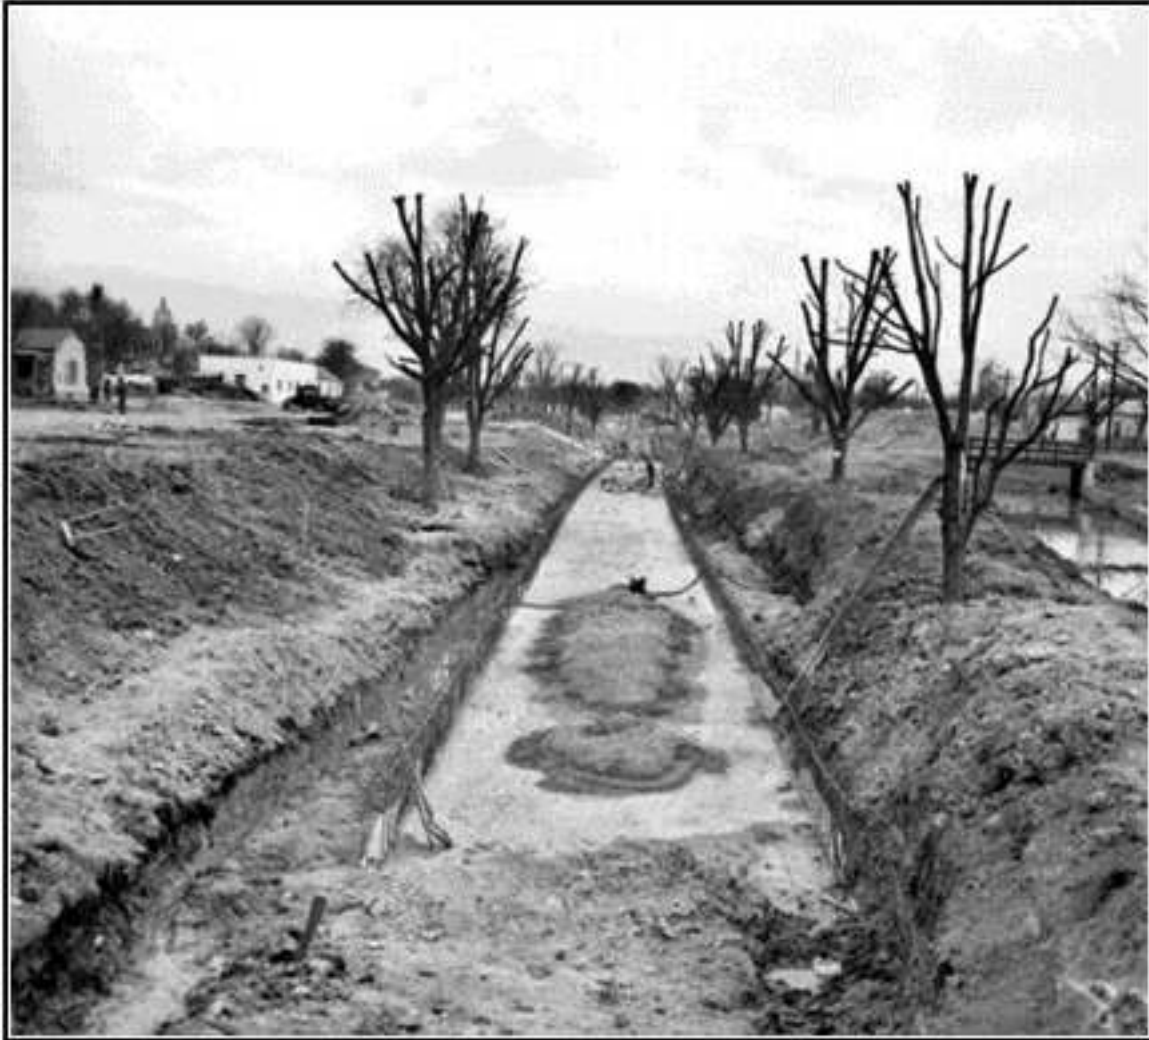
Figure 5-22. *Work along the channel of San Pedro Creek sometime in the late 1940s (UTSA – digital photo collection).*

minutes of City Council Meetings dating to the mid-to-late 1930s indicate a push to fund San Pedro Creek improvements through public bonds, no such bonds were approved by the public during the late 1930s to beautify the channel of San Pedro Creek. However, by 1941, two *San Antonio Express News* articles describe the upcoming work scheduled to be done along San Pedro Creek, aided by the Works Progress Administration (WPA; 7 January 1941; 27 July 1941). The work was to include deepening and widening the channel, paving the creek bed, building a retaining wall, and removing debris. This work coincides with WPA-led beautification efforts along the San Antonio River that led to the lining of long stretches of the channel with limestone walls. The digital photo collection at UTSA also contained images, dating to the late 1940s, of ongoing work in the channel of the creek (Figure 5-22). It is not known if this was the work that was described in the 1940 *San Antonio Express News* articles or if additional funds had been made available for new work along the creek and river. Finally, in a meeting held on February 11, 1960, Council members passed an ordinance granting the SARA easement to the channel of San Pedro Creek “for the purpose of constructing, operating, and maintaining a flood control channel [...]” (CCMM JJ:115). This project was part of the San Antonio Channel Improvement Project, San Pedro Creek, Texas.

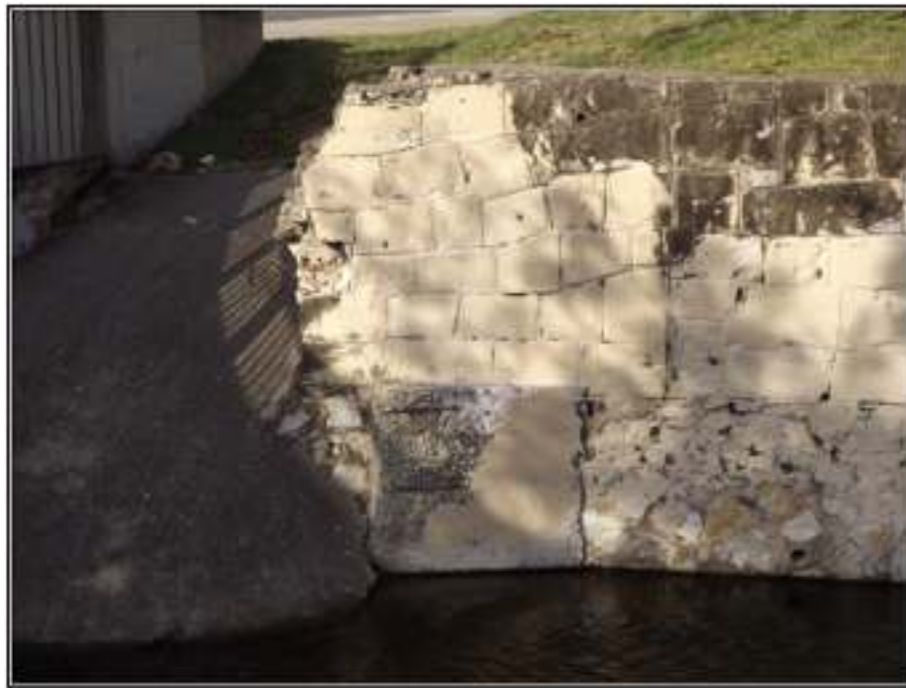
Photographs taken of the stone walls in their current condition indicate that several styles of stone work and at least three different episodes of rock wall construction might have occurred within the current project limits (Figures 5-23, 5-24, and 5-25). While we do not have the precise ages of these construction episodes, it is likely that they date from the 1920s, the early 1940s, and the late 1940s. It is possible that the walls constructed in the 1940s involved WPA crews.

Figure 5-23. *Wall showing two sequences of construction, both likely post-dating 1940s.*

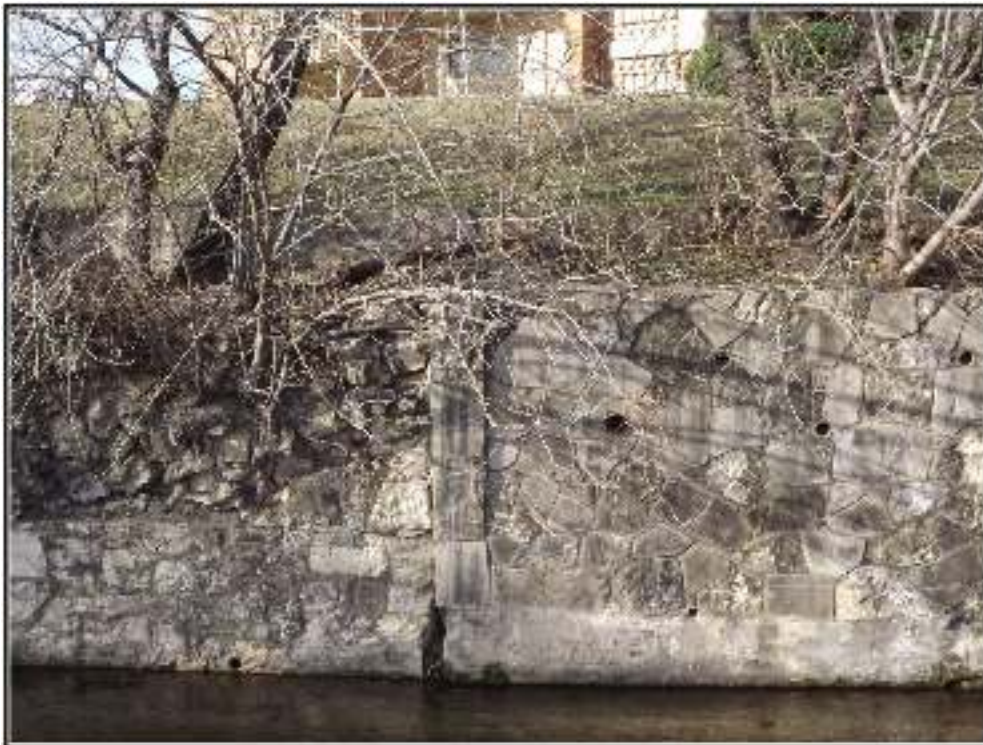
Figure 5-25. *Stone wall along San Pedro Creek showing two construction episodes, potentially dating to the late 1940s and thereafter.*
