Standing Structure Survey of a Portion of San Pedro Creek, San Antonio, Bexar County, Texas

Prepared by:
Center for Archaeological Research
The University of Texas at San Antonio
One UTSA Circle
San Antonio, Texas 78249-1644
Technical Report, No. 51

Management Summary:

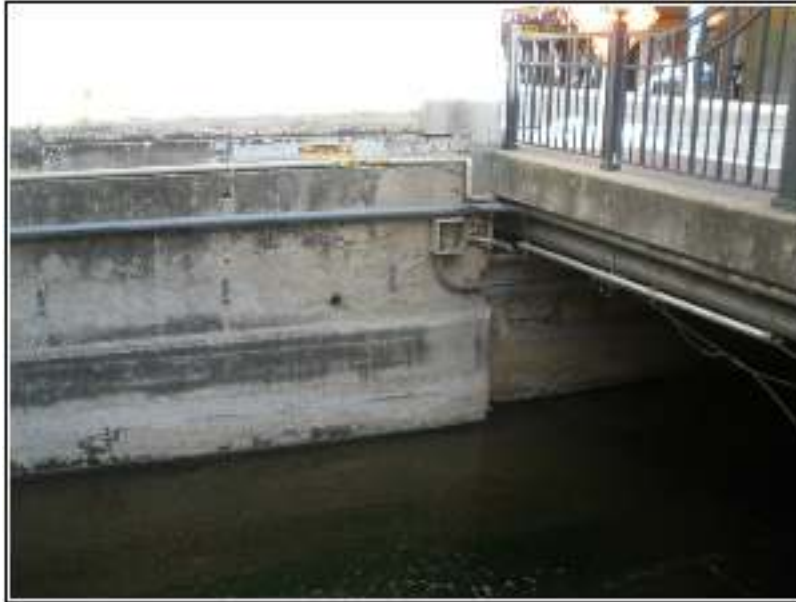
Further south of W. Houston Street and continuing to the northern half of the W. Commerce Street to Dolorosa Street block, the stone wall may be hidden behind a thick concrete/cement veneer (Figure 5-26). This is surmised from the fact that in the southern half of the W. Commerce Street and Dolorosa Street block, the stone wall is actually visible under the veneer (Figure 5-27).

Figure 5-26. *Thick veneer of cement on retaining wall on west bank of San Pedro Creek just south of W. Commerce Street. Note possible original rock retaining wall under bridge.*

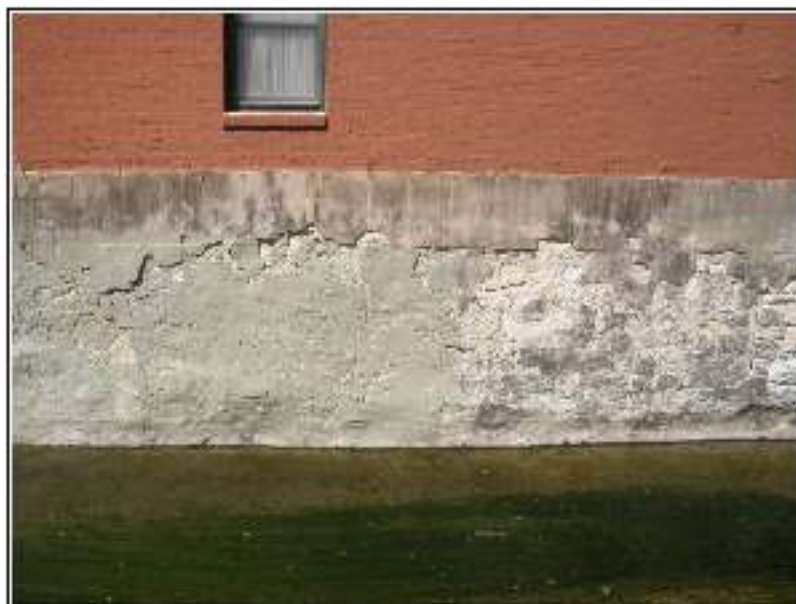
Figure 5-27. *Original stone wall visible under peeling cement veneer, west bank of river just north of Dolorosa Street.*

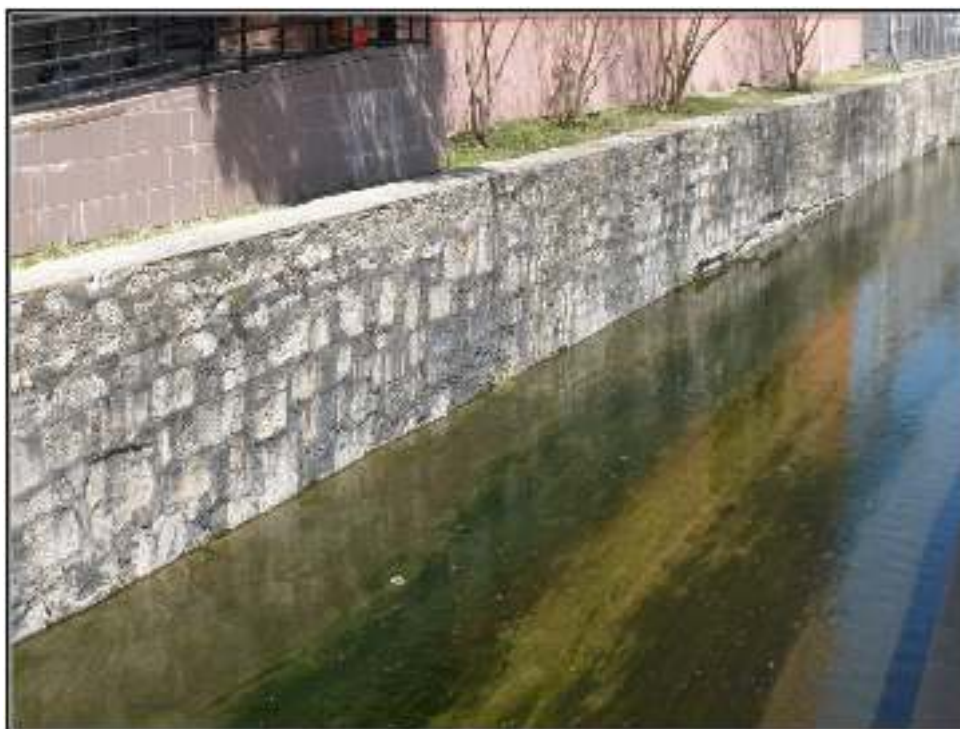
From Dolorosa Street to the south, the rock retaining wall is visible along the west bank of the creek until W. Durango (Cesar E. Chavez) Boulevard when the creek enters the tunnel and is no longer visible until it emerges south of W. Arsenal Street. Within this section, midway between Dolorosa and Nueva Streets, the original rock retaining wall is deteriorating in spots. In one of these areas, an outer veneer of rock appears to be peeling off to reveal an older rock wall (Figure 5-28).

Figure 5-28. Possible outer rock veneer peeling off an older stone wall along west bank of creek between Dolorosa and Nueva Streets.

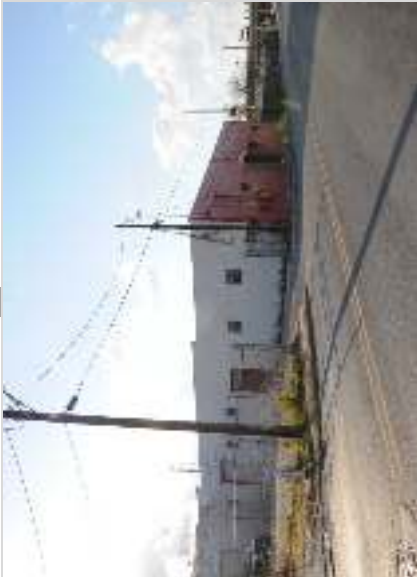
Current Use
 Dimensional Data
 Plot Surface
 No. of Stories
 General Architectural Description
 One-story, brick, flat-roofed commercial building characterized by a rectangular plan. The main façade has a centered, segmented, arched doorway. There are small squared windows along most façades.

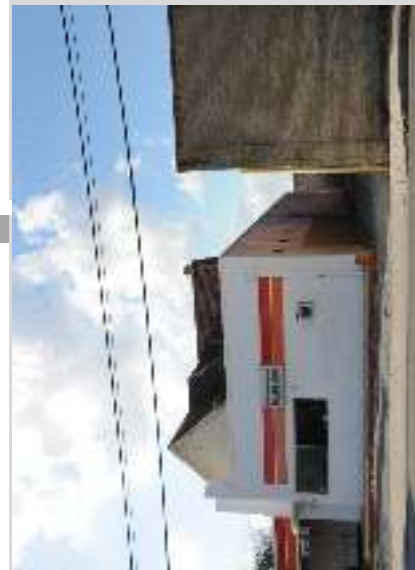
Current Use
 Dimensional Data
 Plot Surface
 No. of Stories
 General Architectural Description
 Two-story, late 19th century, front-gabled, brick house characterized, on the front facing South Flores, by a 1940s one-story, concrete addition with a car port. The corner entrance of the one-story addition is defined by two vertical elements that are typical of the period. One of the three existing 19th century houses of the neighborhood preserves its original door and window, even if in precarious

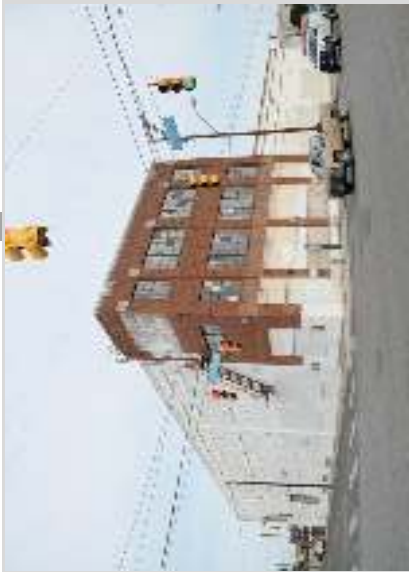
Current Use
 Dimensional Data
 Plot Surface
 No. of Stories:
 General Architectural Description
 Three-story, rectangular plan, flat-roofed, concrete frame, brick warehouse. The façade is classically proportioned since divided by pilasters surmounted by concrete classical ornamental blocks, and a parapet is topped by a continuous concrete cornice. On the first floor all openings are closed. The side and the rear façade are painted with a white wash.

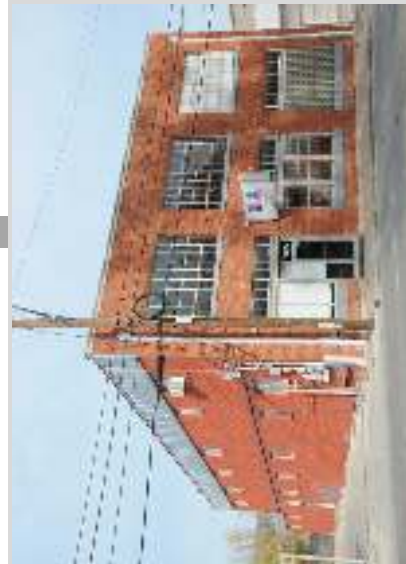
Current Use General Architectural Description
 Dimensional Data
 Plot Surface
 No. of Stories
 Two-story, rectangular plan, flat-roofed, concrete framed building with red brick veneer on the main façade and factory made iron and glass windows. The main façade has three bays, and the entrance is located in the proximity of the corner. The side façade has small, rectangular windows on both floors.

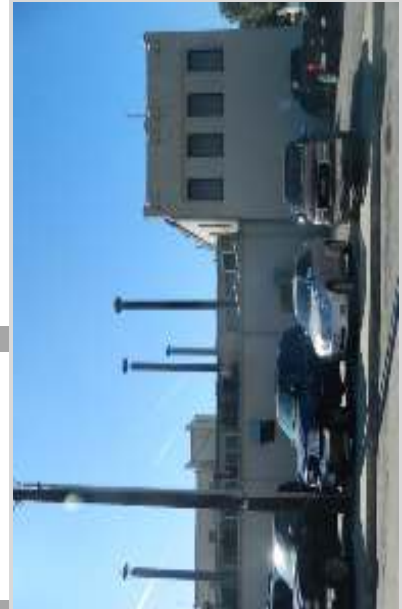
Current Use
 Dimensional Data
 Plot Surface
 No. of Stories
 General Architectural Description
 Large one- and two-story commercial complex composed of several buildings built in different time periods. Parapets on some buildings are characterized by Spanish Colonial decoration.

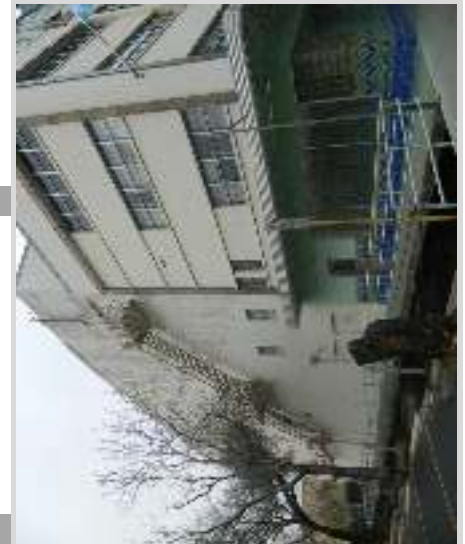
Current Use
 Dimensional Data
 Plot Surface
 No. of Stories
 General Architectural Description
 Four-story complex, ground floor is punctuated by large plate glass windows and tile. Upper floors have continuous window bands framed by terracotta decoration. Front two pilasters decorated with aluminum and topped by a stepped panel of terracotta work with initials.

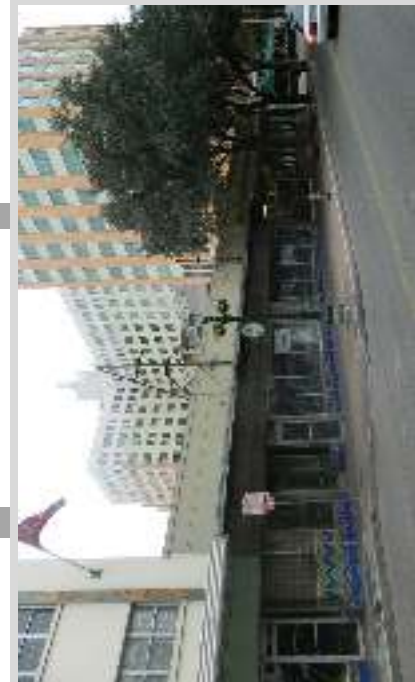
Current Use General Architectural Description
 One-story structure with large storefront windows and colorful tiles with repetitive pattern at the base. Thick concrete parapet cantilevering from the window. It is an annex of the Alameda Theater. The façade and sidewalk have tile and glass inlays.
 Dimensional Data
 Plot Surface
 No. of Stories

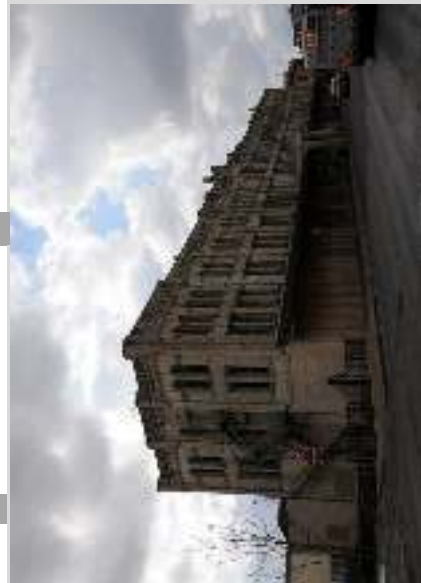
Current Use
 Dimensional Data
 Plot Surface
 No. of Stories
 General Architectural Description
 Three-story building with elongated plan. Italianate windows and expressive stepped brick cornice at the parapet on three sides of the building. The first floor shows several opening modifications.

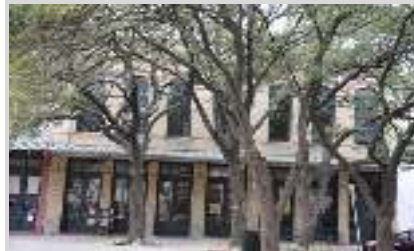
Current Use
 Dimensional Data
 Plot Surface
 No. of Stories:
 General Architectural Description
 Complex of four two-story buildings, all characterized by rectangular plan. The oldest part has a tripartite Italianate stone façade with concrete classical entablature. The two other structures facing on the plaza are Italianate with ornamental stone lintels on one façade, on the other with alternating color brick vossiors. The building located at the corner is stuccoed.

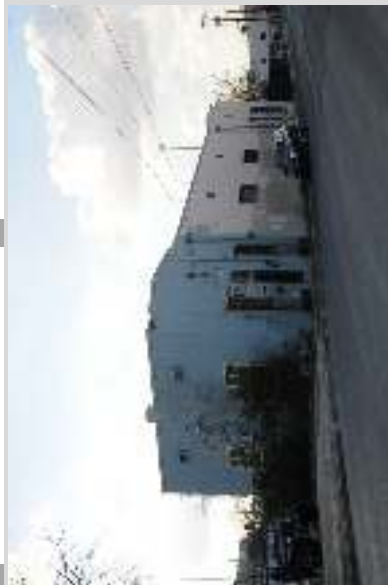
Two-story building with rectangular plan parted in three bays on the front façade on Guadalupe. It has a stucco finish, with each bay colored differently, and does not allow the perception of one whole building.

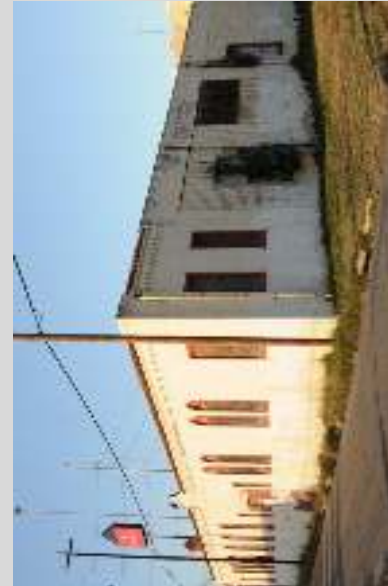
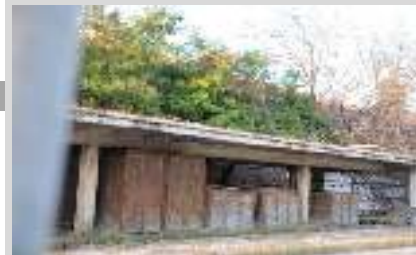
Current Use General Architectural Description
 Dimensional Data
 Plot Surface
 No. of Stories
 Complex with three structures. Principal one is a large stuccoed building. Its main façade is characterized by rectangular and arched windows, and a central doorway parapet of Spanish clay tiles. The other two shed buildings have rectangular plans with concrete structures and were constructed in 1947.

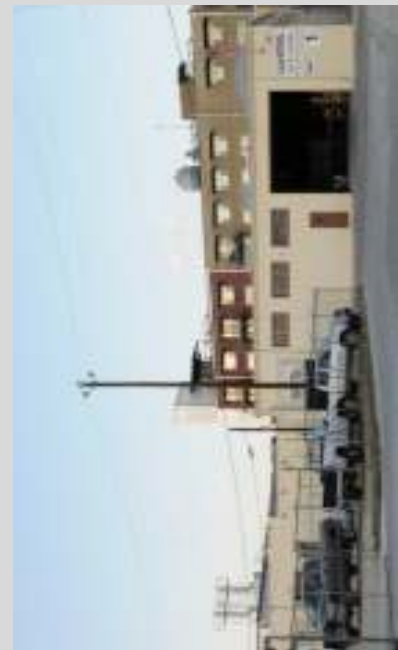
Current Use
 Dimensional Data
 Plot Surface
 No. of Stories
 General Architectural Description
 Complex of buildings in L-shape plan. One-story, stuccoed, CMU building facing Flores Street is a later addition to the existing series of one-story, stuccoed and two-story concrete frame buildings with red brick infill. The older buildings have iron and glass industrial windows.

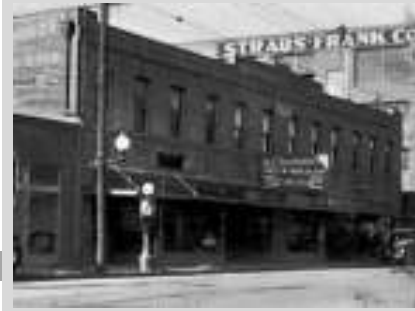
Current Use
 Dimensional Data
 Plot Surface
 No. of Stories
 General Architectural Description
 Two-story, flat roofed, 19th-century Texas commercial, now stuccoed façade with classical influence. The first floor has large storefront windows modified in the 2001 renovation. The second floor has twelve rectangular windows, also modified with the addition of iron railings. The parapet is characterized by a higher element in the center of the main façade, and stepped on the side façade.

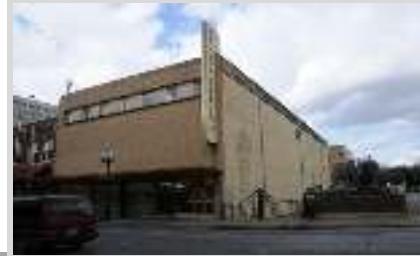
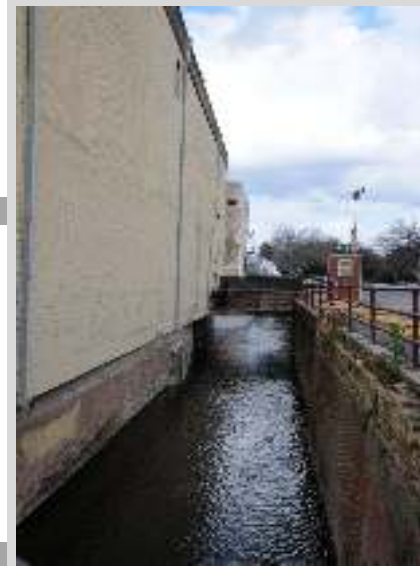
| General Architectural Description | |
|--|---|
| Current Use <input type="text" value="Commercial"/> | Two-story, yellow brick building, with a rectangular plan. It has blank façade marked at second floor by appearance of strip windows created with concrete tiles alternating with narrow windows enclosed within a continuous, thin concrete frame. The side facing directly on the creek shows old foundation walls in red bricks. |

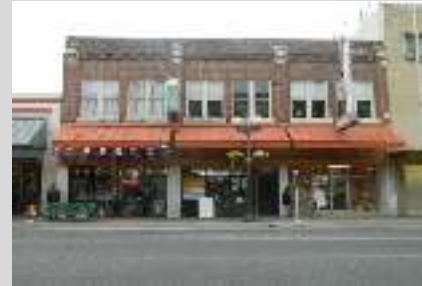
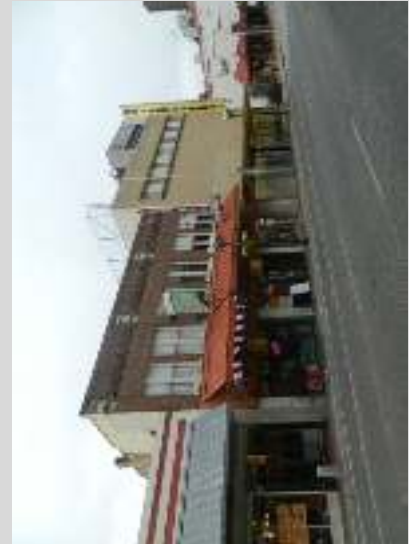
Current Use
 Dimensional Data
 Plot Surface
 No. of Stories
 General Architectural Description
 Two-story red brick building, its façade is divided in three bays by brick pilasters surmounted by concrete classical ornamental blocks and tied to expressive stepped-brick classical cornice at the parapet. The first floor is characterized by large storefront windows, the second floor has three series of twin squared wooden windows.

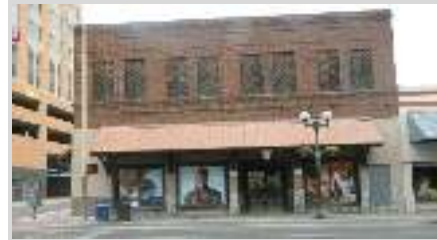
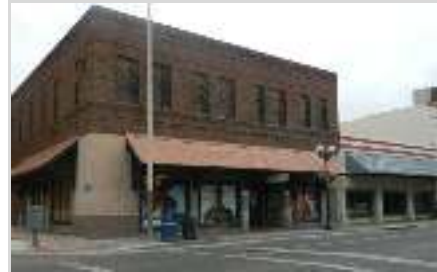
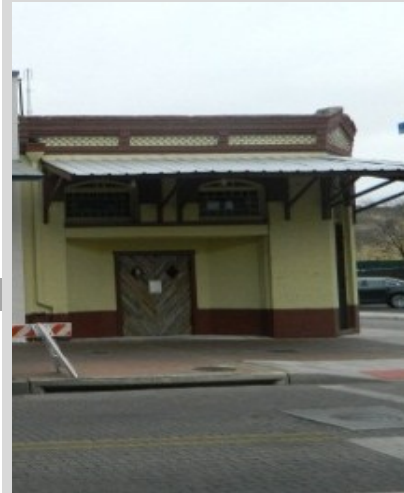
Current Use General Architectural Description
 Dimensional Data
 Plot Surface
 No. of Stories
 Two-story, commercial, brick building. Façades marked horizontally by a classical stepped brick cornice at the second floor level and parapet. Parapet cornice is ornamented with soldier coursing. Cement tiles with repetitive classical pattern on the base.

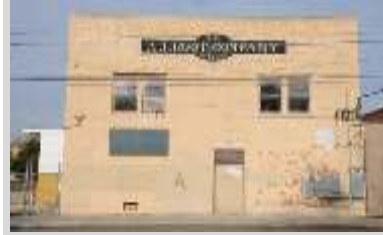
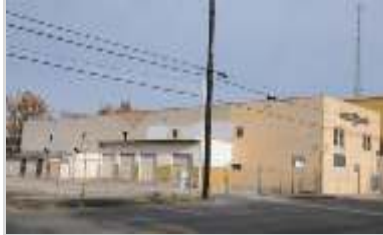
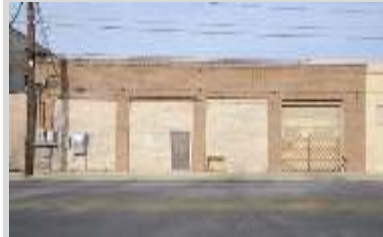
Current Use
 Dimensional Data
 Plot Surface
 No. of Stories
 General Architectural Description
 Complex is three adjacent buildings. One is a two-story, yellow brick, rectangular building. It is adjacent to a one-story, red brick building with large windows, today closed. The last building is partially one-story toward Flores Street, on the northern side it is two-stories high.

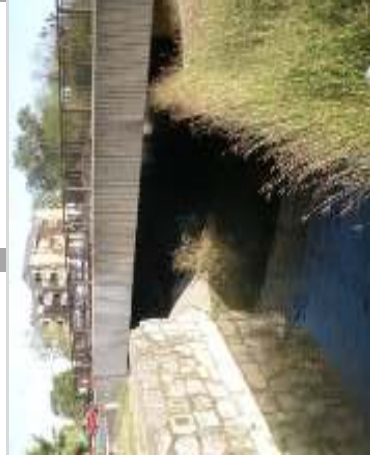
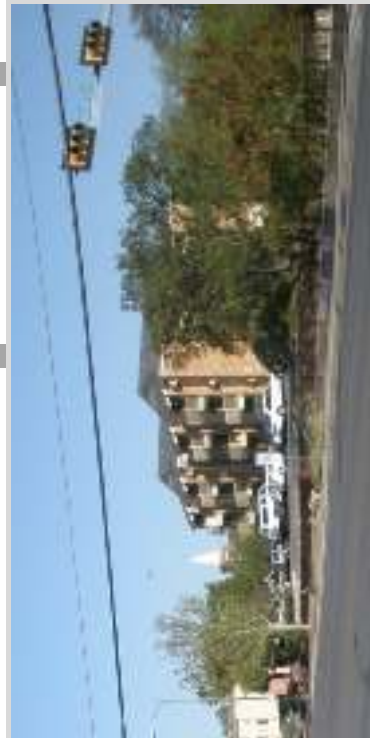
Current Use
 Dimensional Data
 Plot Surface
 No. of Stories
 General Architectural Description
 Reinforced concrete with asphalt road surface with steel beams and railings. Large, cut limestone blocks articulate with the ends of the bridge at each of the four corners. Concrete apron protects the footing of the bridge from flood damage. Note that the vertical decorative details on the sides of the bridge mimic the wooden slats seen in the historic photo of a bridge near the same location.

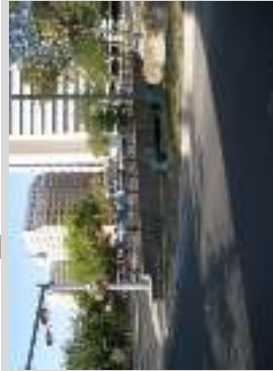
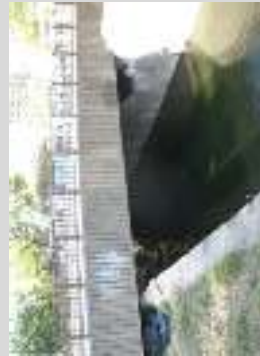
Current Use
 Dimensional Data
 Plot Surface
 No. of Stories
 General Architectural Description
 Reinforced concrete with asphalt road surface with steel beams and railings. Large, cut limestone blocks articulate with the ends of the bridge at each of the four corners. Concrete apron protects the footing of the bridge from flood damage. Construction style similar to bridge at W. Martin.

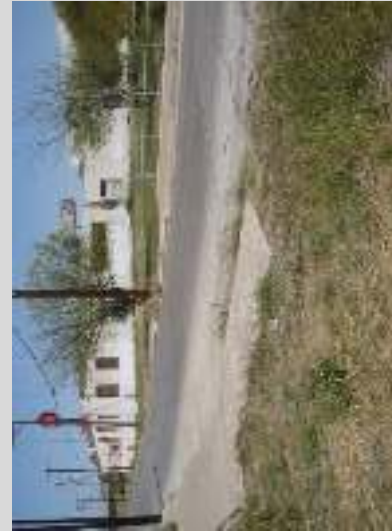
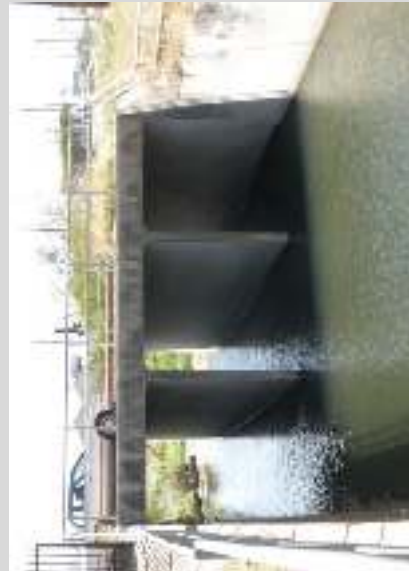
| Current Use <input type="text" value="Traffic"/> | General Architectural Description Reinforced concrete with asphalt road surface with steel I-beams and welded pipe railings. Concrete sidewalks facilitate pedestrian traffic across bridge and asphalted road surface affords two-way vehicular traffic. Columns of bridge are similar in construction to the columns supporting the entrance and exit at the tunnel of San Pedro Creek. Replaced wooden bridge that existed at location until at least 1956. |
