Archaeological Services for Utilities Placement on Commerce Street, San Antonio, Bexar County, Texas

Texas Antiquities Permit No. 7893

Prepared by:
Center for Archaeological Research
The University of Texas at San Antonio
One UTSA Circle
San Antonio, Texas 78249
Technical Report, No. 73

**Archaeological Services for
Utilities Placement on Commerce Street,
San Antonio, Bexar County, Texas**

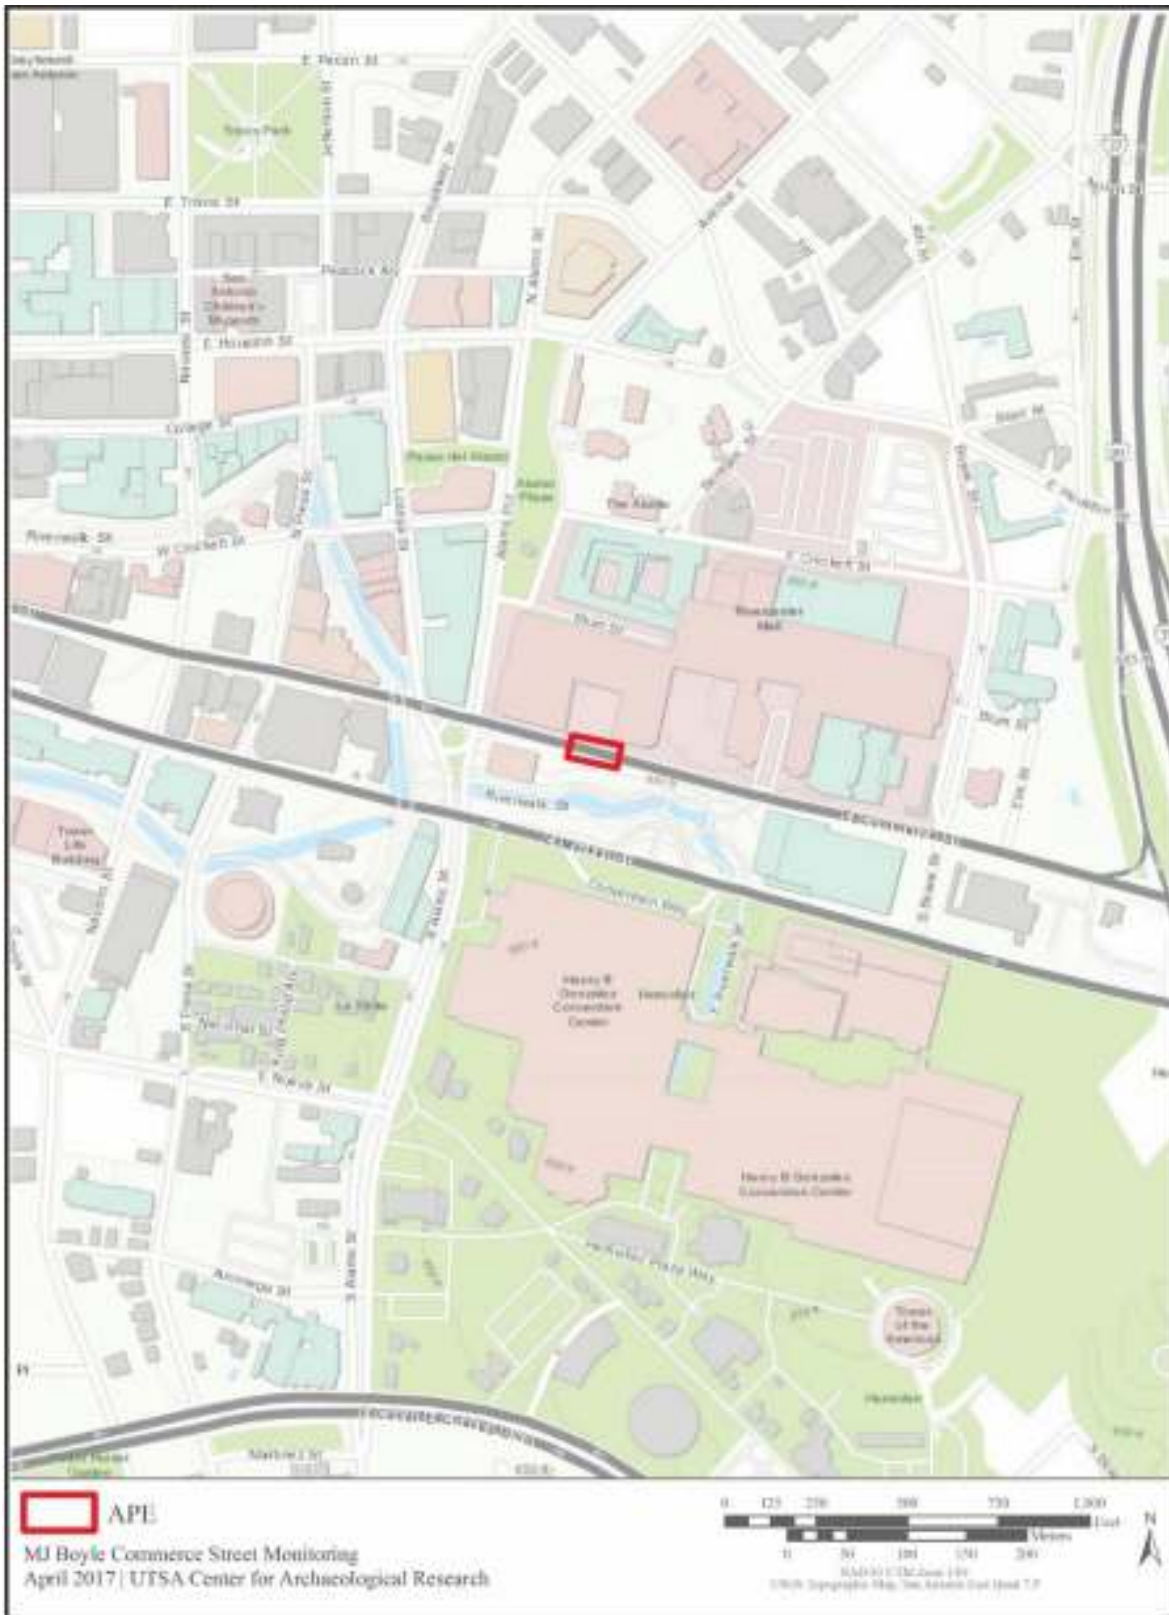
Figure 1-1. Project APE (in red) on the San Antonio East USGS 7.5-minute quadrangle.

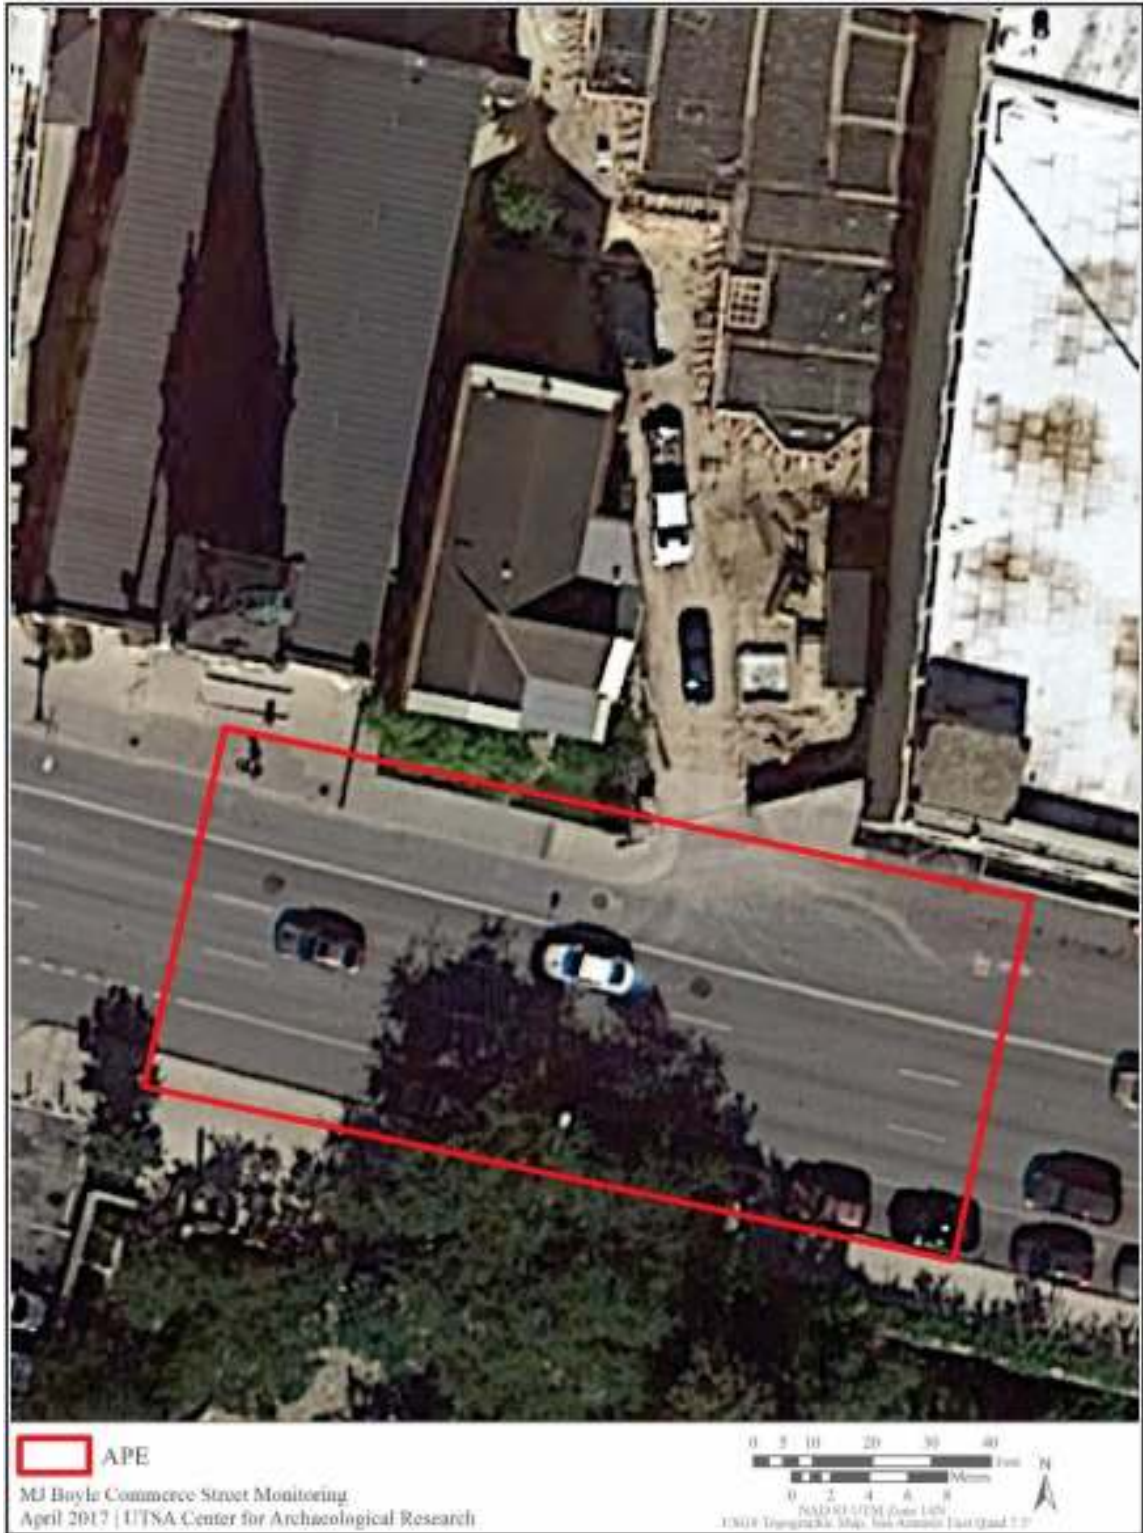
Figure 1-2. Project APE (in red) on satellite imagery, along Commerce Street.

The project area was located on the 600 block of East Commerce Street. The Area of Potential Effect (APE) focused on four trenches and the opening of a manhole. The trenches began at the property line of the church and extended into Commerce Street. CAR archaeologists monitored the excavation of the trenches.

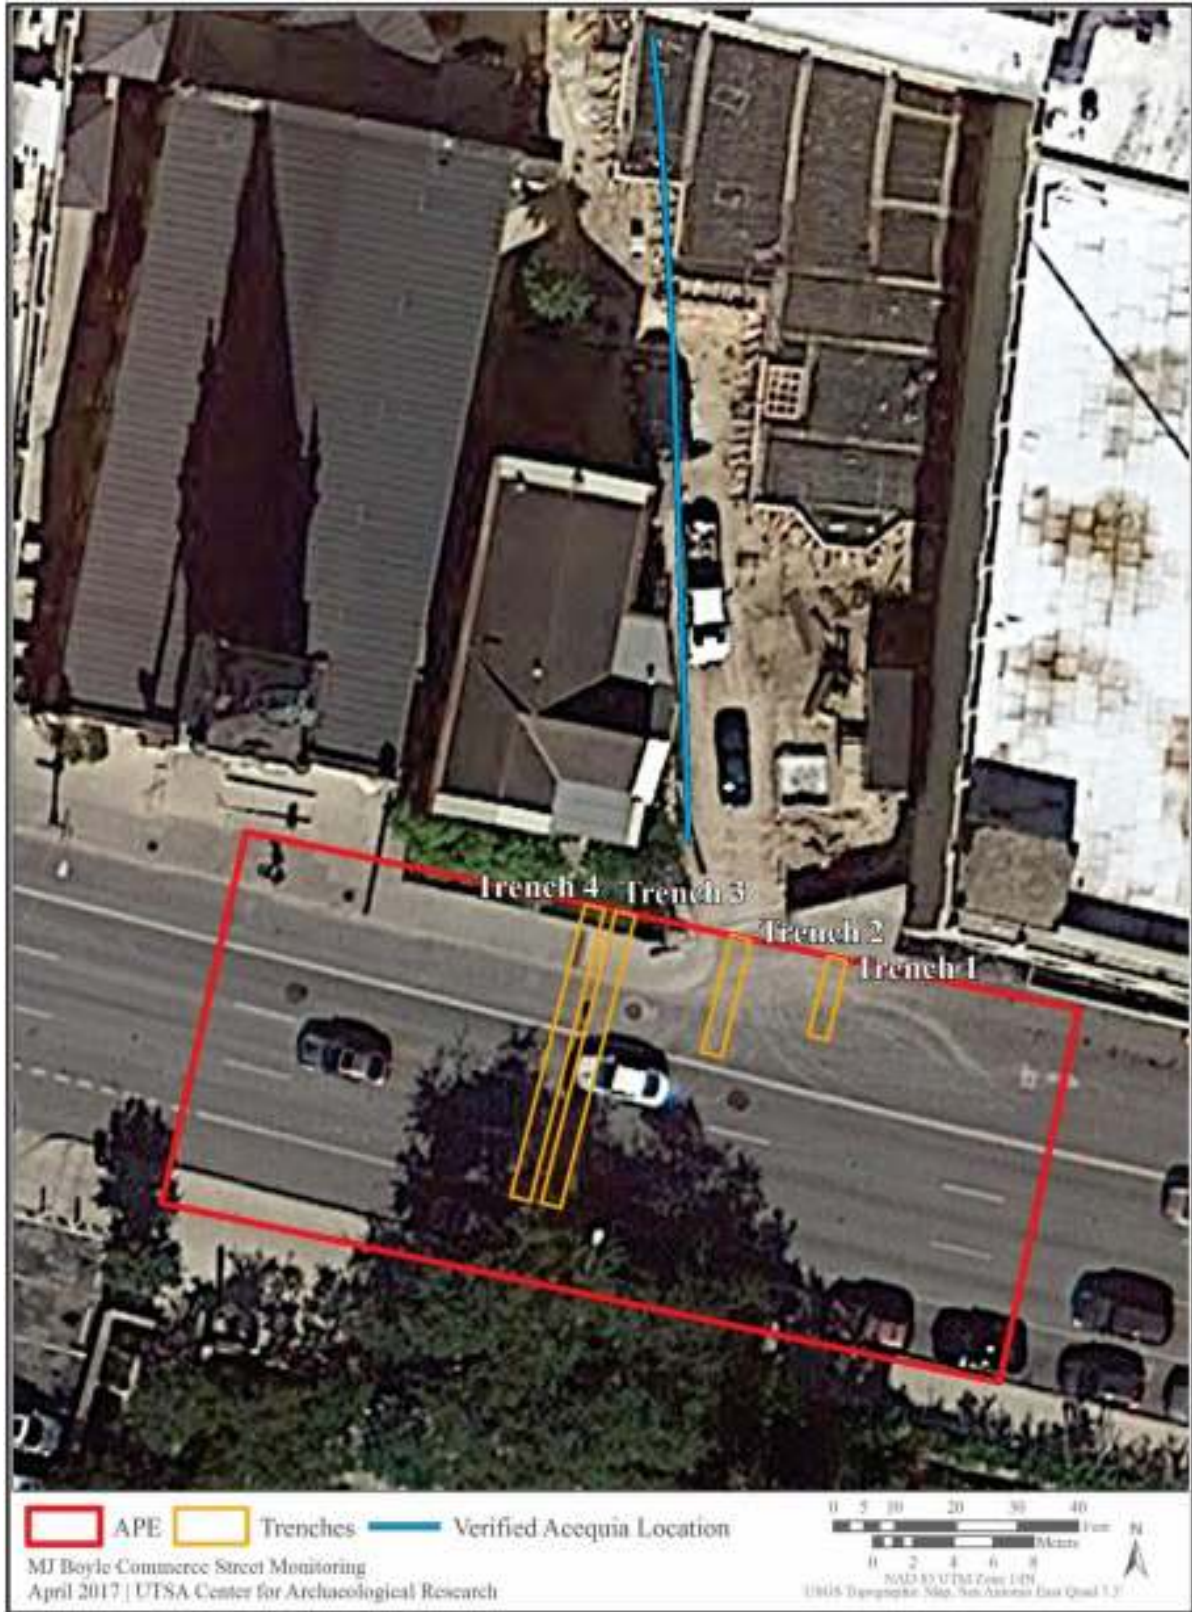
Figure 4-1. Utility trenches monitored by CAR.

Four locations were excavated in the project area between the dates of January 23, 2017, and February 7, 2017 (Figure 4-1). Three of the trenches were associated with SAWS utility lines, while one excavation was for a CPS Energy line. All trenches contained old utilities and showed evidence of some disturbance. Cultural material was noted in two of the trenches (Trenches 3 and 4), located just west of the acequia. After excavations, utilities were installed, trenches were filled, and asphalt was replaced. Trench 4 continued into the church property, outside this project's defined APE, and the acequia was encountered again (see Zapata 2017).

Trenches 3 and 4 were excavated just south of the Rectory (see Figure 4-1). The trenches were orientated north/south and were 5.5-m long and 1.5-m wide. Both trenches contained remnants of the historic electrical railway tracks (41BX2163) that functioned in the early 1900s (Kemp et al. 2017). In Figure 4-4, Trenches 3 and 4 are shown with intact and disturbed remnants of the historic railway system. Trench 3 contained an intact wooden track tie, while Trench 4 had evidence of a metal track.

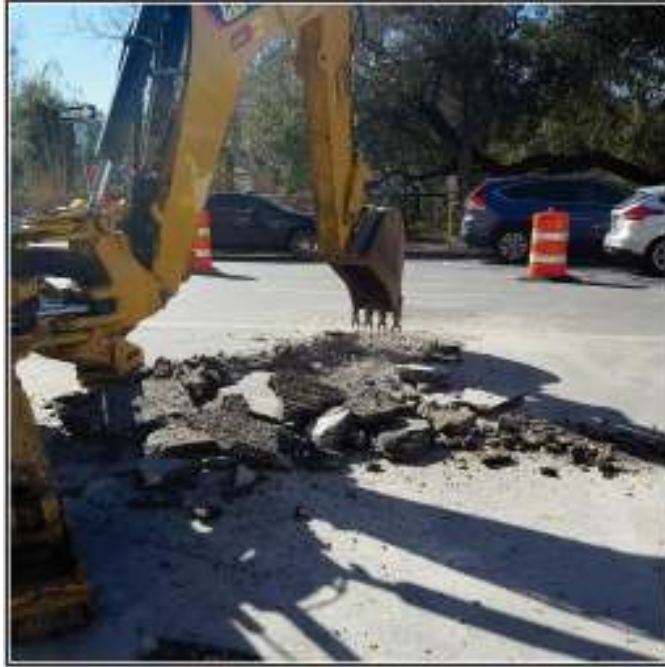
Figure 4-2. Trench 1 excavated for CPS Energy line, connecting to manhole.

Trench 1, associated with a CPS Energy line, was located to east of the church gate entrance (Figure 4-2). The trench spanned from the church fence line to a manhole located in Commerce Street (Figure 4-3). The trench was orientated slightly northeast/southwest and was 6-m long, 1-m wide, and 1.5-m deep. There were few areas with undisturbed soils, but the natural soil was a dark brown clay loam. Several preexisting utilities encased in concrete were present in Trench 1. The contractors implemented hand digging to uncover these utilities. Directly under the blacktop and base is a layer of Portland cement that was seen in all the trenches. No cultural material was observed in this excavation.

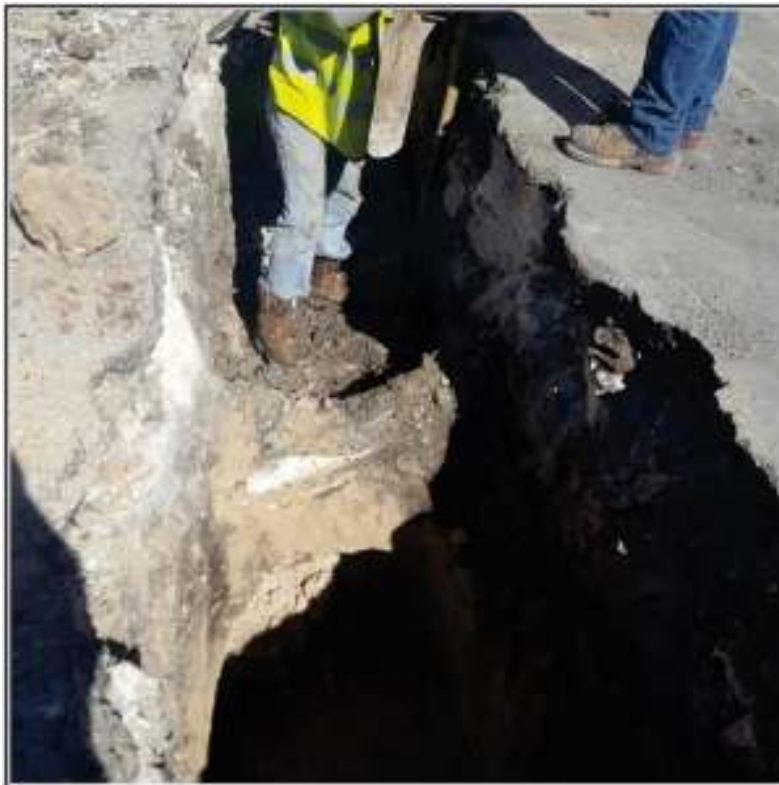
Figure 4-3. Trench 2 excavated to the west of Trench 1 and associated with SAWS utilities.

Trench 2 was orientated slightly northeast/southwest and was 6-m long, 1-m wide, and 1.8-m deep. There were few areas with undisturbed soils, and the natural soil was a dark brown clay loam followed by a light tan soil with calcium carbonates. Several preexisting utilities were present in Trench 2 (Figure 4-3). The contractors hand dug around all encountered preexisting utilities.

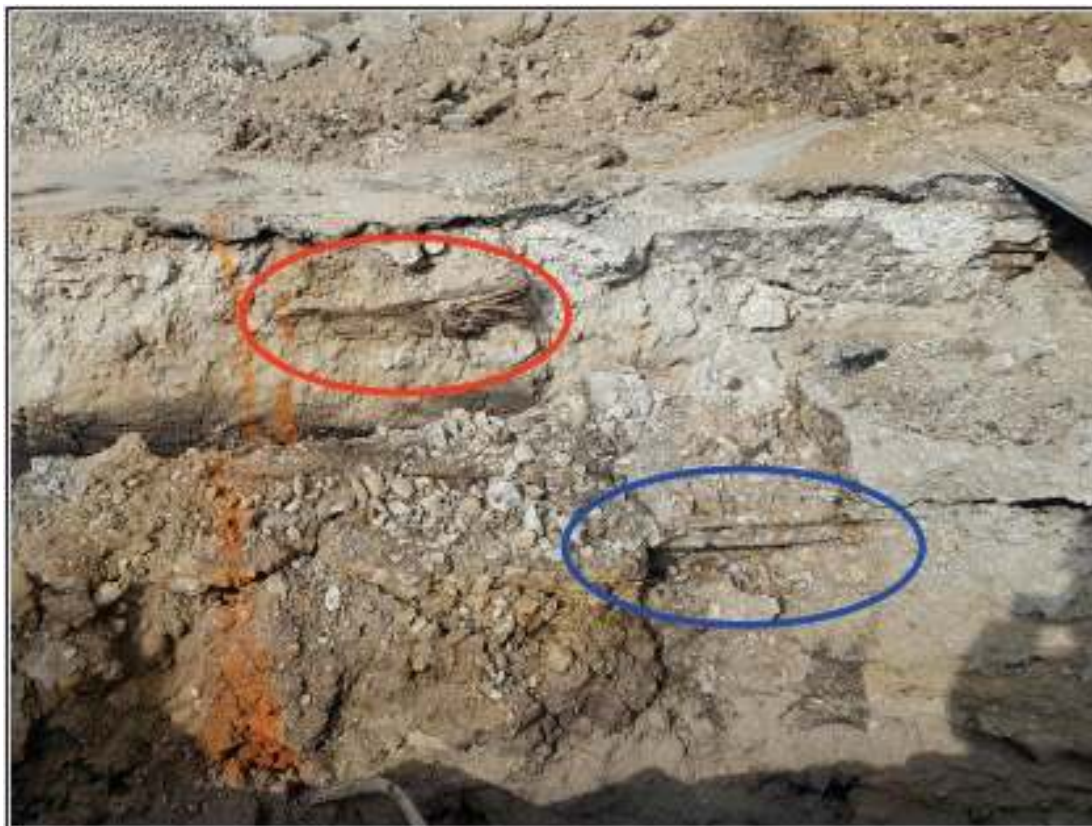
Figure 4-4. Trenches 3 and 4, intact wooden ties (orange circle) and disturbed metal track fragment (blue circle) associated with 41BX2163 (facing northwest).

Archaeologists observed cultural material related to sites 41BX8 and 41BX2163 in Trenches 3 and 4. Both trenches were associated with SAWS utilities. In Trenches 3 and 4, disturbed and intact portions of the electrical railway (41BX2163) that once traversed Commerce Street were encountered. During the monitoring of the northern portion of Trench 4, cultural material likely associated with the historical maintenance of the acequia (41BX8) was found. Due to the disturbance caused by previous utilities in both trenches, further work was not recommended by CAR, and work can proceed as planned.

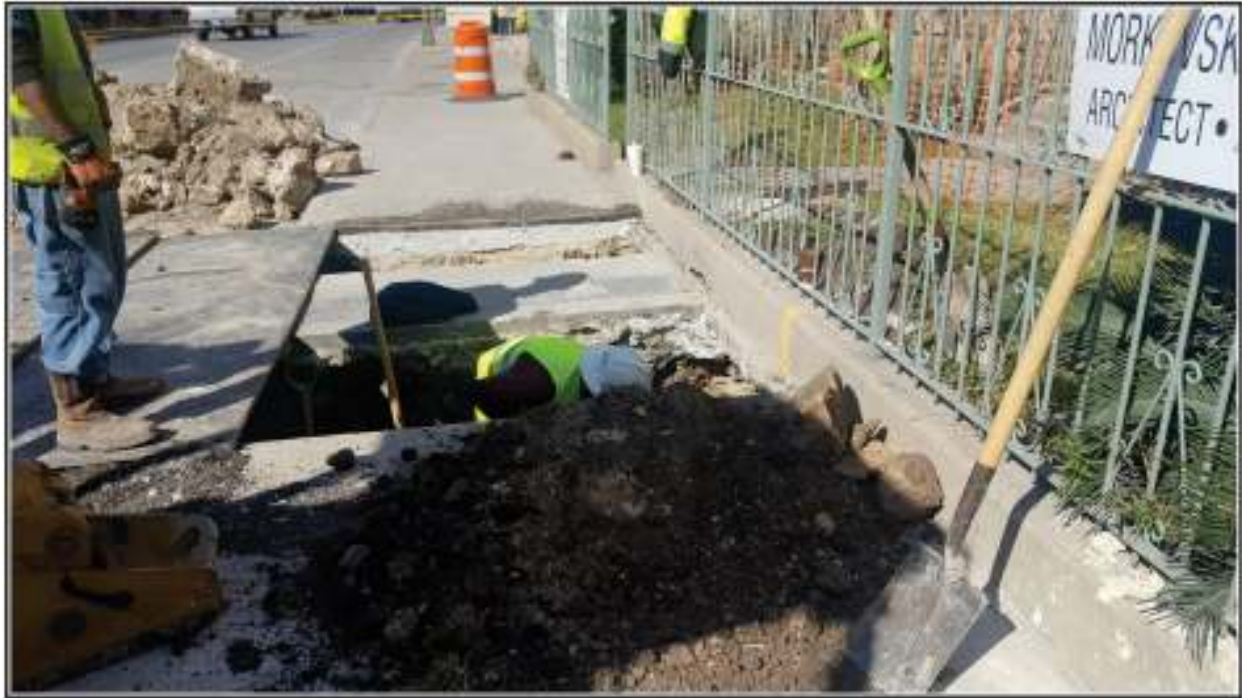
The northern portion of Trench 3 continued outside the APE and onto church property (see Zapata 2017). Figure 4-5 illustrates the hand digging of Trench 3 due to encountered utilities. A small amount of cultural material was recovered from back dirt during Trench 3 excavations, which abutted the fence line and extended to a depth of one meter. Materials included faunal material (bovine), ceramics, glass, and metal mixed with loose limestone cobbles (Table 4-1). The trench was located immediately west of the path of the acequia wall (41BX8). The cultural material appeared to be in disturbed context based on the presence of utilities (Figure 4-6). The deposits likely represented debris removed from the acequia during historical

Figure 4-5. Trenches 3 and 4, just east of acequia's path.

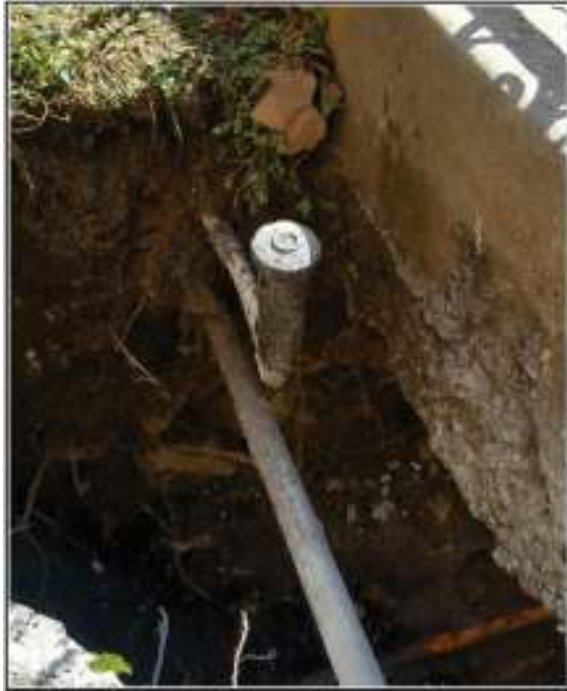
maintenance of the water feature. Although the acequia lateral may have crossed this area, there was no evidence present in the excavations. The fence and utilities also impacted the deposits observed in both trenches. The presence of white earthenware and olive glass are representative of nineteenth-century material (Figure 4-7). There was no evidence of burning on the bone or other artifacts (Figure 4-8).

Figure 4-6. Utilities in Trench 3 where cultural material was observed.

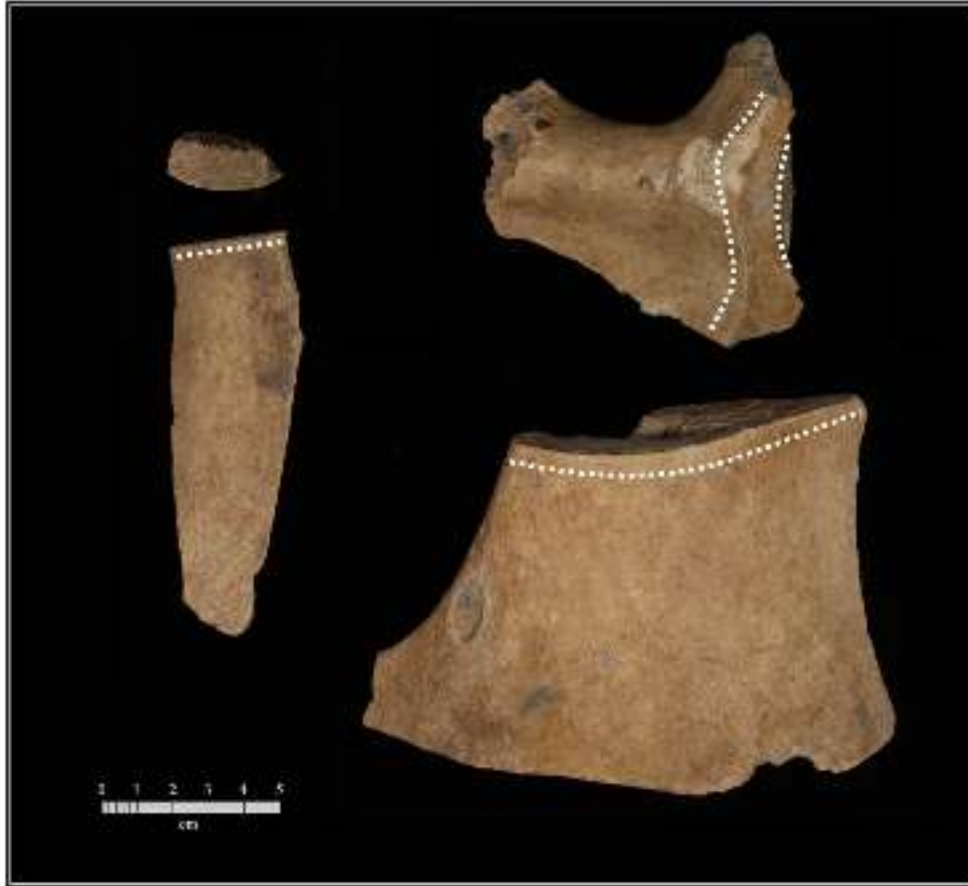
Figure 4-8. Cut bone (dotted line indicates cut edge) recovered from Trench 3.
