Archaeological Monitoring for the San Pedro Avenue, Main Avenue, and Navarro Street Roundabout Project, San Antonio, Bexar County, Texas

Texas Antiquities Permit No. 7906

Prepared by:
Center for Archaeological Research
The University of Texas at San Antonio
One UTSA Circle
San Antonio, Texas 78249
Technical Report, No. 74

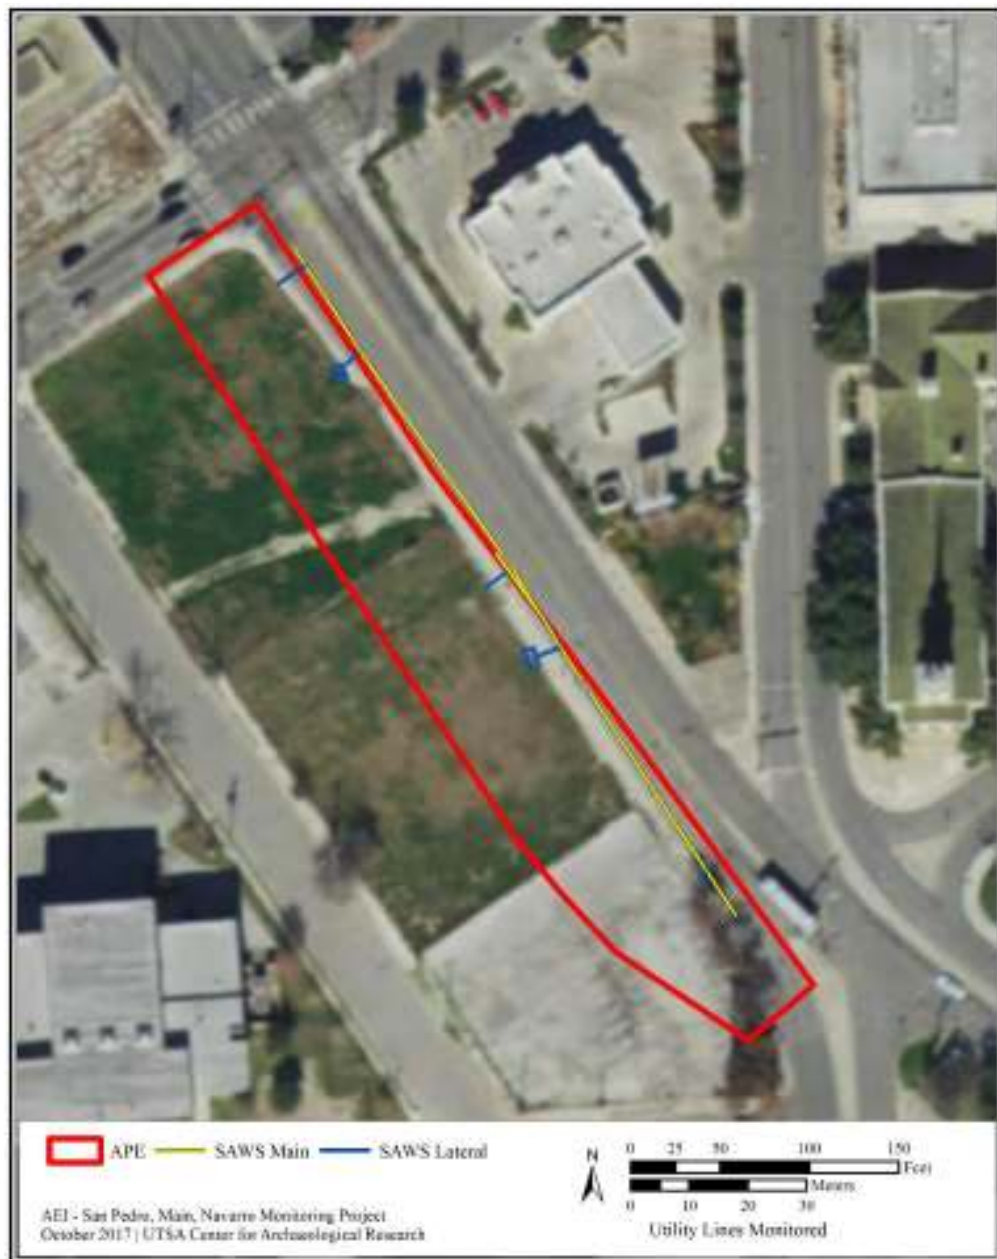
Figure 4-1. SAWS utility installations monitored by the CAR during the project.

Below-ground excavations associated with SAWS utilities installations and COSA roadwork were conducted from March 2017 through February 2018. This chapter summarizes the archaeological monitoring, beginning with the SAWS utilities and concluding with the COSA roadwork. Figure 4-1 displays the SAWS utilities monitored by the CAR. All trenches contained old utilities and showed evidence of some disturbance. After excavations, utilities pipes and equipment were installed, trenches were filled, and asphalt was replaced.

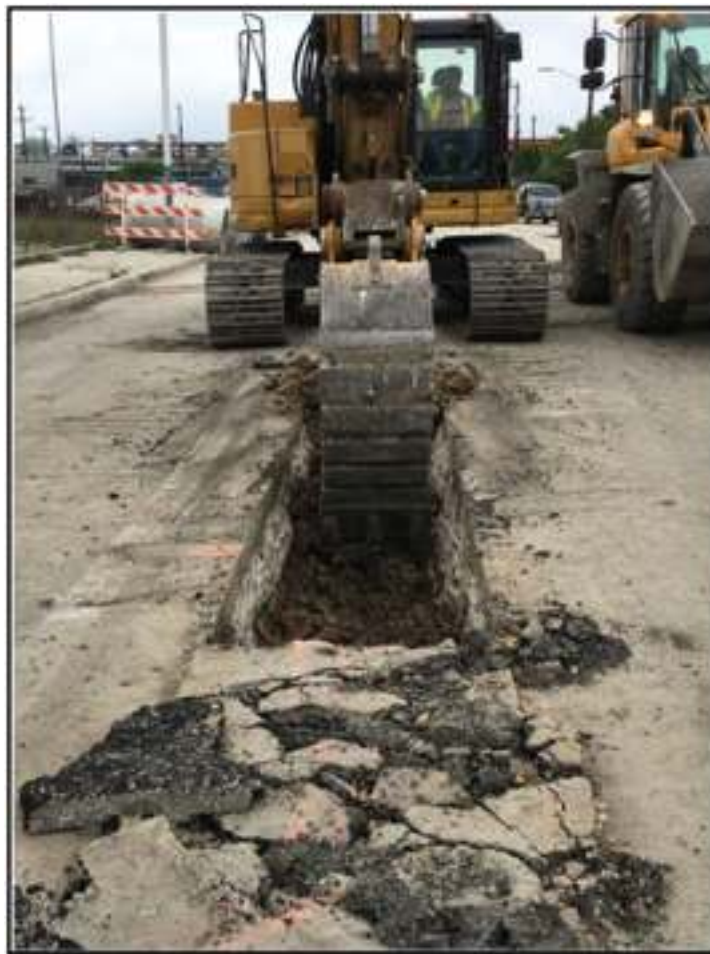
SAWS work consisted of a main water line and associated lateral lines. Archaeological monitoring for this portion of the project began on March 21, 2017. SAWS utility work continued intermittently until February 2018. CAR monitored the SAWS main line for which the excavations reached a depth of 1.5 m (5 ft.) below the surface (Figure 4-2). Fill material was represented by sand used to cover the previously installed utility lines. Sections of undisturbed soils were observed in some areas not impacted by utility work. These soils consisted of a dark brown (10YR 3/3) clay with few inclusions. No cultural material was observed during these excavations, and further work is not recommended. As seen in Figure 4-3, the water main excavations spanned the entirety of the APE.

Figure 4-2. Excavation of main SAWS utility prior to blacktop removal (facing south).

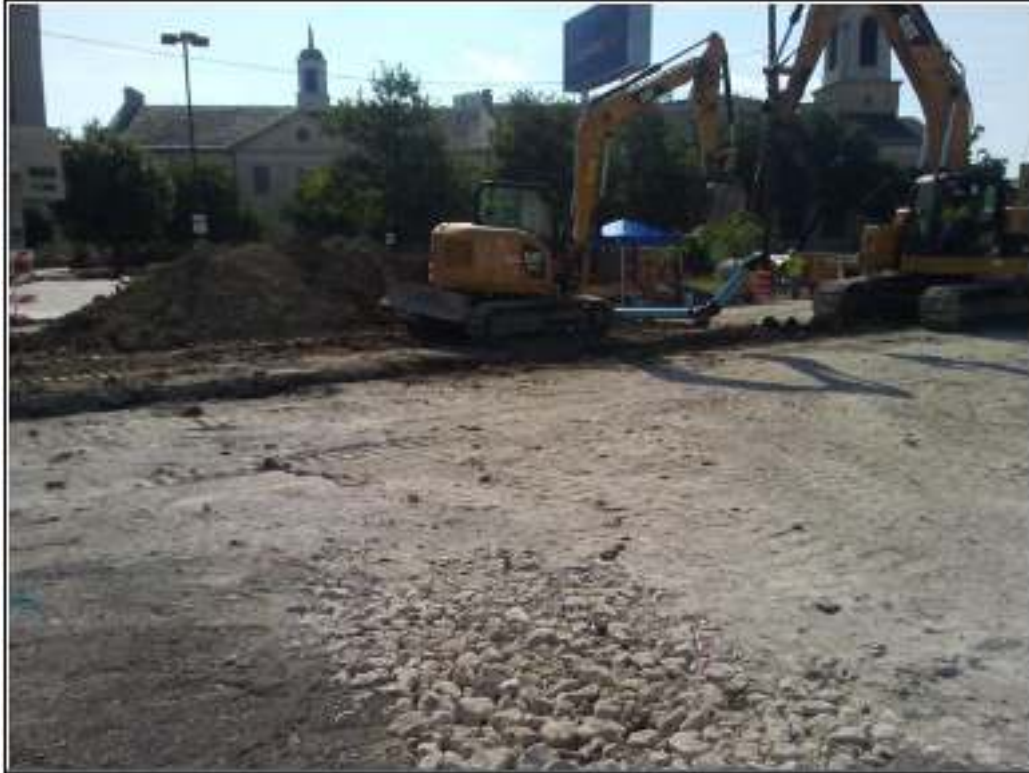
Figure 4-3. Photograph of main SAWS water utility trench and installation of pipe.

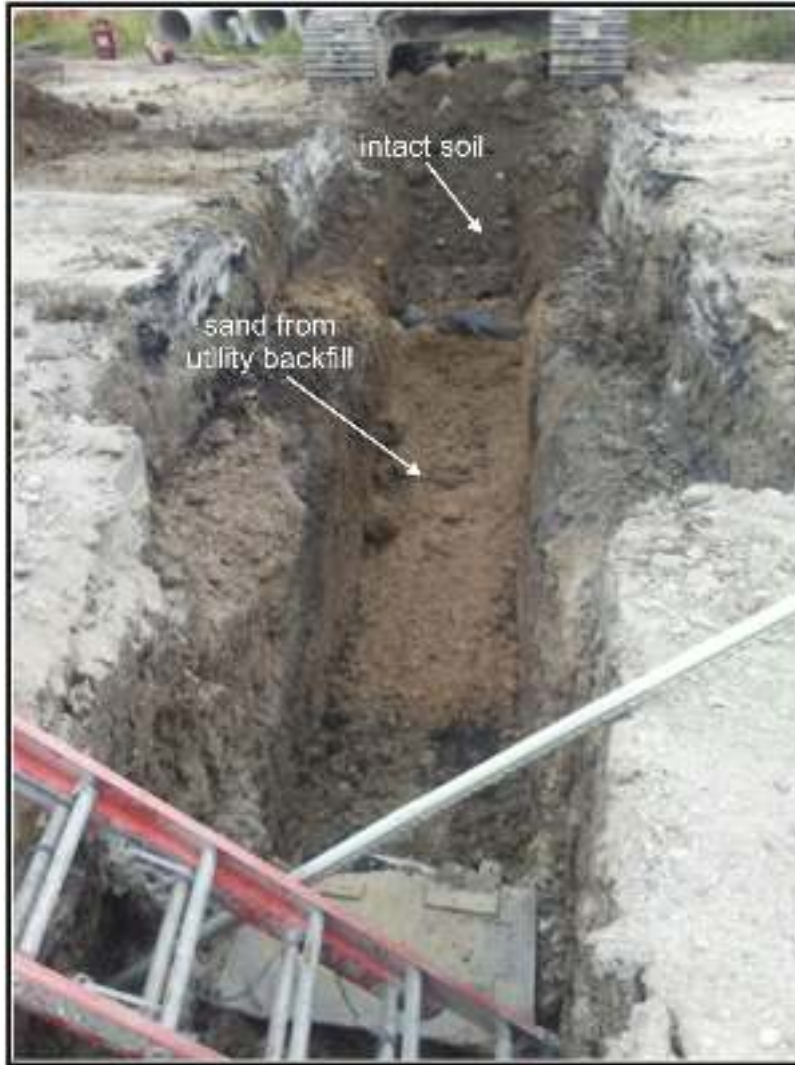
As noted, contractors excavated lateral lines that connected to the SAWS water main trench. These excavations were conducted and monitored intermittently by CAR staff from April 5 through May 8, 2017. The excavations ranged in depth from 1.5 m below the surface (mbs; 5 ft.) to 1.8 mbs (6 ft.). The maximum width of one lateral line excavation was 2.4-m (8-ft), while the remaining lateral trenches were a standard bucket width of 0.6 m (2 ft.). Figure 4-4 shows one of the lateral line excavations. As seen in the photo, much of the area had been disturbed by previously installed SAWS utilities. Undisturbed portions of the excavations revealed a dark brown (10YR 3/3) clay. During the lateral line excavations, no cultural material was observed or collected. Further archaeological work for these areas was not recommended.

Figure 4-4. SAWS lateral excavations, note differences in soils.

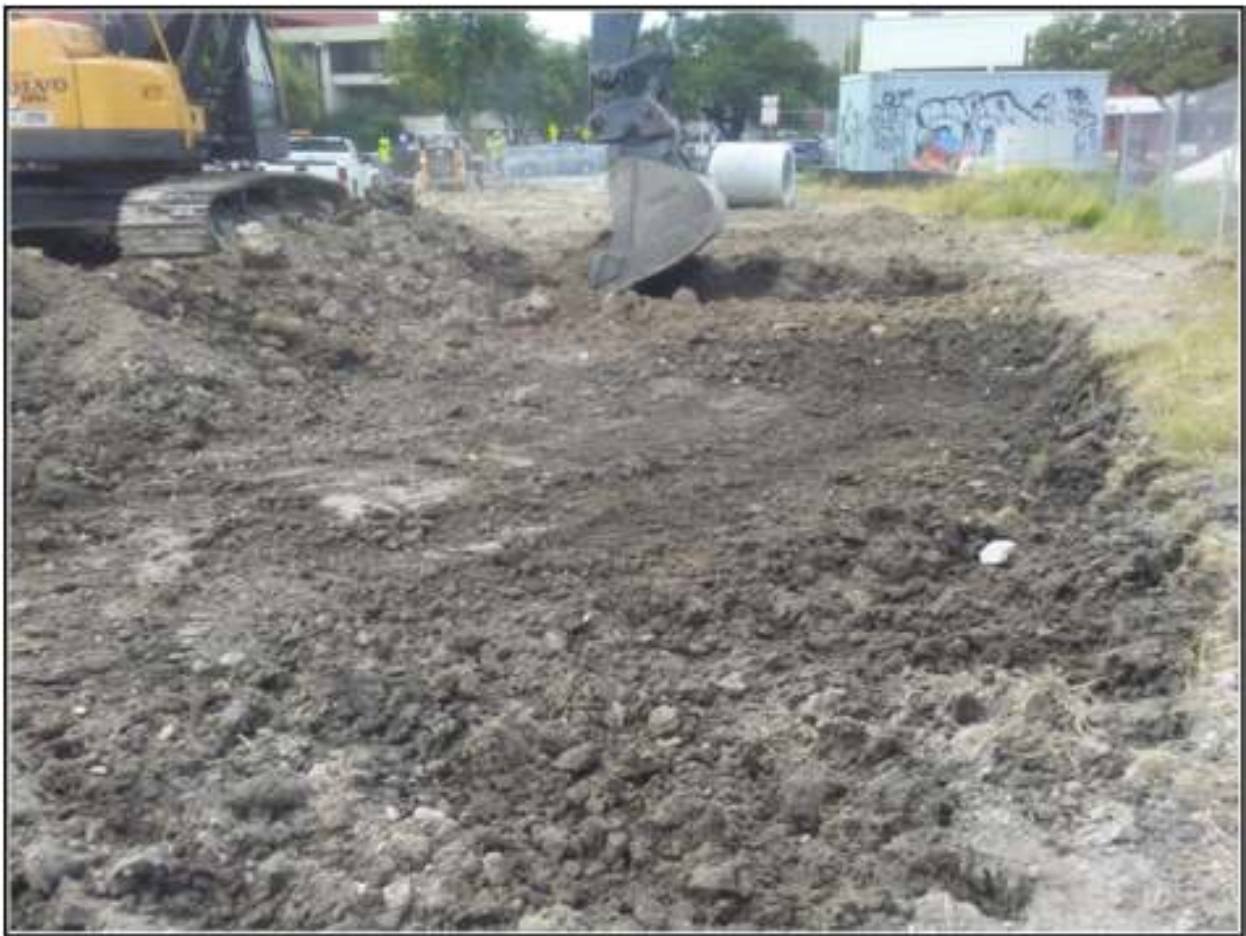
COSA excavations were associated with the installation of storm sewers and road grading. Contractors conducted the road grading over the entire APE. During the grading activities, removal of the blacktop and base was conducted with only spot monitoring. Grading included the removal of about 0.16 mbs (0.5 ft.) of asphalt and gravel base. The remainder of the grading was conducted intermittently between July 31 and August 3, 2017. These excavations (Figure 4-5) were done with a larger excavator and to a depth of 0.5 mbs (1.6 ft.). Much of the area had been disturbed by previous utilities, and excavations in the northern portion of the APE revealed concrete and rebar. No cultural material was observed or collected during these excavations, and further work was not recommended.

Figure 4-5. COSA road grading with large excavator (facing south).

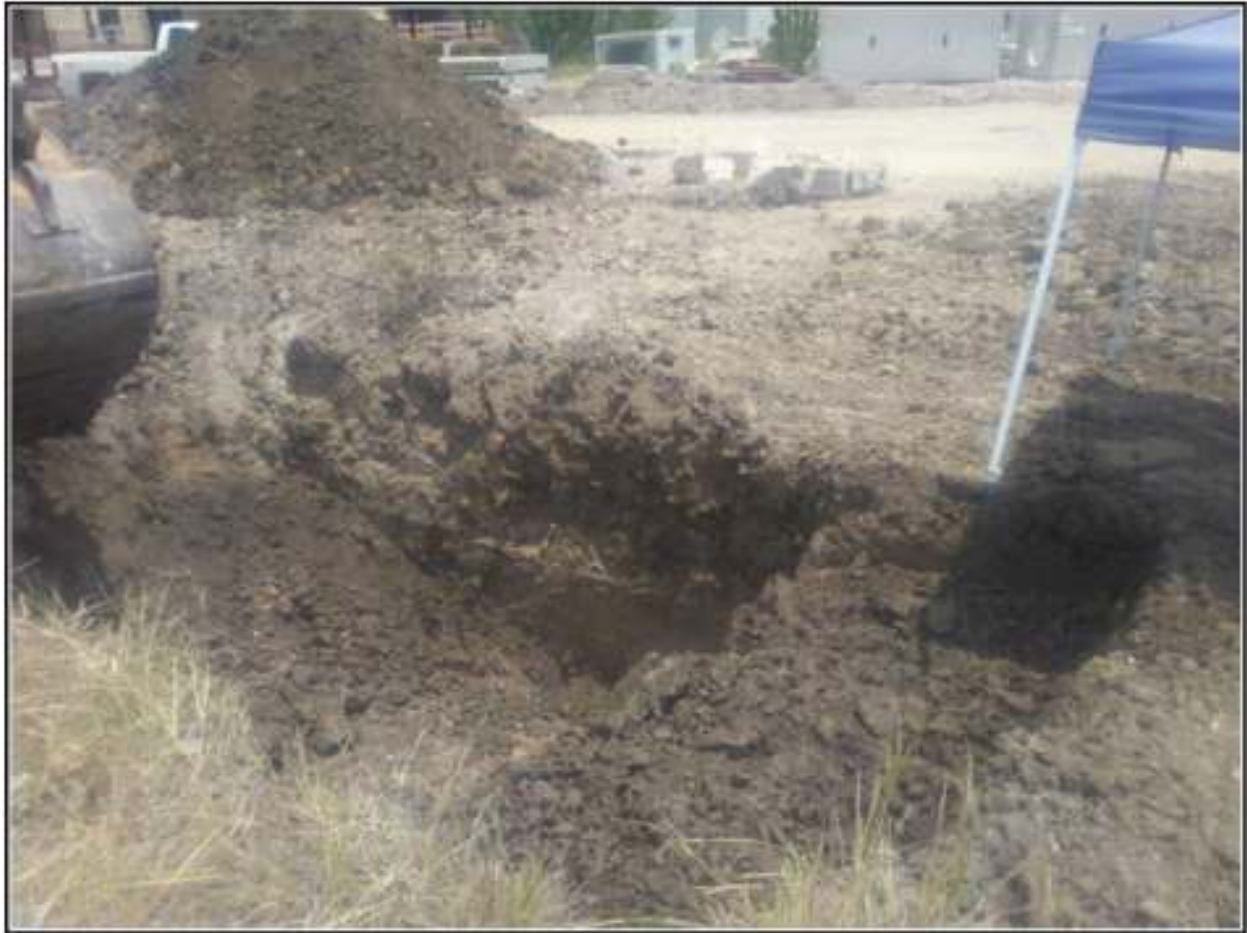
Excavations for storm sewer drains were also conducted on behalf of COSA. As seen in Figure 4-6, the excavations measured to a depth of 1.8 mbs (6 ft.) and were up to 4 m (14 ft.) in width. Much of the areas excavated were disturbed by previous utility work. Undisturbed soils were dark brown (10YR 3/3) in color. No cultural material was observed or collected during these excavations, and further archaeological work was not recommended.

Figure 4-6. Storm sewer excavations for COSA.
