# Intensive Pedestrian Survey of the Leon Creek Greenway Trail from Levis Strauss Park to the Lackland Corridor Monument, San Antonio, Bexar County, Texas

Texas Antiquities Permit No. 8527

Prepared by: Center for Archaeological Research The University of Texas at San Antonio One UTSA Circle San Antonio, Texas 78249 Technical Report, No. 80

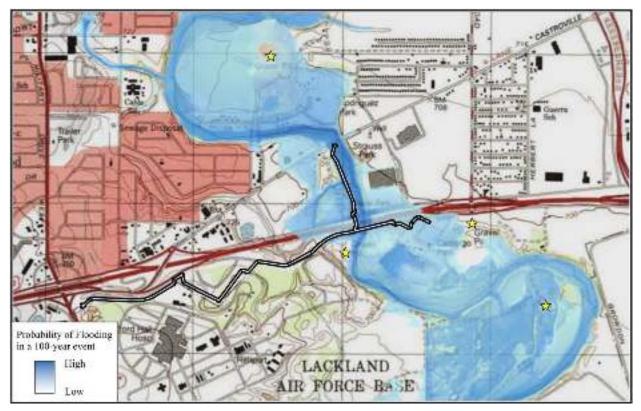
Figure 2-1. The APE within the 100-year floodplain (FEMA/SARA 2018). Locations of former gravel pits are marked with a yellow star.

San Antonio is close to the Gulf of Mexico, where severe storms, including hurricanes, will develop in the late summer and fall. Storms that produce extreme rainfall events can lead to localized or regional flooding depending on the storm's severity and longevity. The project area (Figure 2-1) is subject to flash flooding during these intense periods of rain as shown in the Risk Mapping, Assessment, and Planning map by the Federal Emergency Management Agency and San Antonio River Authority (FEMA/SARA 2018). Over the years, flooding has resulted in the deposition of gravels and cobbles from further upstream within and adjacent to the floodplain making gravels a commercially viable product (former gravel pits are shown in Figure 2-1).

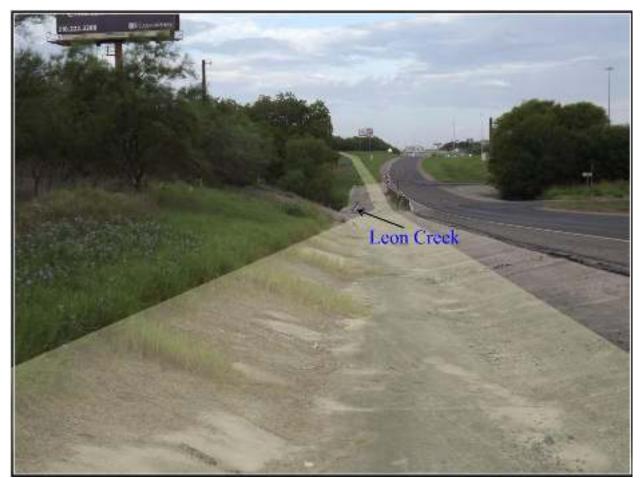
The survey began on August 20, 2018, at Mateo Camargo Park (Segment 3) and proceeded west to the Lackland Corridor Monument (Segment 2). Sixteen shovel tests were excavated in this portion of the APE. The first four shovel tests were placed east of Leon Creek with two located in Camargo Park. The shovel tests in Camargo Park were both negative with ST 1 going to 60 cmbs (23.6 in.) with soils of dark grayish brown (10YR 4/2) silty clay and very dark gray (10YR 3/1) clay. Shovel Test 2, consisting of very dark brown (10YR 2/2) silt, terminated at 8 cmbs (3.1 in.) due to gravels. Shovel Tests 3 and 4 were located along the access road outside of Camargo Park heading west to Leon Creek (Figure 4-2) and fall with the Pit and Quarry map soil unit. The excavated soils ranged from dark grayish brown (10YR 2/2) to yellowish brown (10YR 5/4) silt to grayish brown (10YR 5/2) clay sand.

*Figure 4-2. The APE (highlighted) near ST 4 leading to Leon Creek. View to the east.*

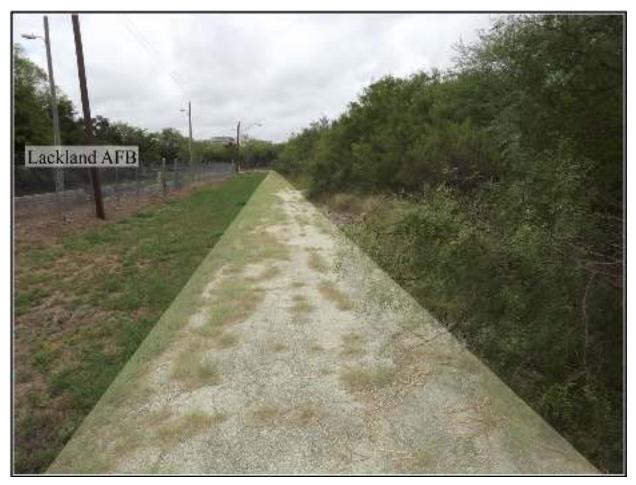
Shovel Tests 5 through 8 were placed on the west side of Leon Creek leading to the abandoned portion of Castroville Highway. Shovel tests were shallow ranging from 8-30 cmbs (3.1-11.8 in.) and were terminated due to gravels. The excavated soils were a dark grayish brown (10YR 4/2) to brown (10YR 5/3) silty clay. The abandoned roadway was walked and examined for artifacts (Figure 4-3). No shovel tests were excavated in this portion of the survey due to the asphalted roadway.

Figure 4-3. The APE (highlighted) in the abandoned Castroville Road section. Lackland AFB is on the left of this image.

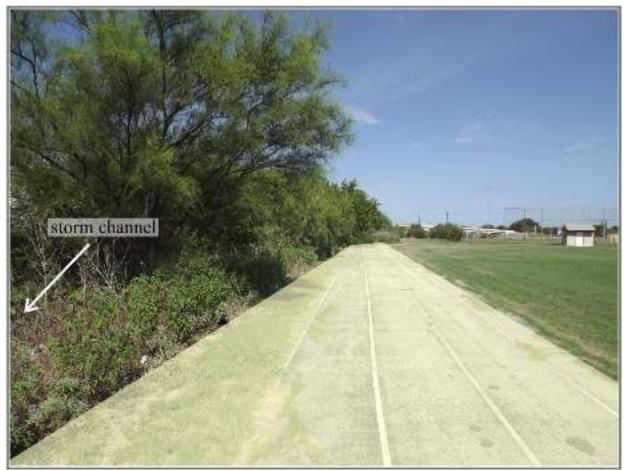
Shovel Tests 9 through 13 are located behind the New Life Church property. Soils consisted of brown (10YR 5/3) to dark grayish brown (10YR 4/2) to very dark grayish brown (10YR 3/2) to black (10YR 2/1) silty clay terminating with gravels and/or cobbles. Shovel Tests 12 and 13 were excavated between the asphalt track and a large storm channel (Figure 4-4). The storm channel was constructed in the 1960s to divert floodwaters into a drainage leading to Leon Creek. No artifacts were observed on the surface or found in the shovel tests. Moderate-sized chert cobbles, 10-15 cm (3.9-5.9 in.) in length, were noted on the surface near ST 11, and the presence of the cobbles was likely due to past construction grading in that area.

Figure 4-4. The APE (highlighted) near ST 12. A large storm channel is adjacent to the APE.

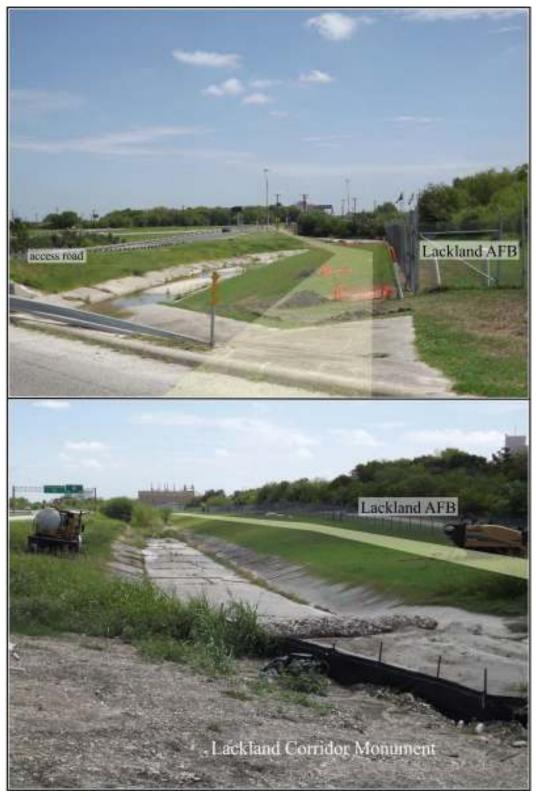
The remaining three shovel tests (STs 14-16) in this portion of the APE also followed the storm channel (Figure 4-5). The distance between shovel tests was increased due to the construction impact. The soils were very dark gray (10YR 3/1) to dark gray (10YR 4/1) to very dark brown (10YR 2/2) silty clay with gravels and cobbles. No artifacts were found in the shovel tests. During CAR's investigation, a trench for gas utilities was being excavated in this portion of the APE. The excavated matrix from the trench was examined for artifacts, and none were observed.

Figure 4-5. Views to the east of the APE (highlighted) along the storm channel and north of Lackland AFB. The top photo shows the APE from the Security Gate at Lackland. The bottom photo shows the APE from the Lackland Corridor Monument (under construction).

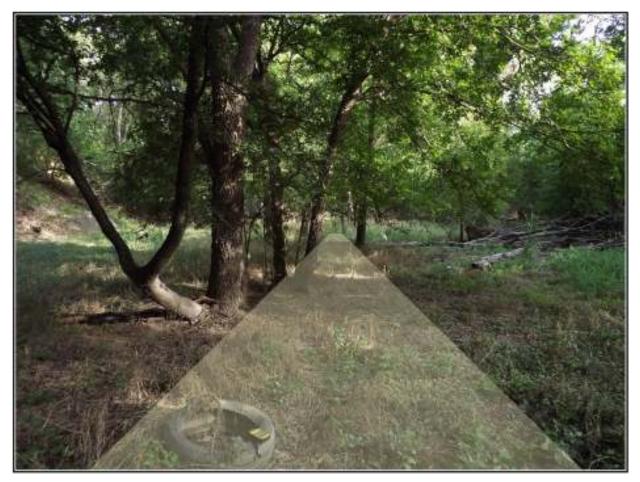
Beginning at Levi Strauss Park (Segment 1) on August 22, 2018, eight shovel tests (STs 18-24) were placed along the Leon Creek portion of the APE (Figure 4-6). As noted in Chapter 2, this portion of the APE is within an active floodplain as identified on the 100-year flood map (see Figure 2-1). The depth of the shovel tests ranged from 10-50 cmbs (3.9-19.6 in.), and all of the tests were terminated due to gravels and cobbles. Gravel banks and washouts were observed along the APE indicating the strong velocity of flooding in this area. The excavated soils were a grayish brown (10YR 5/2) to dark grayish brown (10YR 4/2) silty clay. The results of two of the shovel test included modern debris consisting of asphalt, glass, plastic, and cloth fragments (not collected). Flood debris observed on the surface included tree limbs, plastic and glass bottles, aluminum cans, and highway safety cones and barriers. No shovel tests were excavated in the area under U.S. Hwy. 90 due to previous construction. However, it was visually surveyed with no artifacts recorded.

*Figure 4-6. The APE (highlighted) within the Leon Creek floodplain near ST 19. Note the debris in the foreground and in the background.*

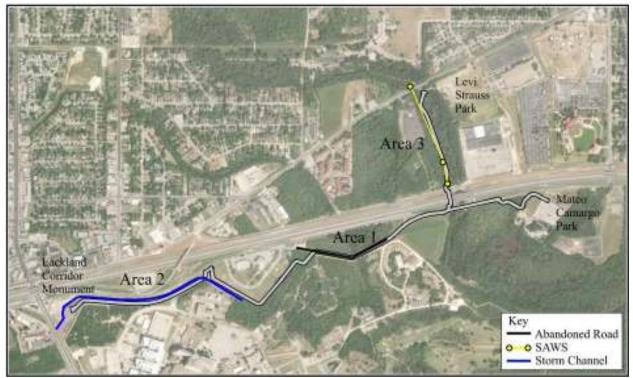
Area 3: Along the Leon Creek portion of the APE, CAR reduced the distance between shovel tests to approximately 50-60 m (164-196.8 ft.) due to the greater potential of archaeological deposits adjacent to a waterway. On the southern end of that segment, two San Antonio Water System (SAWS) manholes were observed. Post-field research revealed that a 54-inch sewer line (built in 1973) ran adjacent to and in this segment of the APE (SAWS 2018).

Figure 4-7. Previous construction locations within or adjacent to the APE (red outline).
