Archaeological Investigations of the Monterrey Park Improvements, San Antonio, Bexar County, Texas

by Antonia L. Figueroa Texas Antiquities Permit No. 8798

Prepared by: Center for Archaeological Research The University of Texas at San Antonio One UTSA Circle San Antonio, Texas 78249 Technical Report, No. 81

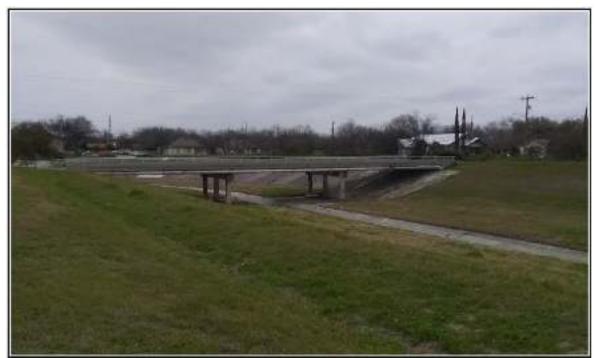
Figure 2-1. Zarzamora Creek facing northeast towards Fortuna Street bridge.

The soil series present in the APE are represented by the Tinn and Frio soil complex (Tf). This soil type is a clayey loam that occurs along flood plains (Natural Resources Conservation Services 2019). Zarzamora Creek runs along the eastern portion of the APE. The creek originates in northern Bexar County and stretches 12.7 km (8 miles) through the western part of San Antonio, where it terminates at San Pedro Creek (Texas State Historical Association 2010). The portion of the creek along the APE has been channelized (Figures 2-1 and 2-2).

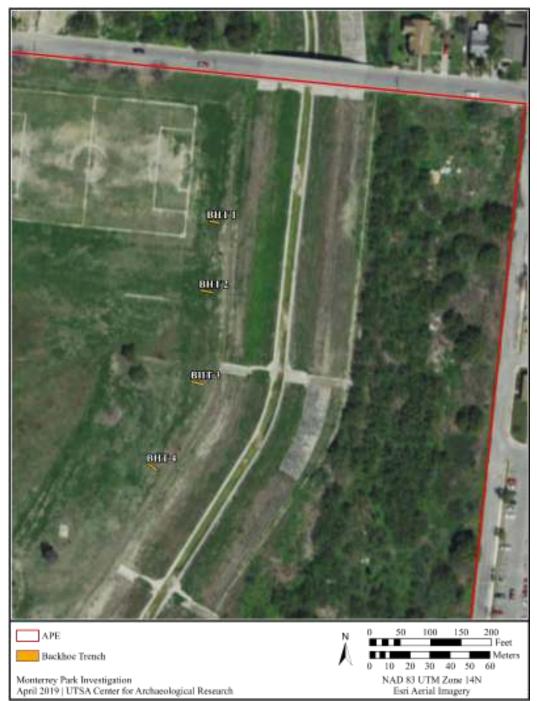
Figure 4-1. Aerial image of the APE displaying backhoe trench locations.

On March 4, 2019, CAR staff conducted exploratory backhoe trenching within Monterrey Park along Zarzamora Creek (Figure 4-1). Four backhoe trenches (BHTs) were excavated during CAR's investigations. No cultural material or archaeological sites were encountered or recorded during the investigation.

As seen in Figure 4-1, four backhoe trenches were excavated along the west bank of Zarzamora Creek. The soil profiles were slightly different in each backhoe trench; therefore, a 1-m representative profile for each trench is displayed in Figure 4-2.
