Archaeological Survey and Archival Research of the Naegelin Tract (41BX1600) in San Antonio, Bexar County, Texas

by
Jennifer L. Thompson
and
Antonia L. Figueroa

Center for Archaeological Research
The University of Texas at San Antonio
Archaeological Survey Report, No. 354
2005

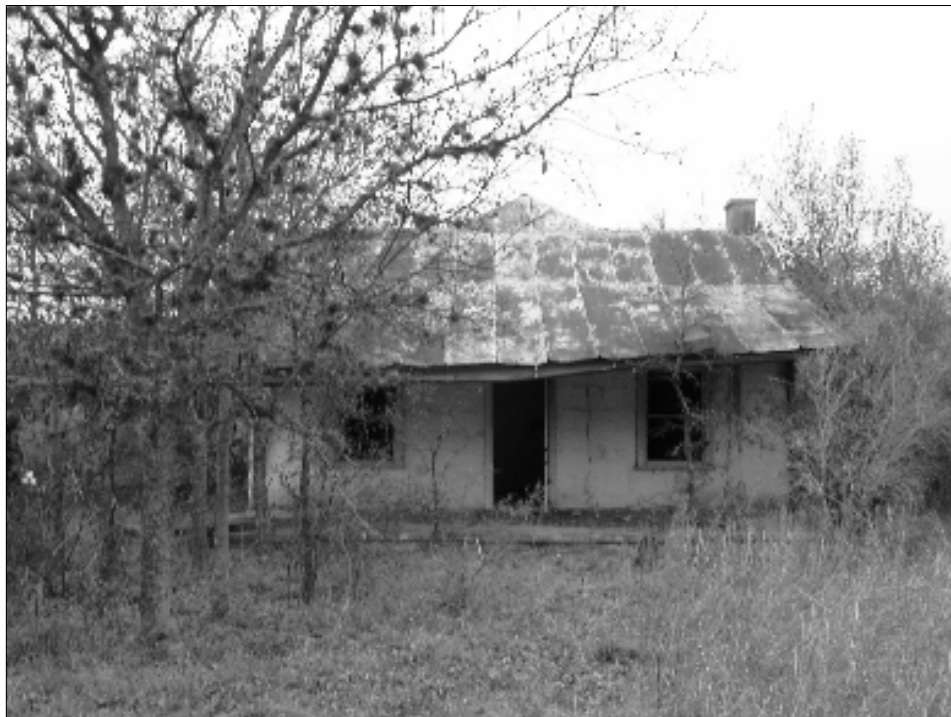
stone cottage that was later split into two smaller rooms with a wall between the north window and the door (Figures 15 and 16). During the survey, the façade on the east elevation of the original structure included a central wooden door flanked by wood-framed, double-hung sash windows (Figure 15). The roof of the original structure was of standing seam metal.

Figure 15. *Eastern façade of the stone residence (Resource 1).*

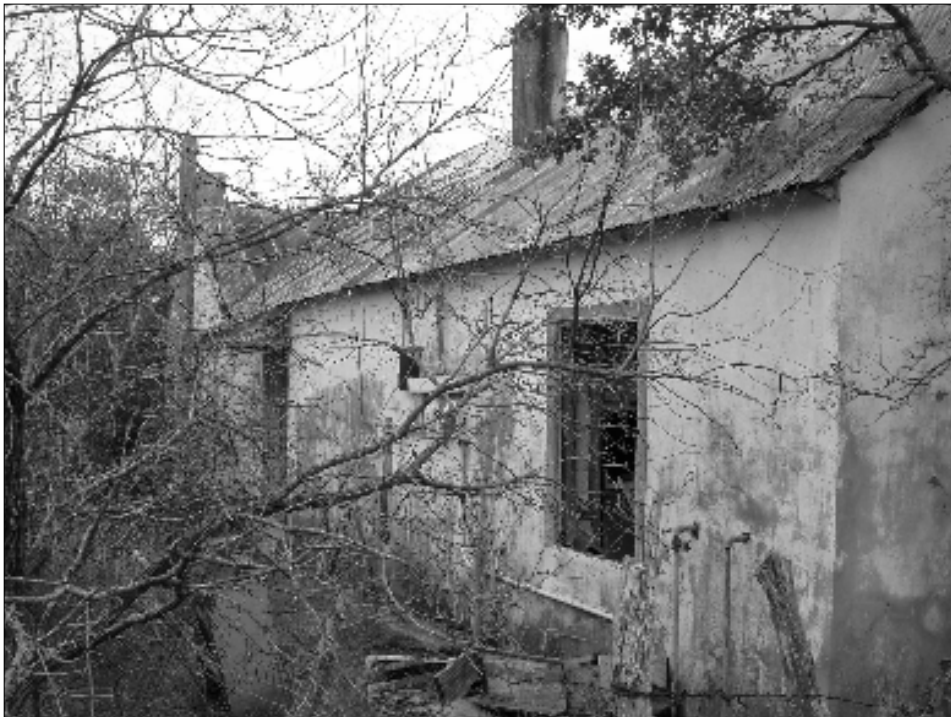
Sometime after its initial construction, a rear L consisting of two stone structures was added to the original building (Figure 17). The larger, western-most structure was split into two rooms by an interior wall. Two doors with small stoops lead outside to the north and south in the middle structure and two windows provided a view to the outside to the north and west in the western-most structure that also has two south-facing doors. The floor of the rear L is poured concrete slab and the roof is covered with corrugated metal.

Figure 17. *Northern façade of residence (Resource 1).*

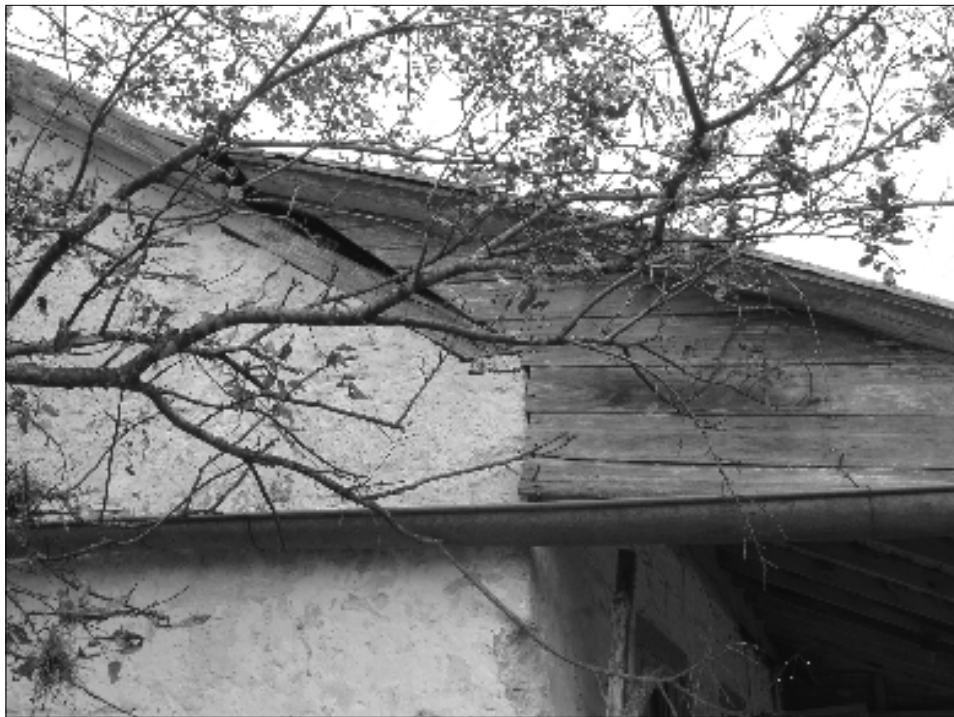
The first of the two wooden additions to the basic cut stone L plan was a porch added to the east elevation to shelter the front door and entrance. The porch had a concrete floor and was covered by an extended secondary roof of corrugated metal (Figures 18 and 19). No porch supports were present at the time of the survey; instead, tree limbs supported the roof.

Figure 19. *Roof detail of porch addition to the original house.*

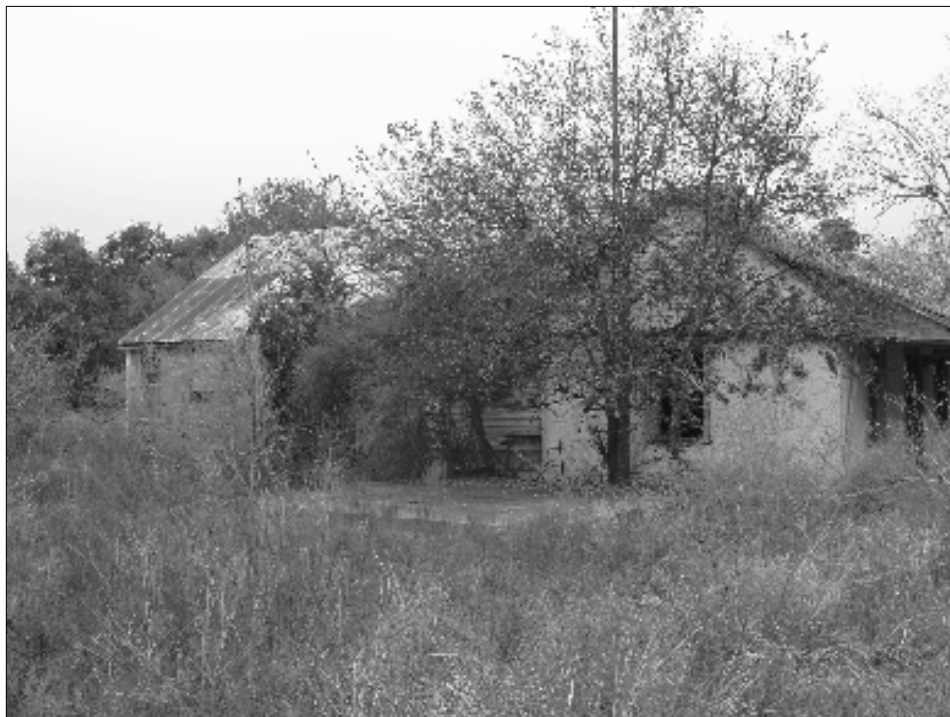
The second wood-framed addition was one-unit-deep and ran along much of the south elevation, essentially turning the L plan into a rectangular floor plan (Figure 20). This wood-framed addition was clad in weatherboard siding with a corrugated metal roof. Work on the second addition raised the roof to include an attic space (Figure 21) and extended the floor plan to include two additional rooms including a bathroom.

Figure 20. *Southern façade of residence (Resource 1).*

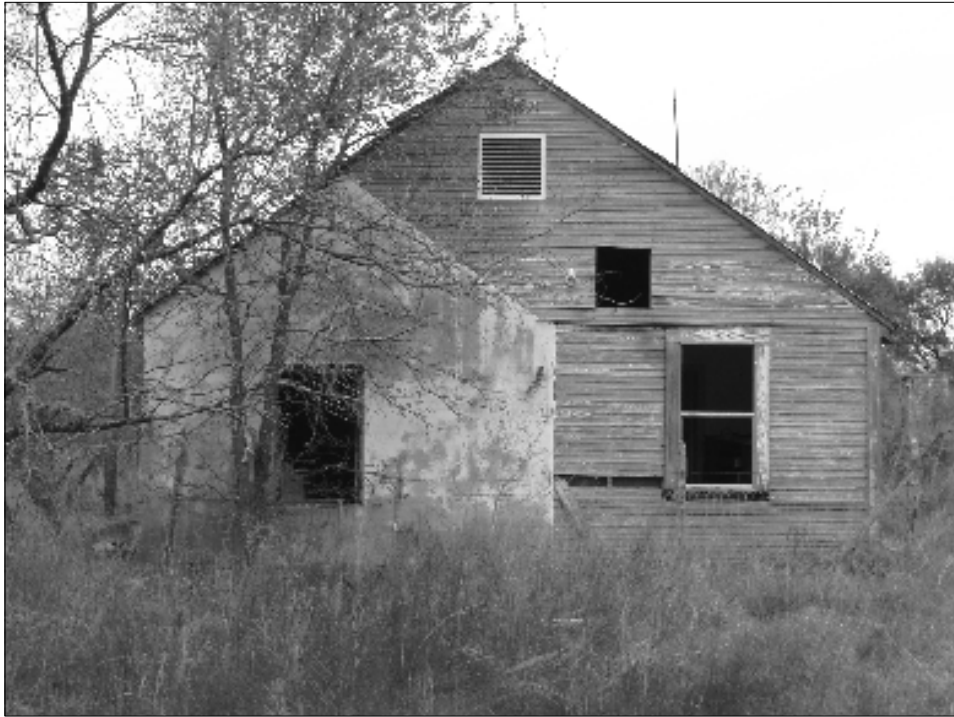
Figure 21. *Western façade of residence (Resource 1).*

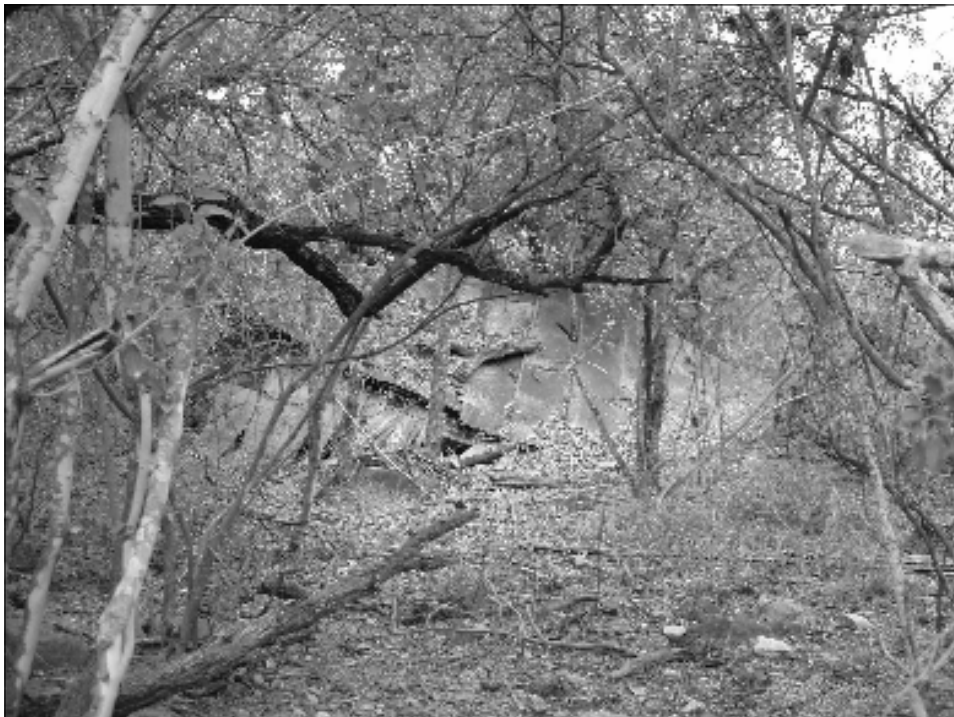
Outbuilding 1 is a collapsed, wood-frame structure with a standing seam metal roof. It is located northeast of the main house, north of Outbuilding 2 (Figure 22). It does not retain historic integrity. This building does not appear on the 1939 aerial photograph, therefore, its construction likely post-dates 1939.

Figure 22. *Outbuilding 1 (Resource 2).*

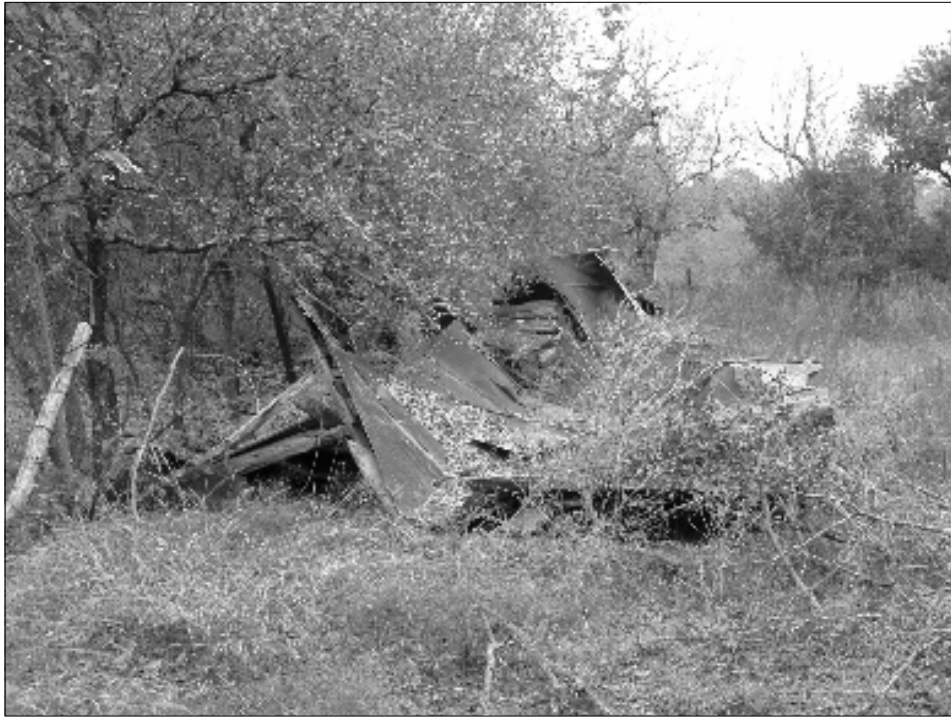
The second outbuilding is also a collapsed wooden structure with metal roofing (Figure 23). Resource 3 does not retain historic integrity. This outbuilding does appear on the 1939 aerial photo, therefore, at least some elements of it are minimally 50 years old.

Figure 23. *Outbuilding 2 (Resource 3).*

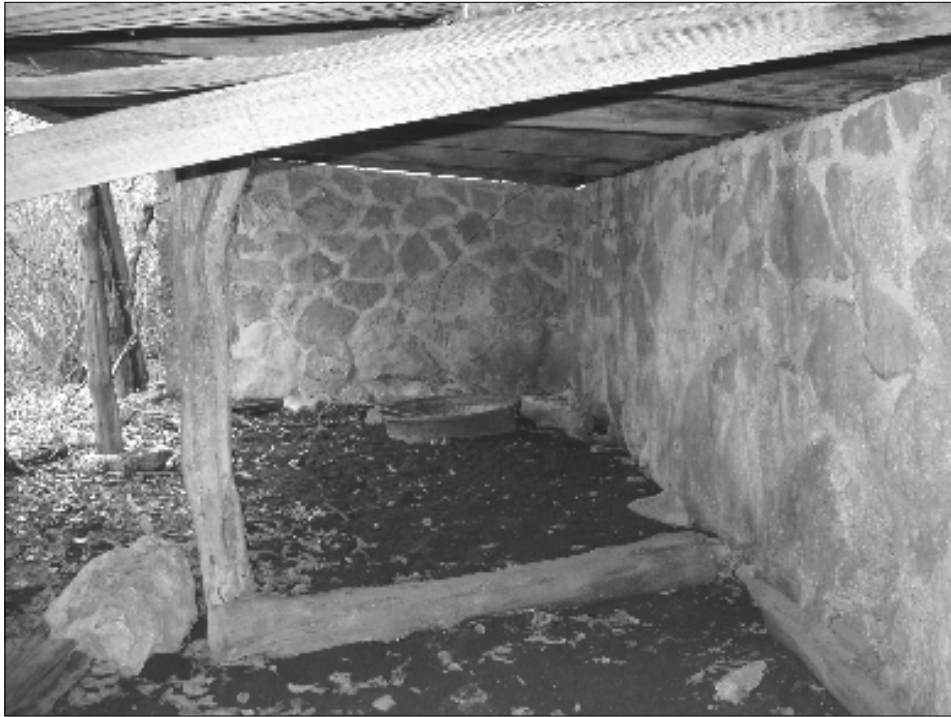
This structure exhibits some fine masonry of limestone fieldstone and mortar. There are only two walls, the northern and western, and they are very short with a low corrugated metal roof. This was likely a hog pen (Figure 26). According to Mrs. Babcock, the structure was built by a master stone mason named Andres (last name unknown). Resource 6 is structurally sound and in good condition. This outbuilding does appear on the 1939 aerial photo so at least some of its elements are minimally 50 years old.

Figure 26. *Outbuilding 5 (Resource 6).*

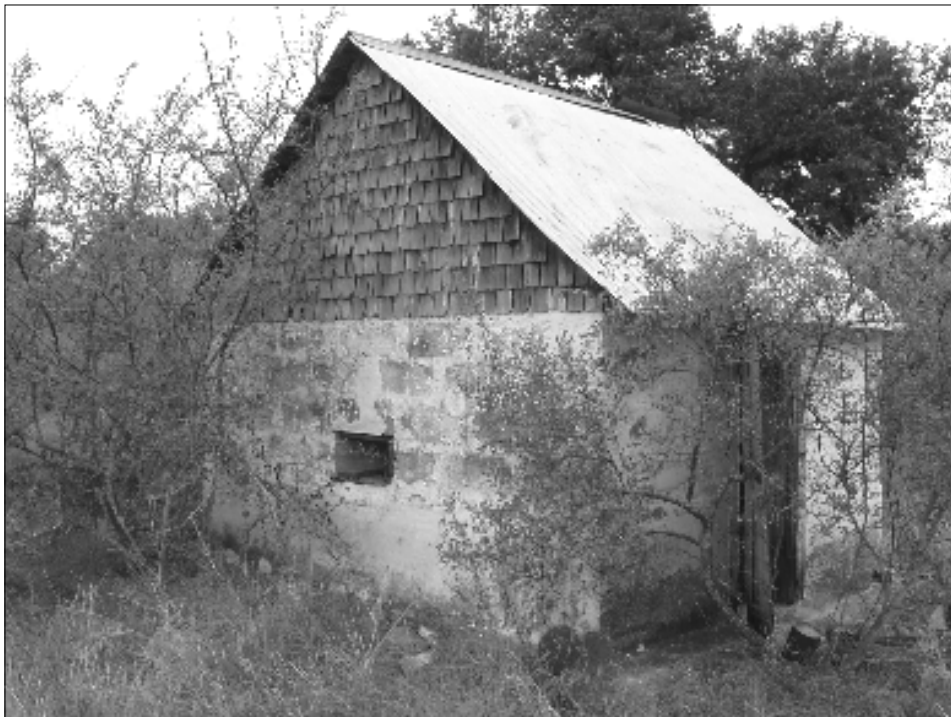
Outbuilding 6 is also stone (Figure 27). It has a side-gable roof with wooden shingles filling in the gables on the eastern and western sides and corrugated metal roofing material. The structure is at the end of a sidewalk that leads from the main house, which sits to the north. This structure served as the root cellar for the homestead. The foundation is cement and the interior has a sunken floor. This root cellar was structurally sound and in good condition at the time of the survey. This outbuilding appears on the 1939 aerial photo, therefore, at least some of its elements are minimally 50 years old.

Figure 27. *Outbuilding 6 (Resource 7).*

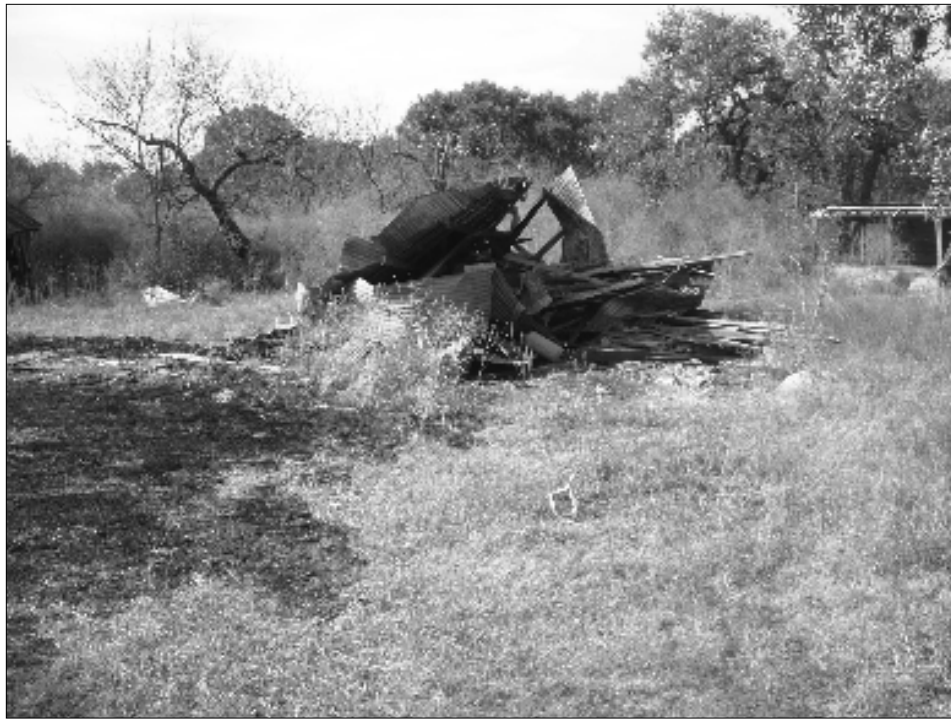
This outbuilding is northwest of the main building at the end of the dirt driveway curving past the stone structure (see Figure 13). The building has been torn down and it is currently identifiable only by pile of lumber and sheets of

corrugated metal that probably served as its roof (Figure 32). According to Mrs. Babcock, this structure was a garage. The structure appears on the 1939 aerial and, therefore, at least some of its elements are minimally 50 years old.

Figure 32. *Outbuilding 10 (Resource 11).*

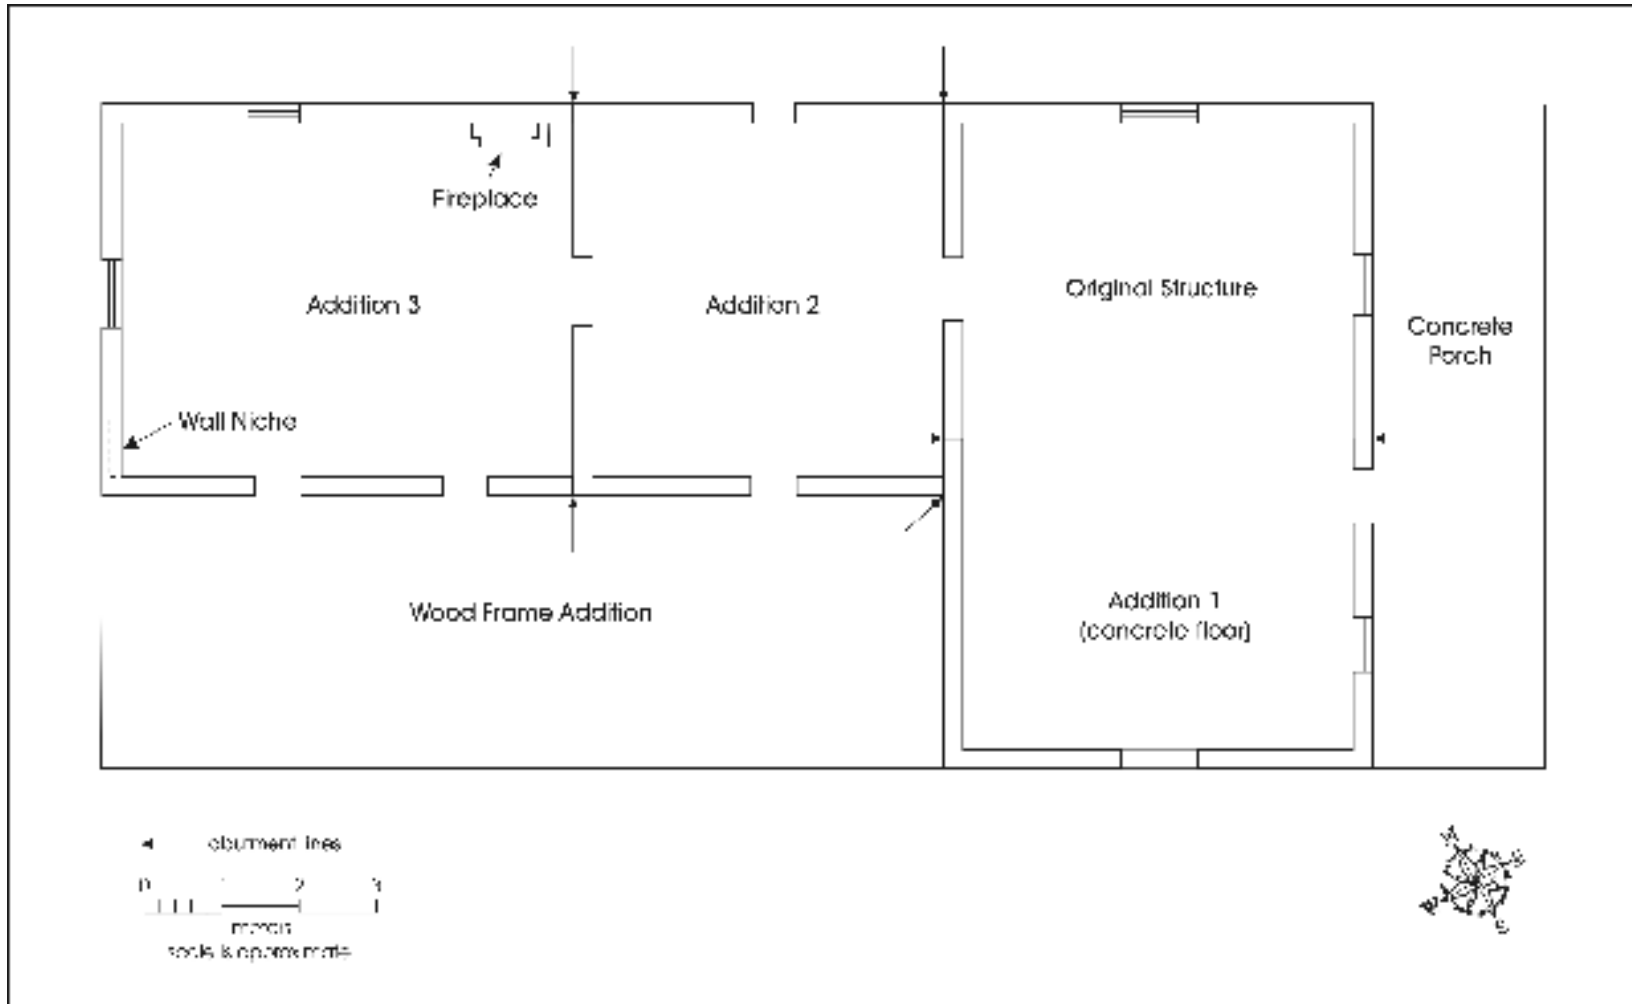
Figure 39. Sketch floor plan of the stone portion of the Benke/Naegelein homestead.

Addition 2 abutted the west wall of the original room and extended to the west (Figure 39). It measured approximately 4.2 x 4.7 meters on the inside and had doors in all four walls. Neither of the doorways in the northern and southern walls had keystones, although the eastern and western wall doorways were capped with keystones. The absence of keystones in two of the doorways may be reflective of distinct craftsmanship and a later construction given the wire nails that held the wood door framing in place.

Addition 3 abutted the western wall of Addition 2 and abutment lines were clearly visible along the interior corners and along the outside of the southern wall (Figure 39 and Figure 43). This room measured approximately 6.3 x 4.2 meters on the inside and had windows in its northern and western walls and two doors along the southern wall. A cooking hearth was present along the north wall of the addition (Figure 44) and an inset niche was located in its west wall immediately next to the window (Figure 45). The eastern wall doorway incorporated a keystone into its construction, although it appears to have been replaced at

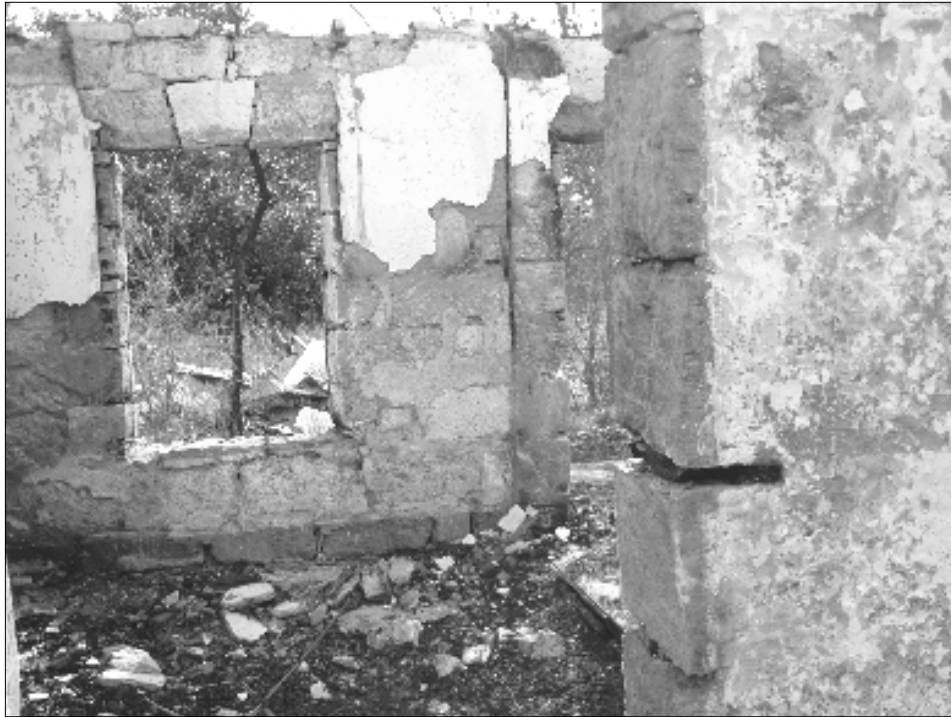
Nonetheless, based on photographs taken during the various visits to the property, a careful examination of wall construction and abutment lines suggests that there may have been as many as three phases of construction of the main stone house. Judging from an obvious abutment line adjacent the front door (Figure 40), and the presence of a concrete slab that covered the southern portion of this room and extended outside and served as the floor of the patio, it appears that the homestead may have originally consisted of a single wooden-floored room that made up the northern half of the main structure (Original Structure in Figure 39). The original one-room stone cottage measured approximately 4.2 m x 5 m on the inside. A chimney flue and chimney emerging from the north wall of this room suggest that it may have been heated by a potbelly stove. The north wall of this room contained a window, and it is possible that the east wall of this room contained a doorway that was later partially modified to serve as a window when the size of the room was extended to the south at the abutment line noted adjacent the present doorway (Figure 41).

Figure 40. *Abutment line and concrete floor of Addition 1 of Benke/Naegelin homestead.*

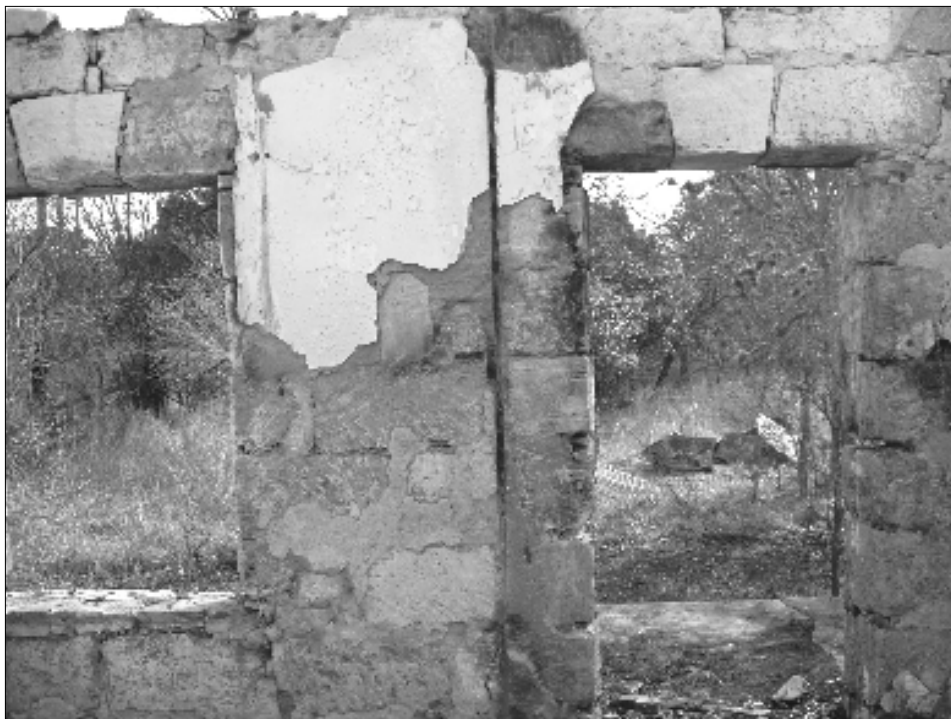
children, Theodore Benke, was born in 1891 (see Appendix A), it is possible that this first addition would have been built shortly before or after his birth. Keystones were present on all of the windows and doors in the original room and in Addition 1 (Figure 41). The window framing in Addition 1 was secured with forged nails (Figure 42) and the limestone blocks were of higher quality.

Figure 41. *Inside of original portion of homestead employing keystone above the window and doorway (facing west).*

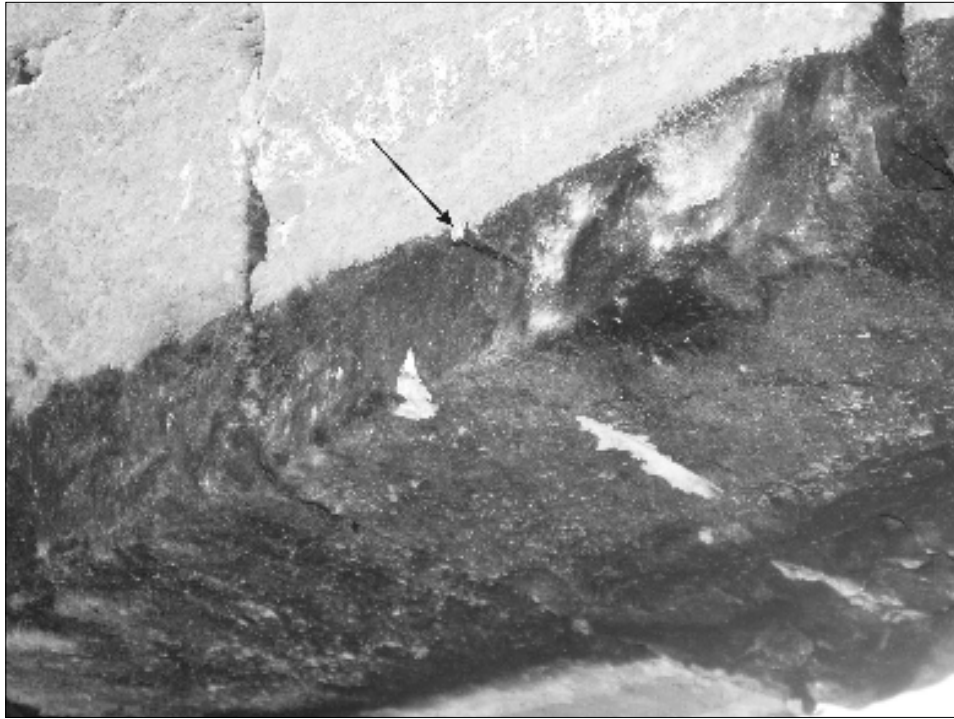
Figure 42. *Forged nail that originally supported wood framing around the south window of Addition 1.*

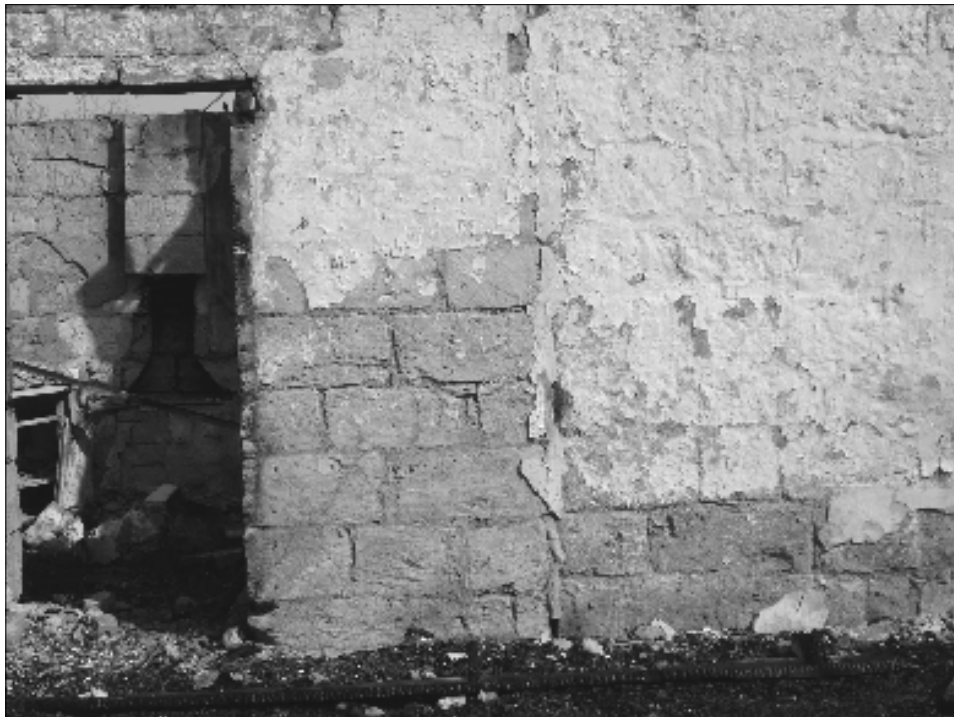
Figure 43. *Abutment line and easternmost doorway of Addition 3 to Benke/Naegelin homestead.*

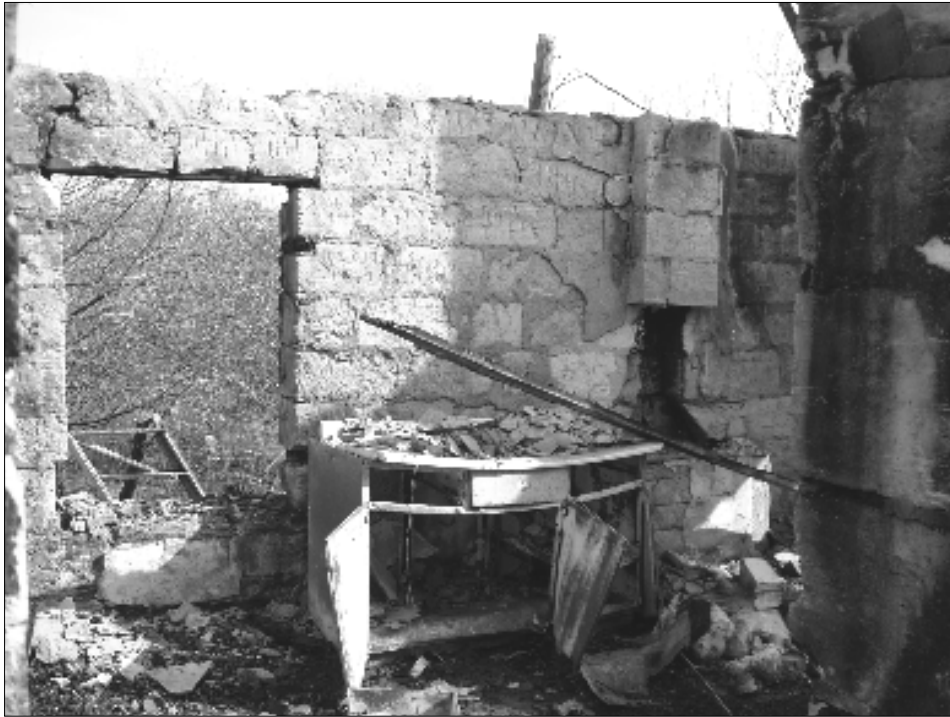
Figure 44. *Hearth in north wall of Addition 3. Also note north wall window and stonework detail.*

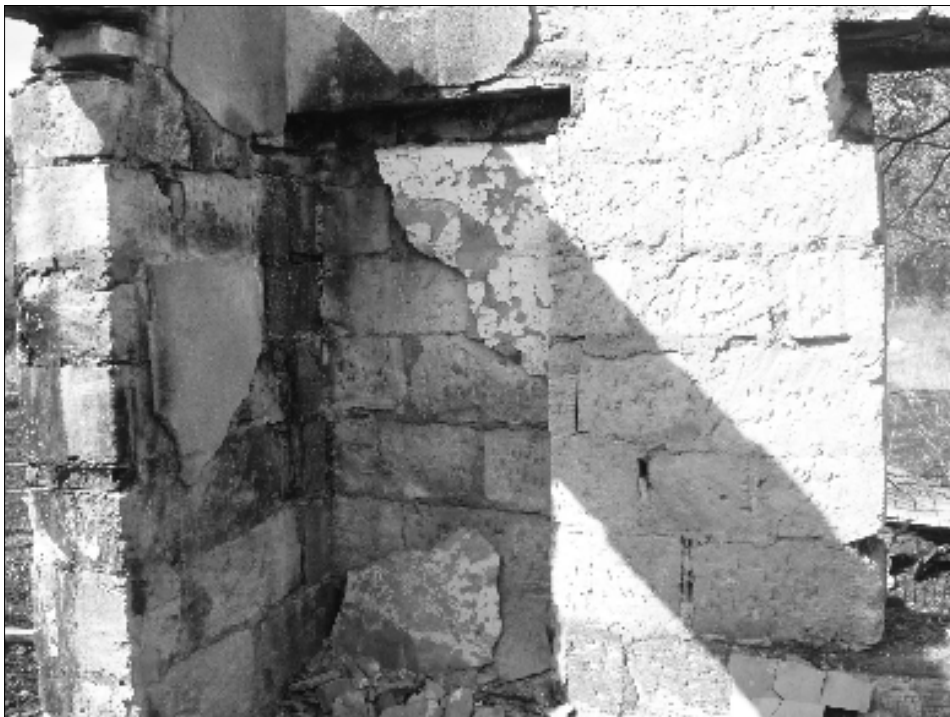
Figure 45. *Niche in west wall of Addition 3, south of window.*

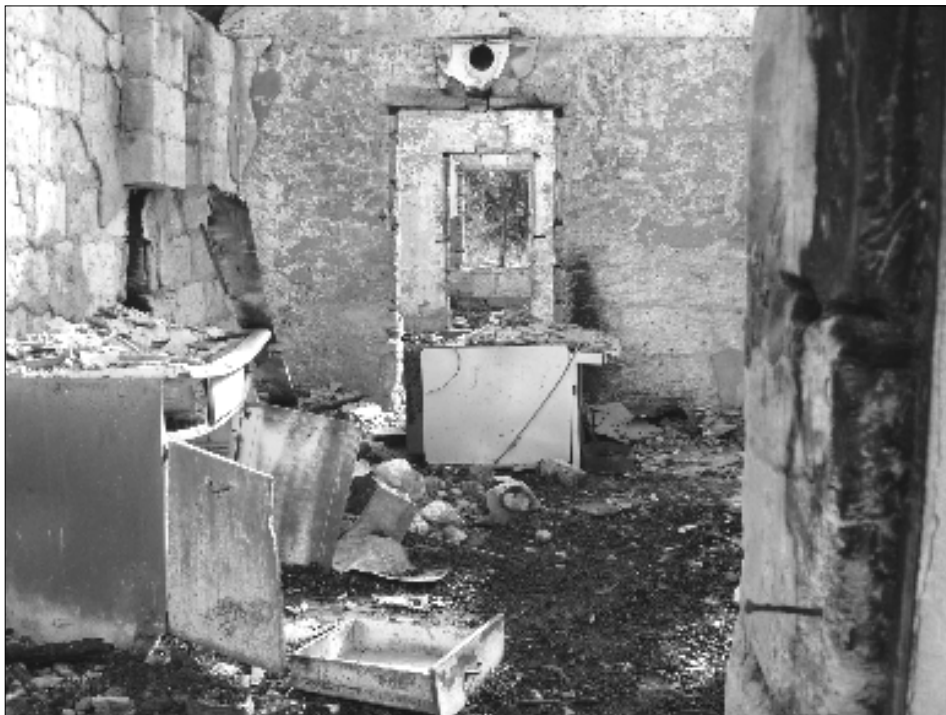
some later point with a chimney pipe opening (Figure 46). None of the other doorways or windows incorporated keystones in their construction and the wood framings around these openings were secured by wire nails (Figure 47). Finally, the quarry marks on the stone used in this addition are different from the marks on the stones in the original structure (Figure 48).

Figure 46. Chimney pipe above door to Addition 3. Note keystones above door in Addition 2 and window in original structure.

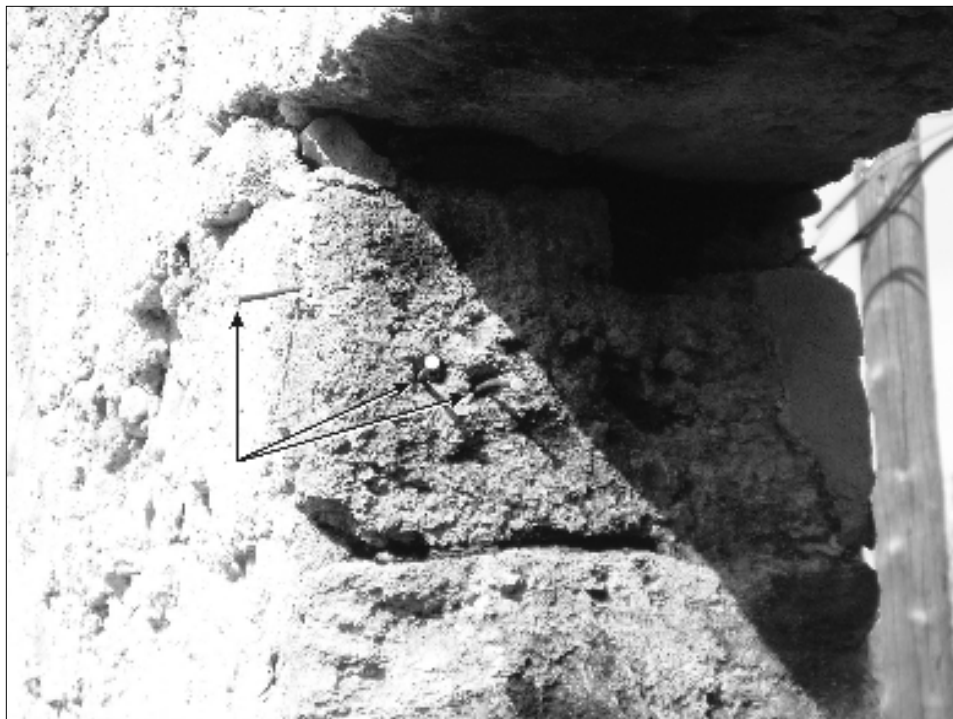
Figure 47. Wire nails that originally supported wood framing around the west doorway of Addition 2.

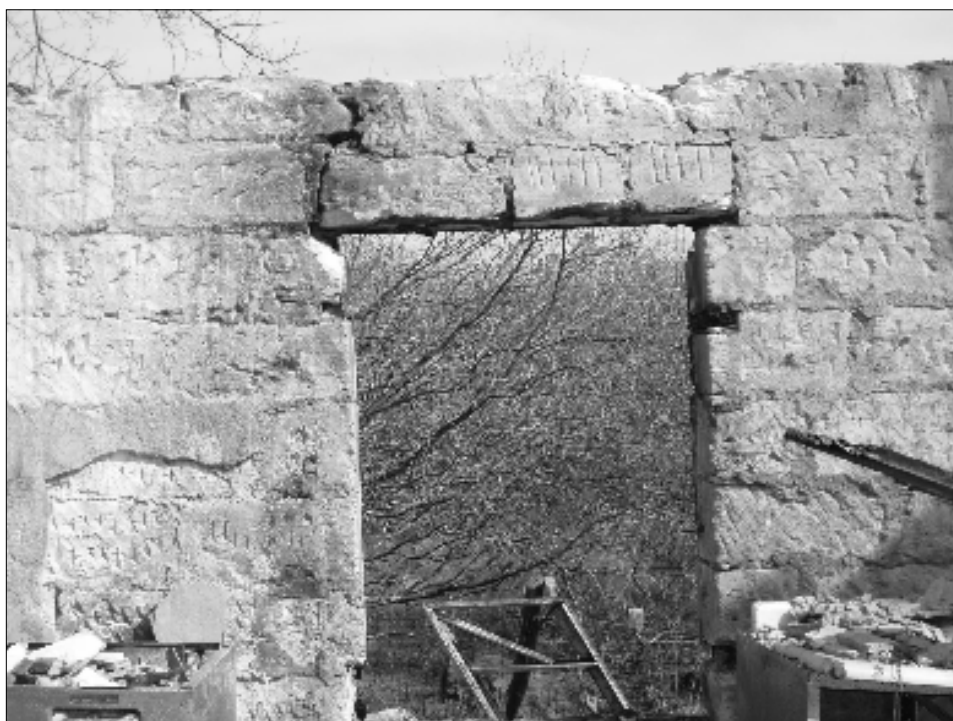
Figure 48. Addition 3 of homestead with no keystones present and chisel marks on the limestone blocks (facing north).

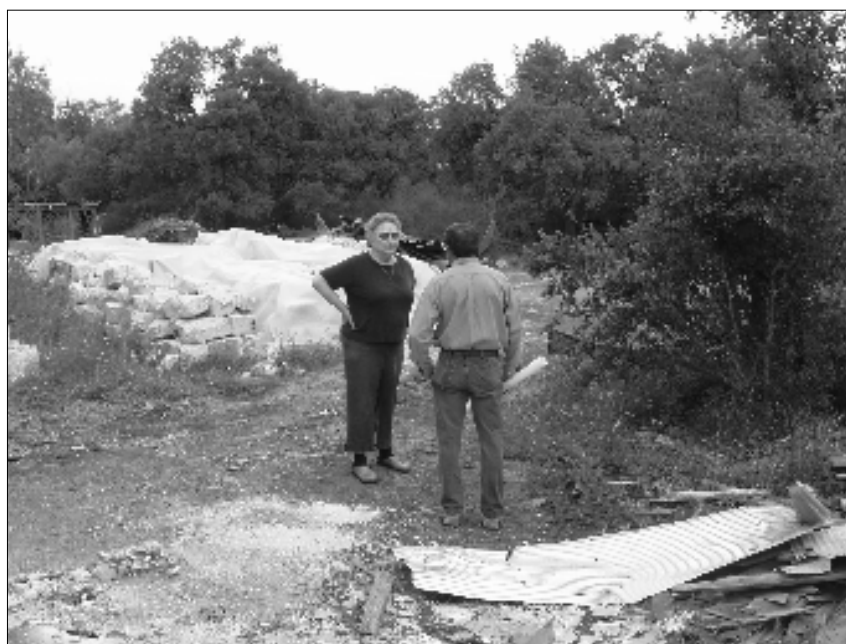
Subsequent to the initial recording of the site and after the completion of the first draft report, the main stone complex was severely damaged by fire. While the fire revealed architectural details that were not previously noted, it also severely weakened the structure. In addition, asbestos was discovered within the ruins of the complex and its abatement could not proceed given the potential risks to the abatement crews by the weakened walls. Therefore, the walls of the structure were razed as was the only structure not previously damaged by fire, Outbuilding 6 (Figure 50).

Figure 50. *Photograph of the Naegelin property after the razing of the main house and root cellar (Mrs. Mildred Babcock, left, Steve Tomka, right).*

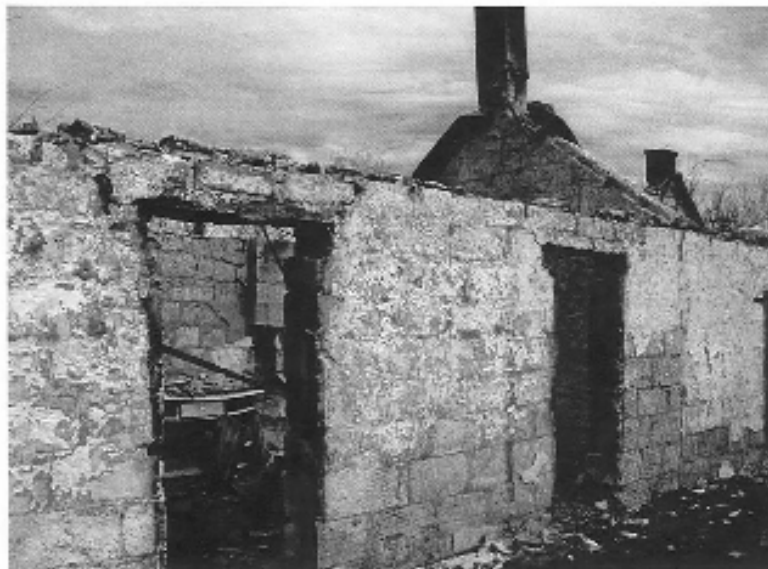
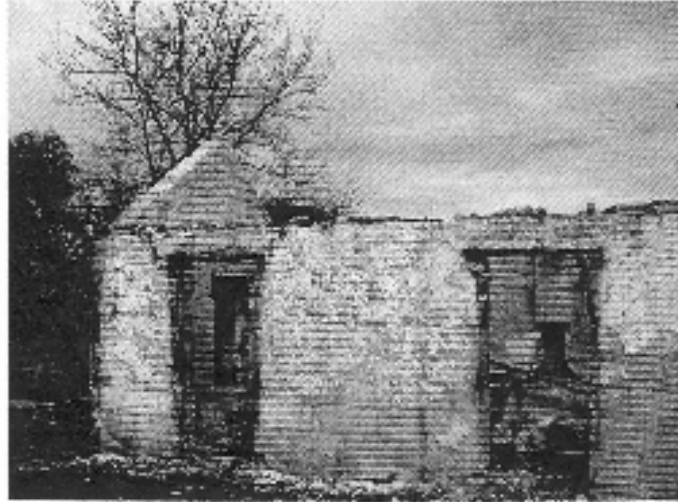
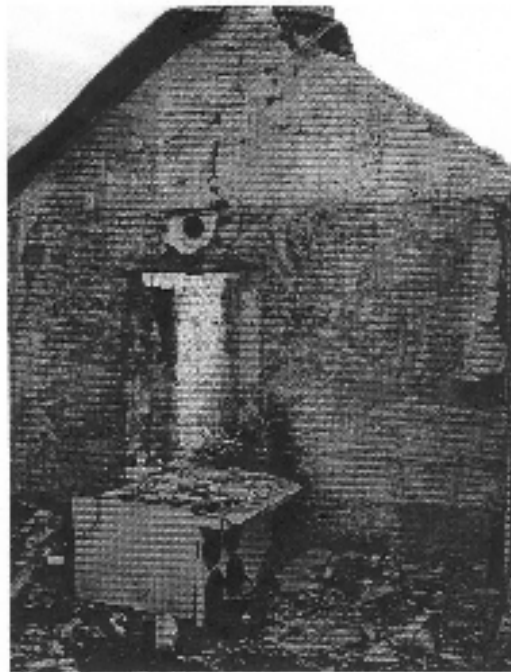
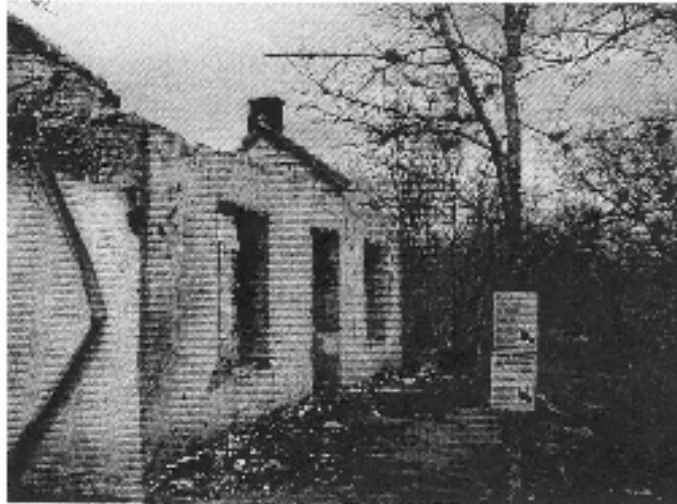
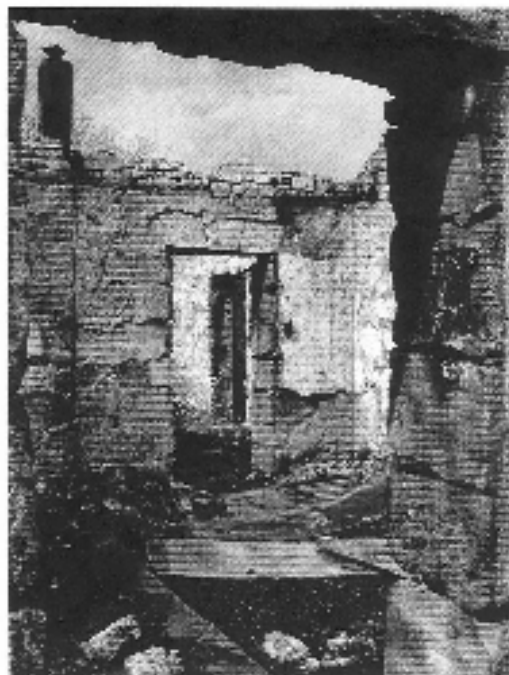
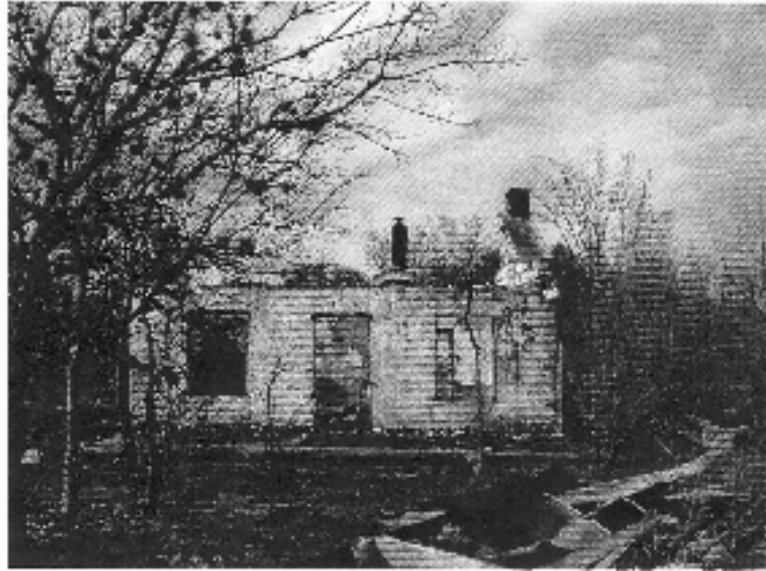
A Phase I Environmental Site Assessment was completed in August 2002. Asbestos containing materials were identified to be present. On August 3, 2004, STC was asked to confirm the presence and types of asbestos containing materials. Asbestos containing sheet vinyl and floor tile were confirmed to be present essentially throughout the structure. During this asbestos inspection, the question of historical significance was raised. After considerable discussion and research, the structure has been declared to be of historical significance. However in January 2005, during the time period of discussion and research, vandals set fire to the structure. After the fire only the limestone walls remained standing (See Photos 1, 2, 3, 4, 5, 6 and 7). The smaller limestone structure was not vandalized (See Photo 8).

PHOTO 2: Additional view of structure after the fire.

PHOTO 3: Additional view of structure after the fire.

PHOTO 4: Additional view of structure after the fire.

PHOTO 5: Additional view of structure after the fire.

PHOTO 6: Additional view of structure after the fire.

PHOTO 7: Additional view of structure after the fire.

It is strongly recommended that the remaining structure be demolished as soon as possible from the exterior under NESHAP's regulations governing structures containing asbestos. The debris will require disposal as asbestos containing material. This is recommended since this structure is now considered to represent a significant safety risk to the public since the area is not secure. It is suspected that vandals set the fire since the structure was also tagged with paint from the near by residential development. It is also suspected that vandals returned to cause the most recent destruction of the south wall. If vandals return again, they in fact would significantly endanger themselves if they attempt further destruction. In addition, if any homeless individuals seek shelter during inclement weather or strong winds, they would be at great risk due to not only the collapse of walls, but also exposure to asbestos. Therefore any delay in demolition is considered to greatly increase the safety risk present to the public and represents significant liability to the owner.

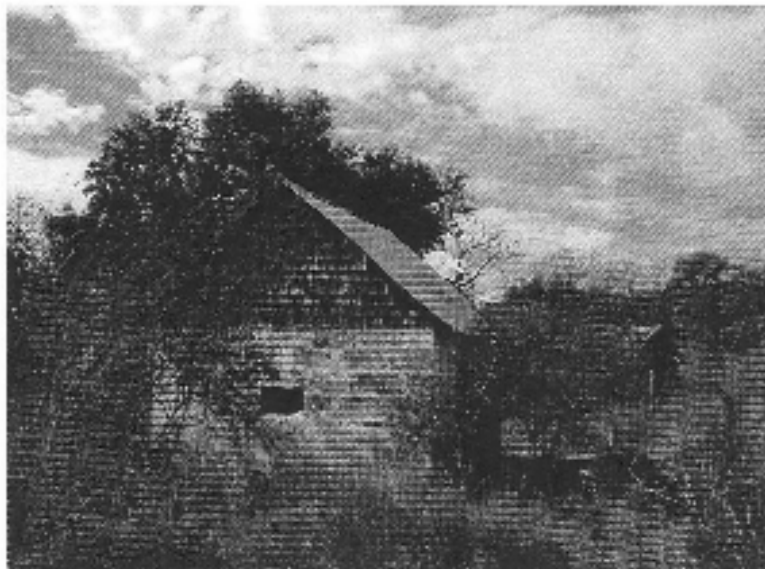
PHOTO 8: View of small structure currently still standing on the site.
