# Archaeological Survey and Historic Background Research Conducted for the Alamo Community College District at the Former Site of Playland Park, San Antonio, Bexar County, Texas

Texas Antiquities Committee Permit No. 5076

Prepared by:  
Center for Archaeological Research  
The University of Texas at San Antonio  
Archaeological Report No. 400

Prepared for:  
Facility Programming and Consulting  
Alamo Community College District

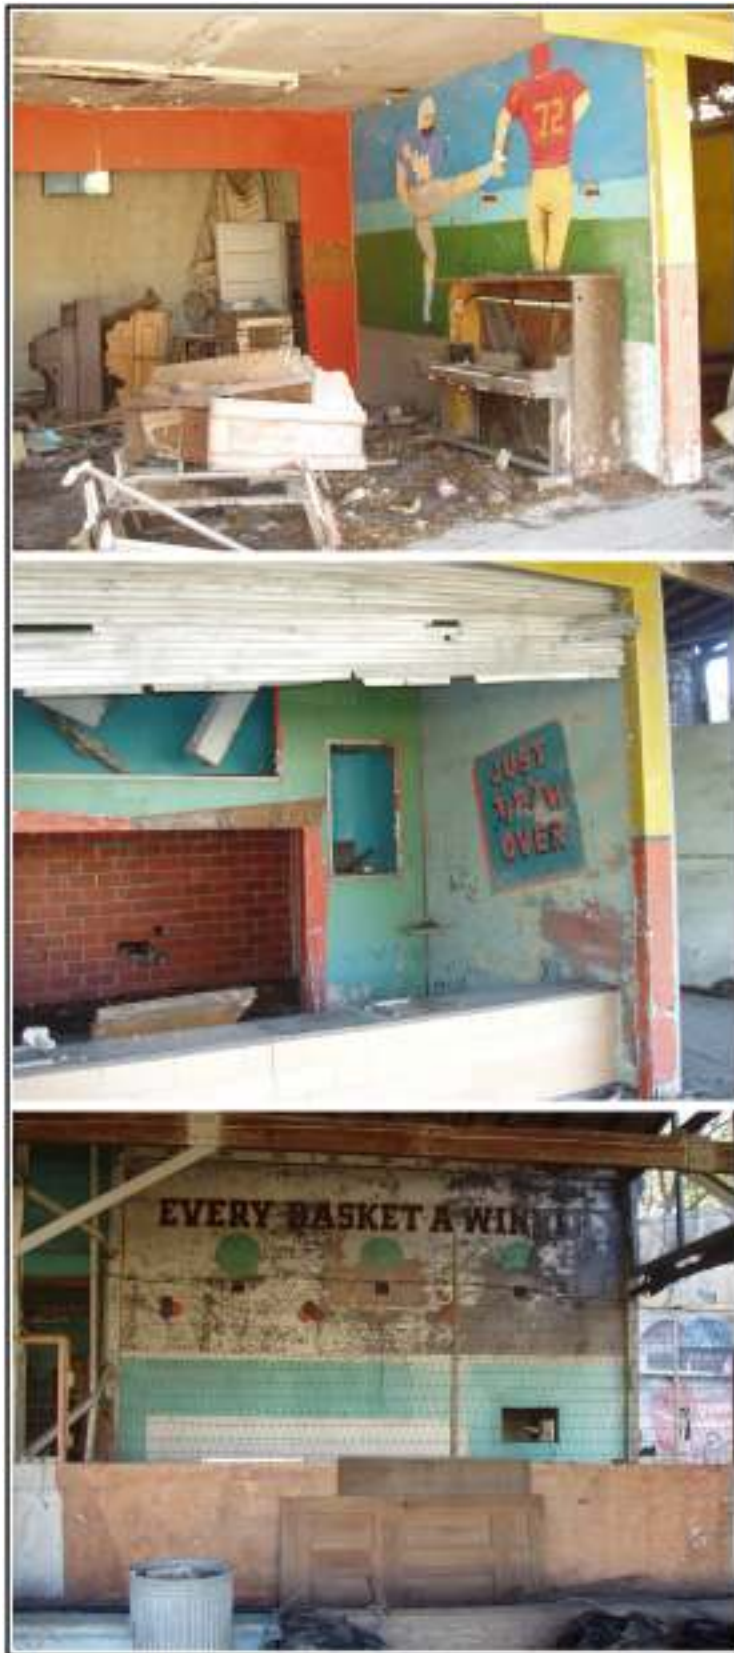
Structure 3 is the remains of the building known as "The Midway" (Figures 3-1 and 3-5), originally constructed on the remains of one of Paul Poppe's greenhouses (Gaida 2007:31). The building was open-sided on the north side, with this area subdivided into several spaced where various "games" were offered. The wooden roof of Structure 3 extended beyond the building to provide cover on the north side (Figure 3-5b). Figure 3-6 shows views of the remains of three of the "games" areas.

Figure 3-6. Three views of the remains of several of the individual “games” areas in the Midway.

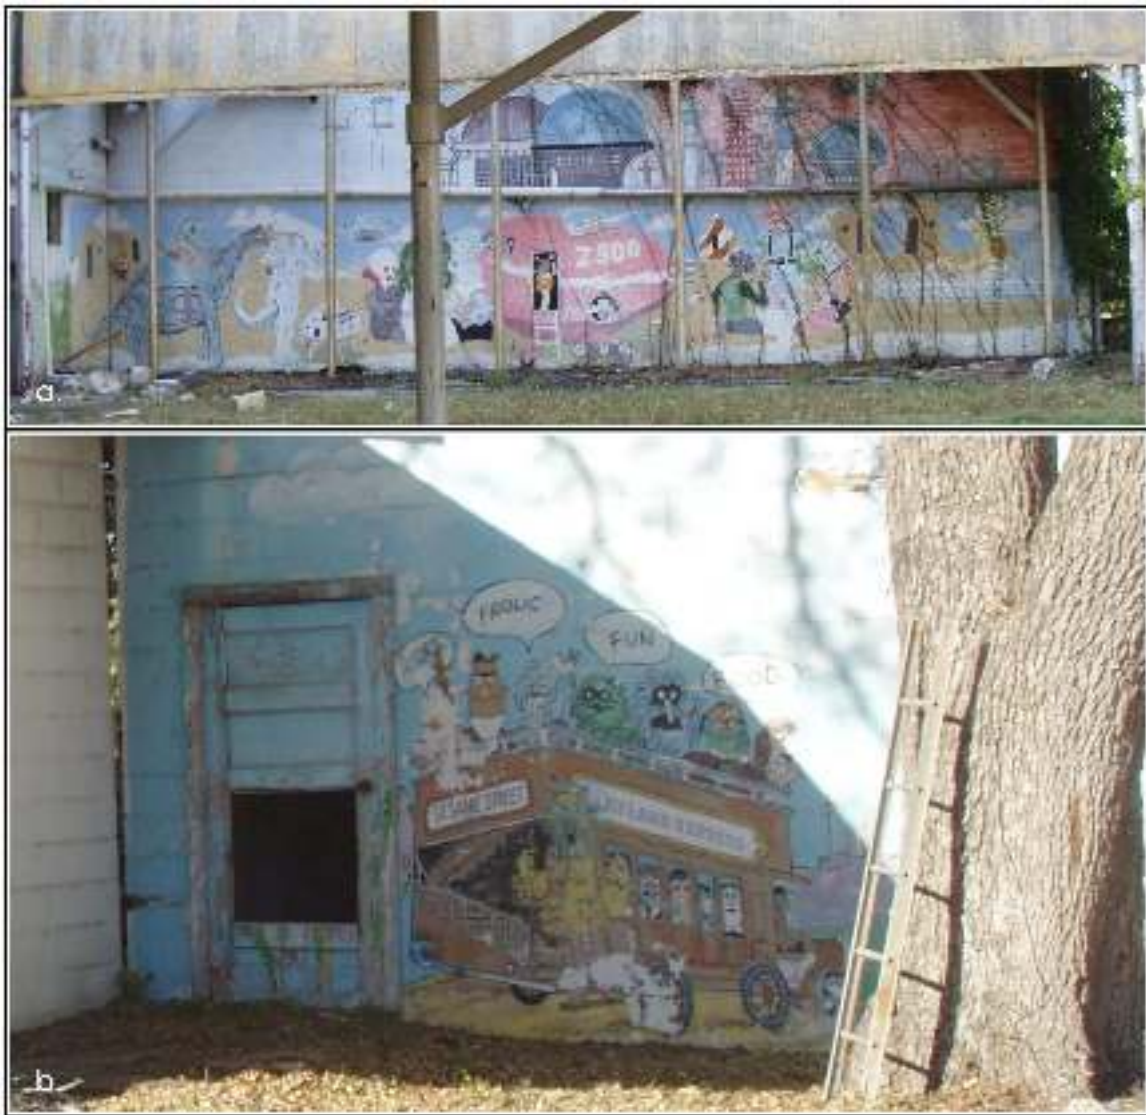
Two large murals decorated each end of Structure 3. On the west end was a flight of fancy featuring a number of “aliens”, an American “moon lander”-type vehicle and human visitors to the scene arriving in a space ship (Figure 3-7a). The mural on the east side of the building includes a number of Sesame Street ® characters on a trolley that has Playland Express lettered on it (Figure 3-7b).

Figure 3-7. Murals on the Midway building: a) west side "Alien Landscape"; b) east side "Necanic Street."

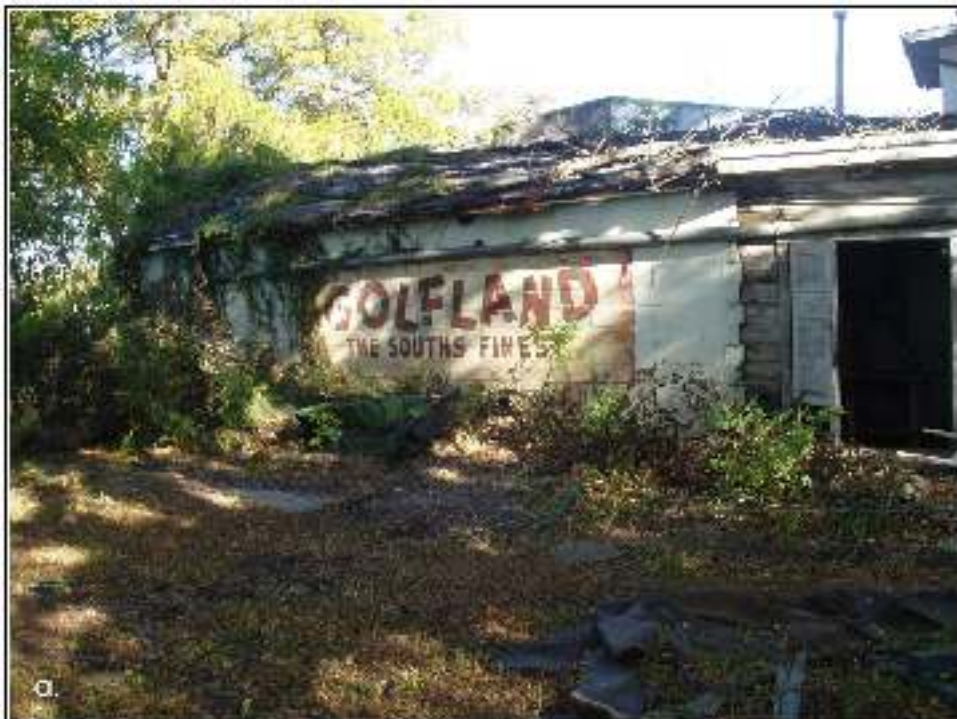
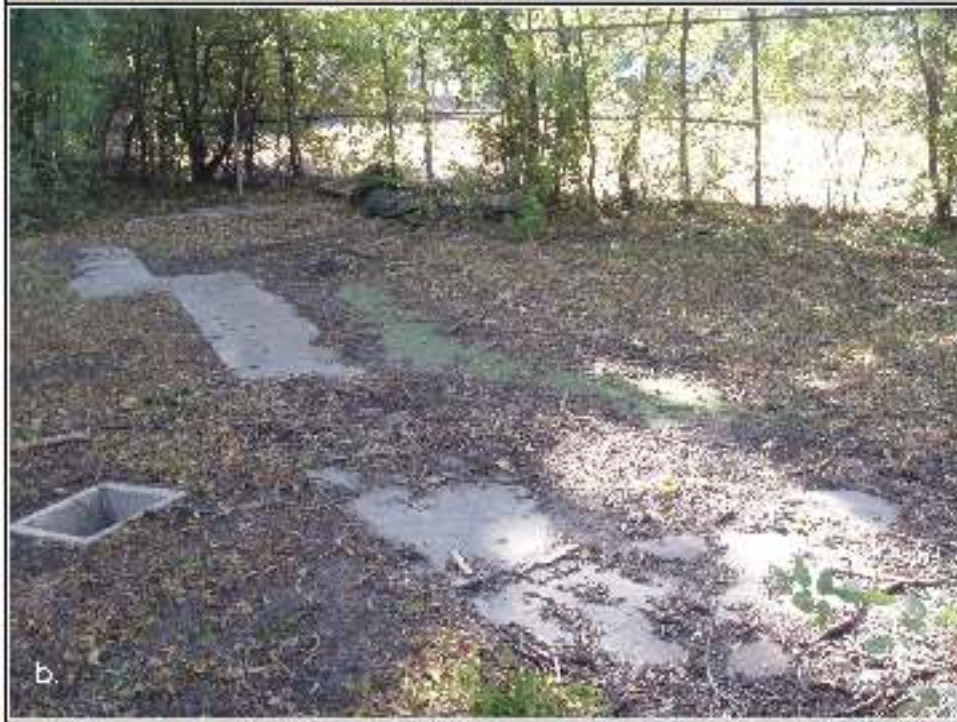
The southern half of Structure 3 contained the administrative offices of the park (Figure 3-8) and the entrance to the Putt-Putt gold course (Figure 3-9; see also Gaida 2007:82). Note that the concrete footings for the golf course are listed as Structure16 in Table 3-2.

Figure 3-9. Remains of the Putt-Putt golf course: a) entrance building at the back of the "Midway"; b) remnants of the putt-putt golf area.

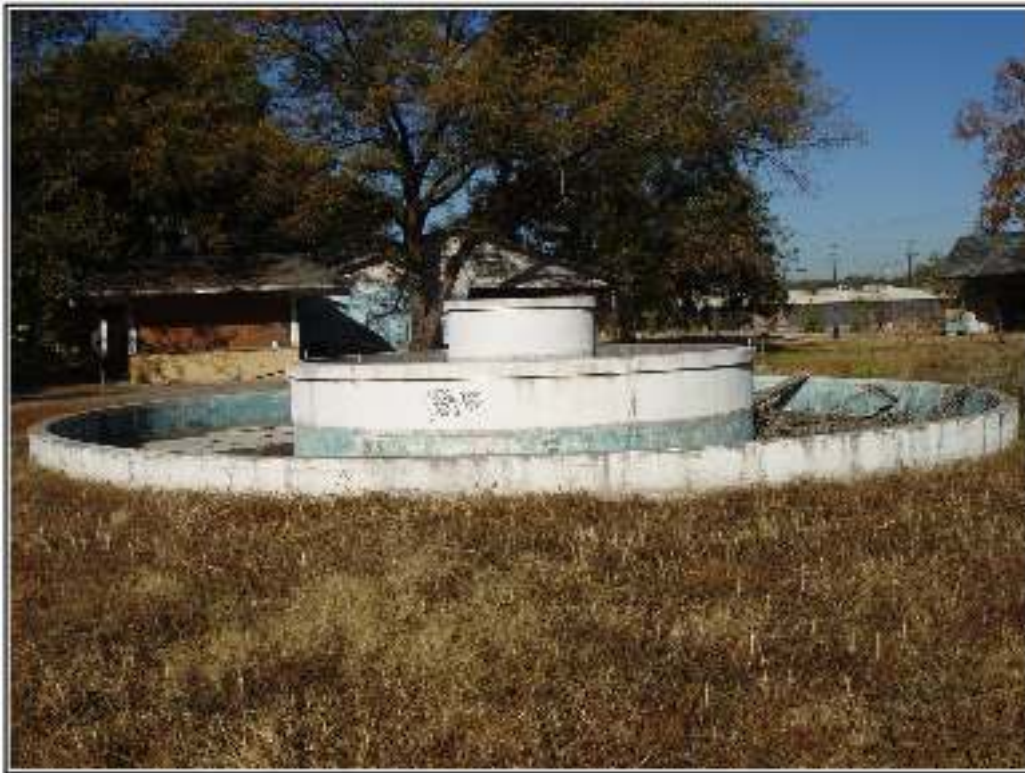
Structure 6 is the remains of a large concrete fountain (Figures 3-1 and 3-11; see also Gaida 2007:136). This fountain was located just east of the most active area of Playland, and would have provided a little bit of cooling for the crowds in the hot South Texas summers.

Figure 3-11. *Remains of a large circular concrete fountain.*

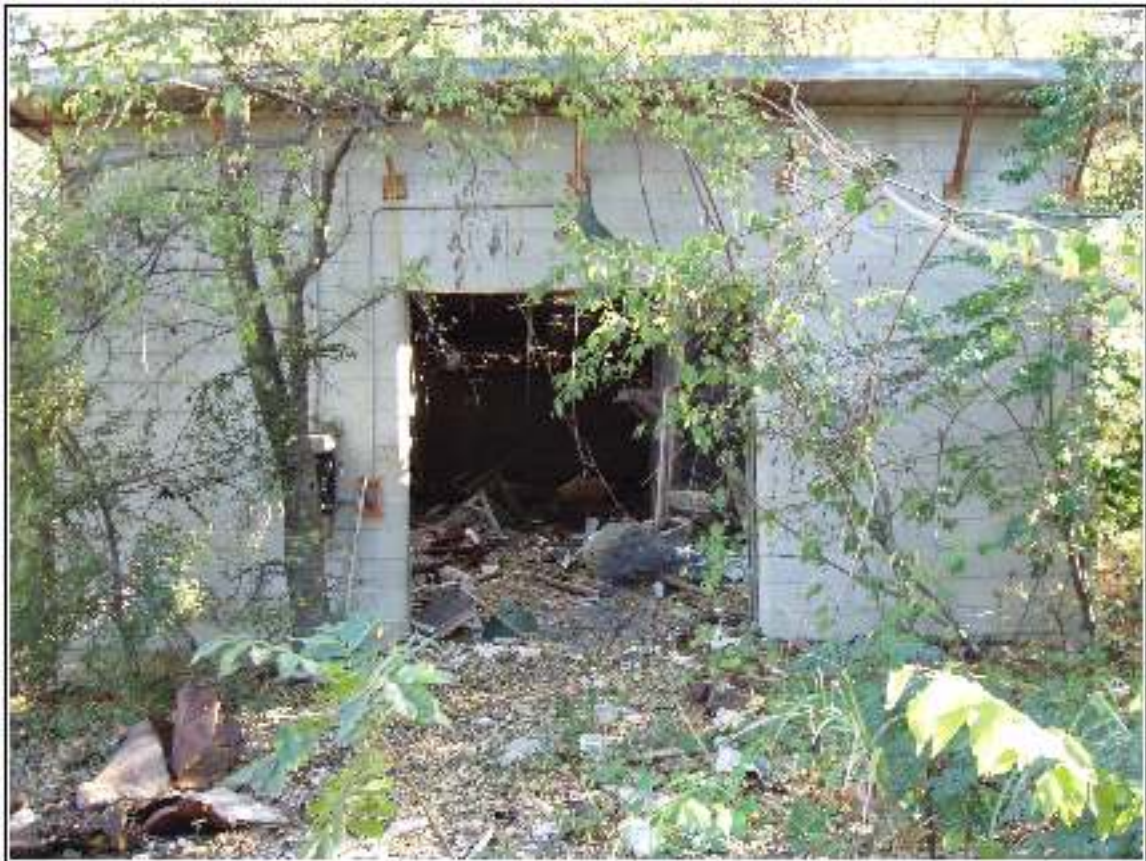
Figure 3-14. *Entrance to Structure 12.*

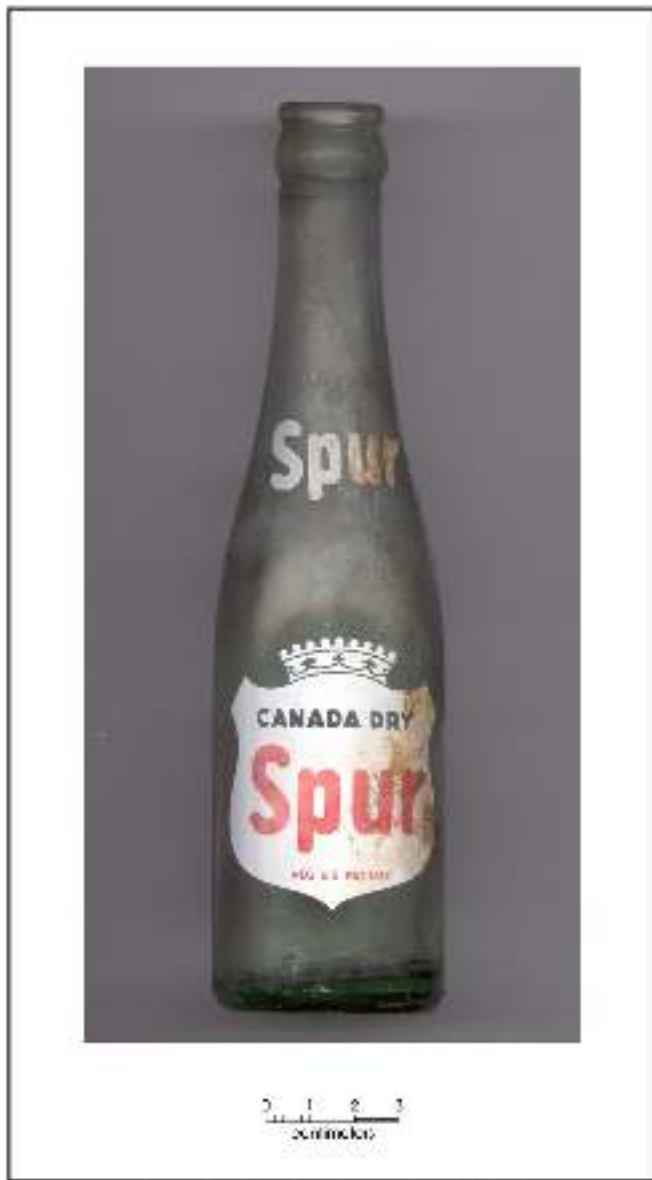
Figure 3-15. Example of the bottles from the bottle dump mentioned by Gaida (2007:23). See Figure 3-13.
