Archaeological Investigations within the Church Sacristy at Mission San José (41BX3), San Antonio, Bexar County, Texas

David L. Nickels
Anne A. Fox
with contributions by Al B. Wesolowsky
and James E. Ivey

Texas Antiquities Permit No. 294

©copyright 1999 Center for Archaeological Research The University of Texas at San Antonio Archaeological Survey Report, No. 242 The following information is provided in accordance with the General Rules of Practice and Procedure, Chapter 41.11 (Investigation Reports), Texas Antiquities Committee:

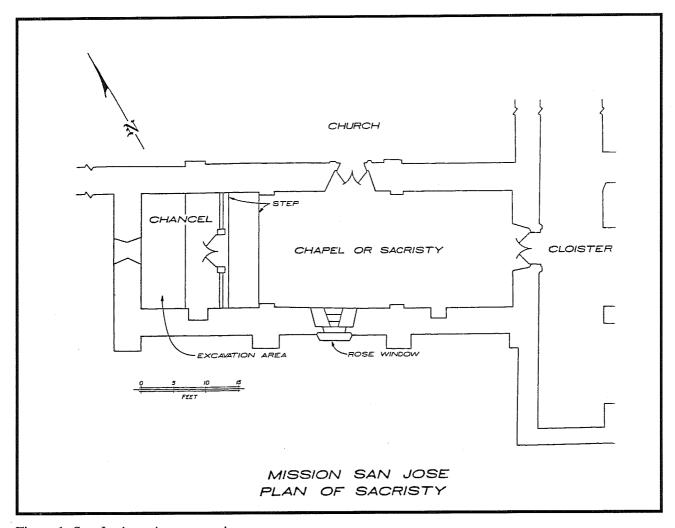
Figure 1. San José sacristy excavation area.

The sacristy is a room against the south wall of the church which today has two doors, one opening into the church and one into the south arcade of the convento, or cloister (Figure 1). In the south wall of the sacristy is a large window with elaborately carved decoration on the exterior. This has traditionally been called the Rose Window or Rosas Window because of a legend concerning its ornate carvings. A high window in the west wall provides the only other illumination for this room.

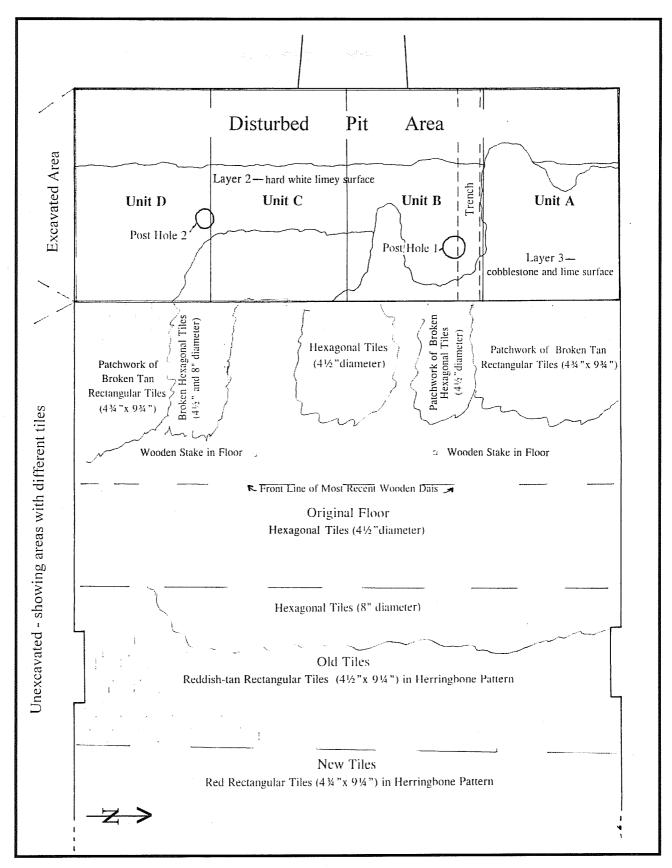
Figure 3. Excavations within the Sacristy.

Beneath the soft overburden and exposed wooden beams was a layer of a hard, white, limey surface (Layer II) across all four units. This possible floor surface became less distinct and smooth as it neared the west wall. In the eastern portion of Unit A and in Unit B a firm cobblestone and lime (*chipichil*) surface (Layer III) was encountered resting on the white limey layer. Both rectangular and hexagonal broken tiles were found in Layer III in all four units (see Figure 3). Below the limey surface was dark brown soil (Layer IV).

A trench was laid out along the north edge of Unit B (Figure 3). Human bone fragments were encountered in the eastern portion just below the limed layer, in the dark brown soil (Layer IV). An area on both ends of the trench appeared to have been disturbed. A posthole was observed near the east end. Human bone fragments were also recovered from the disturbed area on the west end of the trench in Layer IV which archaeologists designated Feature 1 (see discussion in Appendix D).

Postholes 1 and 2 (Figure 3) were dug to a fourth level. Posthole 1 (within the burial area) yielded no ceramics. Posthole 2 (outside the burial area) contained one type of sherd (transfer ware) that spans the early postcolonial periods, and two types (whiteware, porcelain) that represent post-colonial development.

The human skeletal remains were from Levels I and II, and in Posthole 2 in the San José sacristy (Figure 3). They are poorly preserved, fragmentary, and incomplete. Indeed, fewer than ten bones are intact (and these are from the hand and foot); the remainder could be classified as "unidentifiable fragments."

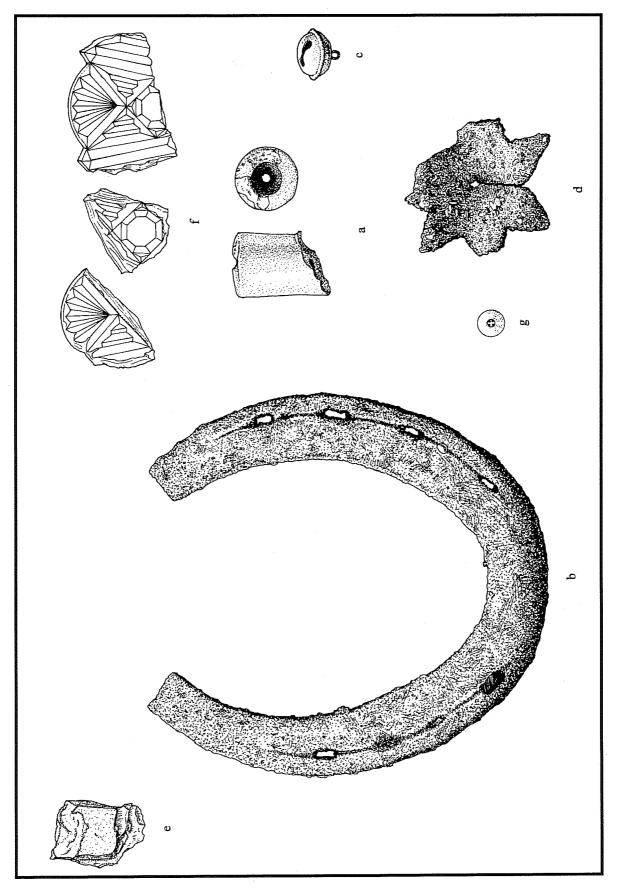
Figure 4. Selected artifacts recovered from excavations within the sacristy: a, pipe bowl fragment; b, horseshoe; c, metal jingle bell; d, shell button; e, slate fragment; f, cut glass fragment; g, shell button.

A polished redware clay smoking pipe bowl fragment (Figure 4a) was recovered from Level 1 of Unit A. Its origin is unknown; however, pipes of this type were commonly being molded at Texas potteries during the last half of the nineteenth century (Sudbury 1979:200–203).

A badly rusted horseshoe (Figure 4b) was found in Level 2 of Unit C. Its distinctive rectangular nail holes and sunken grooves to fit the nail heads suggest it was manufactured in England or the United States

A small metal jingle bell (Figure 4c) found in Level I appears to have been a decorative Christmas item. Christmas trimmings were commonly stored in mission sacristies (Montgomery 1949:67, 197–199). A copper boss, or raised ornament used for architectural decoration (Figure 4d) found in Posthole 2 may have once been a piece of the candelabria that adorned the carved cedar doors or vestment cabinets. A slate fragment (Figure 4e) found in Level 4 of Posthole 2 is typical of slate used as chalkboards in mission schools.

Three cut glass fragments (Figure 4f) from Level I are typical of finely crafted, decorative glassware used in church services.

A 4-hole, sew-through type shell button (Figure 4g) came from Level I, Unit D. Buttons are useful not only inferring clothing styles, but also as chronological placements. Shell buttons were used as utilitarian fasteners for children's clothes, underwear, and shirts. They were made from the non-iridescent freshwater shells. Before 1900, most shell buttons were imported from Europe. By 1900, over 200 shell button factories were in operation in the United States. Popular in the United States from ca. 1890 through ca. 1910, they were generally replaced by plastic buttons after World War I (Crouch 1987:283, 289).

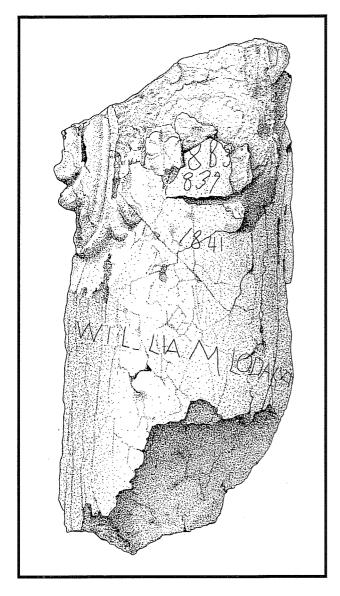
Figure 5. Grafitti inscribed limestone façade fragment.

A carved limestone façade fragment (Figure 5) was found in Level 1 of Unit B. Graffiti inscribed into the face bears the name "William Lodaka" and a date of "1841". Neither Texas census records nor Republic of Texas Army files during the period list anyone by that name.

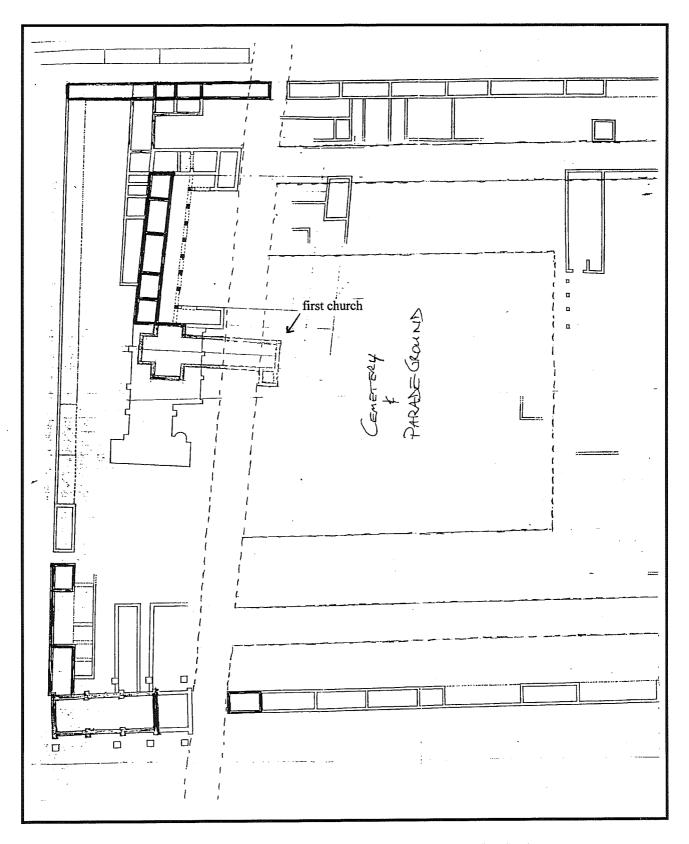
Figure D-1. Ivey's interpretation of the location of the first church at Mission San José.

At any rate, the "Burial Pit" is most likely to be the backfilled traces of the transept footing.
