Archaeological Investigations at the Spanish Governor's Palace, San Antonio, Bexar County, Texas

Texas Antiquities Permit No. 4770

Prepared by:
Center for Archaeological Research
The University of Texas at San Antonio
Archaeological Report, No. 410

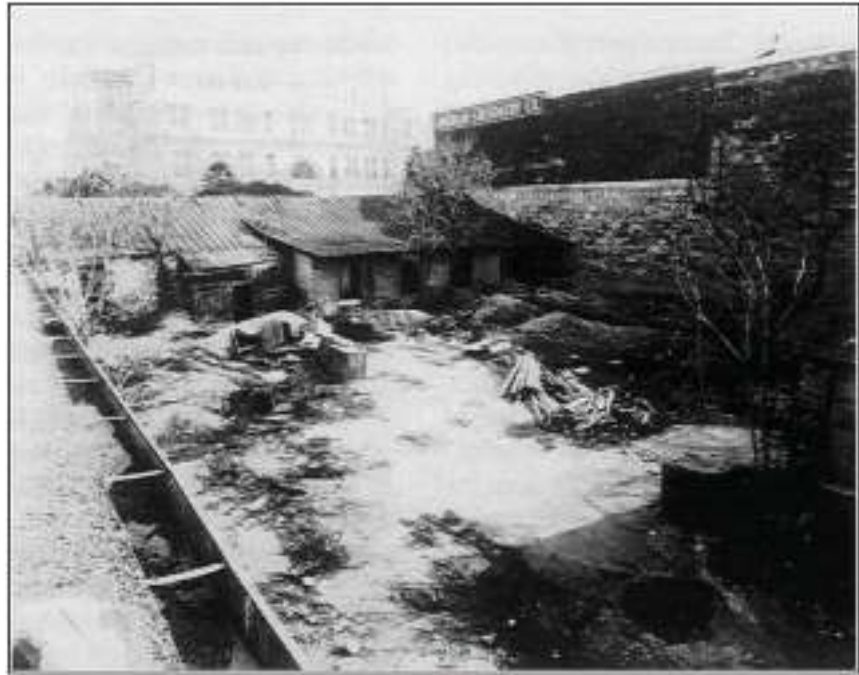
Figure 2-1. Back yard and wall of the Spanish Governor's Palace prior to restoration. Looking from the west. From the San Antonio Light (22 December 1929) collection, the Institute of Texan Cultures.

Prior to any excavations at the Palace, all material deemed modern was removed from the grounds. This included remnants of the tin roof, rafters, the brick additions in the rear, and the wood flooring. A photograph of the courtyard taken during the reconstruction efforts reveals the amount of material present prior to the construction, and the location of some trenches along the courtyard walls (Figure 2-1). The entire back wall of the feed store that had been located within the structure was removed. Several structures located in the rear of the complex were also demolished because they were seen as modern. Smith reported in his newspaper article that only the front wall and small portions of two adjacent walls (which we assume are the north and south wall of the complex) were original, although his floor plan for the restoration efforts shows more walls may have been intact, according to Hafertepe (2003). The drawings indicate that the interior entrance walls of the main hall were original. The walls in the room to the right of the main entrance (likely the Chapel), and the outer walls of the room directly behind (we surmise is the Dining Room) were also intact according to Smith's plans (Hafertepe 2003).

An increase in metal artifacts was noted in Level 5 (40-50 cmbd) and Level 6 (50-60 cmbd) produced a high number of wire nails. The trend in artifact numbers and types may result from the activities carried out by H.P. Smith during the reconstruction of the compound. Wire nails were common during the late 1800s and throughout the 20th century. A layer of limestone was identified at the bottom of the unit (Figure 5-3). The rocks appear to be consistent with construction rubble suggesting that they delineate the construction surface used by H.P. Smith. If this reconstruction is correct, it implies that deposits below this layer may be less disturbed than those above it. The colonial materials above this layer of cobbles may derive from the trenching that was carried out by Smith's workmen to define the foundations of the walls surrounding the courtyard (see Figure 2-1).

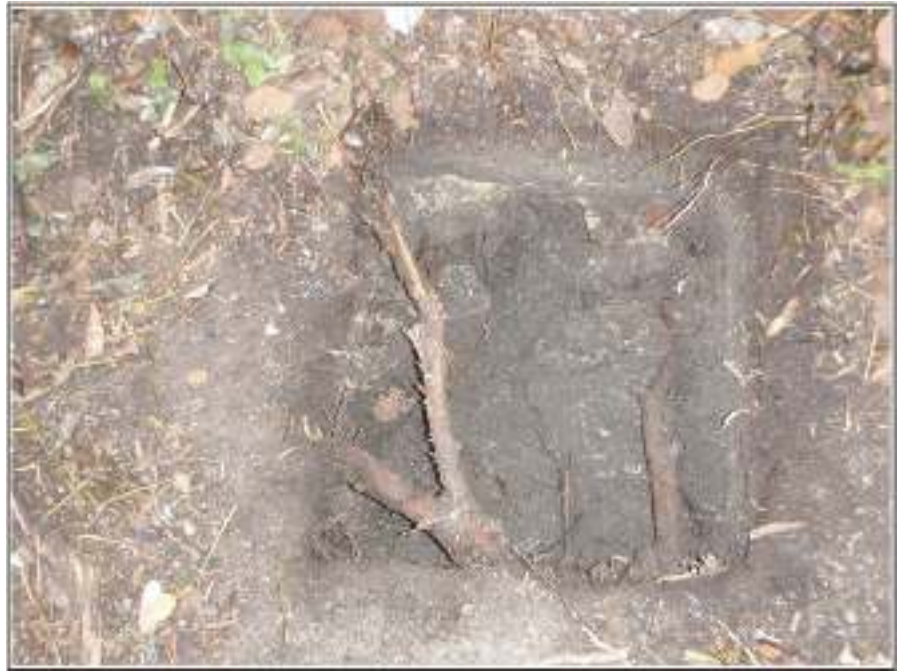
Figure 5-1. Unit 1 at terminal depth showing limestone rocks at base.

Unit 1 produced the largest density of artifacts in the third and fourth levels. The artifacts appear to be a mix of late colonial through 20th century material. An increased number of wire nails was recovered in Level 4 (47-57 cmbd), which may be related to the reconstruction efforts led by H.P. Smith during the late 1920s and early 1930s. The presence of colonial ceramics in Level 3 (37-47 cmbd) and Level 4 (47-57 cmbd) may be a result of soil being moved around during the reconstruction. The upper levels of the unit exhibit signs of continuous disturbance, which is supported by accounts of the grounds keeper. The courtyard at the Spanish Governor's Palace is tended to on a regular basis, and often new plantings are added while others are removed. A few large limestone rocks were observed at the base of the unit (Figure 5-1).

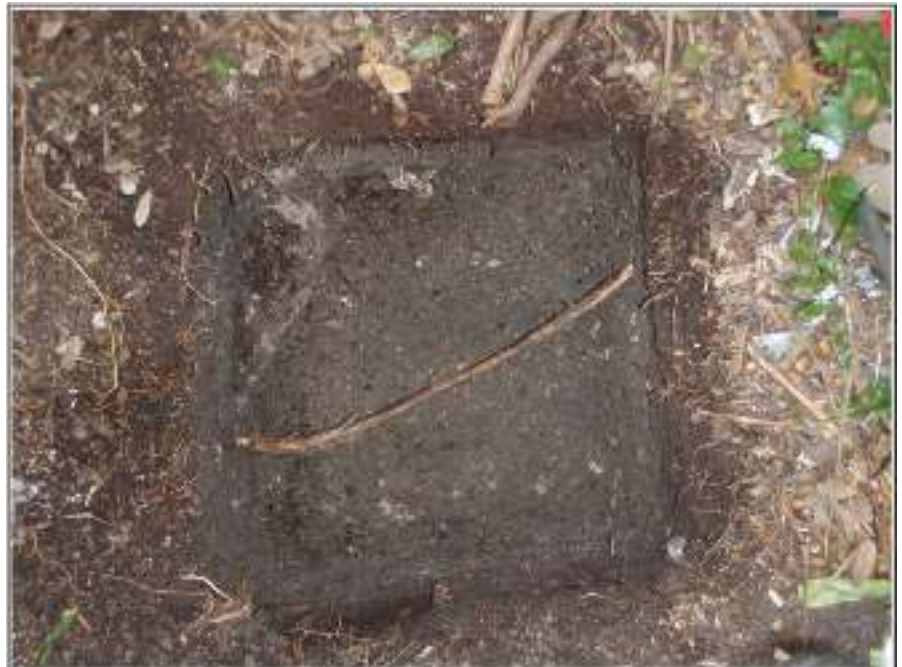
Figure 5-2. Unit 2 at terminal depth showing limestone rocks at base.

deposits. Similar to Unit 1, a few limestone rocks were observed in the base of Unit 2 (Figure 5-2).

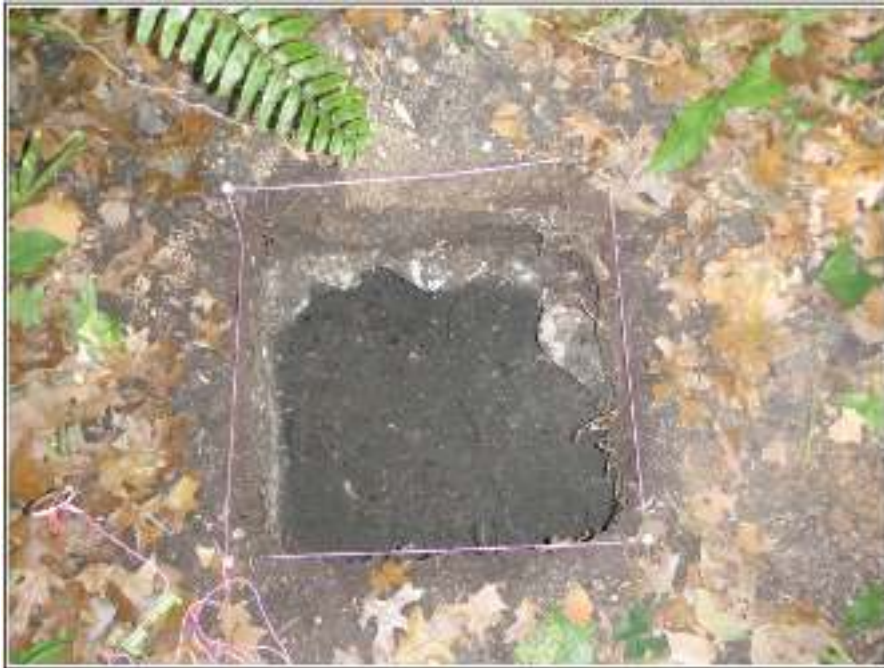
Figure 5-3. Unit 3 at terminal depth showing the level of limestone rocks in north and east wall profiles.

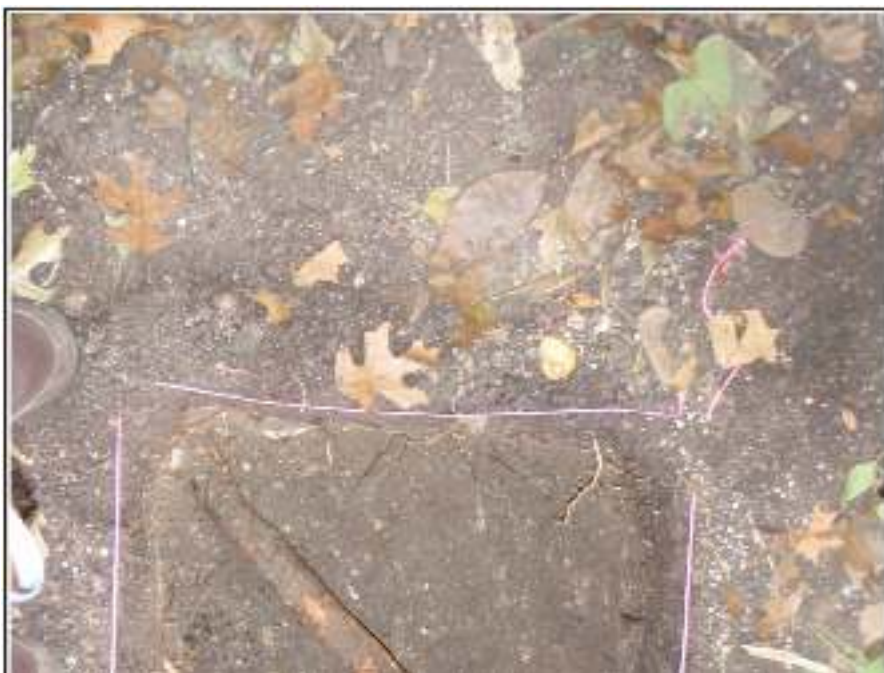
Figure 5-4. Unit 4 at terminal depth showing root and limestone rocks in the northwest corner.

Unit 4 was positioned within a flowerbed and exhibited disturbed soils throughout the five levels. The first three levels (0-30 cmbd) produced no cultural material, and soils were disturbed by roots and landscaping activities. Levels 4 (30-40 cmbd) and 5 (40-50 cmbd) produced cultural material that appears to be related to the later use of the site and the reconstruction, but also had roots present that could have disturbed the deposits (Figure 5-4). No material collected appears to be related to the colonial period. One gold crucifix pendant was recovered from Level 5. The crucifix is corroded, but is likely to be modern. Similar to the other three units, limestone rocks were noted in the bottom of the unit,

although these appear to be slightly smaller in size (see Figure 5-4).

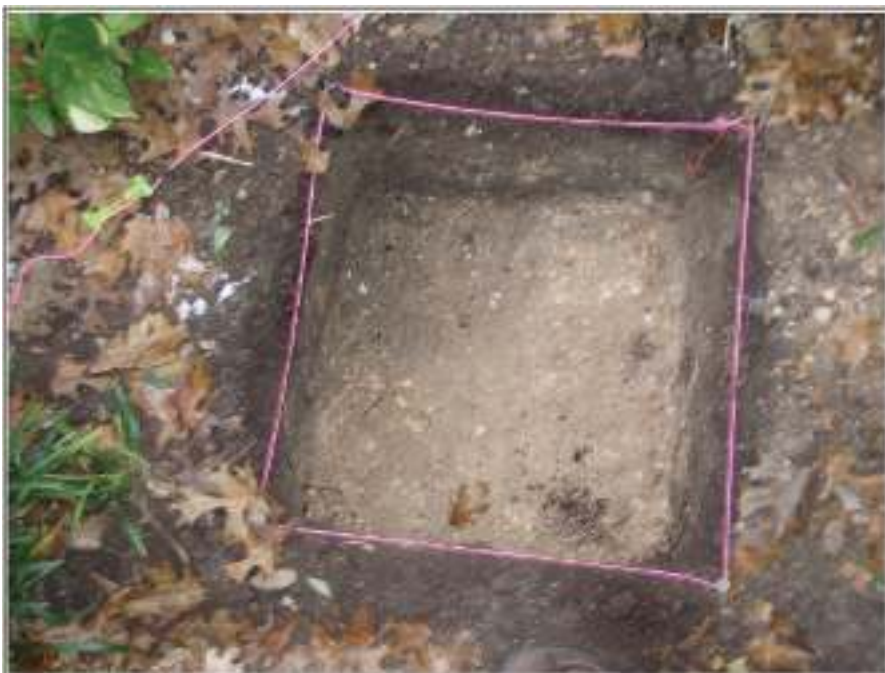
Figure 5-5. *Caliche encountered at the base of Unit 5.*

Unit 5 produced cultural material in all levels excavated. The classes of artifacts that were present in the highest densities were tar and tar paper, and wire nails. The upper levels of the unit were highly disturbed by landscaping, and outlines of potted plants were noted in the unit walls. Tar fragments were present in the unit from 20 cm to 50 cm below datum. A discussion with the arborist at the Spanish Governor's Palace, revealed that the tar may have derived from the resurfacing of the roof of the adjacent building. A continuous layer of caliche was encountered in the bottom level of the unit (Figure 5-5), similar to all other units excavated. This unit reveals highly disturbed deposits that extend to the depth of the impact of the installation of the electrical conduits.
