Archaeological Monitoring and Testing Associated with the Restoration at Mission Francisco de la Espada (41BX4), San Antonio, Bexar County, Texas

Texas Antiquities Permit No. 6928

Prepared by:
Center for Archaeological Research
The University of Texas at San Antonio
One UTSA Circle
San Antonio, Texas 78249
Archaeological Report, No. 448

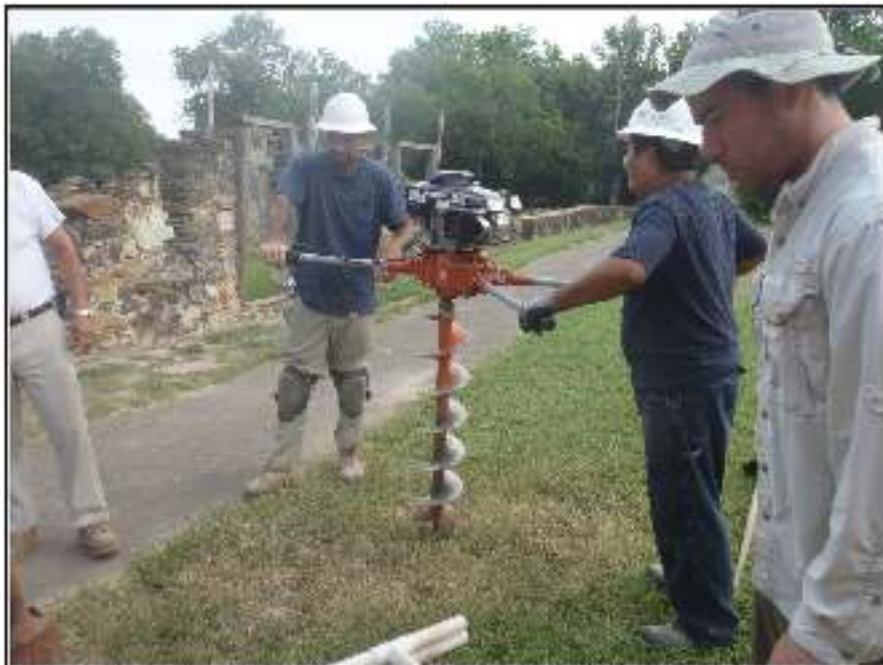
Figure 3-1. Gas powered auger used to excavate bollard and auger holes.

Based on the assessment of the bollard data and previous excavations, 16 tests were excavated in the APE. Nine auger holes were dug with a mechanical auger (Figure 3-1) by personnel with Pugh Constructors. Auger holes were approximately 18 cm (7 in.) in diameter. Excavations were terminated at 20 cmbs (7.9 in.) and were dug in 10-cm (3.9-in.) levels. The depth and location of these tests was based on the depth of gravel in the APE, the depth of the Spanish Colonial foundation and surface encountered in 1998 by Cargill et al. (2004), Fox (1981), and Smith (1980a, 1980b), and the depth of impact associated with the construction. CAR staff screened excavations and collected all artifacts and sediment samples from each test by level. A form for every excavation was also completed. Data collected from each test included the final excavation depth, a tally of all materials recovered from each 10-cm (3.9-in.) level, and a brief soil description (texture, consistency, Munsell color, and inclusions).

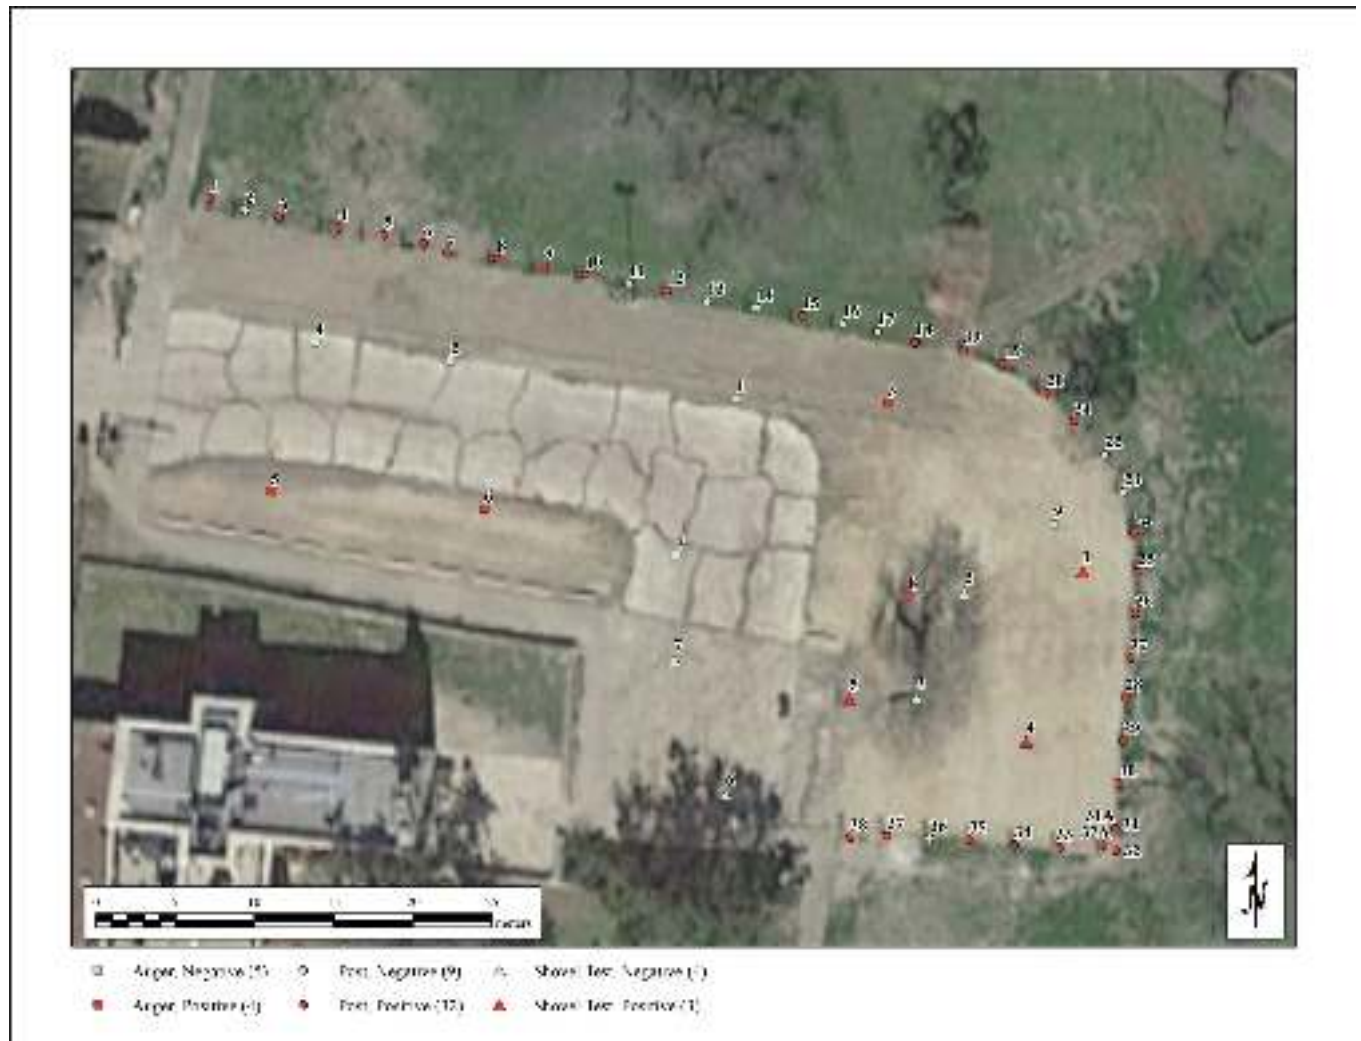
Figure 4-1. Bollards, auger tests, and shovel tests in Area 1 of the APE.

On June 24 and June 30, 2014, the excavation for and installation of 39 bollards around the perimeter of the parking lot were conducted (Figure 4-1). Although only 39 bollards were installed, 41 postholes were excavated. The two extra excavations were a result of a shift in the layout of the bollards. Excavations commenced on the north side of the parking lot starting with bollards 1-21 and 39. Soils from this part of the parking lot consisted of clay loam to silty loam that

During grading of the parking lot, a concentration of faunal material along with Goliad wares were found southwest of positive auger hole 3 and south of positive post holes 18-21 and 39 (see Figure 4-1). The depth of these materials was approximately 20 cmbs (7.9 in.) and included faunal material, such as bovine (436.79 g), *odocoileus virginianus* (6.96 g), and artiodactyla (2.99 g). Two pieces of Goliad ware were also found in this concentration.

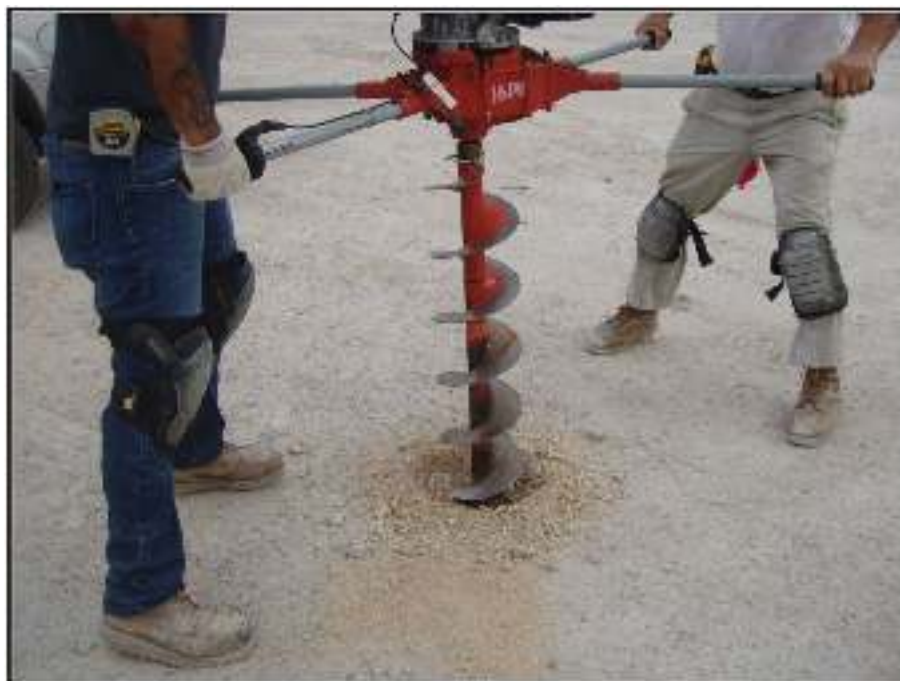
Figure 4-2. Gravel encountered in auger tests.

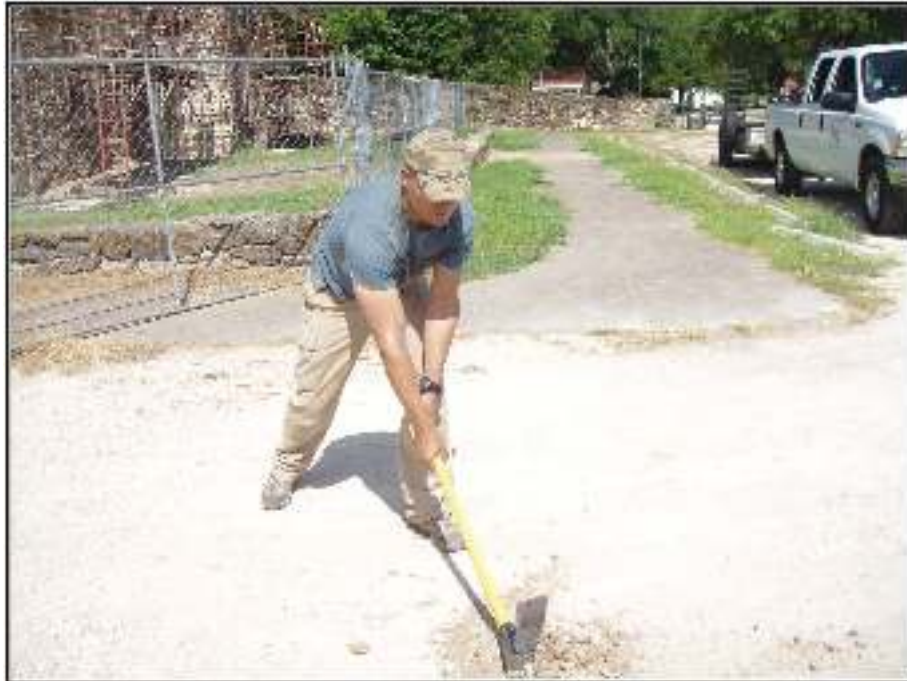
Figure 4-3. Excavation of Shovel Test 7 in parking lot.

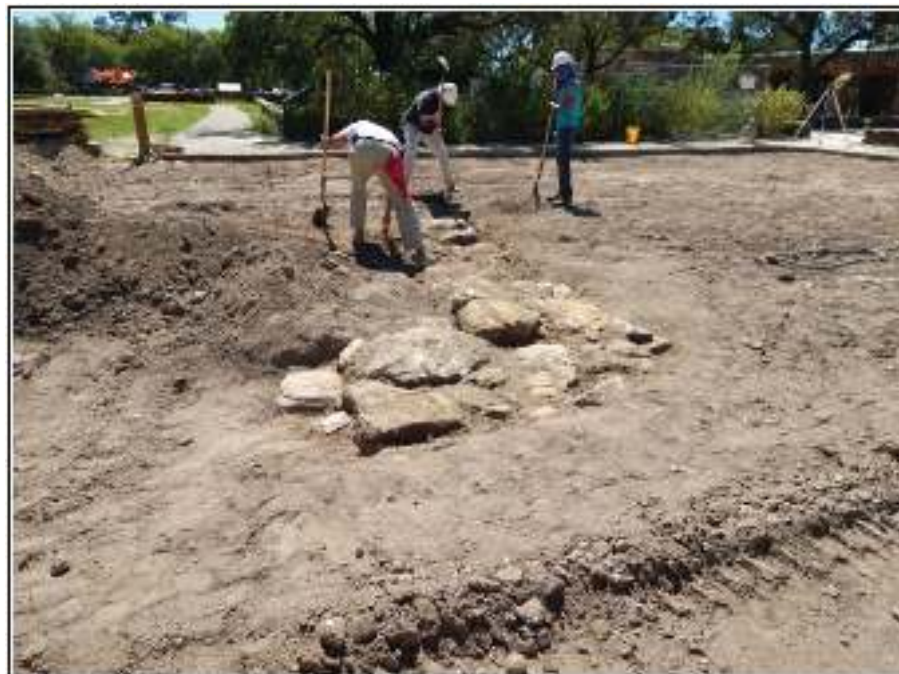
Figure 4-4. Feature 1 encountered during grading of parking lot (facing south).

Figure 4-5 shows the alignment after flagstones were placed adjacent to the feature. It runs roughly southwest-to-northeast and is 12 m (39.4 ft.) in length (Figure 4-4) and 1.5 m (4.9 ft.) in width. However, at the northern end, the feature is 3 m (9.8 ft.) in width. The wall is in the same location as the one found by Smith (1980a; see Figure 4-6). The treatment of Feature 1, the Spanish Colonial wall, was determined in consultation with the THC, NPS, and Pugh Constructors. The

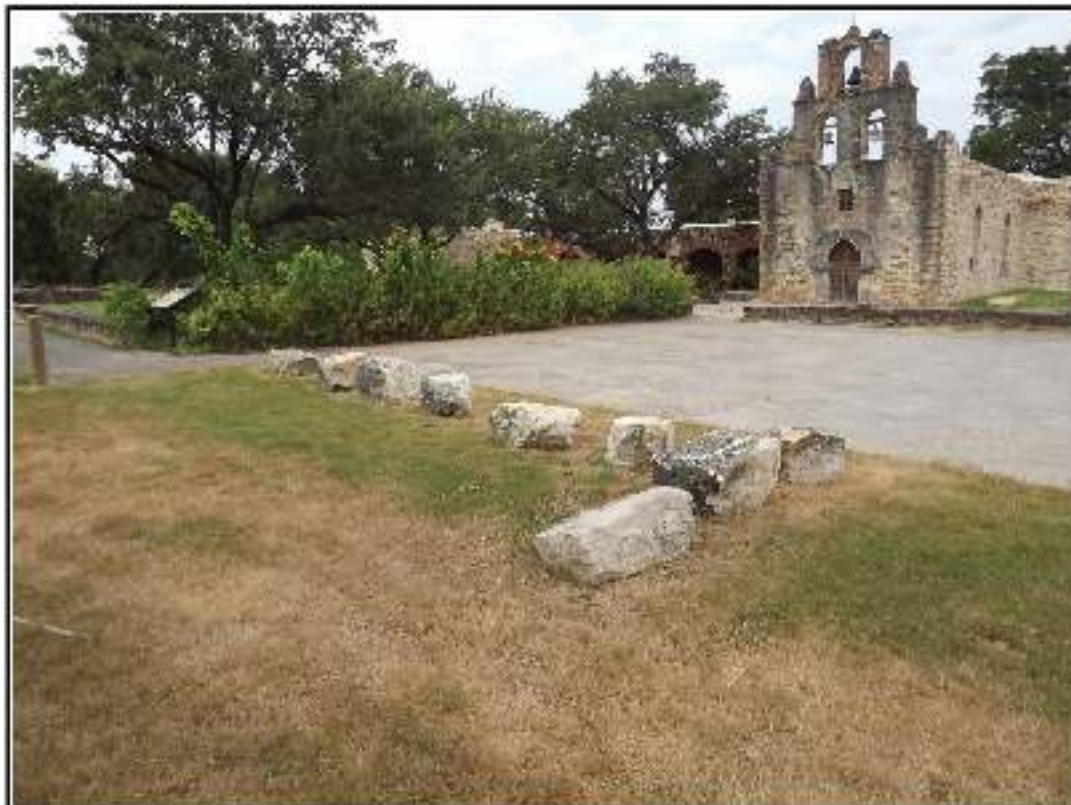
Figure 4-7. Treatment of Feature 1 area (facing southwest).

wall was covered with protective landscape cloth, topped with 5-7.6 cm (2-3 in.) of sand, geogrid, soil/limestone base, and sod. Large irregular stones were placed to demarcate the wall (Figure 4-7).

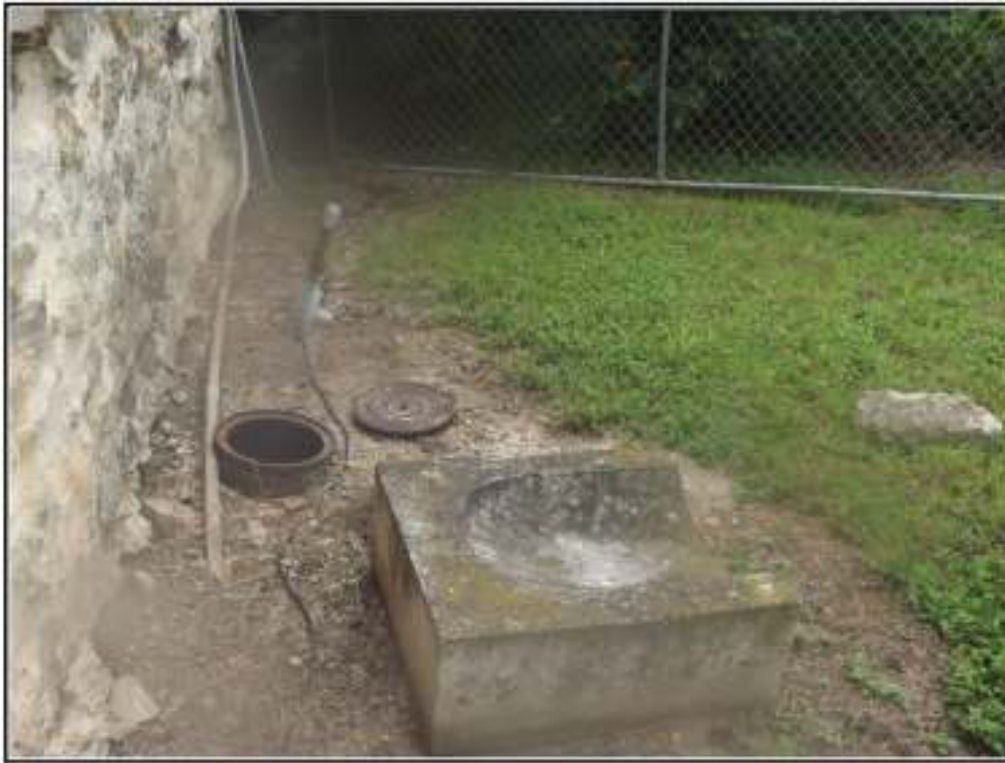
Figure 4-8. Water valve box prior to excavation and replacement.

On June 12, 2014, CAR monitored the excavation and installation of a water valve box. Figure 4-8 shows the water valve box west of the Priests' Quarters/Convento. During

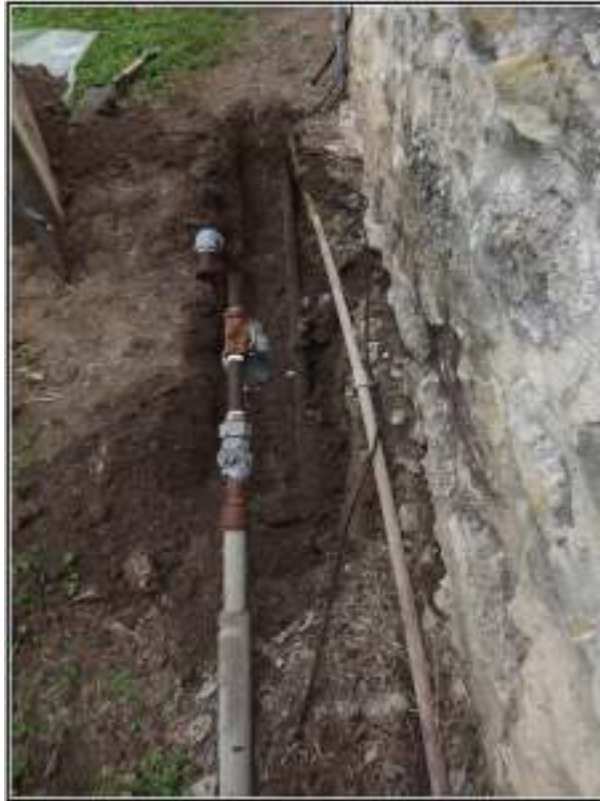
Figure 4-9. Excavation for the water valve box replacement.

After the removal of the water valve box, a larger area was excavated to locate the couplet to the water pipe for the installation of a new box. Initially, the excavation measured 0.61-x-0.91 m (2-x-3 ft.) wide, but it was further extended to 2.4-x-0.91 m (8-x-3 ft.). Figure 4-9 illustrates the excavation conducted for the water valve replacement. The depth of the excavation was 45-50 cm (17.7-19.7 in.). Soil from the excavation was visually inspected, but only a few brick fragments and sandstone were observed. No features or significant cultural material were encountered during the excavations. The area had been disturbed by the installation of existing utility lines.

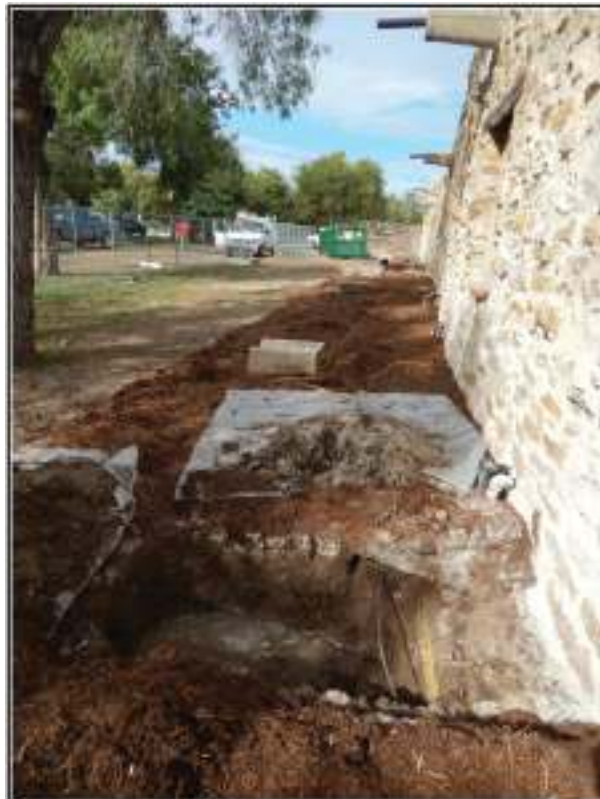
Figure 4-10. Excavations associated with sewage blockage.

On November 7, 10, and 11, 2014, additional excavations were conducted to search for a blockage in the pipes. Five areas were excavated along the west wall of the Priests' Quarters/Convento to locate the blockage (Figure 4-10). These areas had been previously disturbed due to the original placement of the sewer lines. A mixture of modern material and a few historic and Spanish Colonial artifacts (glass and unglazed ceramics) were observed but not collected.

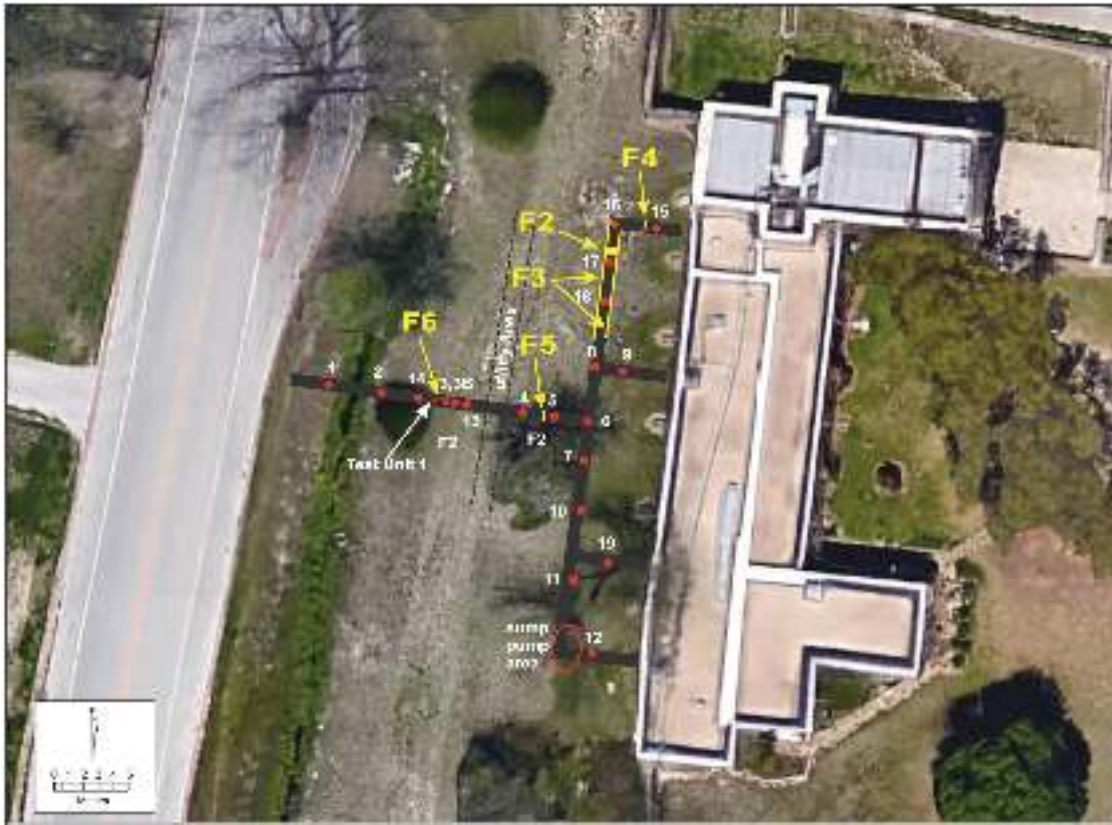
Figure 4-11. Map of trenches, shovel tests, and test units associated with the sewer lateral.

Archaeological work for the proposed sewer lateral included monitoring trench excavations, shovel testing, and unit excavations (Figure 4-11). The CAR excavated 19 shovel tests from February 27 through March 10, 2015. The excavation area was marked, and shovel tests were excavated approximately every 5 m (16.4 ft.). Table 4-4 lists the cultural material recovered from shovel testing. Based on field observations, the majority of these artifacts were isolates and/or were in disturbed contexts. A sewer line runs parallel to the mission, and STs 6, 7, 10, 11, and 12 encountered the line at 35-40 cmbs (13.8-15.7 in.). The contractor stated that the work planned for this area was the removal and replacement of the existing line and that the excavation would be no deeper than the present impact.

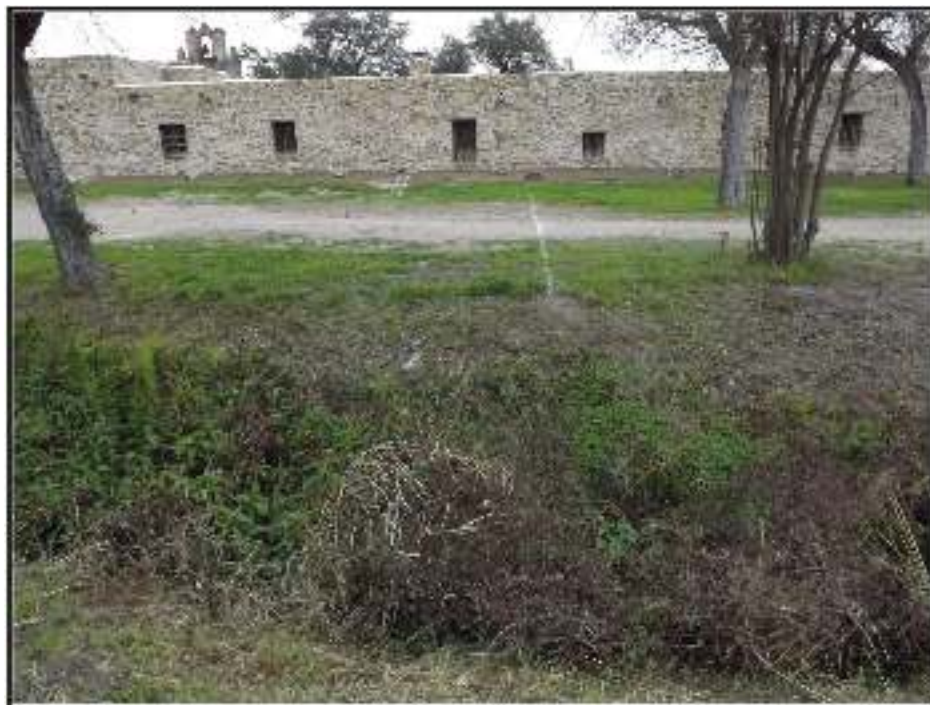
Figure 4-12. The east-to-west main line for sewer lateral.

CAR archaeologists L. Kemp and A. McBride monitored the excavation of trenches for the Espada Sewer Lateral on March 11-13 and 16, 2015. All trenches were marked by the Guarantee Plumbing and Air Conditioning crew prior to excavation. Figures 4-12 through 4-14 show the marked

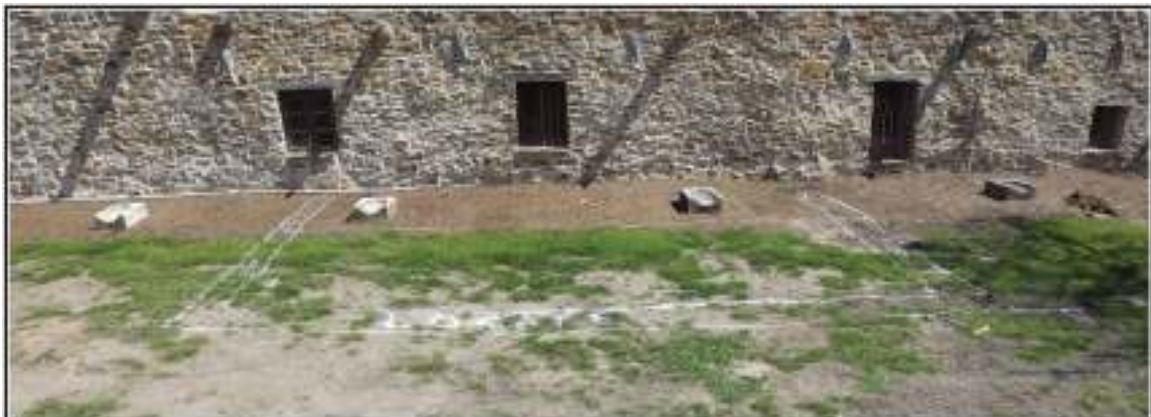
Figure 4-13. Marked areas, north by the sacristy.

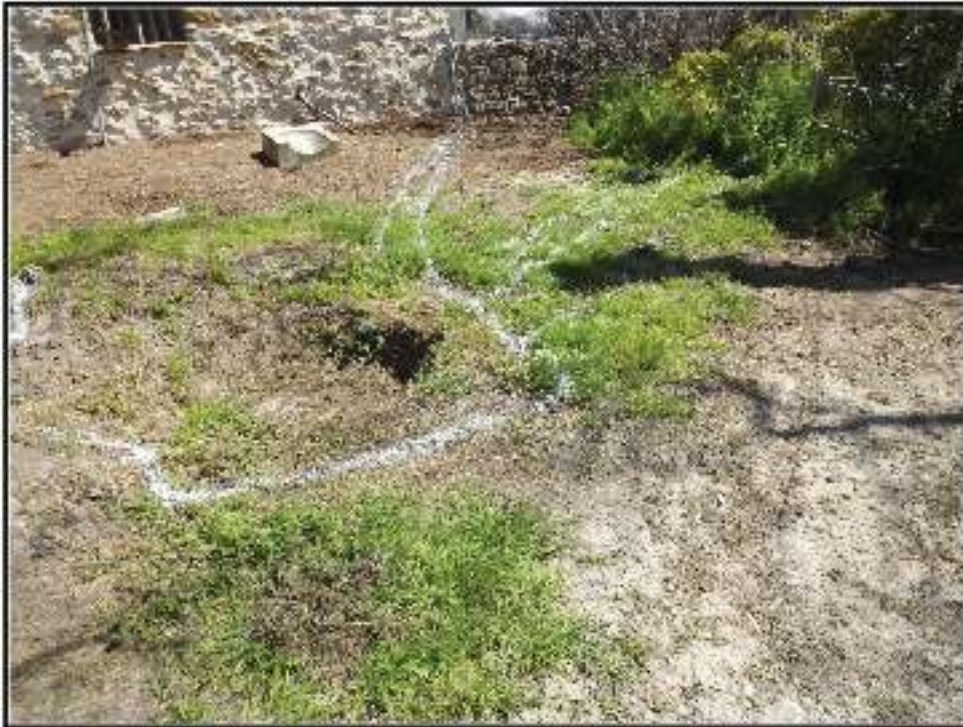
Figure 4-14. Areas excavated for electrical lines for the sump pump.

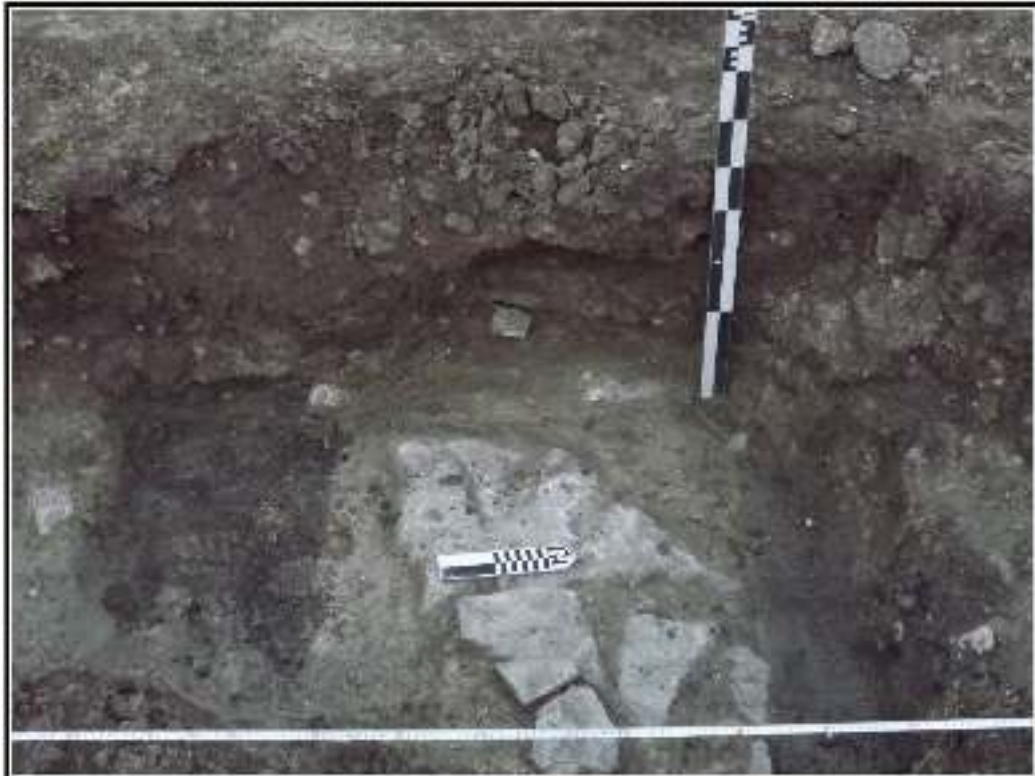
Figure 4-15. Feature 2 showing wall mortar, in situ artifact, and delineation.

In the main north-to-south trench, a limestone wall or foundation, Feature 2, was uncovered 3-4 m (9.8-13.1 ft.) south of the beginning of the trench and previously excavated STs 16 and 17 (Figure 4-15). The center of the feature was recorded using a Trimble GPS unit. Unfortunately, a course of two large, cut limestone blocks were removed from the feature. Another course of limestone lay underneath this course. The discovery of this feature prompted a cessation of work in this area pending further investigation. Both THC and NPS, as well as other parties including Pugh Constructors and Ford, Powell and Carson Architects, were notified of the discovery. The wall feature and the northern portion of the trench was cleaned and documented with photographs, profiles, and plan view drawings. In addition, the feature and trenches were documented with a total data station on March 12. The feature, minus the removed stones, measured 0.80 m (2.6 ft.) north-to-south and 1.2 m (3.9 ft.) east-to-west at a depth of 55 cmbs (21.7 in.). The feature is constructed of limestone block and cobbles with a lime-based mortar. The wall is delineated on either side by a charcoal flecked brown (10YR 4/3) silty clay loam. The wall runs east-to-west, and the area north and south of it was probed for subsurface floor or

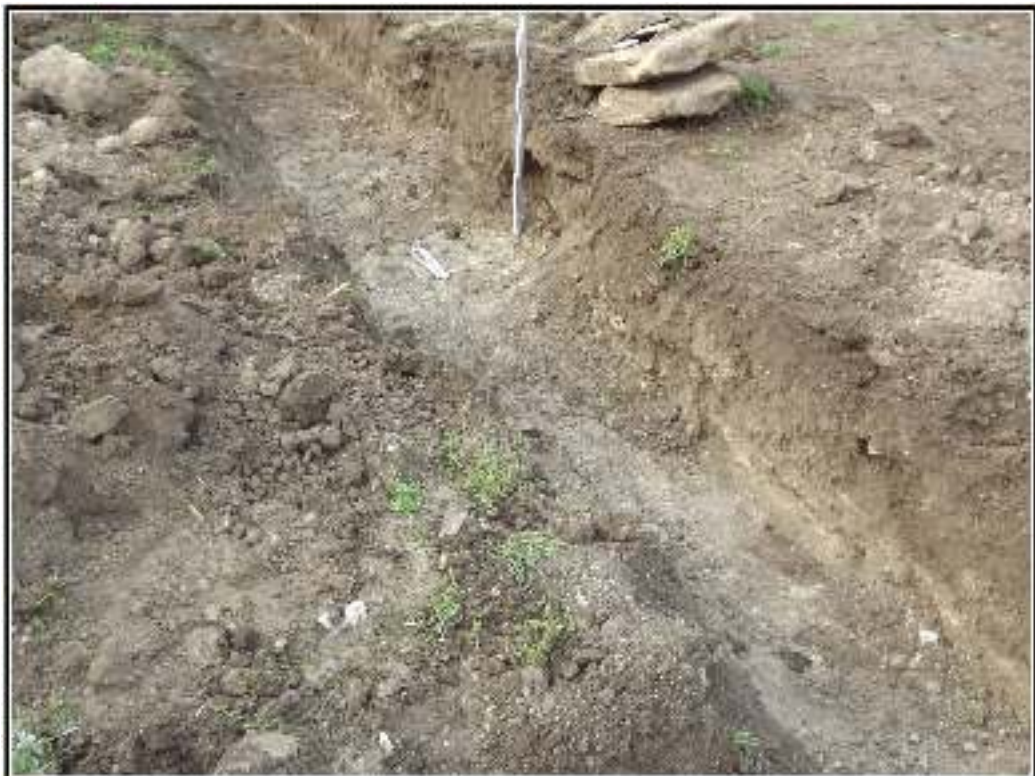
Figure 4-16. West wall profile prior to cleaning, showing plaster floor, Feature 3 (facing northwest).

As the walls were cleaned, it became apparent that there was a continuous line of light gray/white (10YR 7/2, 10YR 8/1) plaster floor (Feature 3) 7.5 m (24.6 ft.) in length on both the east and west walls (Figure 4-16). The soil color change was noted during the shovel testing; however, it was thought to be remnants of modern reconstruction. Feature 3 is truncated by a trench on the east wall. On the west, the plaster floor appears to have a pit-like structure, approximately 20 cm (7.9 in.) in length, at 7 m (23 ft.) south of the northern edge of the trench with the floor continuing for 1 m (3.28 ft.) before its truncation by modern construction (Figure 4-17). Features 3 and 4 were treated as separate features, though they may be related.

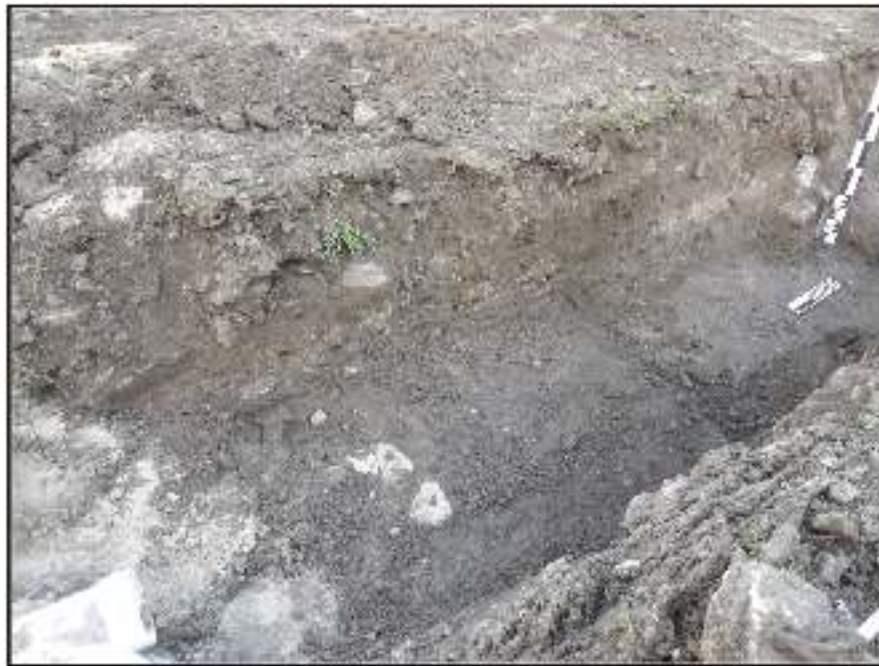
Figure 4-17. View of west wall and the termination of Feature 3, plaster floor; note pit-like feature and limestone cobbles on the trench floor.

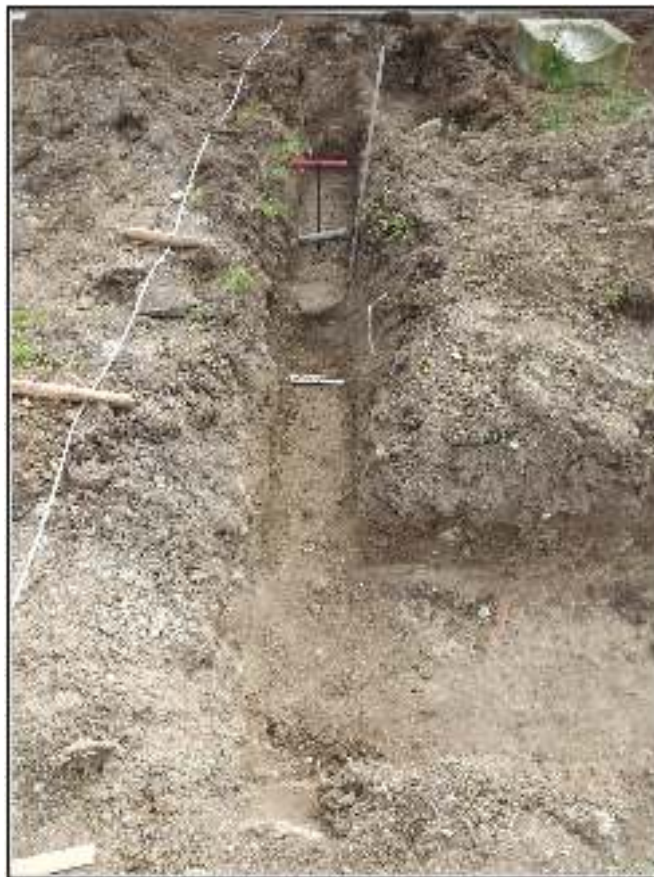
Figure 4-18. View of trench coming from the sacristy showing in situ flagstone, Feature 4, underneath the gas line and probed area of subsurface floor or wall.

Two flagstones (Feature 4) were found 40 cmbs (15.7 in.) beneath a nonfunctional gas line, and a line of plaster was observed in the north wall of the eastern most portion of the trench (Figure 4-18). This trench was probed starting at the flagstone east and west, indicating subsurface stone 20 cm (7.9 in.) east and 1 m (3.28 ft.) west of the flagstone at 10-15 cm (3.9-5.9 in.) below the trench depth.

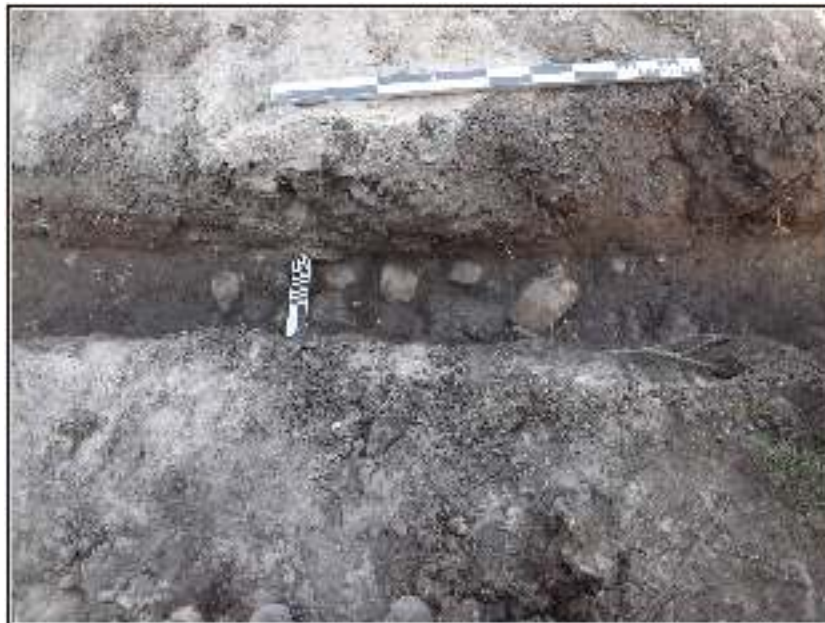
Figure 4-19. View of cobblestone, Feature 5.

During the excavation of the east-to-west trench, a cobblestone feature (Feature 5) was found 40 cmbs (15.7 in.; Figure 4-19). It measured 1 m (3.28 ft.) in length and contained approximately eight cobbles ranging from 10 cm (3.9 in.) to 10-x-20 cm (3-9-x-7.9 in.) in size. Its location was documented with a Trimble GPS unit. The feature was located between STs 4 and 5, approximately 2.5 m (8.2 ft.) east of a utility line constructed in 1999. The feature was photographed, and a wall profile was drawn. The soils above the feature were a dark yellowish brown (10YR3/4) silty clay loam. The trench opening was 30 cm (11.8 in.) in width, which impeded further investigation. It is possible that it may be the spoil pile from the utility construction; however, this comment is solely speculation. Mechanical excavations were allowed to proceed east of the feature terminating prior to the *acequia*.

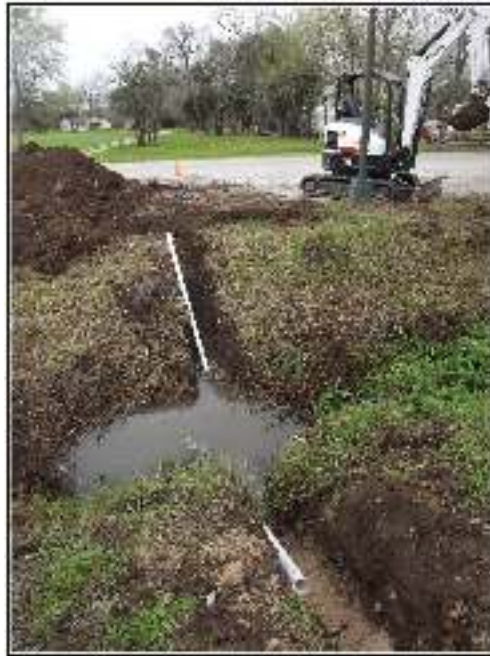
Figure 4-20. View of excavated trench crossing the acequia.

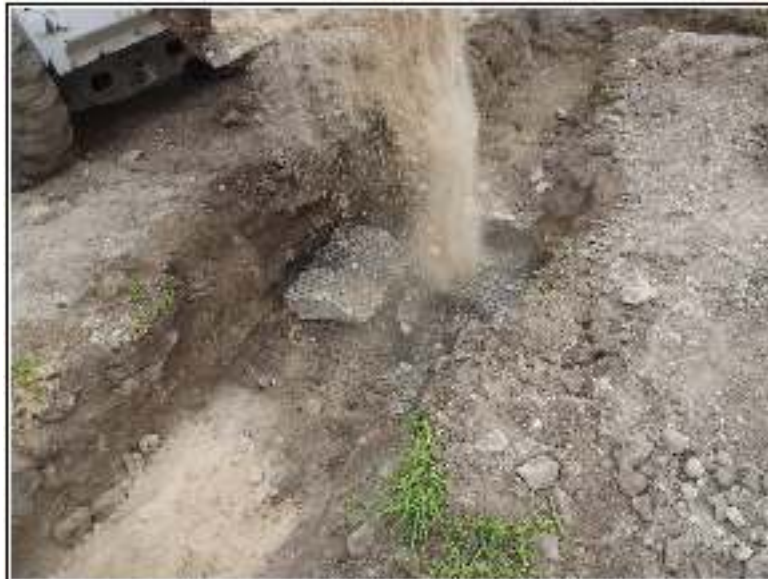
Figure 4-21. Backfilling with sand of wall feature; note plastic webbing.

Following this excavation, the CAR placed webbed plastic netting and sand over the flagstones, wall, and cobblestone features to indicate their presence should any future construction take place in this area (Figure 4-21). On March 16, CAR staff monitored the trenches containing features as they were backfilled with sand and excavated soil.

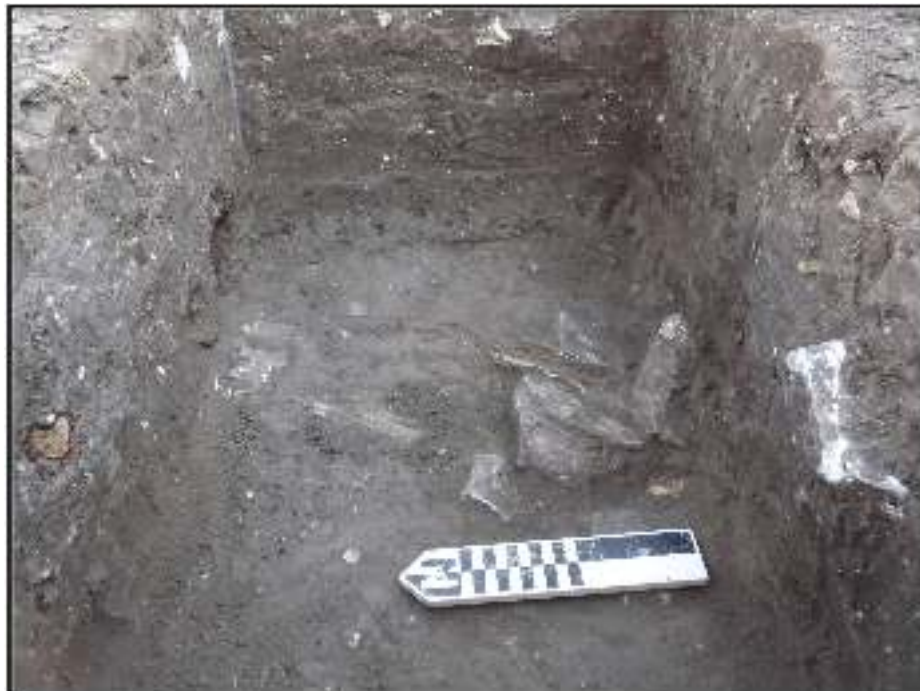
Figure 4-22. Feature 6 in Test Unit 1.

Feature 5 consisted of a cobble wall with no artifacts in association. Similar cobble surfaces have been encountered by Smith (Ivey et al. 1990) and interpreted as the blacksmith shop. Feature 6 was found during shovel testing and further investigated in excavation of Test Unit 1. Feature 6 was defined as an intact midden and is the only feature with associated artifacts. This feature was interpreted as a Spanish

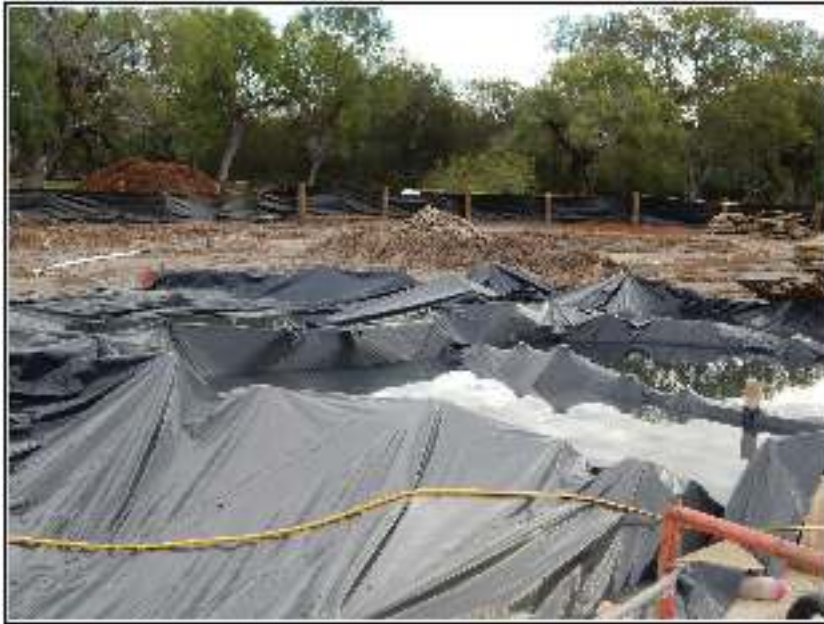
Figure 4-23. Water collected in the parking lot after heavy rains.

Two additional areas that were included in archaeological monitoring were in front of the church (Area 3) and in the mission plaza (Area 4), north of the parking lot. Heavy rains in early November of 2014 caused large amounts of water to collect in the parking lot as seen in Figure 4-23. To drain water off the parking lot area, a small trench 30.5-cm (12-in.) wide and 20.3-cm (8-in.) deep was excavated by hand and monitored by CAR staff (Figure 4-24). Two ceramic sherds were encountered and noted, but they were not collected.

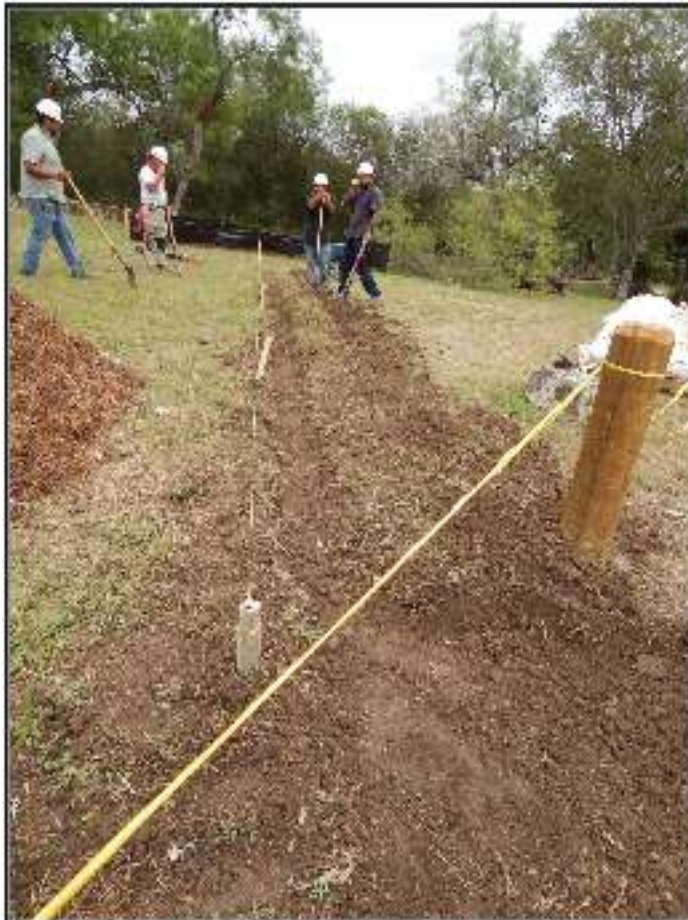
Figure 4-24. Trench excavated for drainage of rainwater collected in parking lot area.

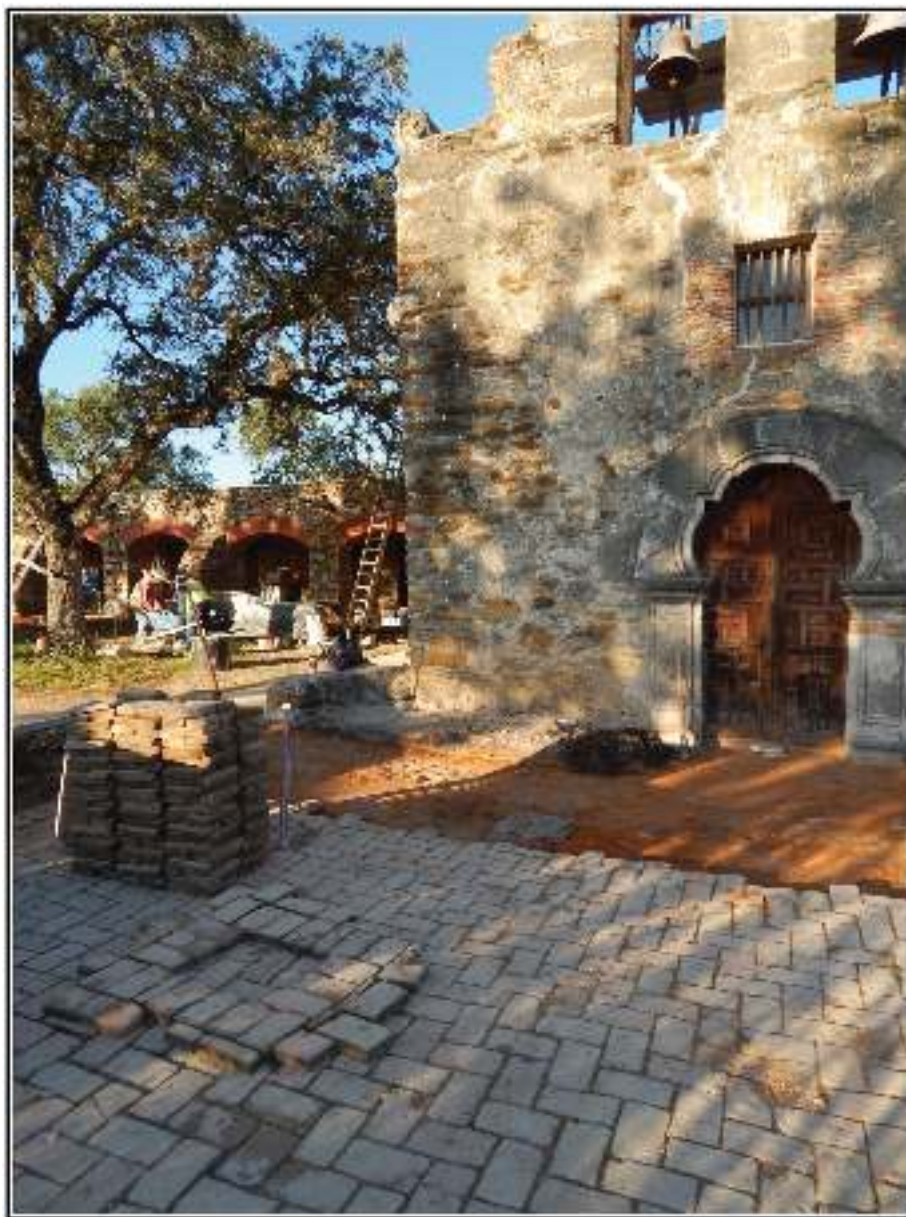
Figure 4-25. The removal of fill underneath pavers in front of the church.

On November 19, 2014, fill from underneath the pavers in front of the church was removed to waterproof the area (Figure 4-25). A CAR staff member monitored the activity. No features or cultural material were encountered during this time.
