**Architectural Survey of Facility No. 2: A 1950s Hangar on
Martindale Army Aviation Support Facility, San Antonio,
Bexar County, Texas**

Technical Report, No. 2
Center for Archaeological Research
The University of Texas at San Antonio

March 2007

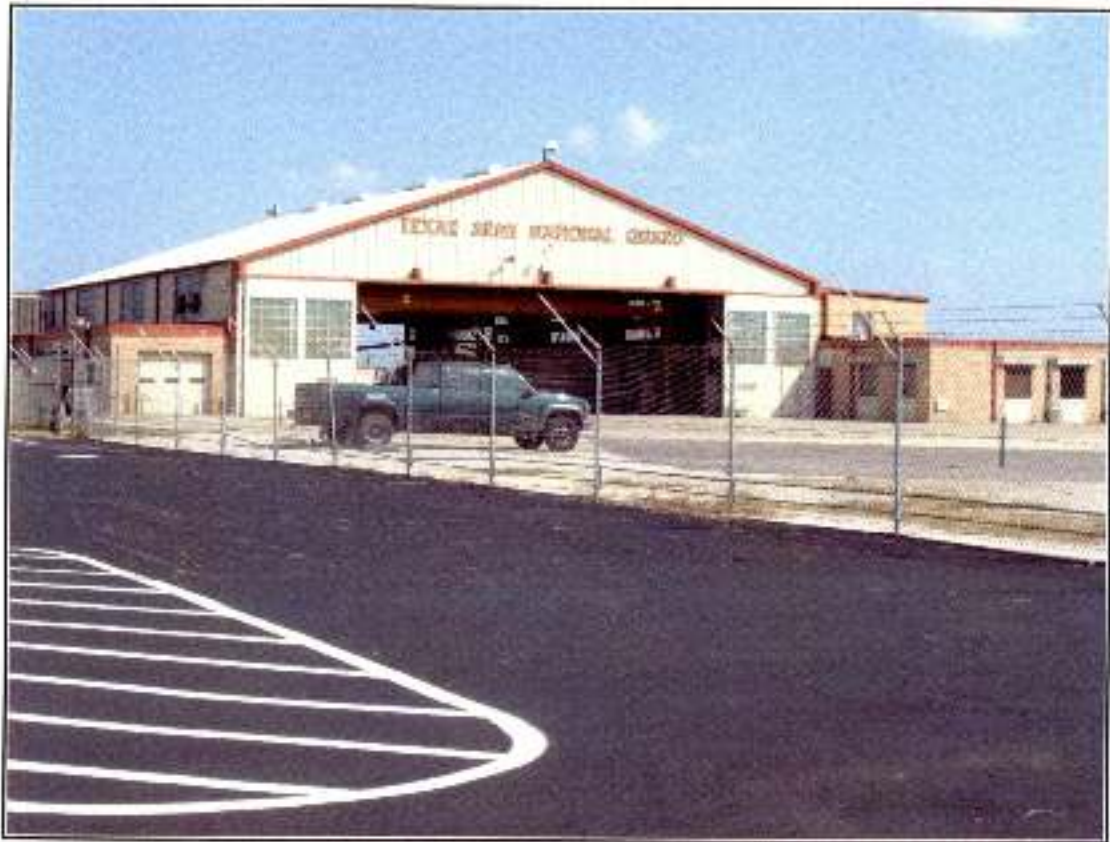
Figure 1-3. 2006 Photograph of the Western Façade of Building 2, the Hangar.

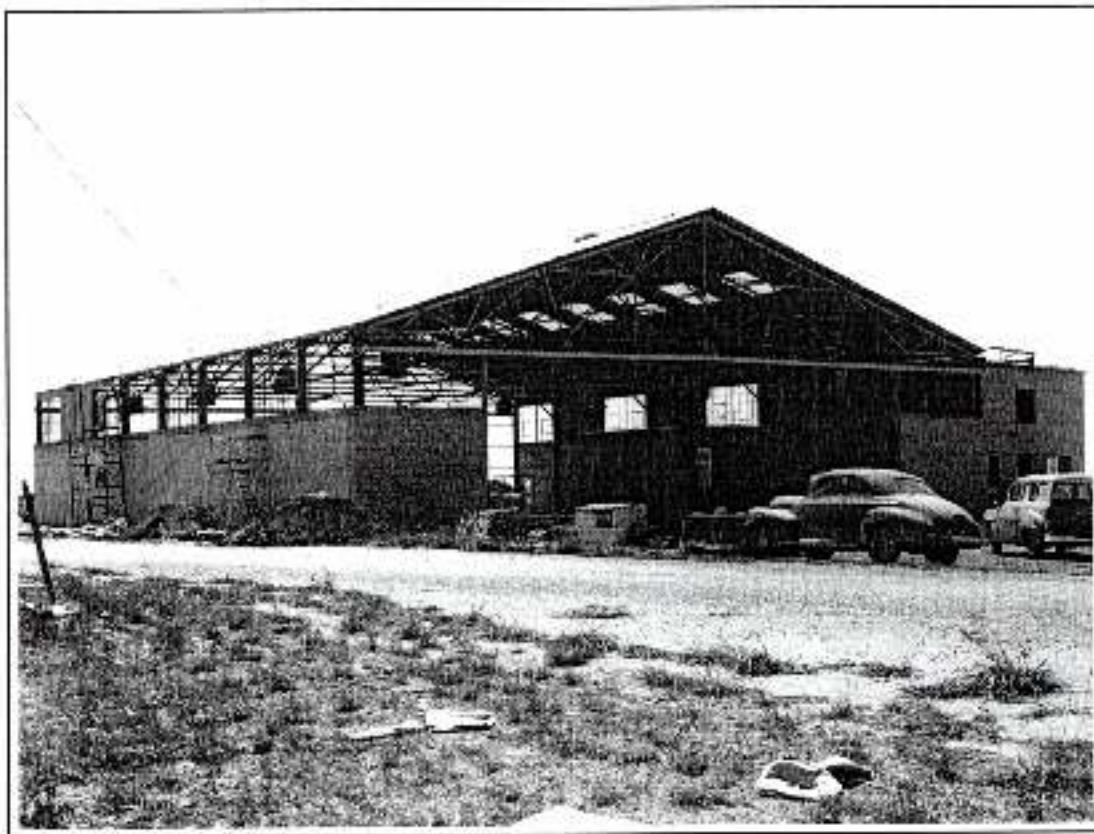
Figure 3-4. Construction of the hangar (Facility No. 2), view facing southeast. Photographed by Sgt. J. T. Elsis, ANG Photo Lab, Kelly AFB, San Antonio, Texas.

Stamped photographs indicate that the hangar at Martindale ASSF was likely built for use by the Texas National Guard, rather than the United States Army. These photographs indicate a Texas Army National Guardsman Sgt. Joe T. Elsis was the photographer during the construction of the hangar (Figure 3-4). Unfortunately, these photographs are not dated. The only dated photograph (1957) in the group also supports the inventory document that suggests the hangar was built by the Texas National Guard rather than the U.S. Army. Though the picture did not capture the hangar in question, the photograph shows L1 planes, OH-23 helicopters, and temporary hangars all used by the National Guard at Martindale (Figure 3-3). The modern hangar likely replaced temporary hangars used by the Texas National Guard, which would probably have needed the upgrade to a permanent hangar designed for maintenance (Luis Alvarado, personal communication 2006).

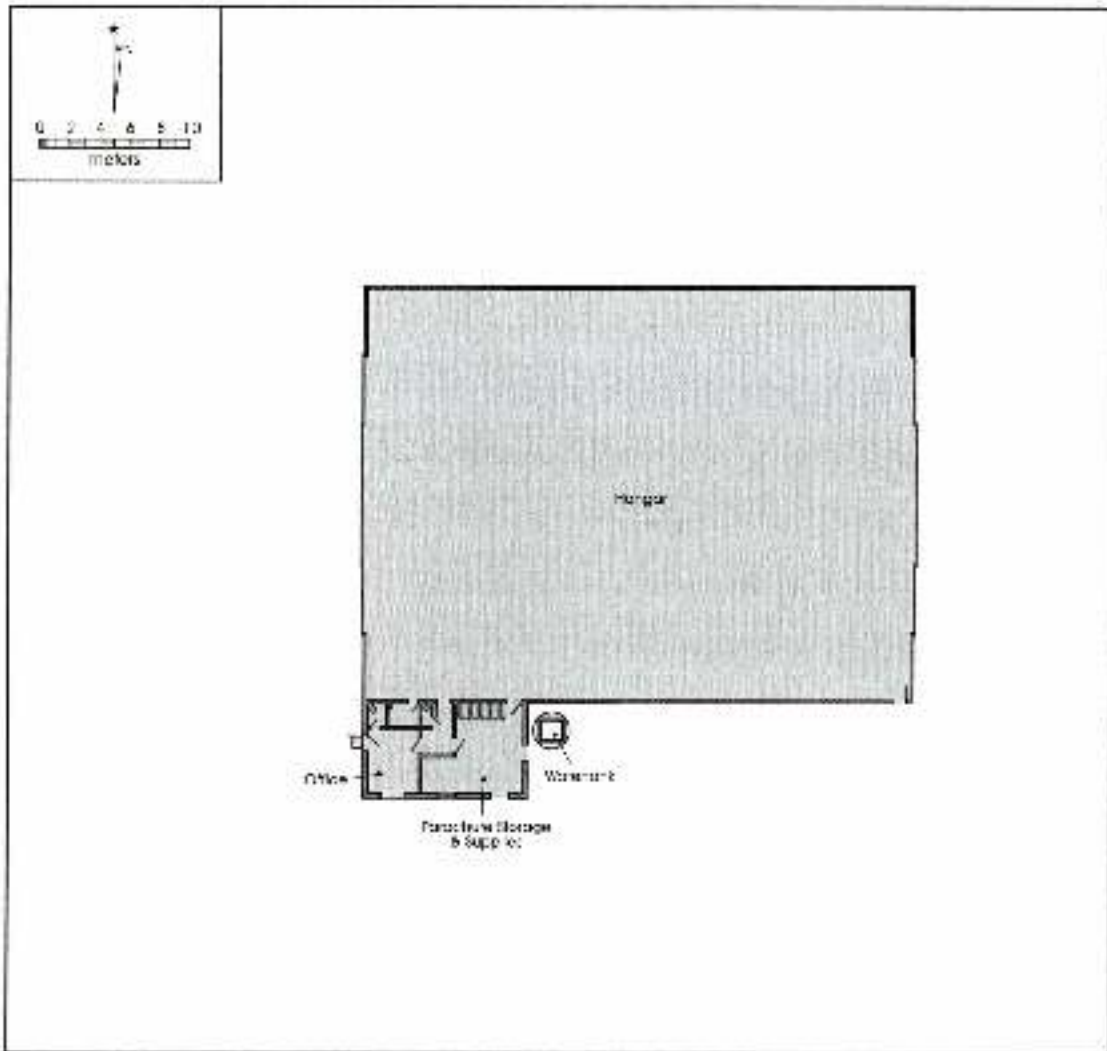
Figure 4.2. Original floor plan of the Martindale AASF hangar.

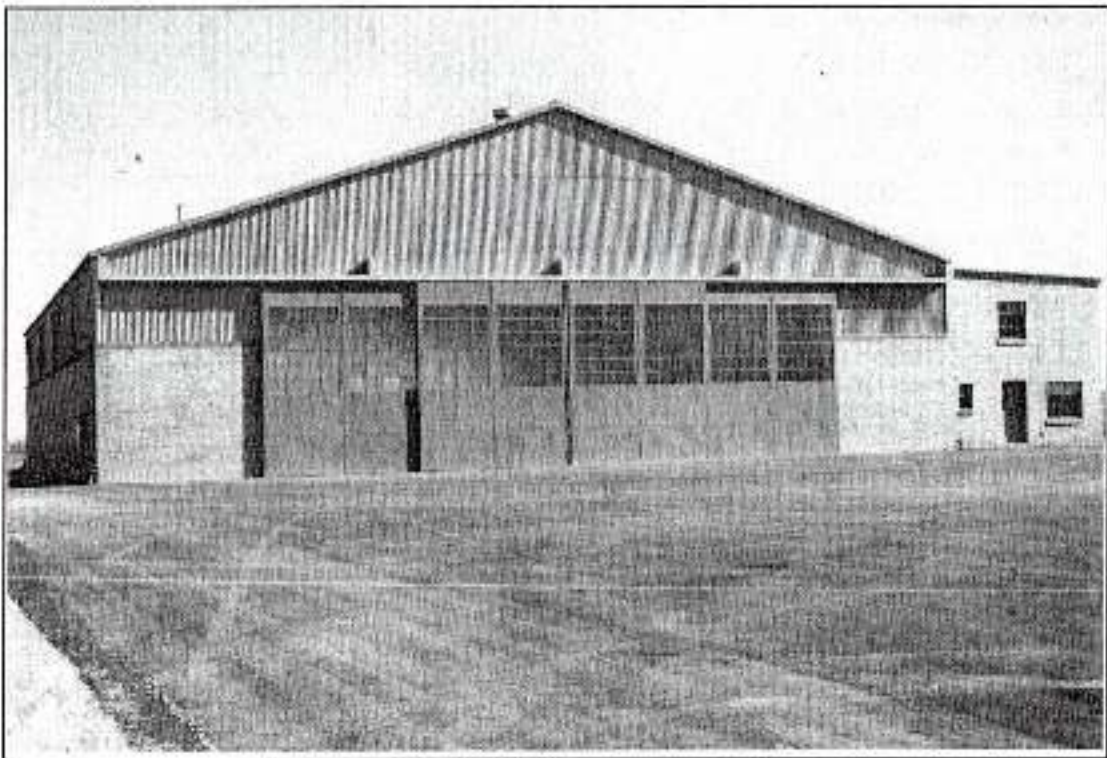
Figure 4-3. 1950s-era photograph of the finished hangar, western façade.

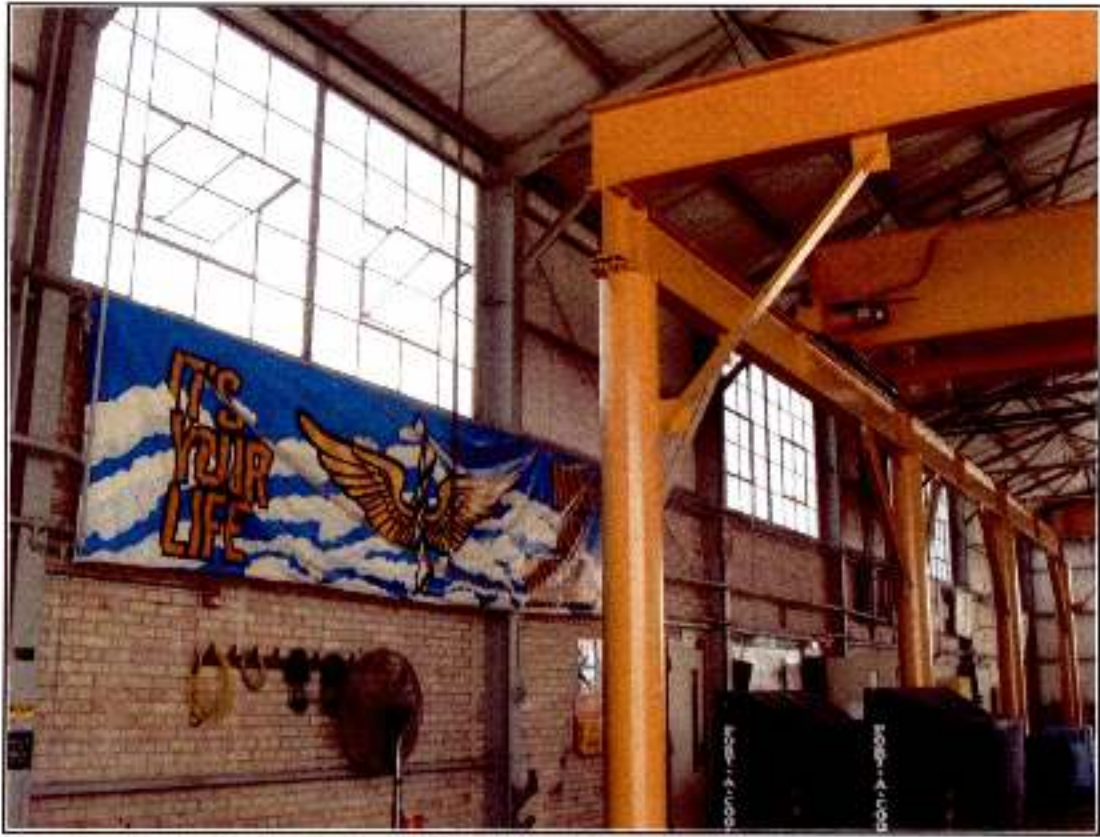
Figure 4-4. Hangar interior detail of windows.

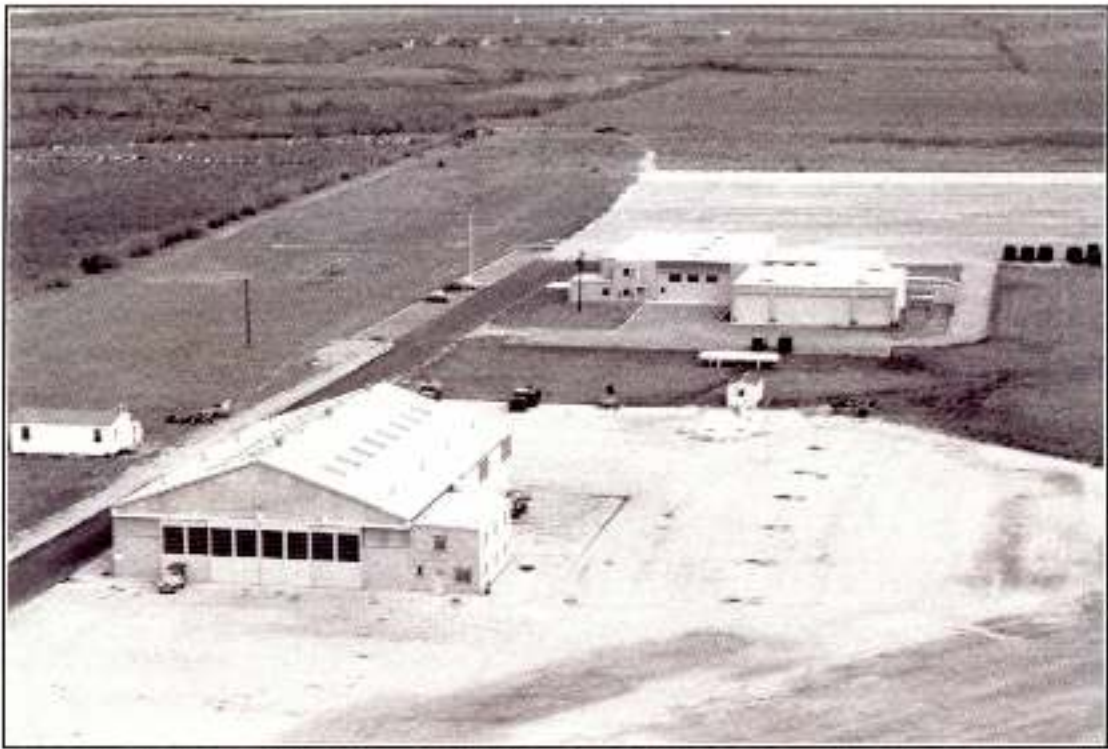
Figure 4-5. Aerial view of the hangar post-1961, facing east. Note southern annex (the site of the explosion in 1961), and the skylights in the original roof.

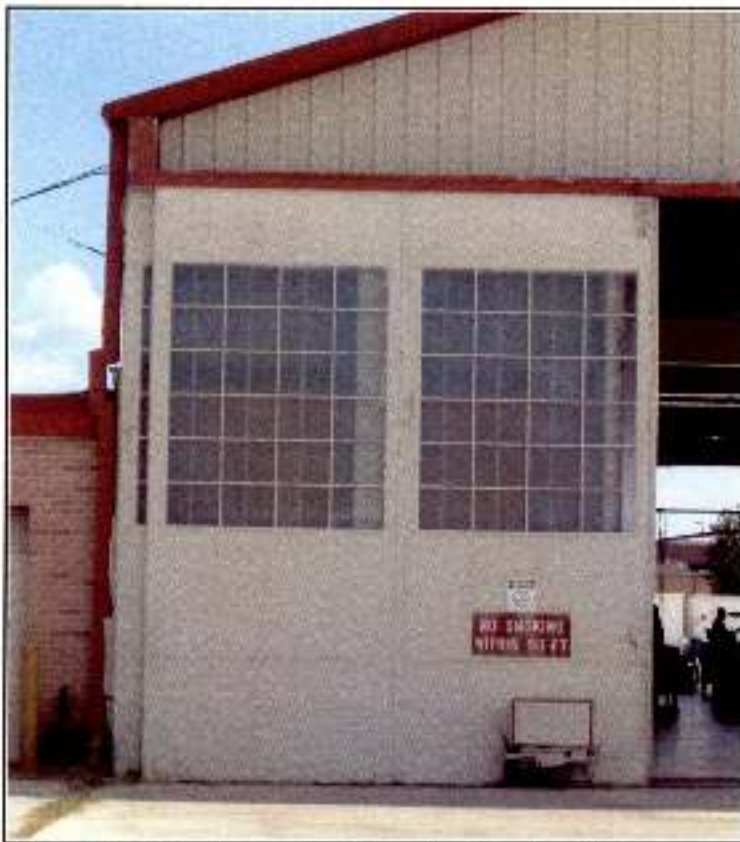
Figure 4-6. 2006 photograph of the western façade of the hangar, showing sliding doors.

Structurally, the hangar remains sound, sitting on a concrete foundation with a steel frame consisting of I-beams that support angle iron gable trusses. This allows for a large, uninterrupted floor space with a high ceiling clearance suitable for aircraft maintenance. The lower two-thirds of the walls are load-bearing masonry made of brick. The main garage has fourteen (seven pair) large industrial windows with twenty panes each. Center panels of four panes in each of these are steel pivoted windows (Figure 4-4). Three pairs are in the north wall, four pairs in the south wall. Above the brick and on the gable ends, the walls were covered with corrugated asbestos siding (transite), since replaced with metal r-panels and batt insulation secured with chicken wire. The main hangar originally had a corrugated metal, gable roof with sixteen corrugated translucent plastic skylights and three round roof vents (Figure 4-5; additional aerial photographs are in Appendix C). Since then, the roof has been replaced with R-panel roofing and four linear roof monitor vents at the ridge, more efficient materials to control extreme summer heat. Batt insulation secured with chicken wire is in place between the roof and the steel frame. Two large 15-x-18 ft. steel, sliding track doors are present at the east and west ends of the hangar, with two steel divided

multi-light windows in the top half of each door (Figures 4-6 and 4-7). An exterior door measuring 3-x-6 ft. is in place at the southeastern corner of the hangar.

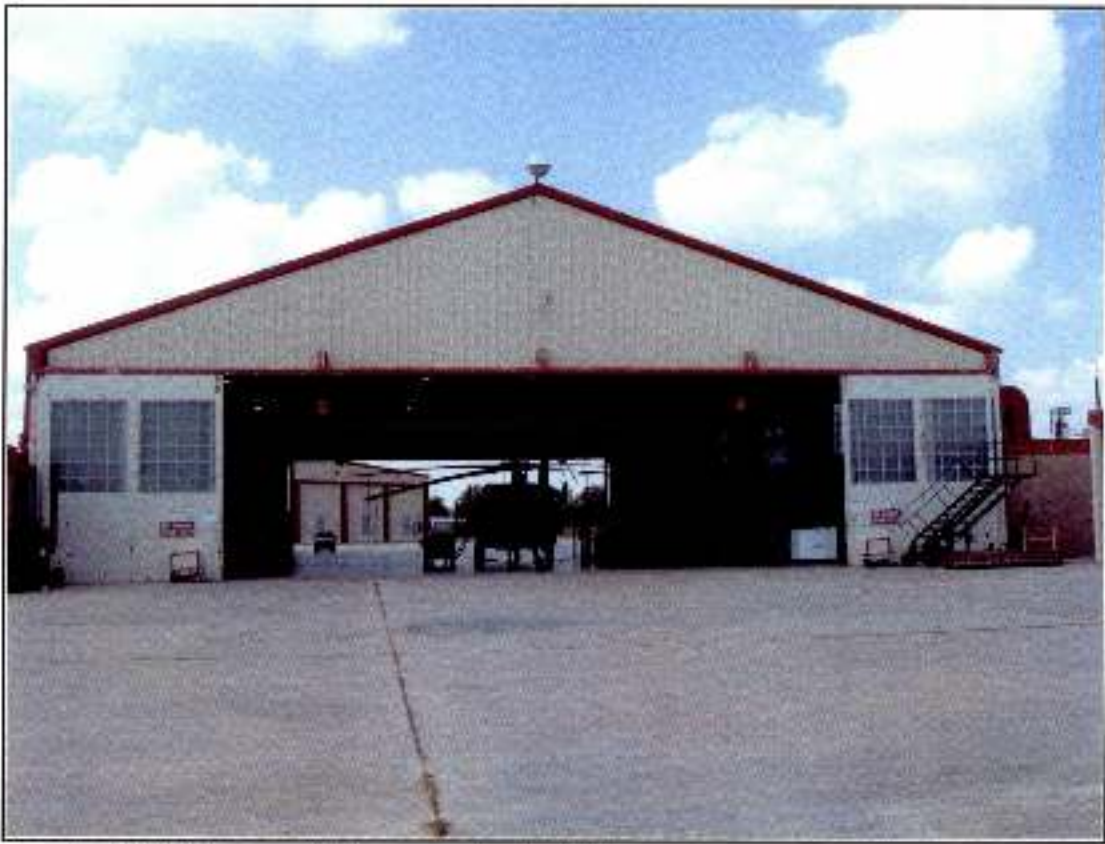
Figure 4-7. 2006 photograph of the eastern façade of the hangar.

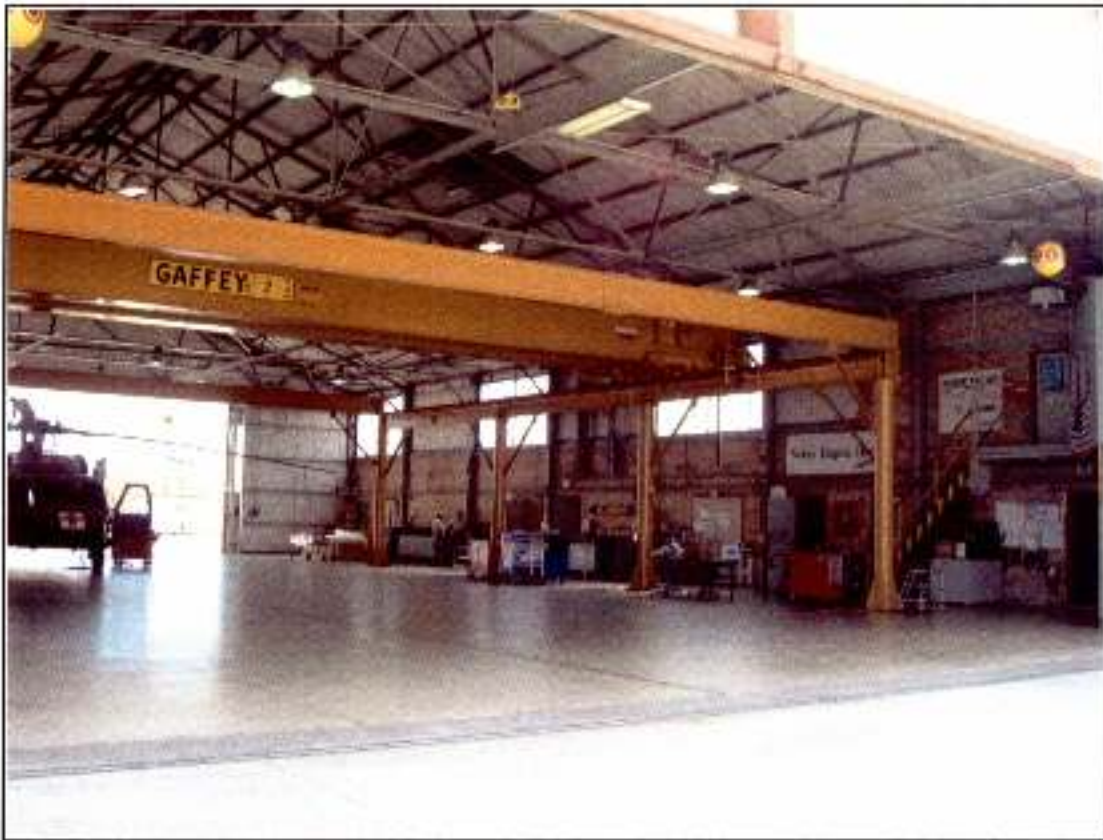
Figure 4-8. View inside the hangar of the modern "Gaffey" hoist system installed in the 1990s.

The inside of the hangar has exposed trusses, columns, and beams visible in all parts of the hangar. The upper level of the hangar is accessed by metal stairs at the west end of the south wall. A large hoist is attached to the floor, updated with a modern Gaffey hoist, which is more versatile than the hoist it replaced in 1991. The Gaffey hoist is attached to a large steel frame that allows the hook to track along two sides of the hangar to load and unload helicopters (Figure 4-8). The previous hook had less mobility and could only move along one wall of the hangar. Because the helicopters' rotor blades prevent parking as close to the wall as the airplanes could, the older hoist was replaced with this more efficient hoist that could load equipment on a helicopter parked in the center of the hangar.

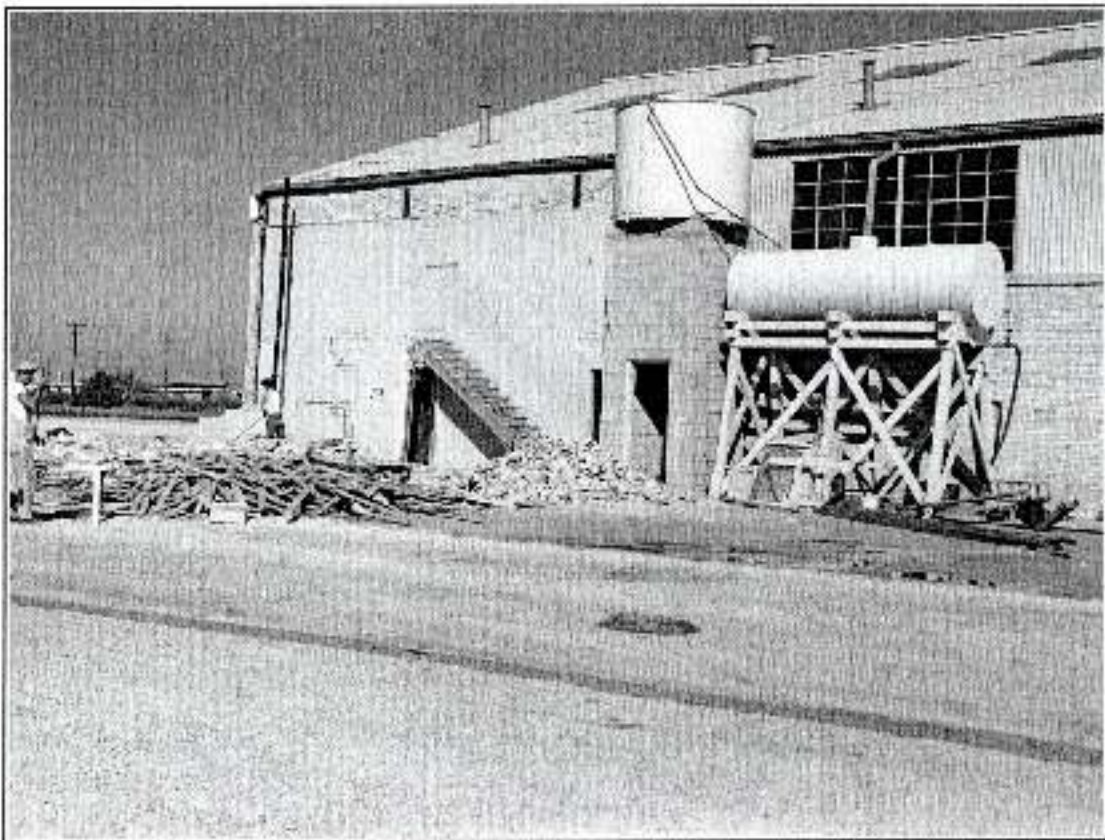
Figure 4-9. Cleanup efforts after the 1961 explosion in the southern annex of the structure show little damage to the main hangar, though six individuals were injured. Photograph by Sgt. Joe T. Elsis, TEXANG, 149th Fighter Group, Kelly AFB, San Antonio, Texas.

On Tuesday, September 19, 1961, an explosion occurred in this annex of the hangar injuring six people. Photographs documenting the cleanup efforts show that although the office complex was demolished, the hangar appears to have remained intact (Figure 4-9). These original rooms were restored sometime prior to 1975, when the first additions were added. All the restoration and the additions were built with brick matching the original hangar.

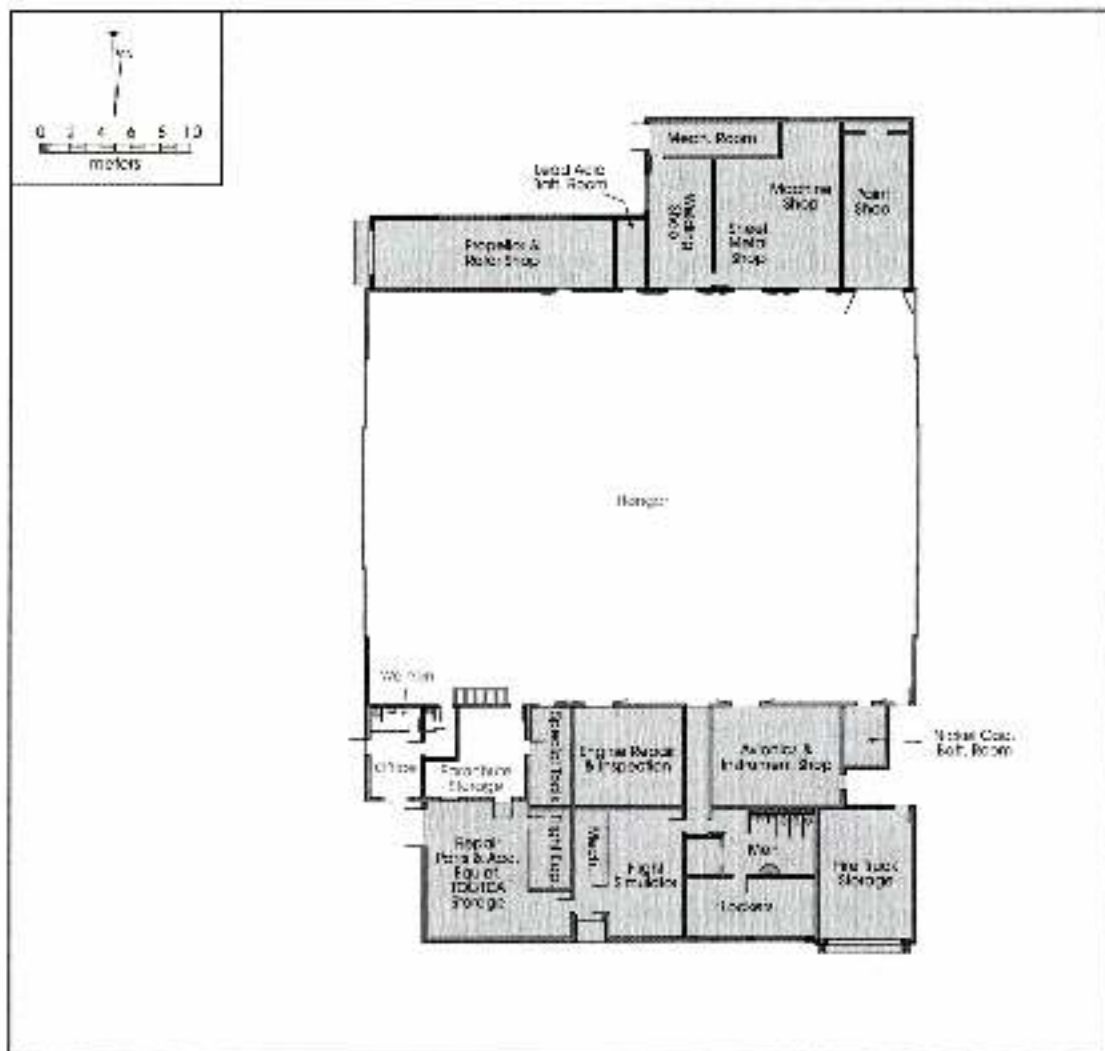
Figure 4-10. Floor plan of the 1975 addition to the Martindale AASF hangar shows additions made to the northern and southern faces of the hangar.

CAR could not locate the original architectural plans for this phase of additions but was able to locate the mechanical plans, which were dated March 1975 (Figure 4-10). The dimensions of the 1975 addition were measured from plans for a second addition dated 1976 because the mechanical plans did not show measurements or architectural features. The southern addition was built around the restored rooms that were destroyed in the explosion. This measures 122-x-53 ft. including some offsets for the existing offices and a covered porch (Figure 4-11). When this addition was built, the exterior windows of the restored offices were left in place and are still visible today (Figure 4-12). We can get some idea of the purpose of the rooms from plans of later additions that note "existing" rooms. Besides the covered porch and entry, two of the rooms were described as an avionics shop and a "NI CAD" battery room. Floor plans dated October 11, 2002 show other rooms in this addition were used for fire truck storage, engine repair and inspection, a mechanical room, a flight simulator, and men's locker room.

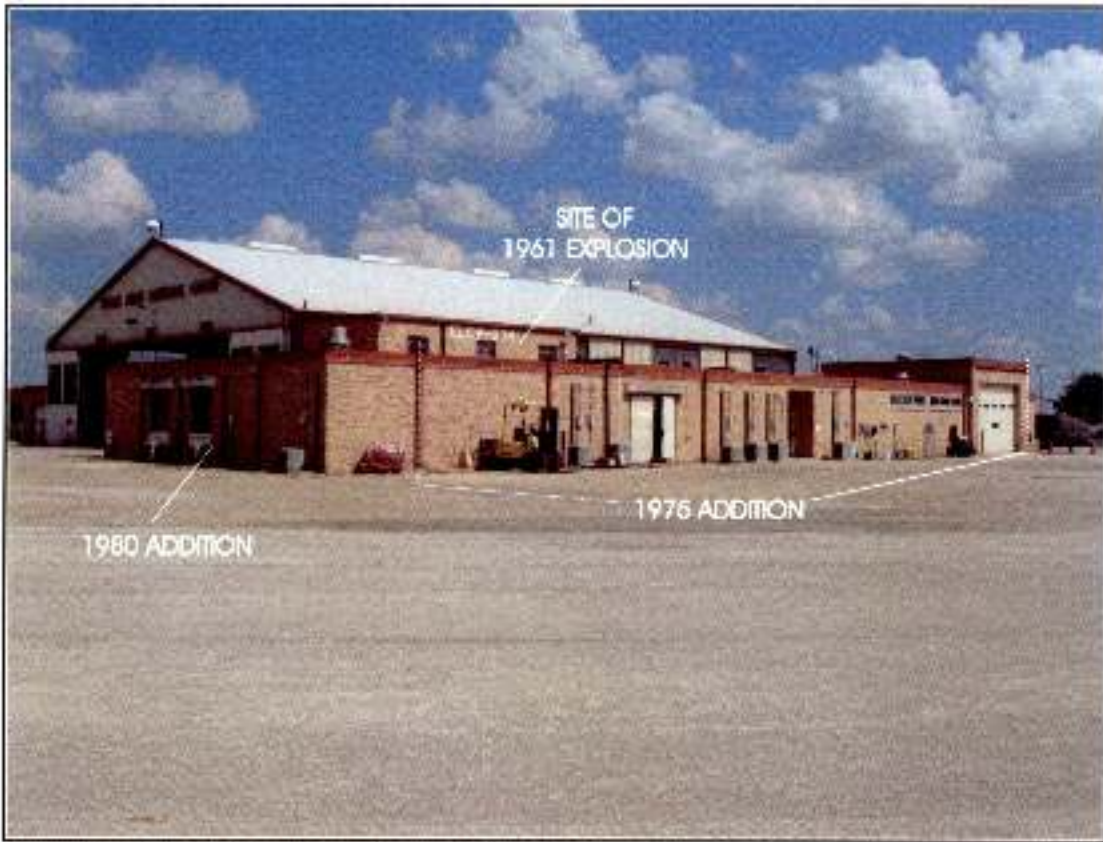
Figure 4-11. 2006 photo of all southern additions, view northeast.

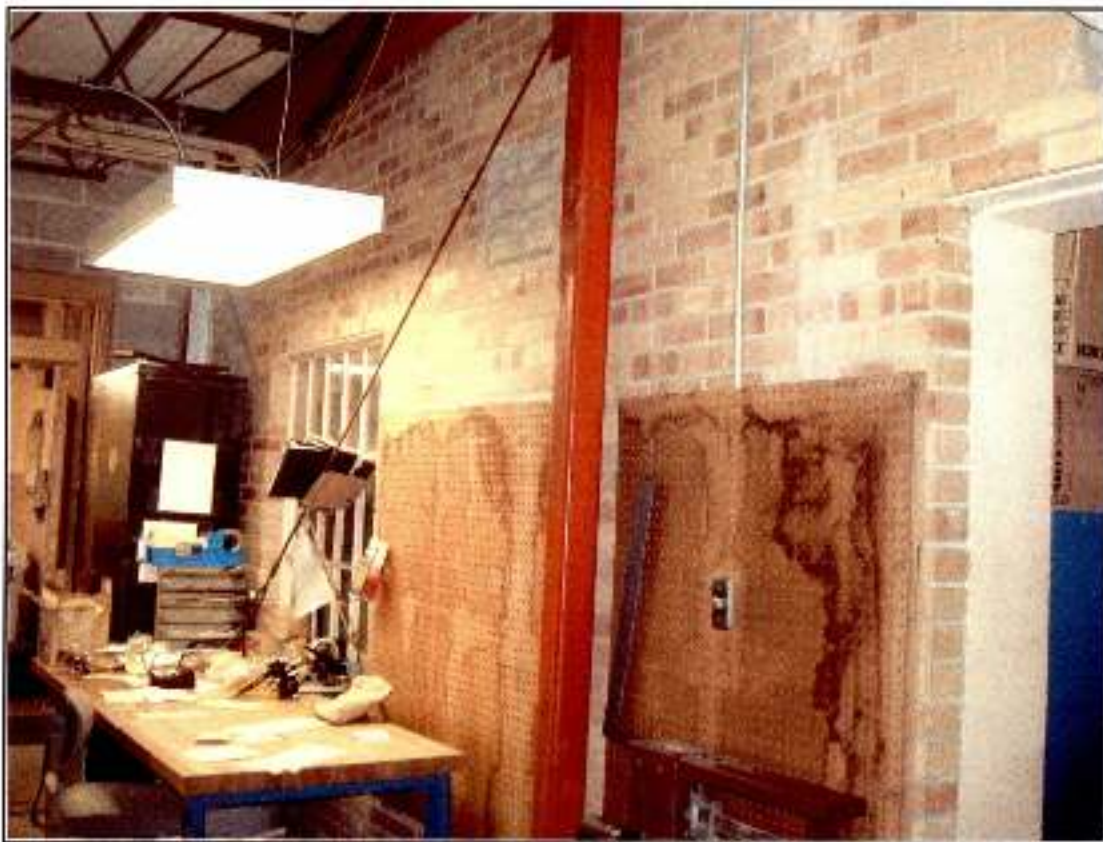
Figure 4-12. Exterior wall (now interior) rebuilt after the 1961 explosion, note exterior window still in place.

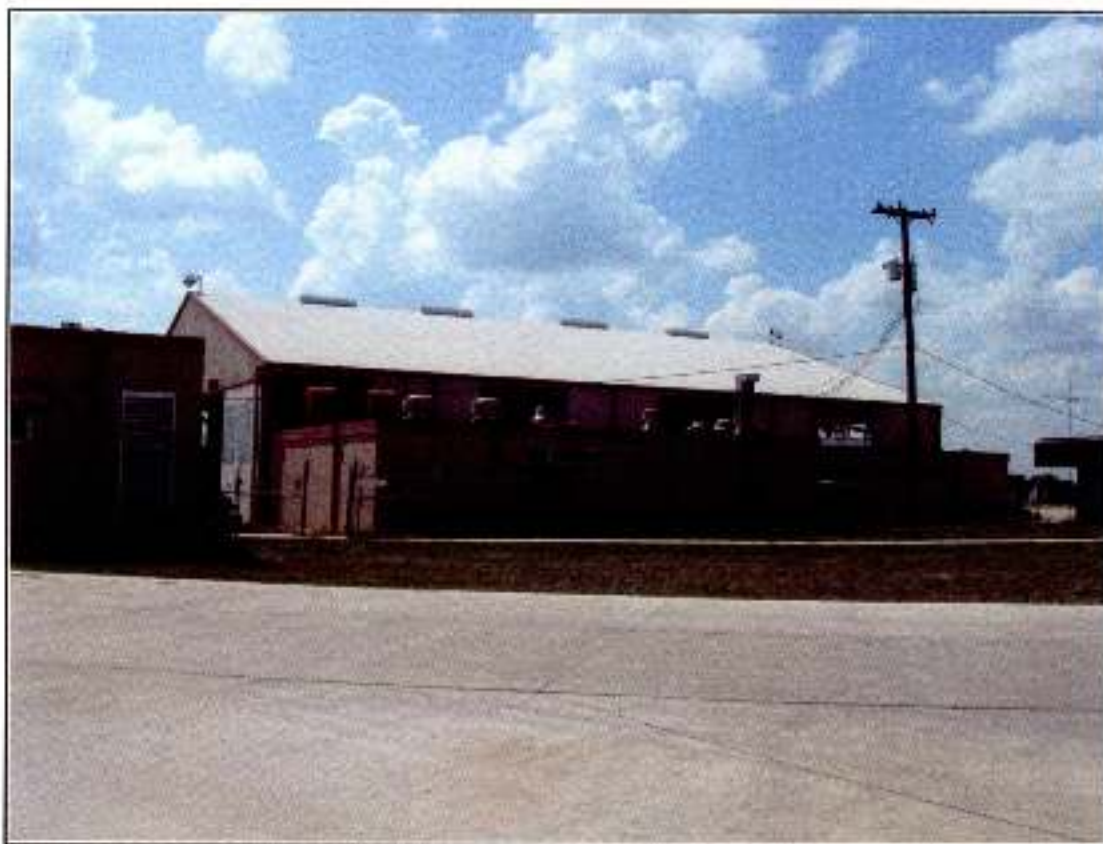
Figure 4-13. *Northern addition to the hangar, built in 1975 (view south).*

The northern 1975 addition measures 129-x-37 ft. (with one offset) and includes six rooms (Figure 4-13). It is slightly longer than the southern addition because it is the same length as the hangar, where the southern addition is not. An overhead door was installed in the western wall of the northern addition to access the propeller and rotor shop (Figure 4-14). The 2002 floor plan shows the other rooms functioned as a lead acid battery room, a welding shop, a paint shop, a mechanics room, and a machine/sheet metal shop. All these shops open onto the hangar except the mechanics room. The function of the rooms in these additions change as the needs of the facility change, but their general purpose remains the same: offices, storage, and maintenance.

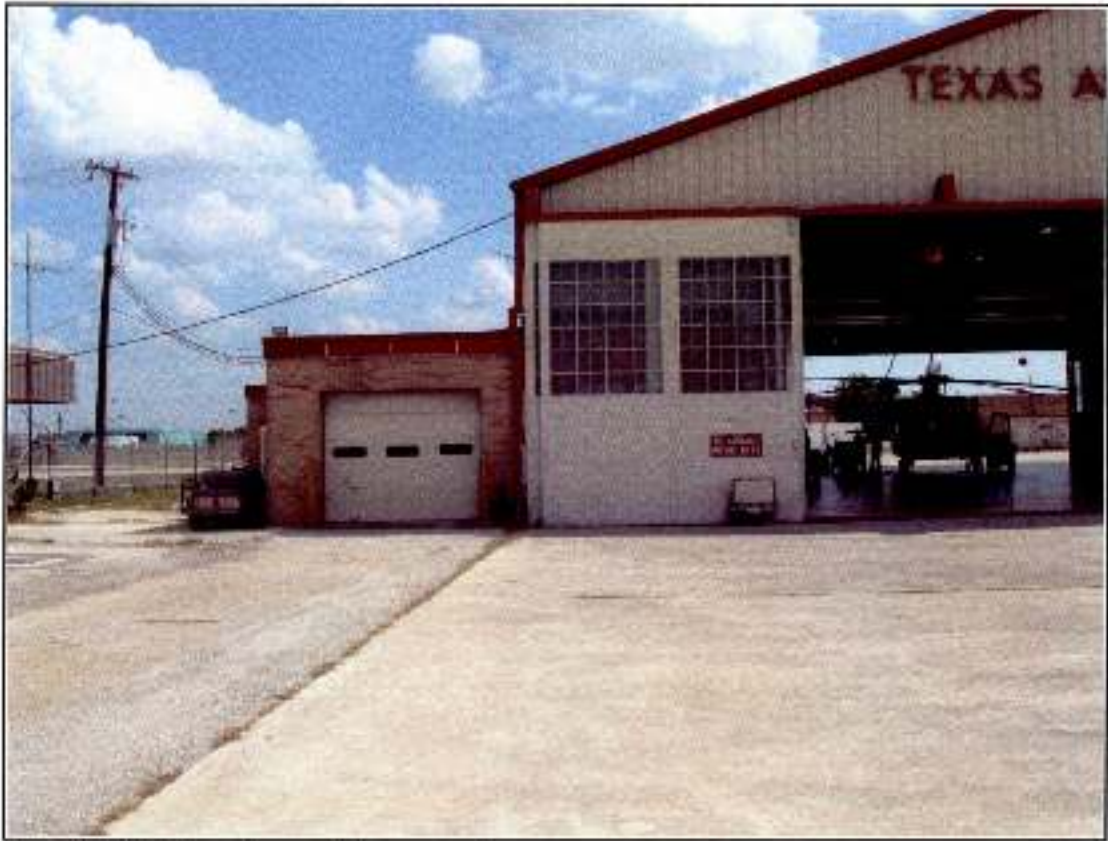
Figure 4-14. 1975 northern addition garage door, view east.

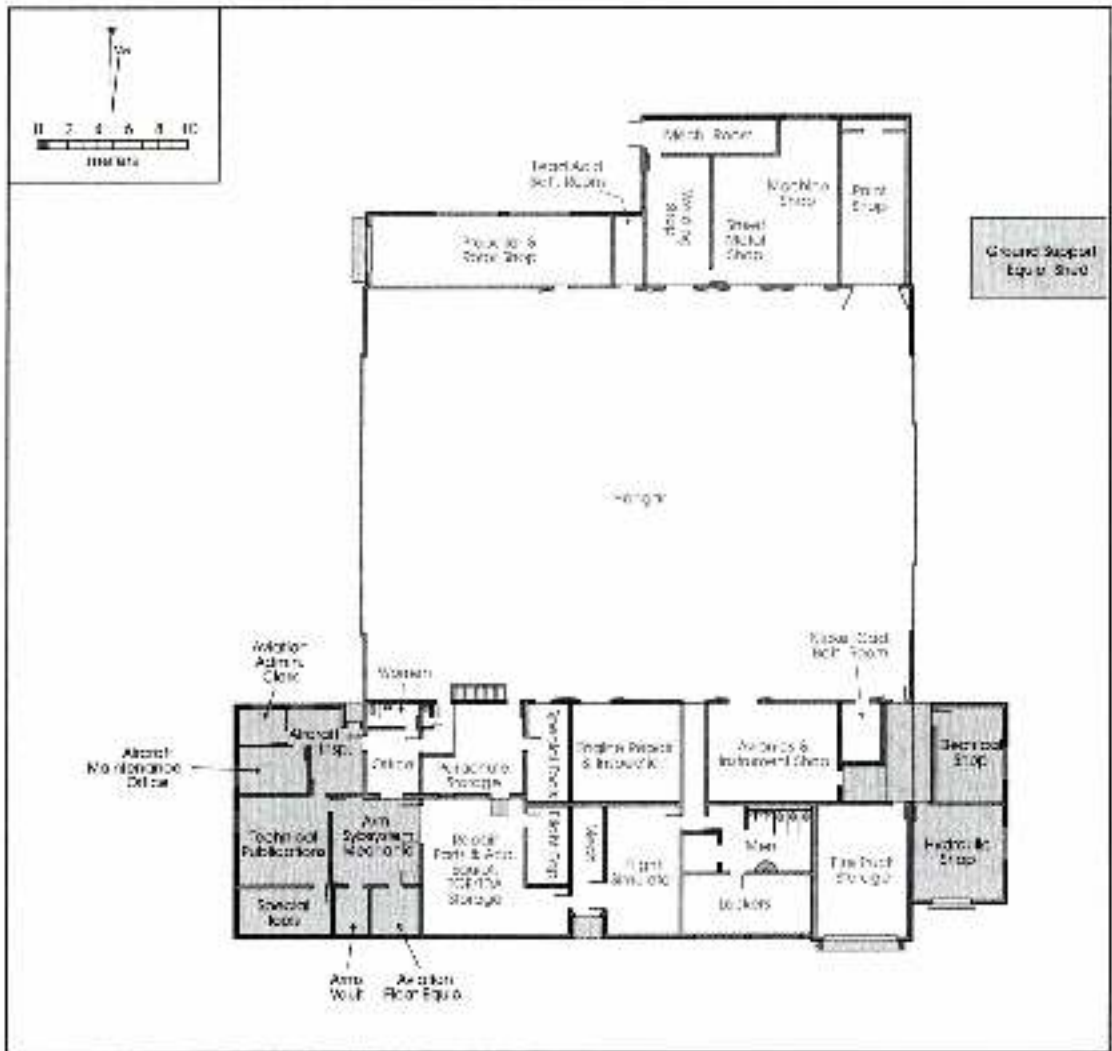
Figure 4-15. Floor plan showing the 1980 addition to the southeast and southwest corners and one shed.

Plans were drawn for more improvements in 1976, though construction was not finished until 1980 (Luis Alvarado, personal communication 2006). These additions are shown in Figure 4-15. At this time, the airfield operations moved from the armory (dedicated in 1960-61) to a new Operations Building. At the same time, a Ground Support Equipment Shed was constructed at the northeast corner of the hangar. This shed is unattached. A small, two-room attached addition was also constructed at the southeast corner and measures 20 ft. 8 in.-x-43 ft. 8 in. (Figure 4-16). At the time, these rooms were designed as an Electrical Shop and a Hydraulic Shop.

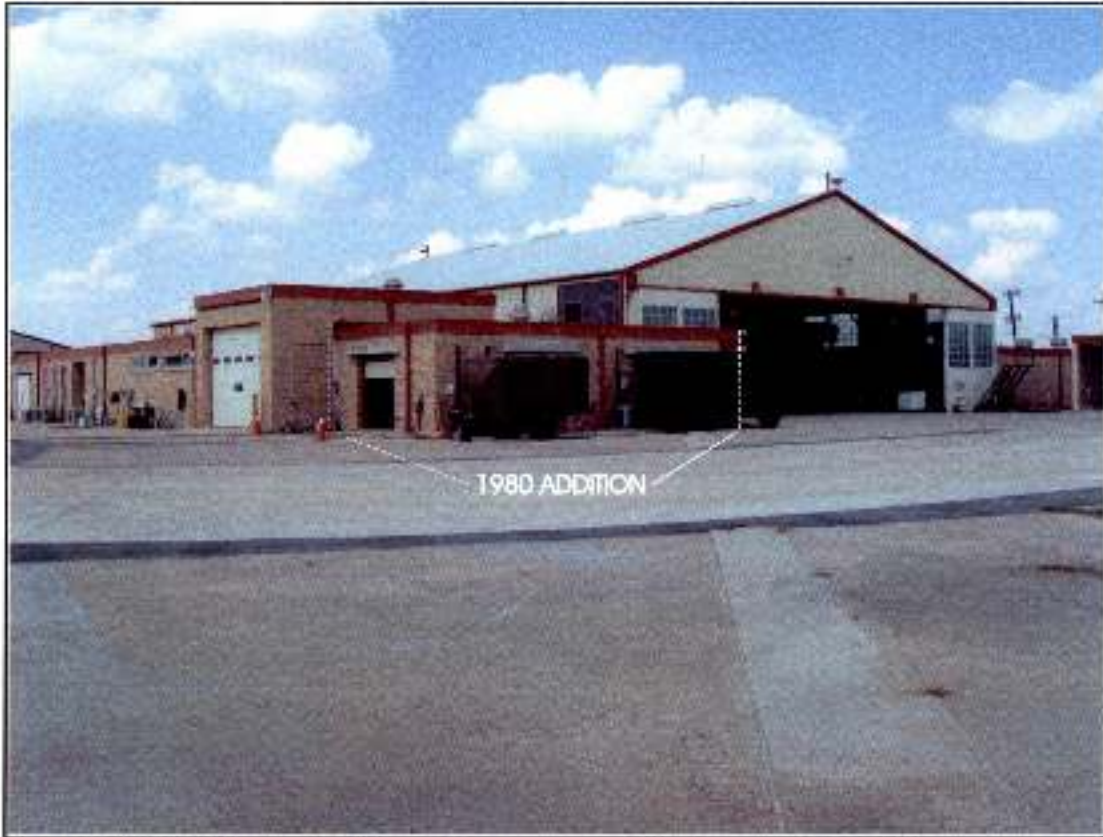
Figure 4-16. 2006 Photograph of the southeastern corner of the hangar added in 1980.

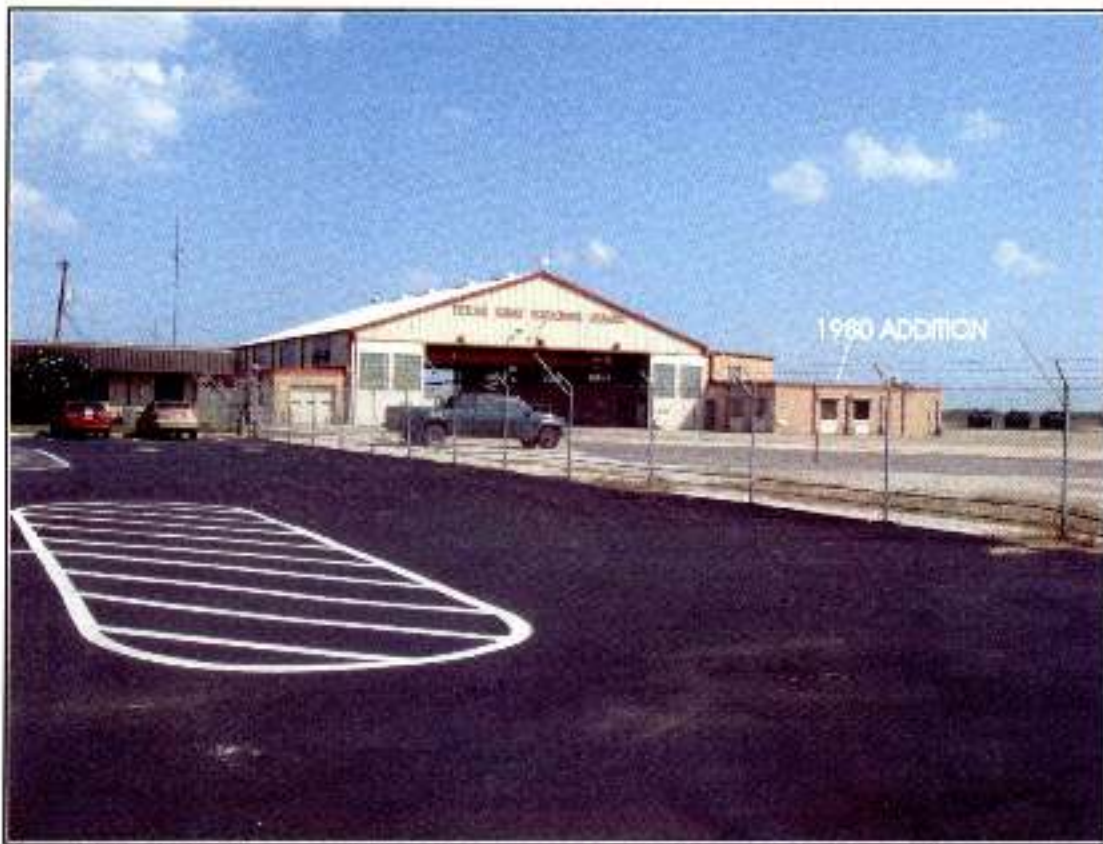
Figure 4-17. 2006 Photograph of the southwestern corner of the hangar added in 1980.

At the southwest corner of the hangar, the final addition wraps around the area where the explosion occurred (Figure 4-17). This measures 51 ft. 1 in.-x-40 ft. 4 in., including the offsets. Plans show three rooms which function as offices for the aviation administration clerk, the aircraft maintenance officer, and the aircraft inspectors. The other five rooms were designed for the Tech Publications, Armament

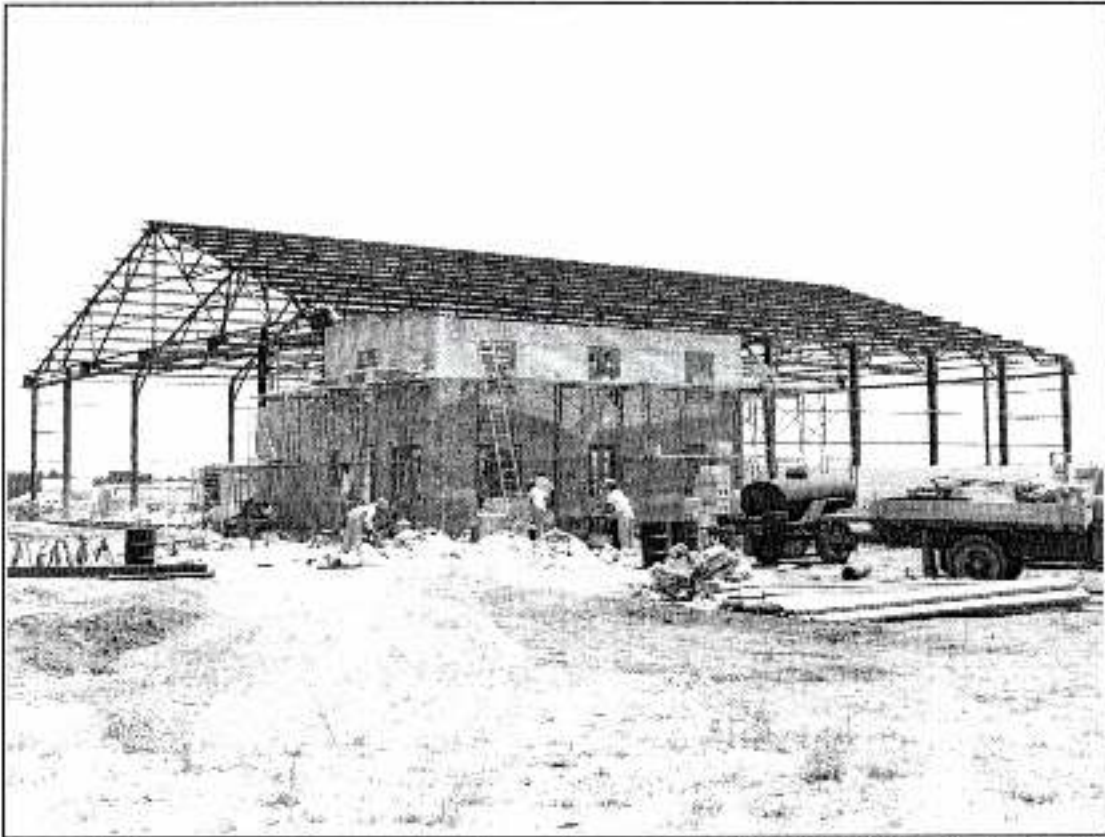
Figure A4. Construction of Hangar offices where explosion occurred in 1961. Photographed by Sgt J. L. Elsis, Aeg Photo lab, Kelly AFB, Texas.

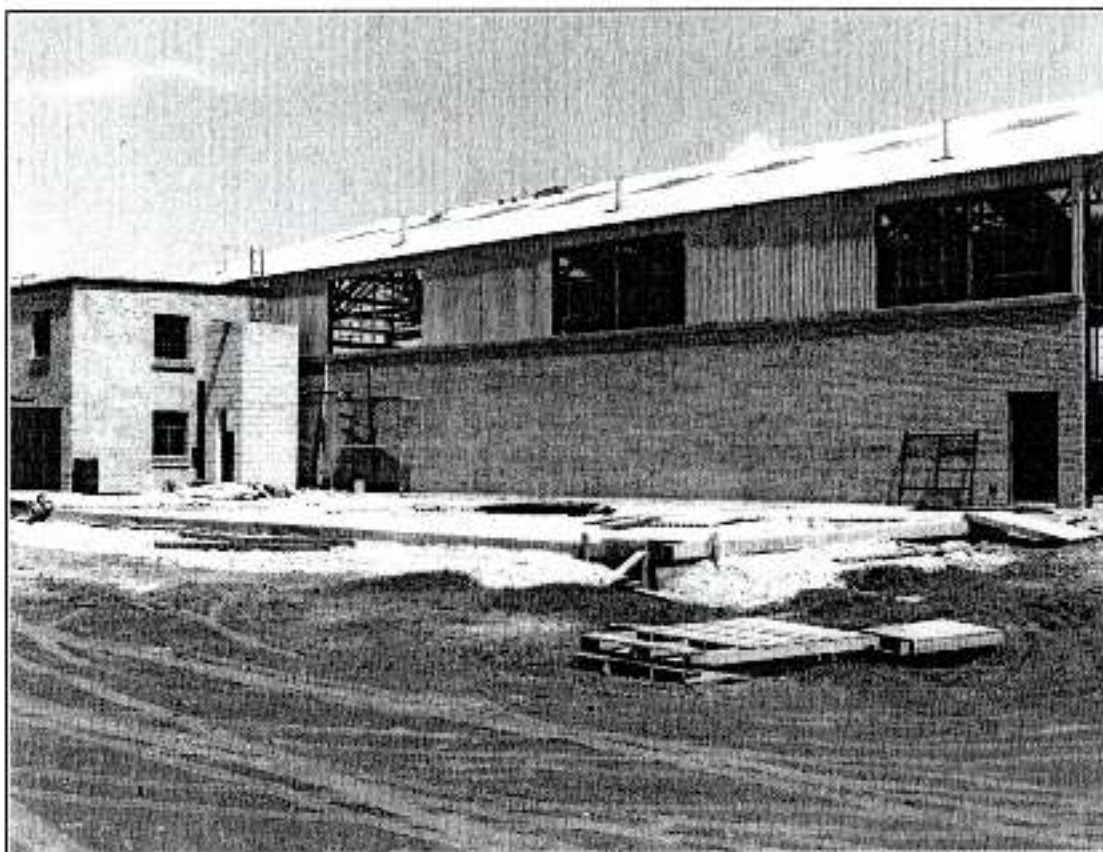
Figure A6. *Construction of Hangar, photographed by Sgt J. T. Elsis, ANG Photo Lab, Kelly AFB, Texas*
Site of explosion, left.
