# Monitoring of the South Flores Parking Garage Expansion, San Antonio, Bexar County, Texas

by  
Nathan DiVito  
and  
Kristi M. Ulrich

Texas Antiquities Permit No. 5620

*Prepared by:*  
Center for Archaeological Research  
The University of Texas at San Antonio  
Technical Report, No. 22

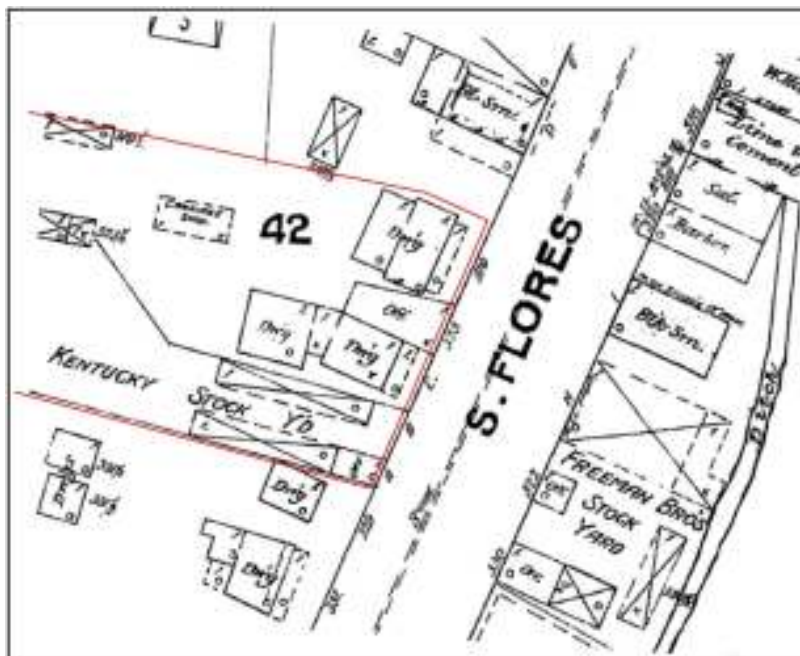
Figure 2-4. Eastern portion of the project area on the 1888 Sanborn Fire Insurance Map.

The next map in the sequence indicates that there were no changes made to the portion of the lot that makes up the APE through 1888. The same structures are depicted on the map as in 1885, though one previously vacant structure is now labeled as a dwelling, and the Kentucky Stock Yard occupies the majority of the APE (Figure 2-4).

According to the Sanborn maps the Kentucky Stockyard would have been in this area in 1888 (Figure 2-4). Generally, stockyards do not have elaborate underground drainage systems and are used to feed and house livestock. Following the Kentucky stockyard sales stables were set up and are shown on the 1896 and 1904 Sanborn maps (Figures 2-6 and 2-7). Given the date of the bricks in the drains, and the fact that stockyards and sales stables do not have underground features, the drainage system is likely associated with the building shown on the 1912 Sanborn map (Figure 2-8). The drainage seems to follow the outside footprint of this structure. Whatever the drains led into was probably destroyed by previous construction activities.

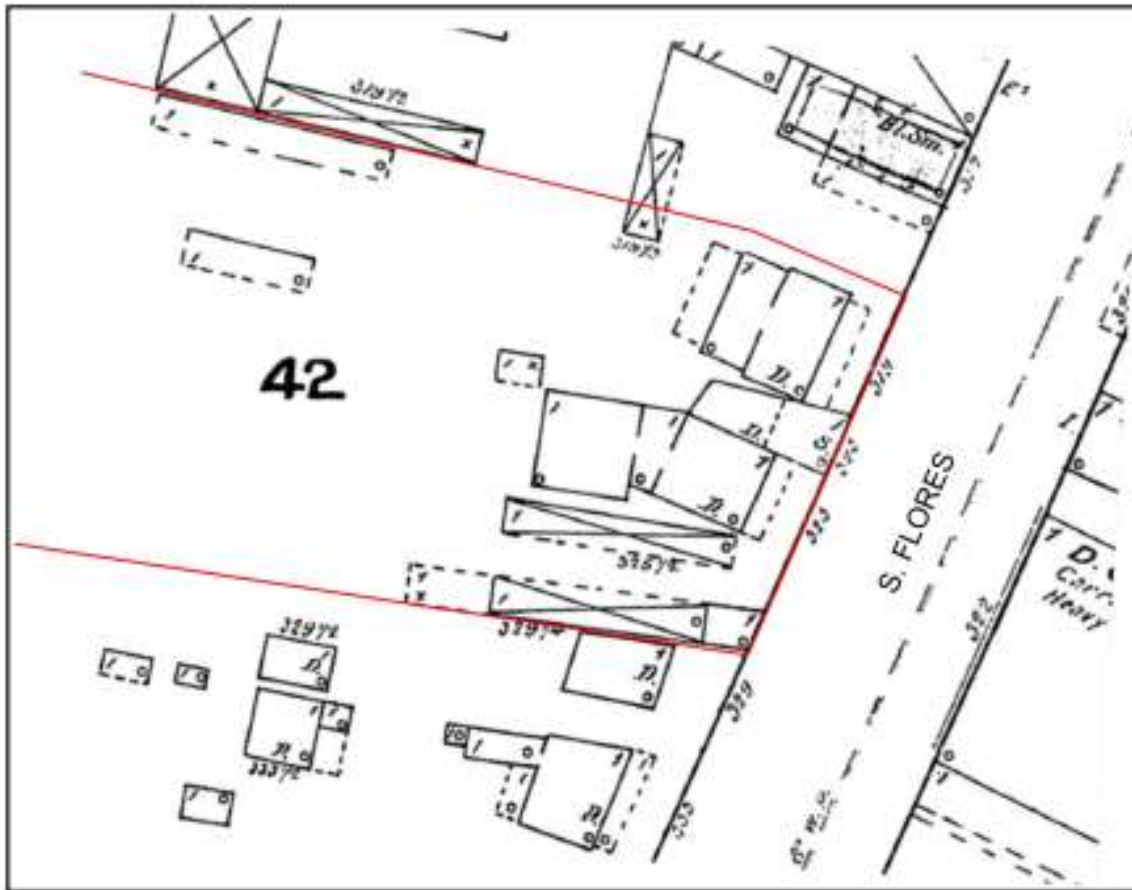
Figure 2-5. Eastern portion of the project area on the 1892 Sanborn Fire Insurance Map.

The next map in the sequence dates to 1892 (Figure 2-5). At this time, there is no mention of the Kentucky Stock Yards, though two structures that were associated with it in the past are still present on the map. The dwellings present in 1885 and 1888 are also present. A few outbuildings that were noted on the previous maps are missing suggesting that they were demolished (Figure 2-5). The carriage shed also appears to be missing from the 1892 map although it is possible that it is the unmarked structure located along the property line.

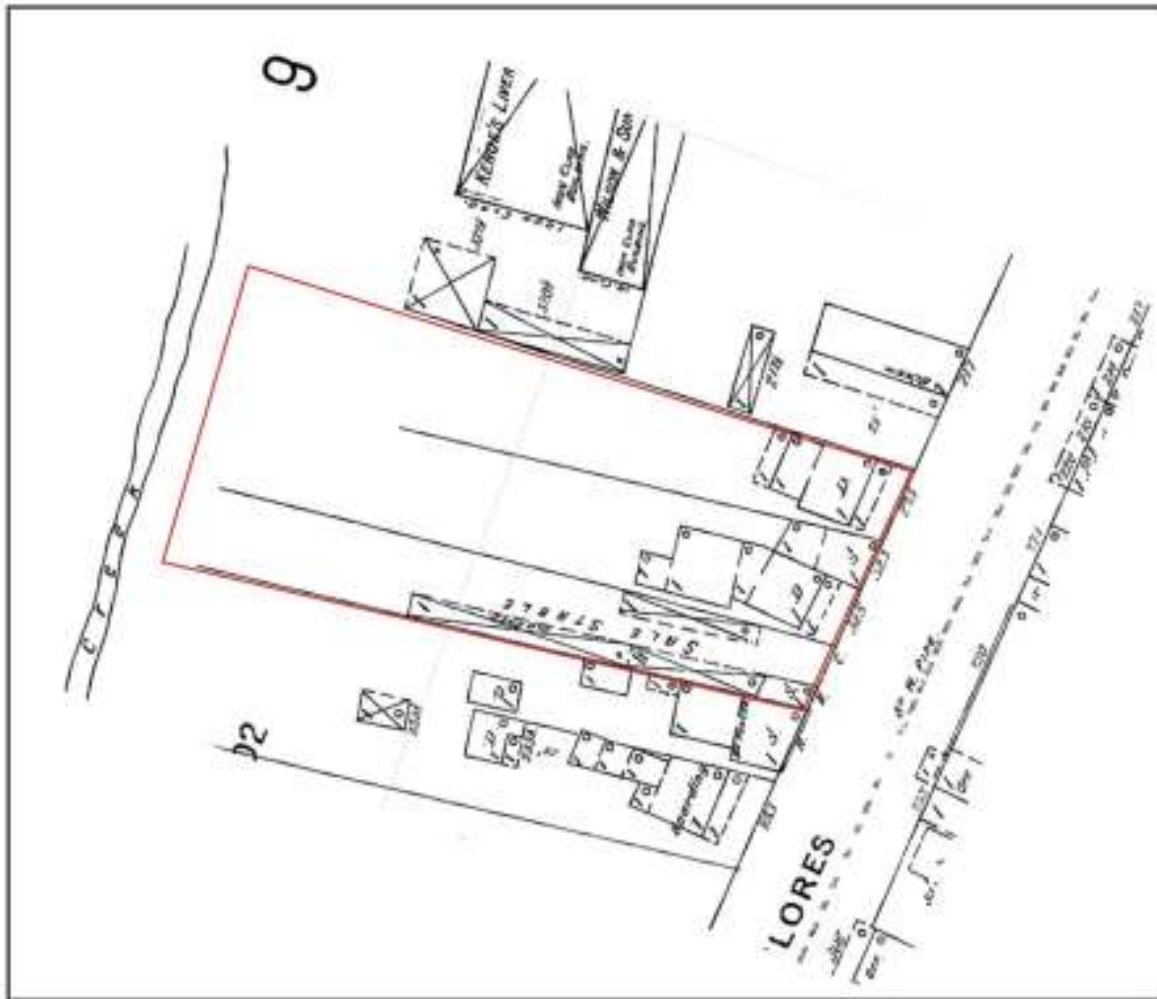
Figure 2-6. The project area overlaid on the 1896 Sanborn Fire Insurance Map.

A few changes are noted in the next map drawn in 1896 (Figure 2-6). Additional stables appear to have been added to what was the Kentucky Stock Yard in 1888. The area on the 1896 map is referred to as the Sale Stable, with the addition labeled as “Old Shed”. The northeast portion of the APE changed only slightly, though outbuildings associated with the northernmost dwelling have disappeared from the map.

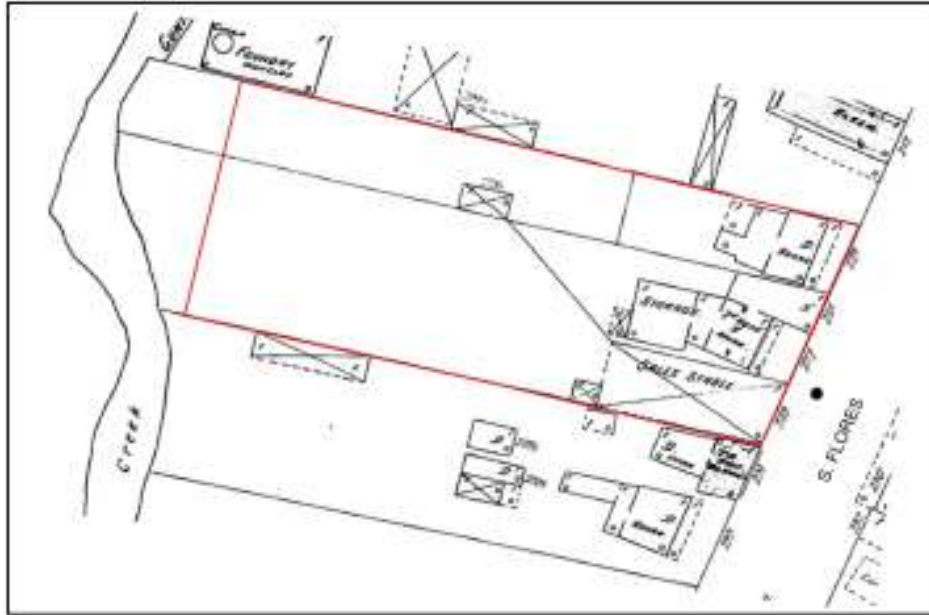
Figure 2-7. Project area on the 1904 Sanborn Fire Insurance Map.

By 1904, the properties have undergone some changes that consist of the reappearance of an outbuilding that may have been the carriage house (Figure 2-7). In addition, it appears that a property line has been drawn to the west of the northern dwelling. The Sales Stable changed shape, and is now not as deep in the property as in 1896. The structure located just north of the Sales Stable had a second story added during the eight-year span between the two maps. In addition, the attached room that was once labeled as a dwelling is now been identified as storage. The dwelling that was located in the northeast portion of the APE is now been identified as adobe.

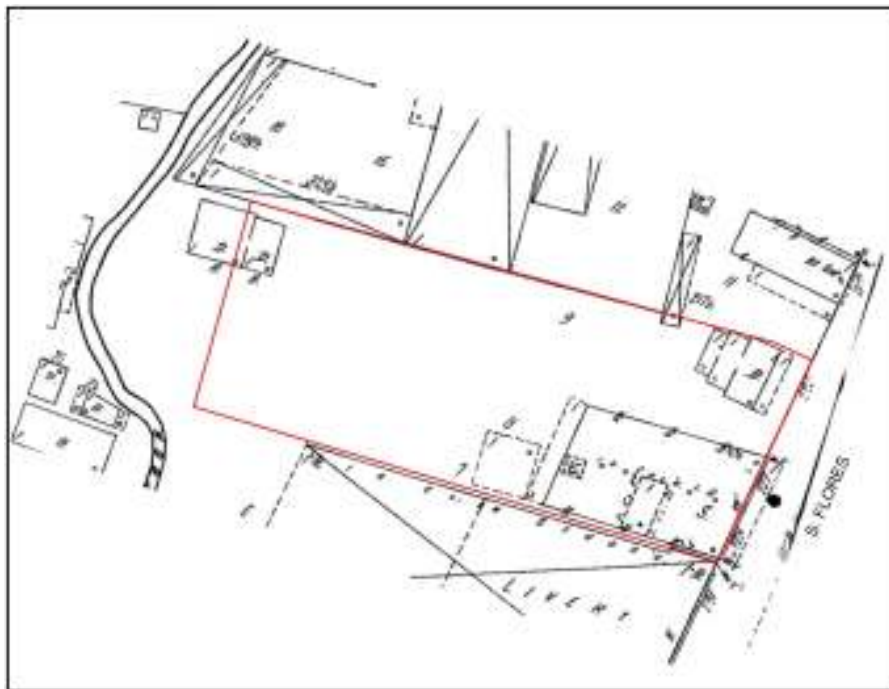
Figure 2-8. The project area overlaid on the 1912 Sanborn Fire Insurance Map.

The Sanborn map of 1912 shows significant changes to the structures present on the lot (Figure 2-8). The Sales Stable and adjacent structure was converted into a rectangular building. It also is possible that the structure in the 1904 map was razed and this was a new one. The adobe structure that was located in the northeast portion of the APE appears to still be standing in 1912.

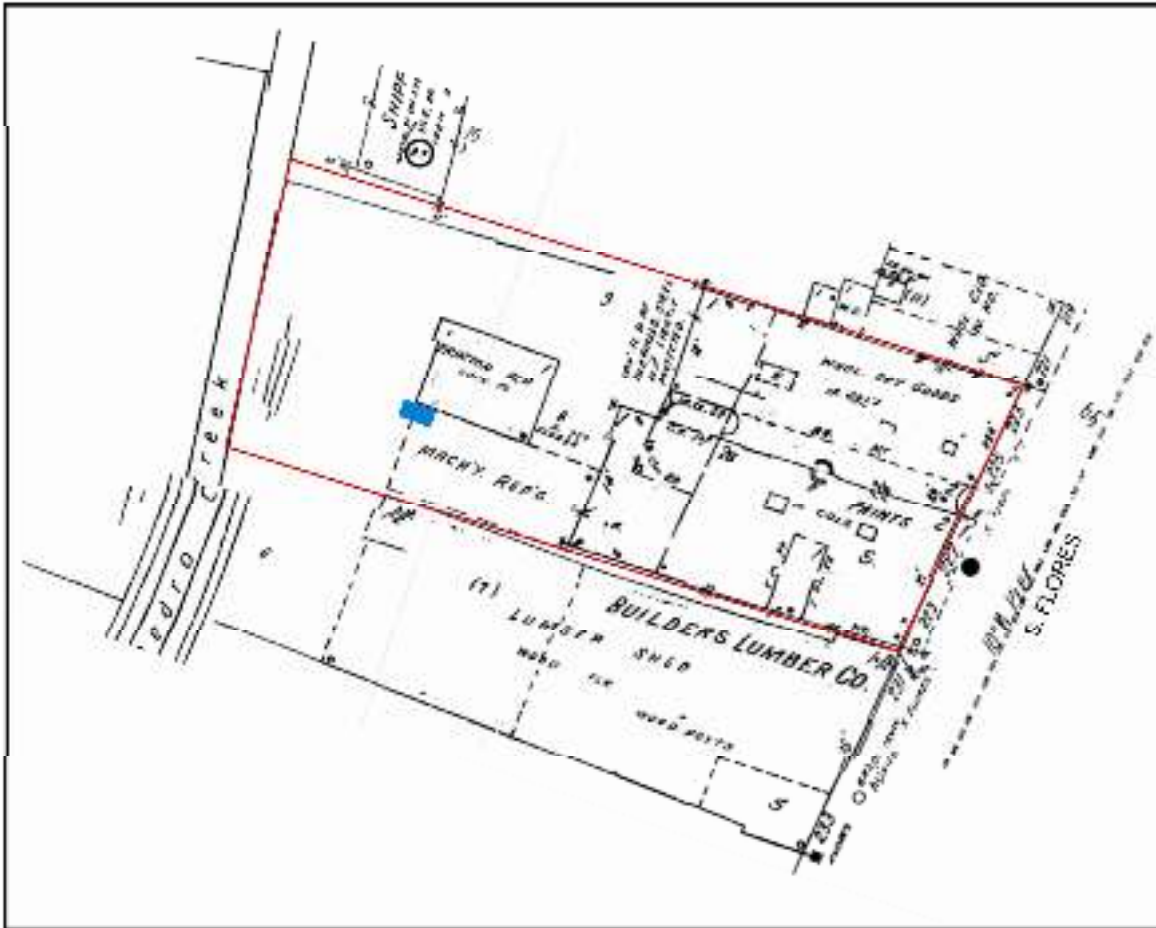
Figure 2-9. The project area overlaid on the 1912-1954 Sanborn Fire Insurance Map. The blue rectangle is the approximate location of an underground gasoline storage tank removed in 2000.

The last of the historic Sanborn Fire Insurance maps consulted shows the lot as it appeared between 1912 through 1954 (Figure 2-9). This map shows significant changes to the APE. All previous structures are gone. In place of the adobe dwelling is a wholesale dry goods store. The rectangular building that had appeared on the 1912 map is now a paint store. A machinery repair garage and a tractor repair facility are added in the central portion of the APE.

The wheels found are likely from farm implements from the tractor repair shop that would have stood in this quadrant. The building first shows up on the post-1912 Sanborn fire map (see Figure 2-9). The wheels observed were various sizes, ranging from 105-120 cm in diameter. There were two different types of wheels, those with single spokes and those with alternating spokes. In addition, among the two styles of spokes, round spokes and flat spokes were noted (Figure 4-11). Some wheels also had the inner and outer hub assemblies still intact. Many of the wheels were in bad condition and heavily rusted.

In 2000, a large underground gasoline storage tank was removed from the middle of the southwestern quadrant of the APE (see Figure 2-9). The soil in this area was black and oily and smelled like fuel. The soil was undoubtedly contaminated by the leaking of the storage tank and it covered a six meter diameter area (Figure 4-12). A small scatter of crushed brick and window glass was observed just north of this area.

During the demolition, four architectural features were encountered. Cultural features were recorded and quickly assessed in the field. None of the features pre-date 1850. The dry goods store foundation dates to circa-1912 as it is shown on the 1912-1954 Sanborn maps (see Figure 2-9). The adjoining room feature dates between 1883, the founding of D'Hanis Brick and Tile, and 1921 when C.B.M.A. maker's marks became standard on bricks of all members. The red brick drainage system dates sometime between 1904, just after the closing of the sales stables, and 1908 when the Blumberg Brick Company was bought out by Lone Star Manufacturing (Anonymous 1908:168). The small foundation encountered adjacent to the drainage system was comprised of a more modern concrete foundation with thick horizontal rebar and its date of manufacture likely post-dates 1912. The primary focus of this project, the pre-1850 adobe structure, could not be located and was most likely destroyed by the building of the basement for the dry goods warehouse.

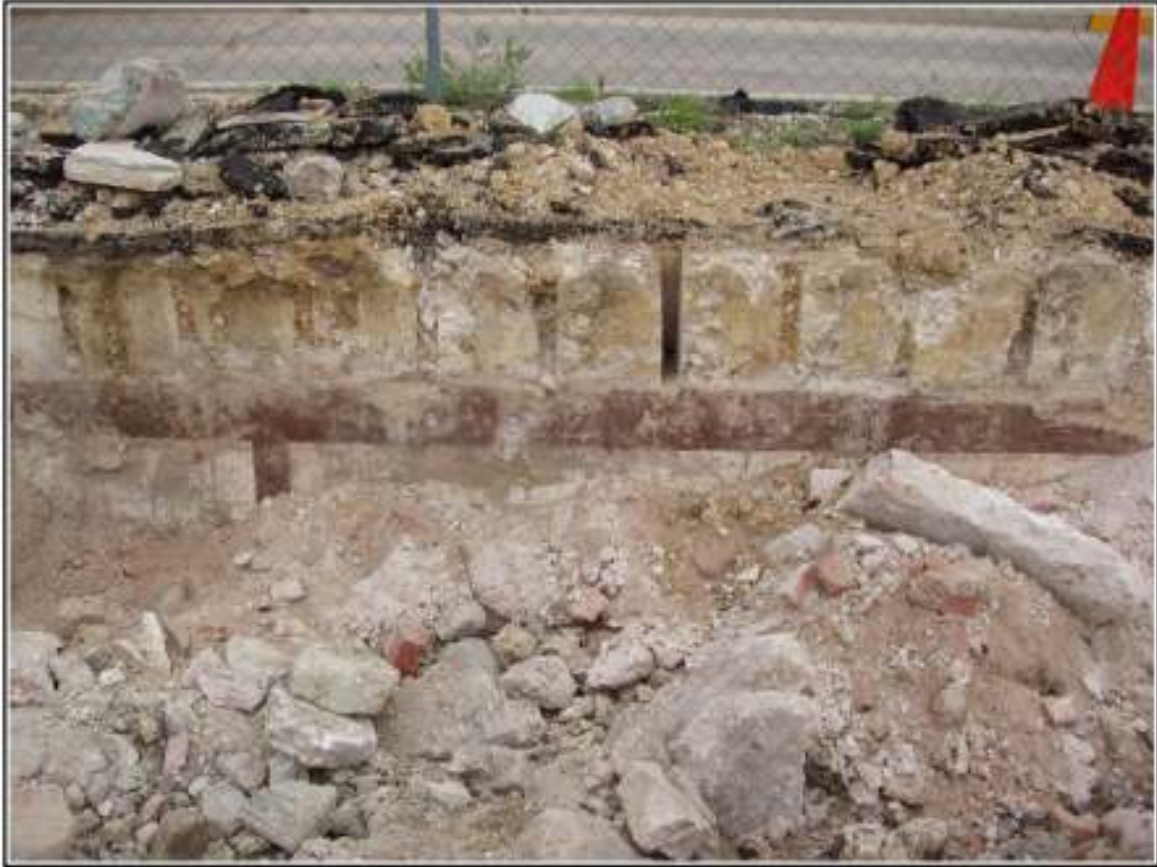
*Figure 4-2. Dry goods warehouse foundation and fill. Note red/brown stripe near top of foundation.*

As noted in the background summary, the northeastern portion of the project area was the main focus of this monitoring project and had the greatest potential to yield cultural deposits and/or features pre-dating 1850. Upon removal of the asphalt in this corner, the foundation of the post-1912 dry goods warehouse was uncovered. It appeared that at least some of the warehouse building had been demolished into the basement of the structure (Figure 4-2). The basement was covered almost all the way to the top with fill and other debris.

The foundation of the warehouse was 50 cm wide and measured 33 meters E-W and 19.6 meters N-S. The walls of the basement are painted and a thick red-brown stripe is near the top of the basement wall. The line extends along the northern wall of the foundation. Some of the fill was excavated along this wall to determine the depth of the basement. Fill was excavated to 120 cm below the red stripe where it became too dangerous to continue. A soil change was noted at 90 cm below the stripe, however everything encountered below was also fill. When heavy equipment was later used to excavate the lot to its terminal depth of 5 feet, the bottom of the basement had not been reached.

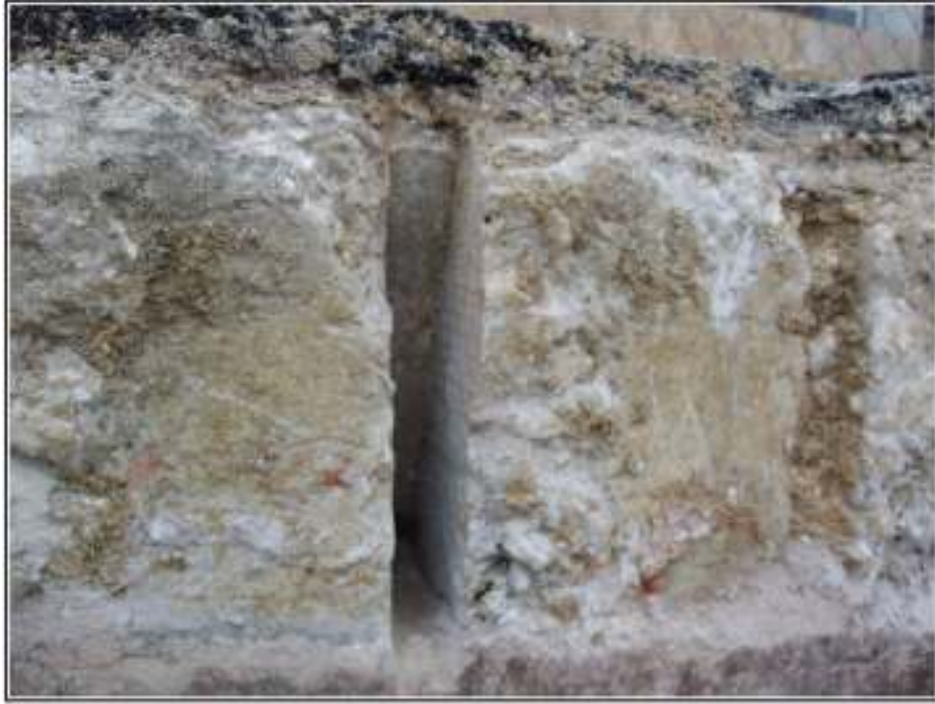
Figure 4-3. Slots in dry goods warehouse foundation.

The foundation of the structure had large slots going down to right above the large red stripe. The slots were evenly spaced along the entire length of the foundation (Figure 4-3).

These slots were probably used as supports for floor joists for the first floor of the building. Spiral rebar was also noted in and around the footprint of the dry goods warehouse (Figure 4-4). The rebar is consistent with buildings that would have been constructed in the early 1900's. In addition, a large piece of twisted lead was collected from the northern portion of the foundation of the dry goods store.

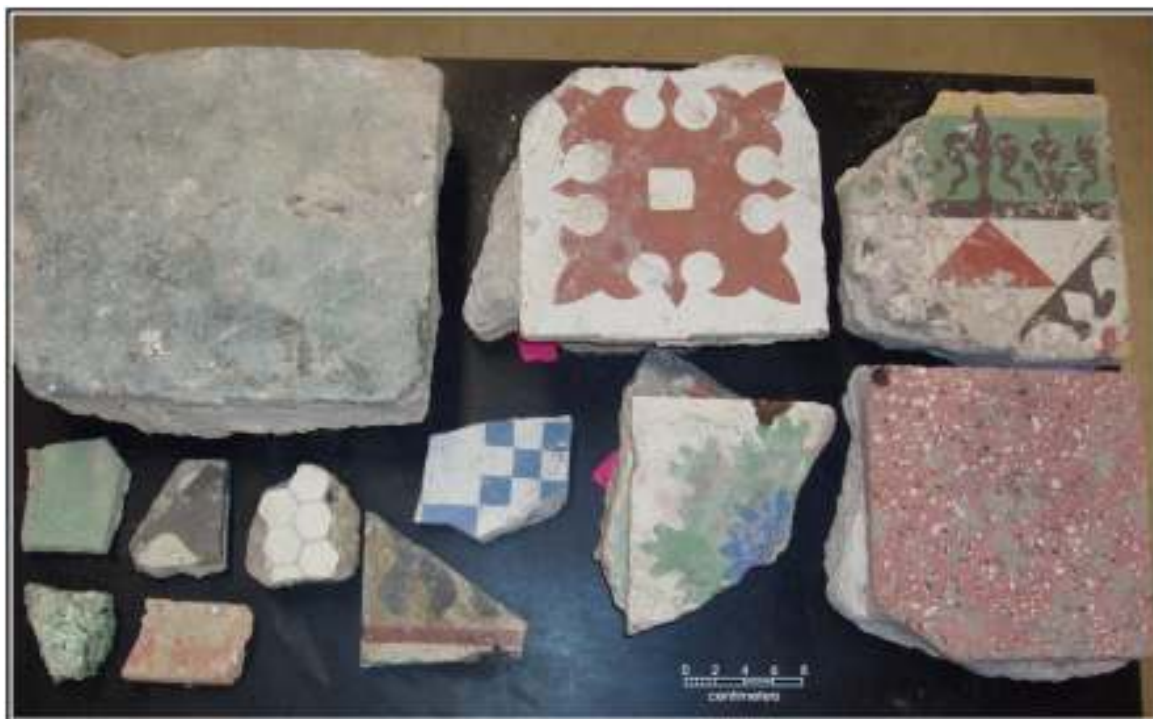
Figure 4-5. Collection of tile samples recovered from basement of dry goods warehouse.

During the excavation of the fill in the basement, samples of the several varieties of tile, probably part of the dry goods warehouse, were recovered. Tile types recovered included: concrete tiles, floor tiles and terrazzo tiles (Figure 4-5).

A sample of the concrete tile was collected. It is produced by mixing concrete with other minerals like mica, marble or onyx. The sample collected was multi-layered and green on top with mica and other minerals mixed throughout. Many different styles of floor tiles were collected from the basement area. Some have colored designs and some are comprised of mixed materials. The colors include red, green, black, and white. A partial maker's mark of "...NTON..." was noted on the back of one of the tiles. This may suggest that some of the tile was made in San Antonio, perhaps by the San Antonio Tile Company, although the partial mark is not enough to make a definitive claim (Figure 4-6). The majority of the tiles collected had concrete on the backside that hid maker's marks and prevented them from being identified.

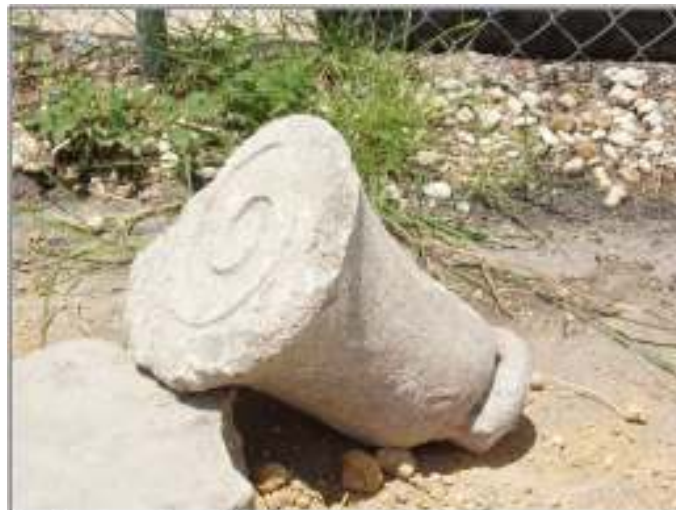
Figure 4-7. Terrazzo column/rail/leg.

In addition to the concrete tiles, Terrazzo tile was also collected. Terrazzo tile is made of marble, granite, onyx and glass chips mixed with a binder and then embedded in cement (Flooring and Carpets 2010). The terrazzo is then cured, polished and cut into tiles or formed. The samples collected are green terrazzo tiles with onyx and marble chips throughout and consist of fragments of what appear to be a rail, column, or curbing of some type. The terrazzo observed in the field was bell shaped and decorative with a swirl design and may have made up a column and was observed in the eastern corner of the dry goods warehouse but was not collected (Figure 4-7).

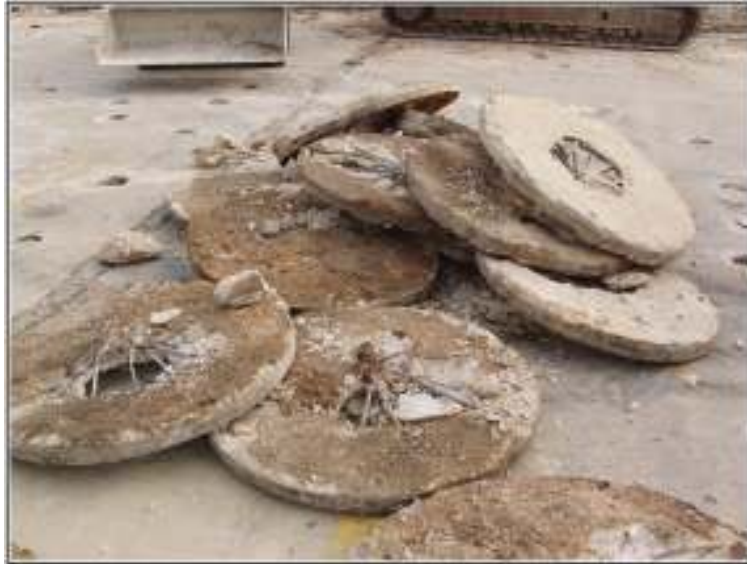
Figure 4-10. *Wheels encased in concrete.*

The concrete removed from this area of the lot also contained large wheels from early 19<sup>th</sup> century farming equipment, as well as other metal and other items that could be used for reinforcement. Fencing, wire and scrap metal were noted encased in the concrete. Sixty to seventy wheels were laid out evenly spaced over the southwestern portion of the project area and parts of the northwest and southeast portions (Figures 4-1, 4-10). The concrete was then poured over the wheels and other metal objects which acted as reinforcement, therefore strengthening the concrete surface of the parking lot.

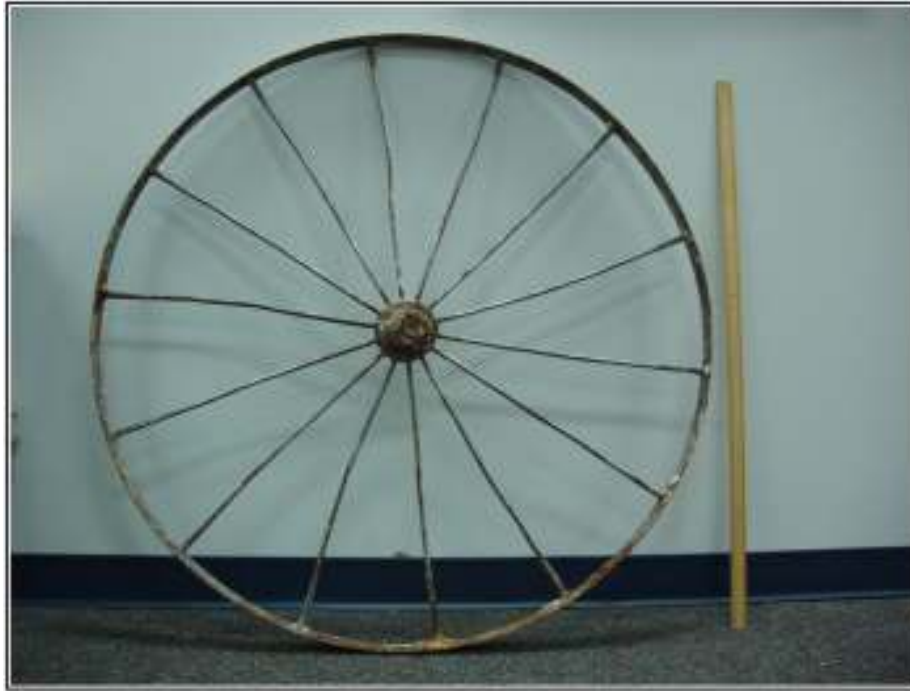
Figure 4-13. Wheel collected for study at CAR.

The only artifact recovered was one of the large wheels (Figure 4-13). It was entirely encased in concrete and had to be chipped out with a mini-jackhammer. It is 105 cm in diameter and is the single, flat spoke variety. The wheel will be cleaned and stabilized and used in a public outreach exhibit.

These wheels would have been used on early 19<sup>th</sup> century farm equipment that would have been worked on at the nearby tractor repair shop (Oldham 2010). The variation in types suggests the wheels are from many different types of farm implements. Considering that rubber tires for farm tractors and implements were first sold in 1932, the wheels from the repair shop would have been manufactured prior to this time. It would have been likely that these wheels types would have been repaired in the shop up until the end of the 1930's and maybe well into the 1940's (Antique Farming 2010).

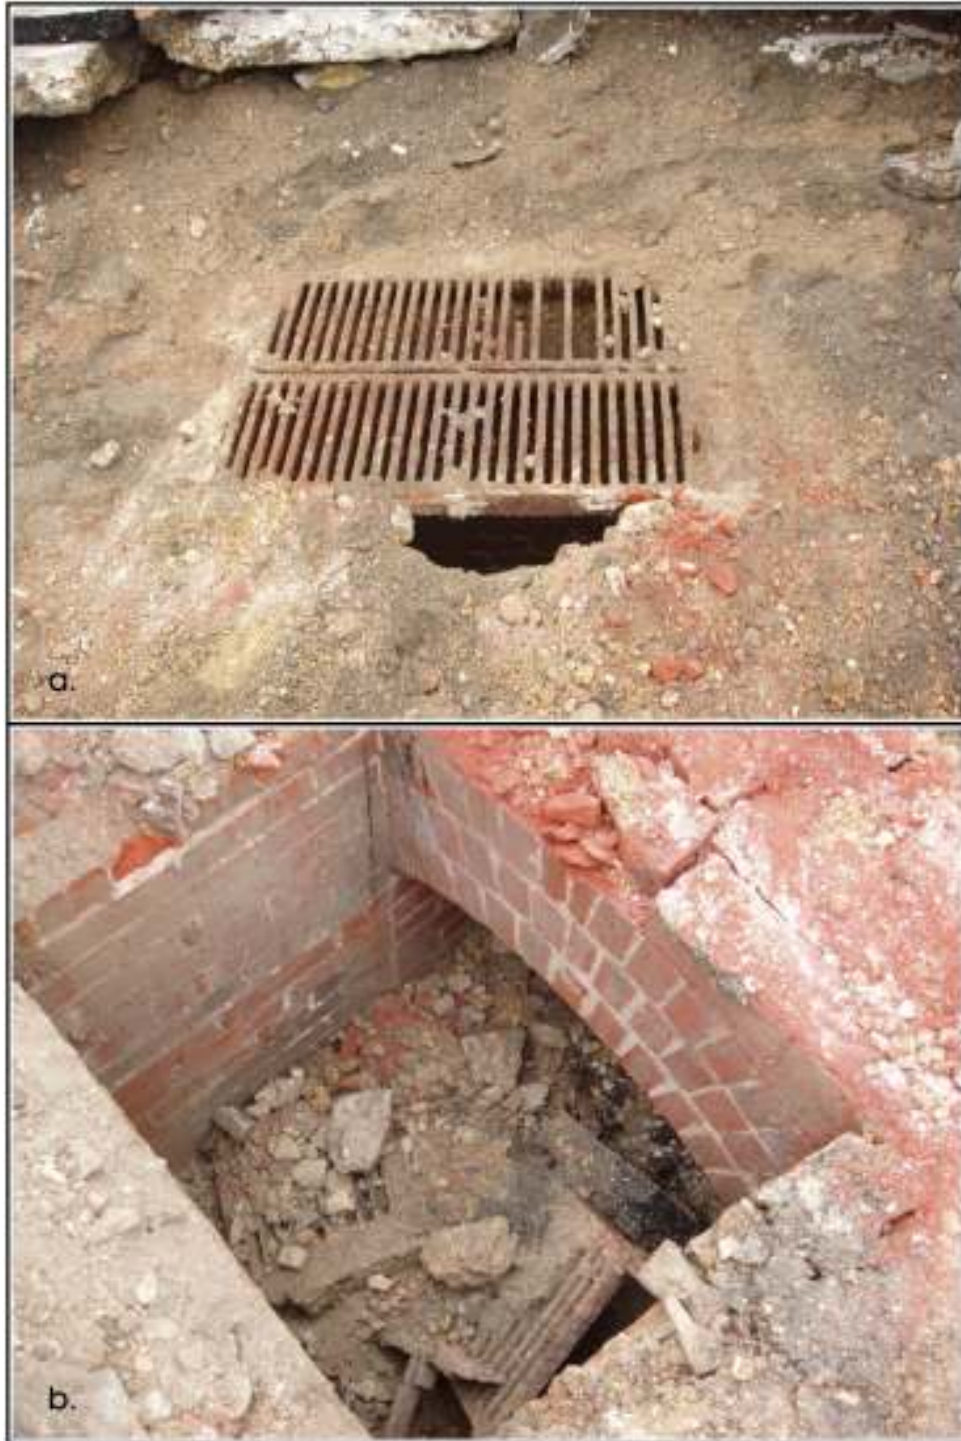
Figure 4-14a, b. Views of red brick drain.

A large brick drainage system extended along the northern and western perimeter of this quadrant. It is comprised of nine drains all composed of the same type of brick. The drains were covered with iron grates that measured 35 x 45 cm wide (Figure 4-15a). The drains were filled with modern fill, trash, and pieces of decayed and burnt wood. The roof of the four western drains is arched (Figure 4-15b). Some of

the bricks inside the middle drain on the west side were badly burned on the side facing into the drain. The southern-most drain extends past the chain link fence boundary. The drains running along the northern perimeter open underneath to the south and have the same overall profile as the western four drains. All of the drains are spaced evenly at 3.6 meters apart and are all the same dimension. The western drains seem to run east while the northern drains seem to run south back toward a central point but nothing was observed in this area.

The artifacts recovered from this quadrant include a single red Blumberg brick from the drainage system and a piece of the hub-assembly from one of the wheels imbedded in the concrete. The hub assembly is in good condition and free of rust. It has an identifying number on it but upon research nothing on the assembly could be found. Blumberg bricks were made locally at the Blumberg Brickyard in Seguin, Texas at the turn of the century. Production stopped in 1908 when the company was bought by Lone Star Manufacturing. (Anonymous 1908:168) This shows that the brick and the drainage system were constructed before 1908. These bricks would have been pressed in dry molds typical of the early 1900's (Gurcke 1987:100-112). How or why the brick in the center drain became burned is not known.

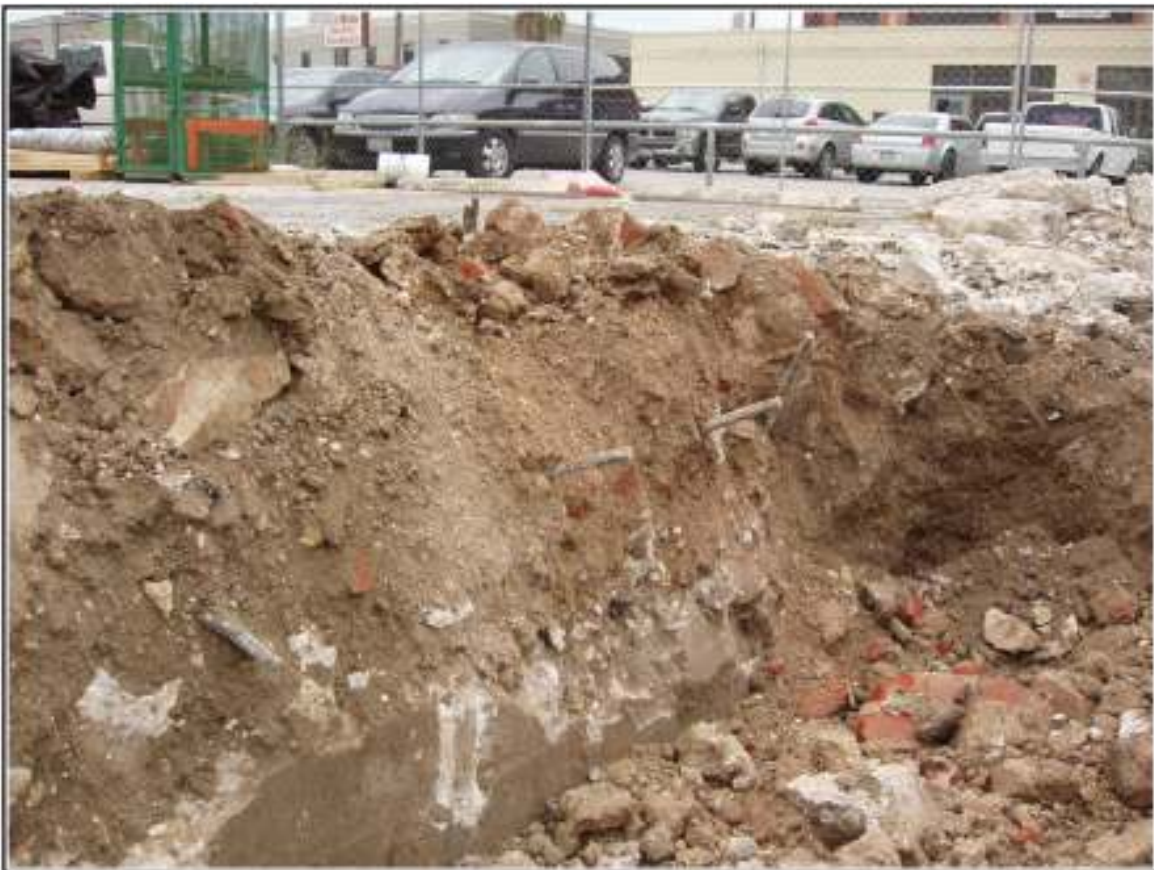
Figure 4-15. *Unknown foundation.*

Another foundation was uncovered just south of the southern-most drainage pit (Figure 4-15). The edge is 2.4 meters west of the drains and is in alignment with the western-most wall of the dry goods warehouse foundation. It was comprised of a thick concrete foundation of unknown thickness with rebar extending horizontally out of it. It extended past the southern boundary of the project area. The foundation extended to an unknown depth below the terminal depth of anticipated impact. No artifacts were collected from this feature.

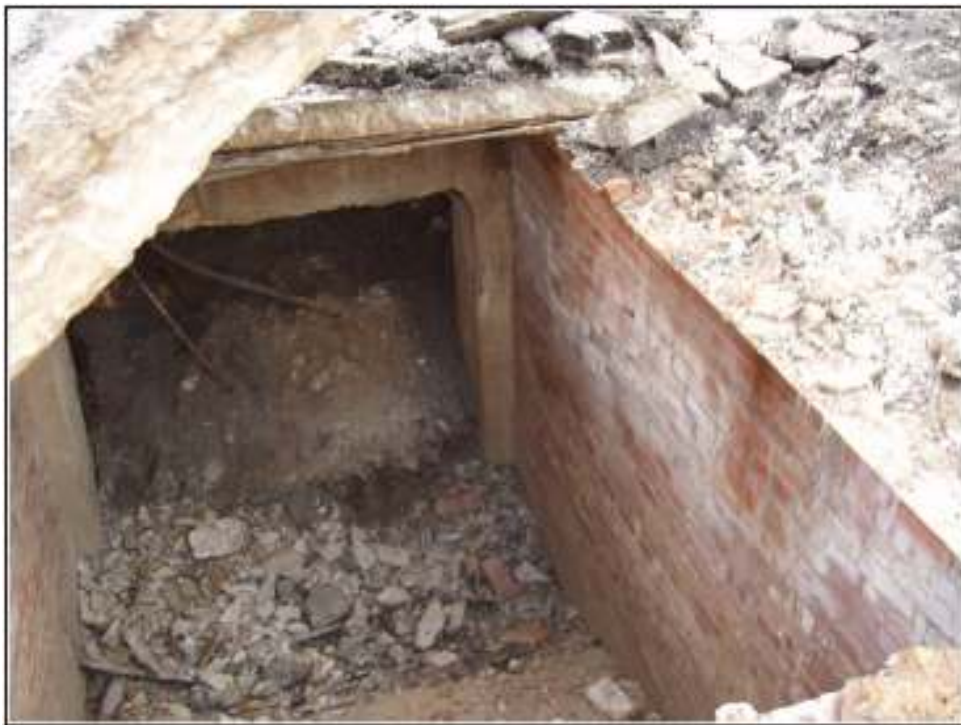
*Figure 4-16. View of room adjoining dry goods warehouse basement.*

A small room was uncovered 9.5 meters from the edge of South Flores Street and adjacent to the southern portion of the dry goods store foundation (Figure 4-16).

The room is 2.44 meters wide and about six meters long. It is adjacent to the southern side of the dry goods warehouse foundation. It is comprised of two red brick walls with concrete arches supporting the reinforced concrete cover. The northern side of the room opens into the basement of the dry goods store. This area is partially filled with debris and building materials. The bricks that comprise the walls are D'Hanis orange bricks that are missing a Common Brick Manufacturers Association (C.B.M.A) mark. They were likely made prior to 1921 when the C.B.M.A. mark began to be used by all association members (Anonymous 1921:417). The brick would have been made in molds at the D'Hanis Brick and Tile Company in D'Hanis, Texas (Gurcke 1987:100-112). No artifacts were collected from this feature.
