Prepared by: Center for Archaeological Research The University of Texas at San Antonio One UTSA Circle San Antonio, Texas 78249-1644 Archaeological Survey Report, No. 57

The Rio Rita Cistern Project (41BX483): The Excavation of a Nineteenth-Century Cistern in Downtown San Antonio, Bexar County, Texas

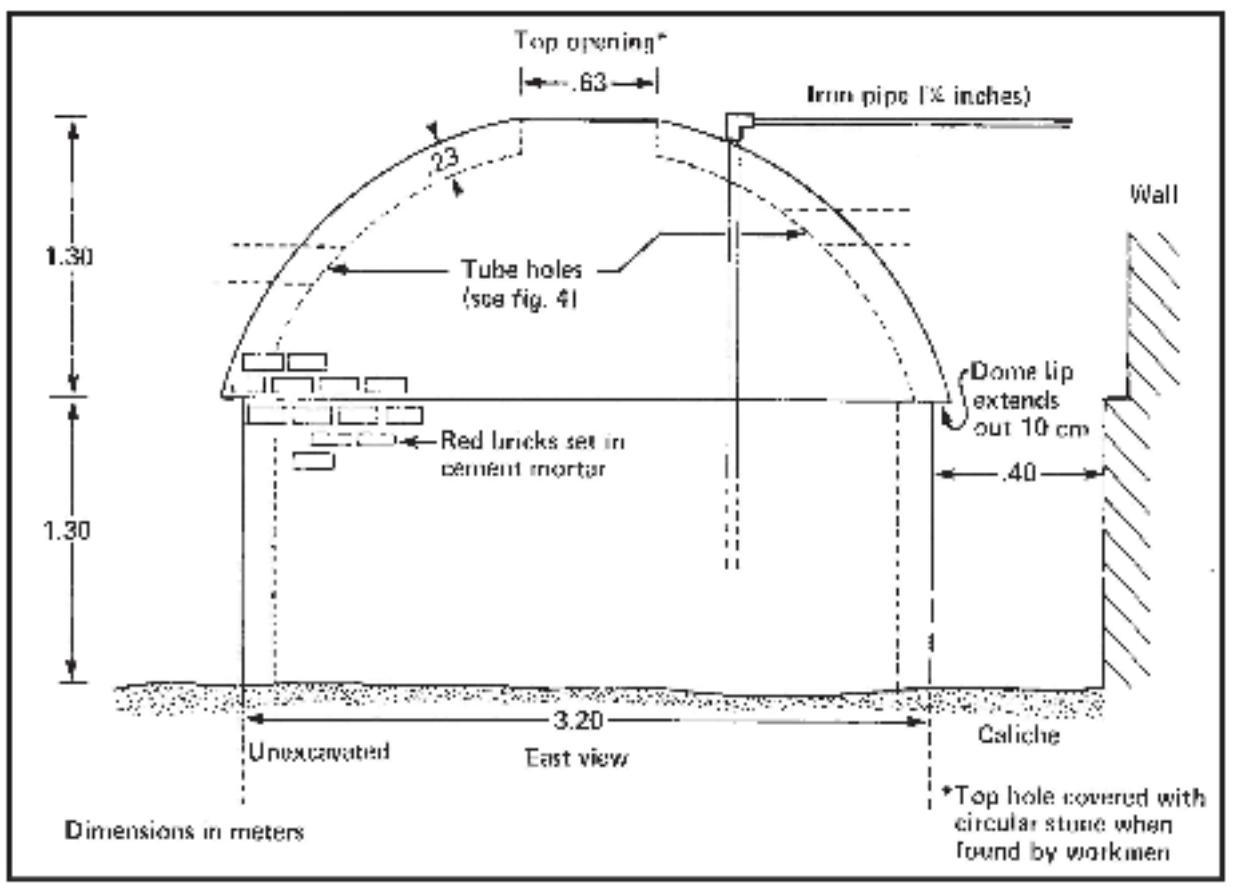
Figure 3. Side view of cistern.

The cistern is built of red bricks set in a cement mortar (Figures 3 and 4). The bricks average 7 cm by 20 cm and are laid in even coursing. A limestone block wall protects the cistern on the south and east sides. The wall is approximately 40 cm away from the cistern. The top of the structure has a dome shape and when found had one pipe and two larger tubes extending out of it. The two tubes apparently were the fill (sheet metal) and overflow (ceramic) conductors, while the 3/4-inch iron pipe, which extends to near the bottom of the cistern, was the output that served occupants of the building. The diameter of the cistern is at the center top of the dome. It is circular with a diameter of 63 cm and when first found was covered with a sub-circular flat stone. The interior of the cistern is lined with cement plaster to improve water retention.

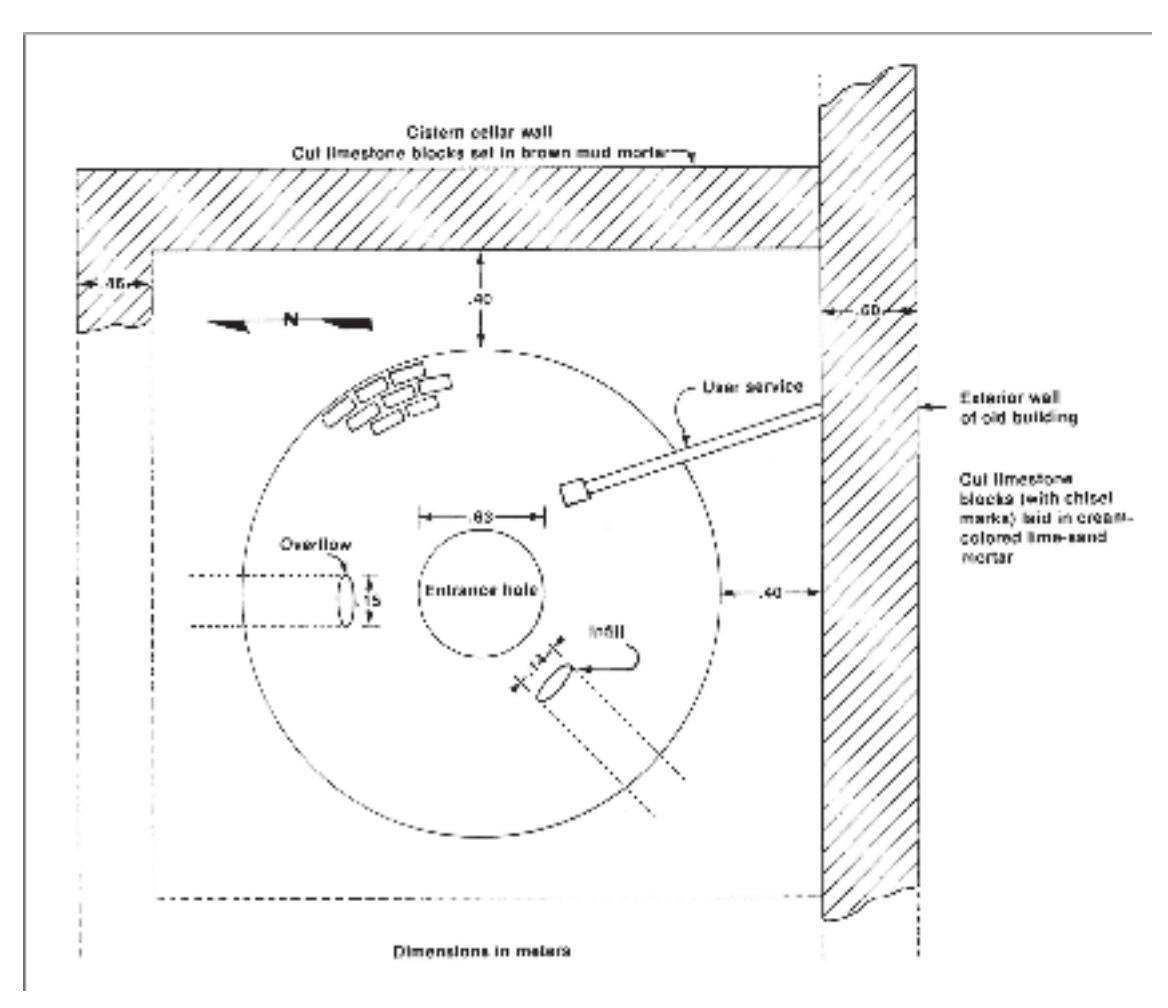
Figure 4. Top view of the cistern. The placement of the cistern within enclosure walls, and the positions of the inflow, outflow, and service tubes are shown.

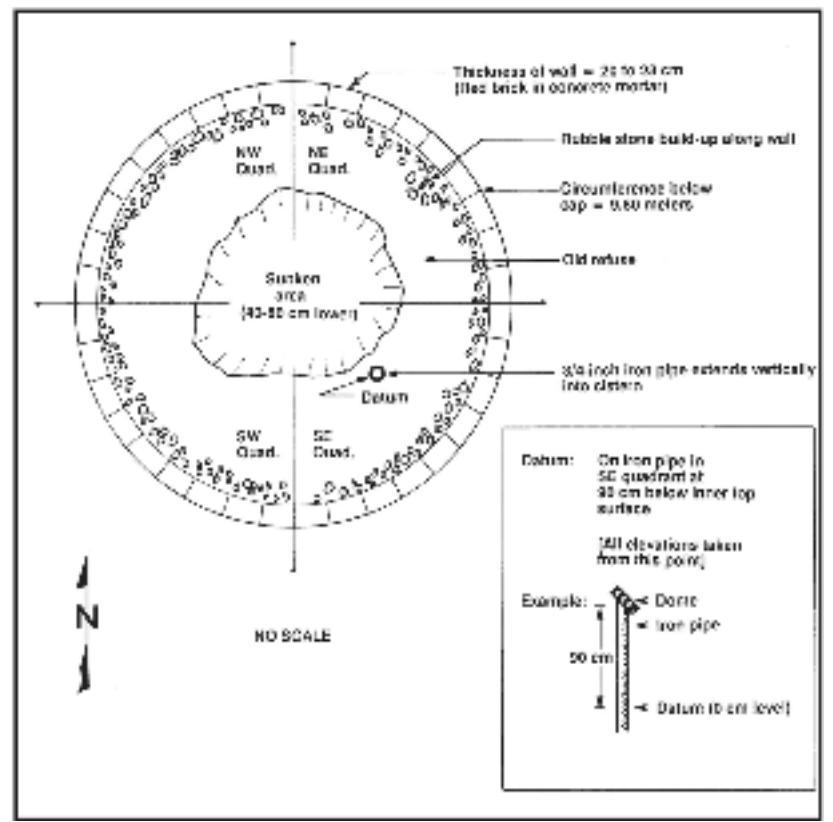
Figure 5. Interior of the cistern. Top view showing layout.

The deposits found within the structure consisted of loose, powdery dirt with inclusions of small stones and artifacts. Rubble stones had built up along the interior wall to near the spring of the dome, while the center area had a depression 40 to 80 cm deeper. The cistern interior was divided into four quadrants for control. Because of limited time and funds, all work was confined to the southeast quadrant (Figure 5).

An arbitrary datum was established for vertical control of excavations. The datum was marked 90 cm below the cistern entrance on an iron pipe that extended deep into the cistern (Figure 5).

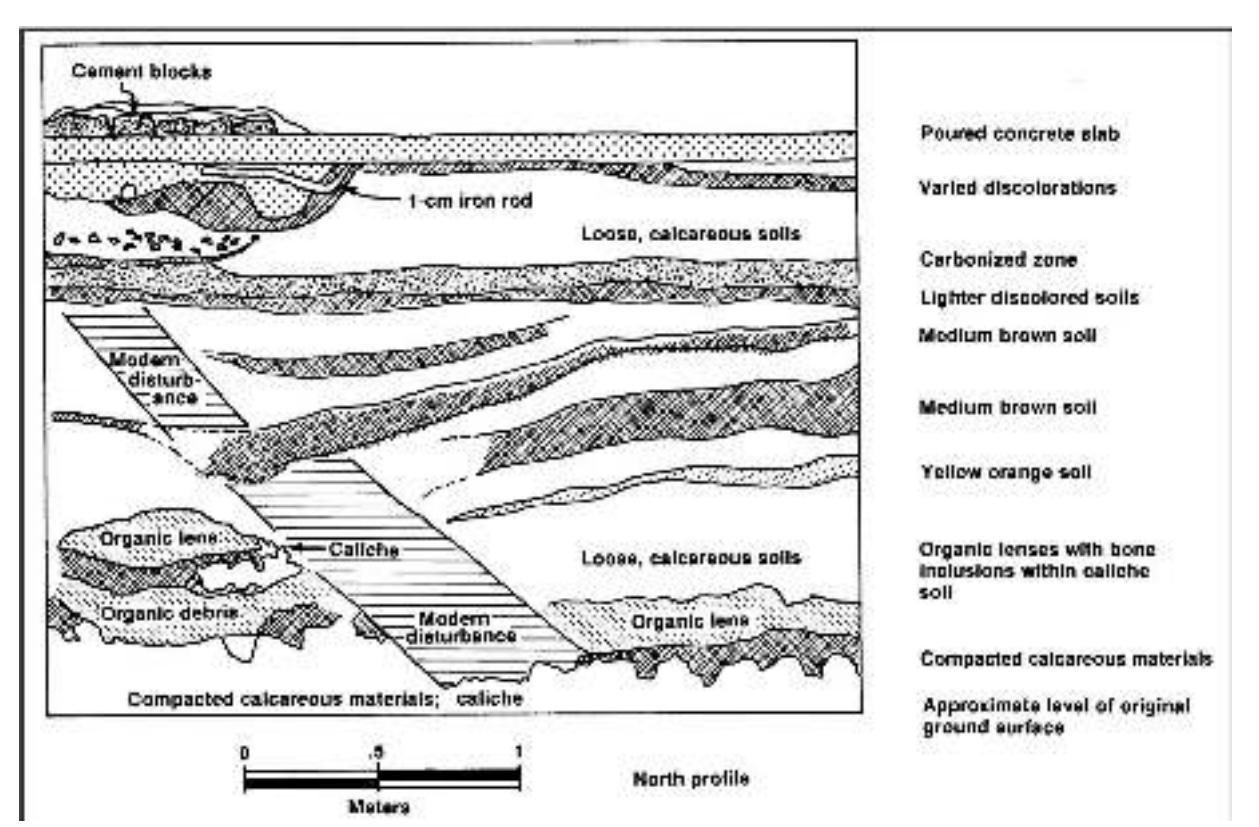
Figure 6. North profile of exterior fill. Stratigraphy of materials comprising the fill that covered the cistern.

A profile of the fill that once surrounded the cistern is presented in Figure 6. The profile shown is on the north side of the cistern and is over 2 m in depth.

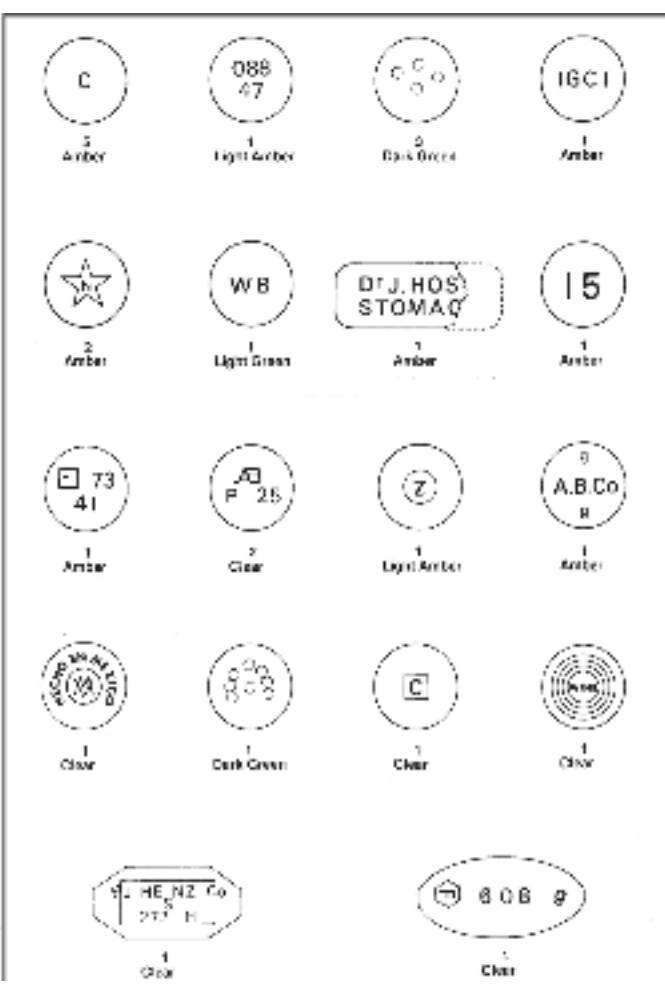
Figure 9. Bottle makers' marks. Numbers refer to number of specimens in that particular color of glass.

Bottle makers' marks were noted on 26 bases. The maker and approximate date of manufacture were identified on 12 of the bases. Makers' marks are illustrated in Figure 9, and the makers' marks with known chronological dates (Figure 10) are compared with mold seam age estimates in Figure 15. While over 80 percent of the sample dates between 1880 and 1916 (see Figure 10), makers' marks suggest over 40 percent of the identifiable sample was manufactured between 1880 and 1910 and presumably discarded during the same period.

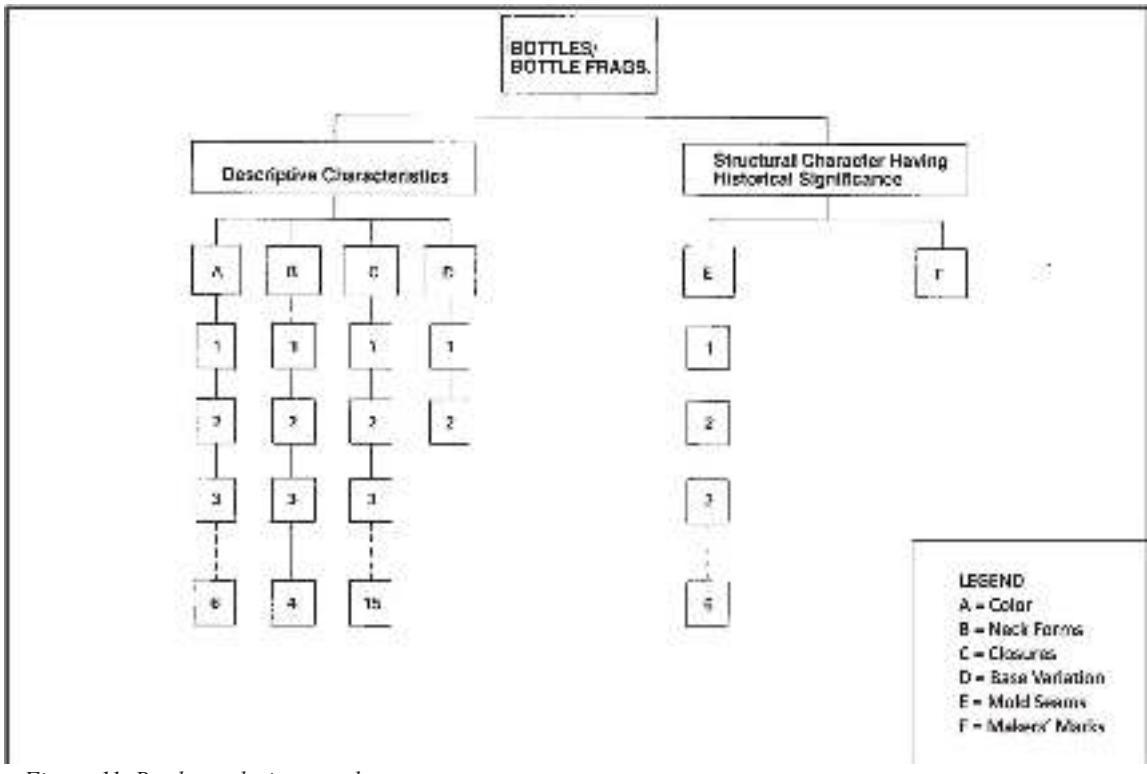
Figure 11. Bottle analysis procedure.

To identify group frequencies and bottle types and to establish a brief chronological association, bottles and fragments were analyzed according to a tentative typology based on various characteristics that included color, neck forms, method of closure, and base variations. A sequence of identifiable makers' marks and lengths of mold seams was then analyzed to establish a general period for the cistern's use as a refuse container. A diagram of analytical procedure is presented in Figure 11.

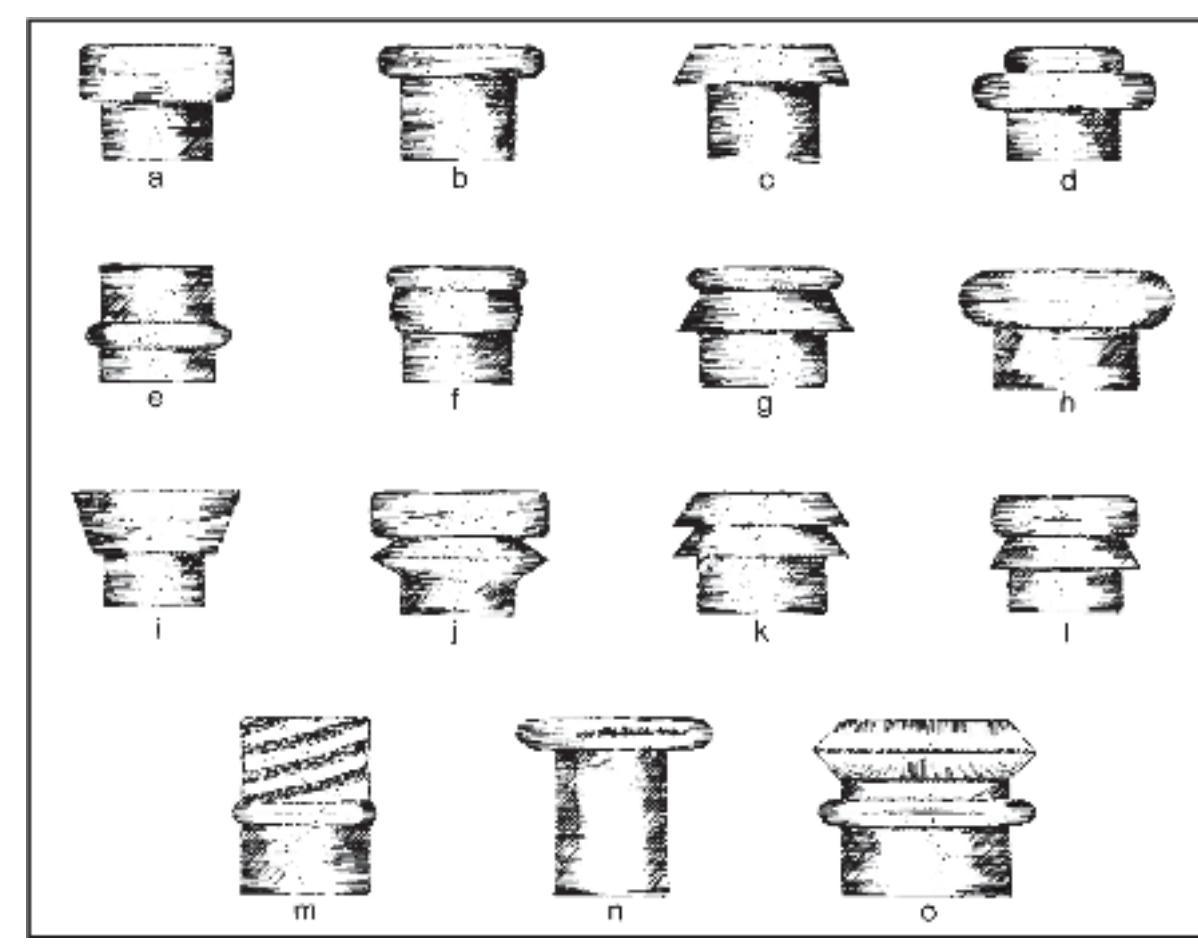
Figure 13. Methods of bottle closures: a) cork-type, lip with wide, parallel sides; b) narrow lip with parallel sides; c) flared (from the top) lip; d) parallel lip, wide parallel collar; e) parallel lip, narrow and rounded collar; f) "crowntop," protruding lip, rounded collar; g) protruding lip, slightly flared (from the bottom) collar; h) blob tip, large, rounded lip; i) large flared lip, from the bottom; j) parallel-sided lip, double-flared collar; k) rolled lip, flared (from top) collar; l) parallel-sided lip, flared from the top collar; m) externally threaded screw top; n) narrow, rounded and protruding lip, parallel long neck; and o) double-flared lip, narrow and rounded collar:

There were 15 different types of closures identified from the whole bottles and neck and head fragments. A narrow, flared lip without a collar was the most frequently observed type. Figure 13 shows the types of closures in this collection.

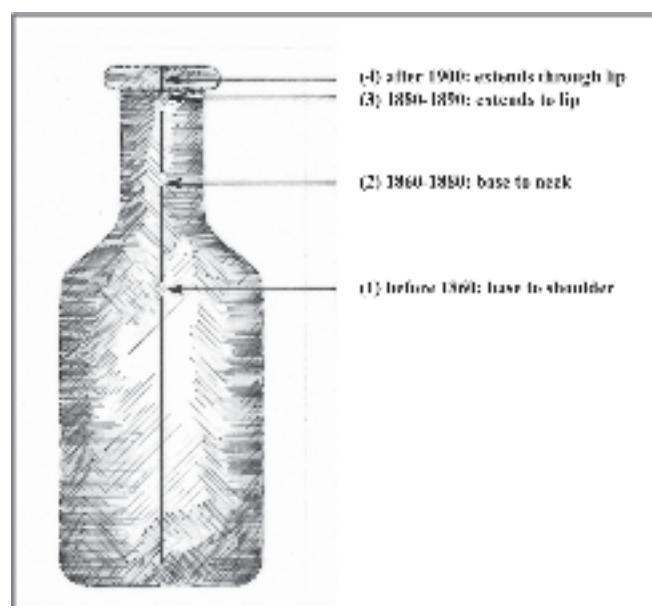
Figure 14. Bottle age by mold seam.

Base variations were subdivided into two groups dependent upon 1) the degree of base concavity (shallow, medium, deep, or rounded convex) and 2) the presence and type of scripting, numbers, or symbols on the base (single or multiple). Table 1 presents the statistical information for each of these base variations. body of a bottle. While these ages are only approximate, Adams suggest the following chronological associations based on techniques of glass manufacture in the nineteenth century (Figure 14).

- 1) before 1860: mold seam extends from base to shoulder;
- 2) 1860-1880: mold seam extends from base to neck;
- 3) 1880-1890: mold seam extends to lip;
- 4) after 1890: mold seam extends through lip.

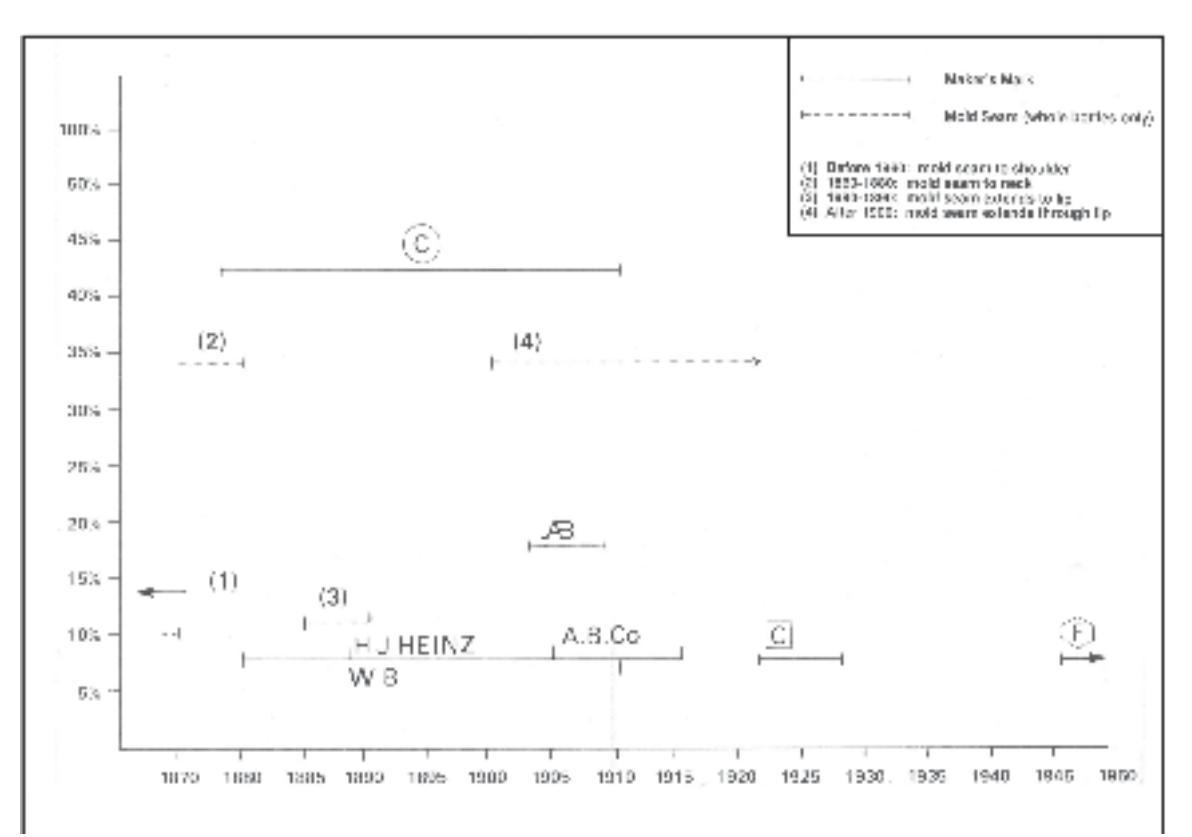
Figure 15. Frequency and chronology of bottles based on mold seams and makers' marks.

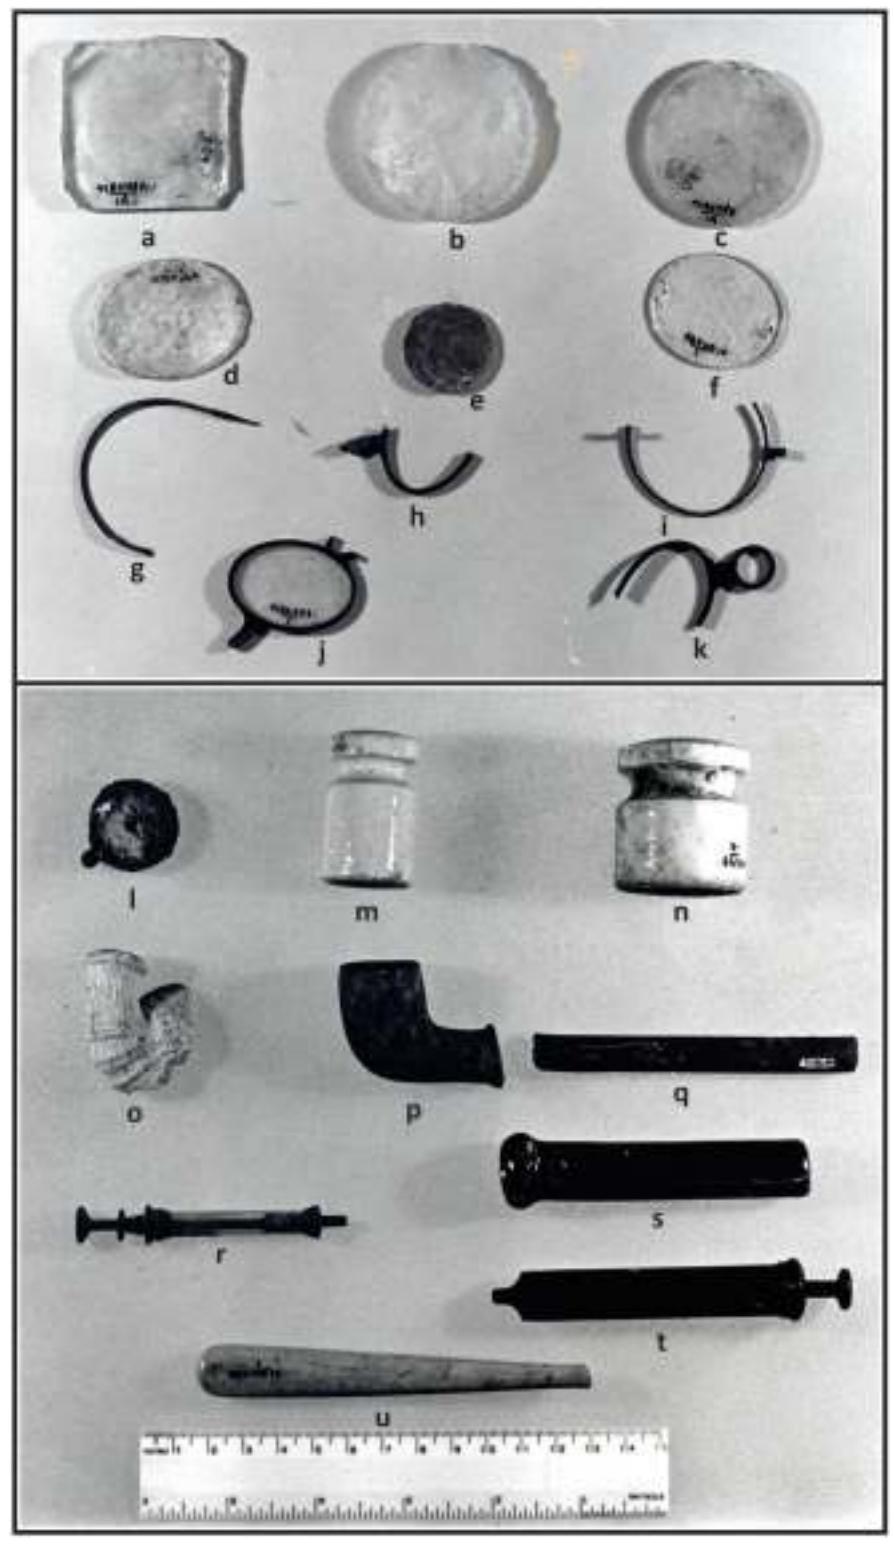
Figure 18. Optical materials and miscellaneous artifacts: a) rectanguloid lens blank; b, c) round lens blank; d) ground lens, no holes; e) bifocal lens plug; f) ground lens, with holes; g) ear hook; h) nose bridge section; i) lens rim; j, k) lorgnettes; l) metal compass; m, n) white ceramic insulators; o) clay smoking pipe bowl; p, q) wood pipe bowl and stem; r) calibrated metal syringe; s) tubular ceramic insulator; t) black plastic syringe; and u) bone toothbrush handle.

a single plug. Of the six specimens recovered, one is set in a rectanguloid blank (Figure 18,a) and one in a round blank (Figure 18,b); two are loose and ready to be inset; and the other two had been inset but are too fragmented to determine blank type.

Both lorgnette specimens are fragments and seem to be made of black plastic. Figure 18,j shows a lorgnette with the lens still intact. Figure 18,k is the other lorgnette, and although it does not have a lens, it does show the cord loop for attaching to one's shirt or to be worn around the neck.

The four wire frame fragments are from three-piece wire frame glasses. One fragment is the ear hook part of the frame (Figure 18,g). Two fragments are the wire rim for glasses. They are in very fragile condition as corrosion has set in, and the rims are ordinarily thin anyway. Figure 18,i shows one of the rim fragments. Figure 18,h shows a small part of the nose bridge section for wire frame glasses.
