The Archaeology and History of **ALAMO PLAZA**

Anne A. Fox, Feris A. Bass, Jr., and Thomas R. Hester

CENTER FOR ARCHAEOLOGICAL RESEARCH
THE UNIVERSITY OF TEXAS AT SAN ANTONIO
ARCHAEOLOGICAL SURVEY REPORT, NO. 16

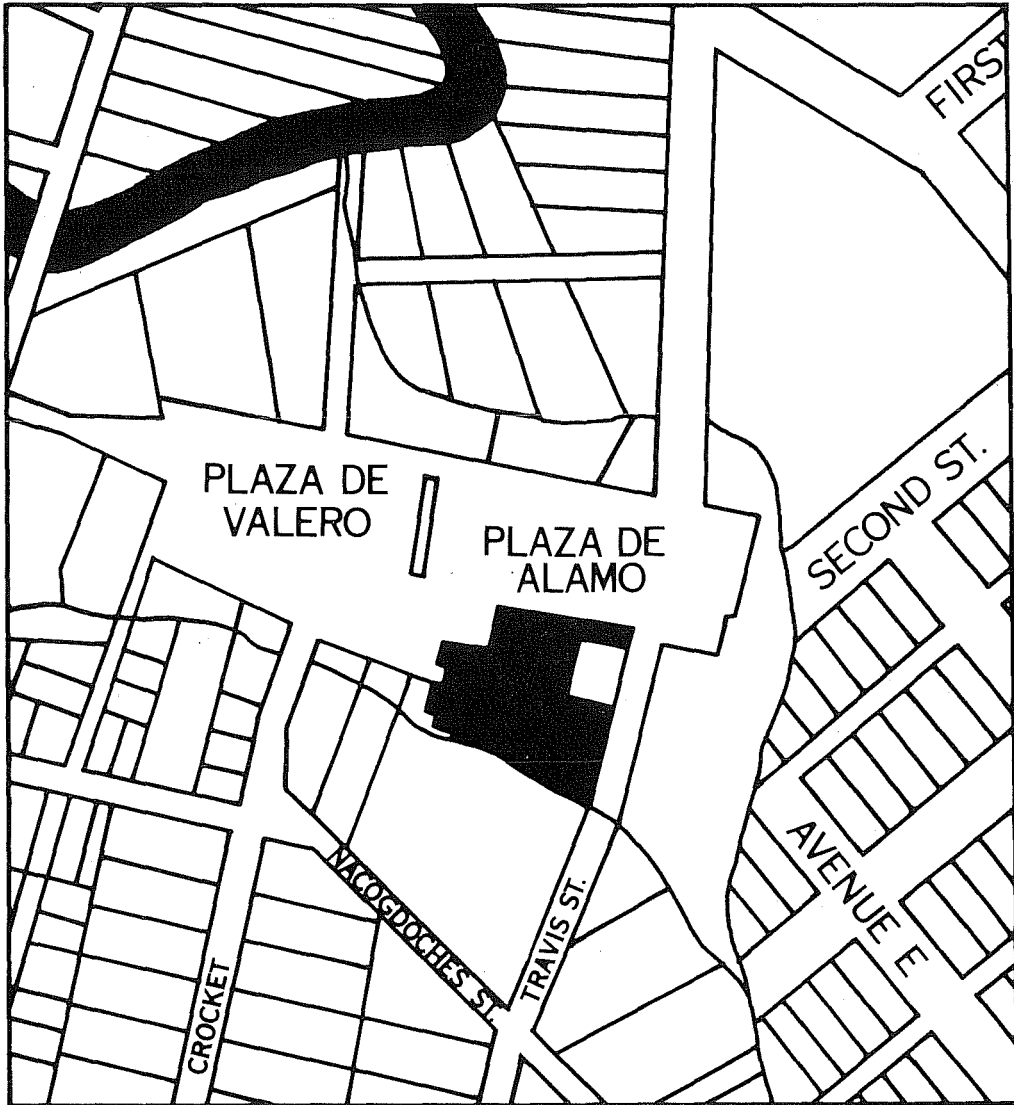
Figure 6. *The Alamo and Surrounding Area in 1868.*
Copy of a section of a map of the City of San Antonio located at the National Archives in the Records of the War Department, Headquarters of the Army, Descriptive Book of The District of Texas, July 1, 1868, No. 220, Map No. 5.

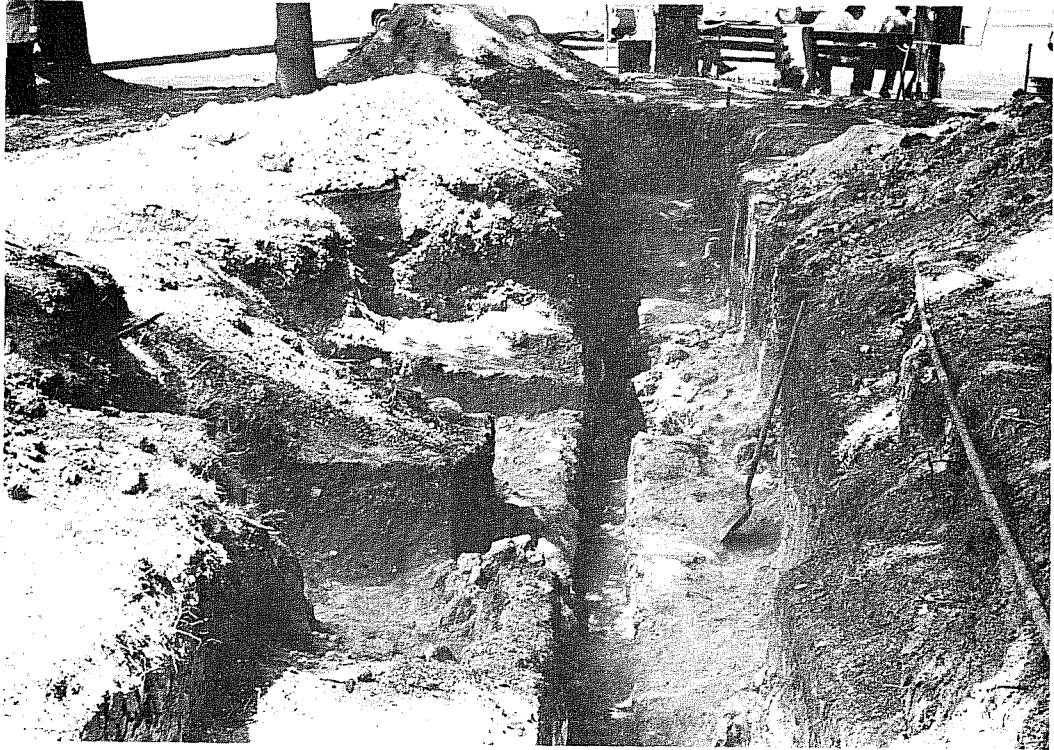
Figure 14. *Excavations in Alamo Plaza, 1975.* a, Trench A looking northwest; b, south wall footing in west profile of Trench A.

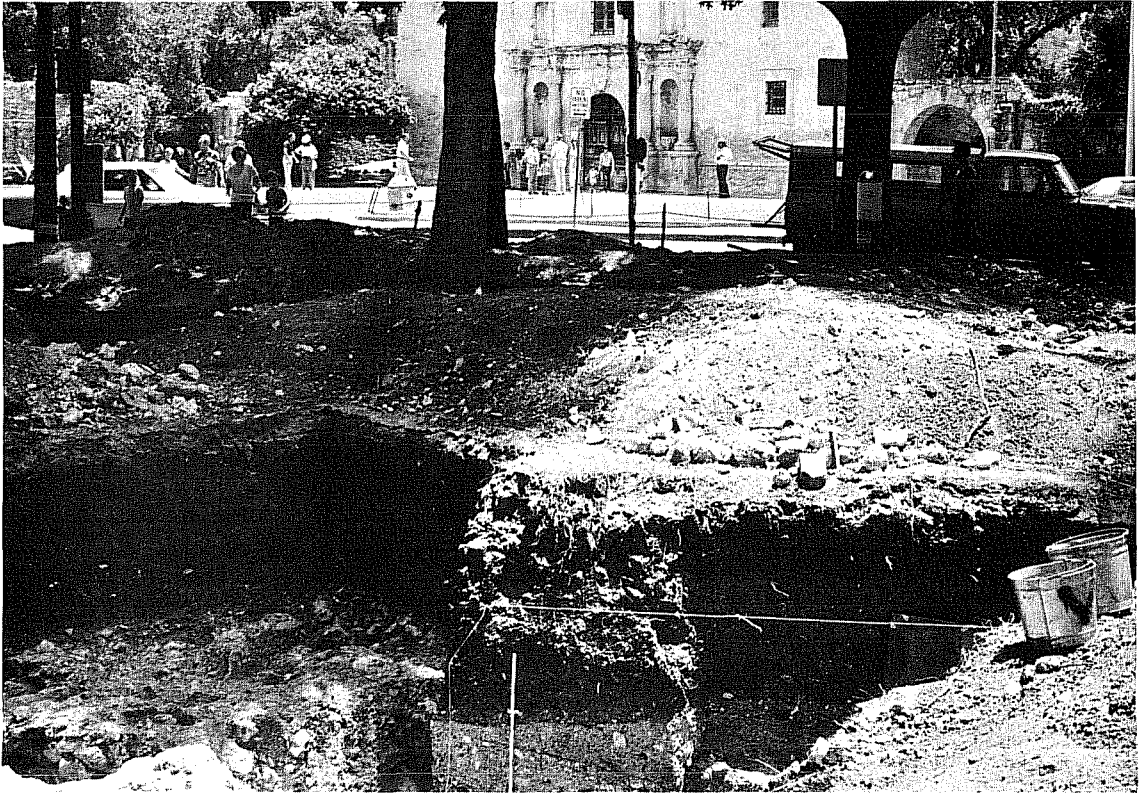
Figure 18. *Excavations in Alamo Plaza, 1975.* a, view looking northeast from west side of Trench B, showing relationship of excavation to chapel and stratification in east profile of Trench B; b, view looking south into the end of Trench B, showing shape of excavated portion of fortification ditch and profile of fill.

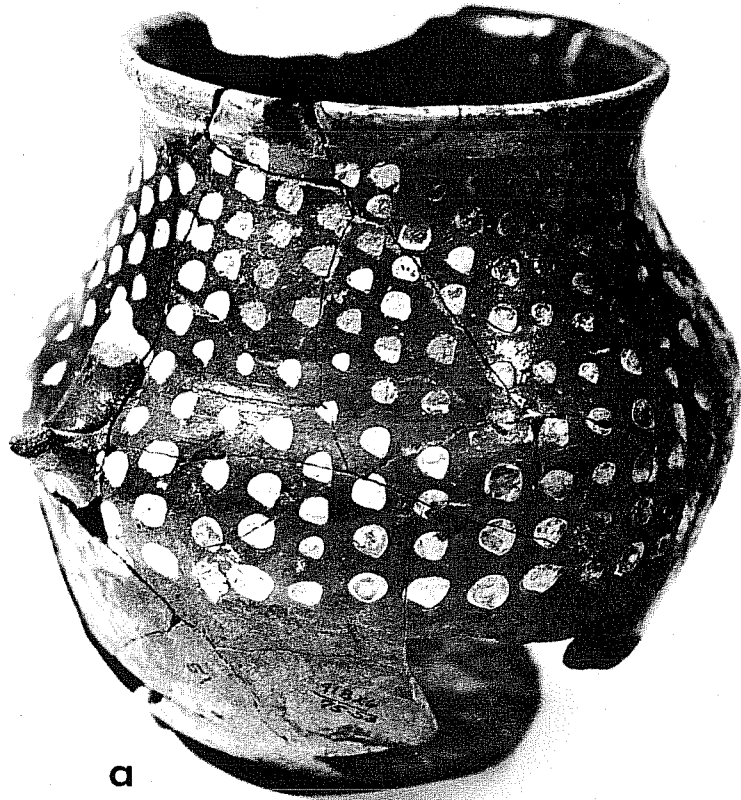
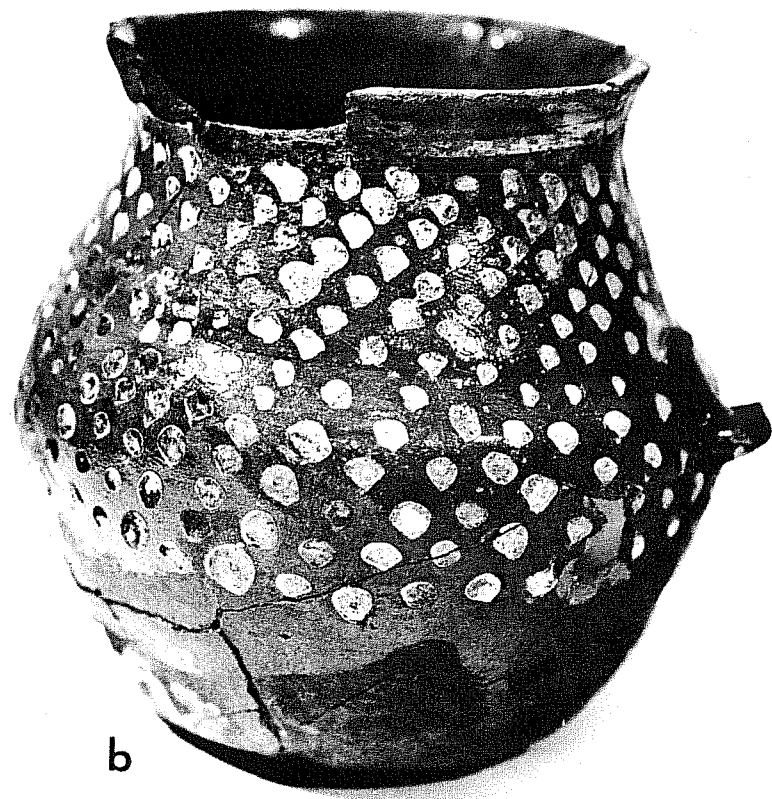
Figure 22. *Ceramic Vessel from Alamo Plaza.* a, b, two views (restored). Jar or pitcher, one handle. Height, 12.5 cm.; diameter at mouth, 9.5 cm.; diameter at shoulder, 13 cm. Green-over-cream band around rim, cream dots, orange paste.
