**Center for Archaeological Research
The University of Texas at San Antonio
Archaeological Survey Report, No. 207
1991**

**TESTING OF THE SAN JOSE MISSION ACEQUIA,
SAN ANTONIO MISSIONS NATIONAL HISTORICAL PARK,
BEXAR COUNTY, TEXAS**

Texas Antiquities Committee Permit No. 1007

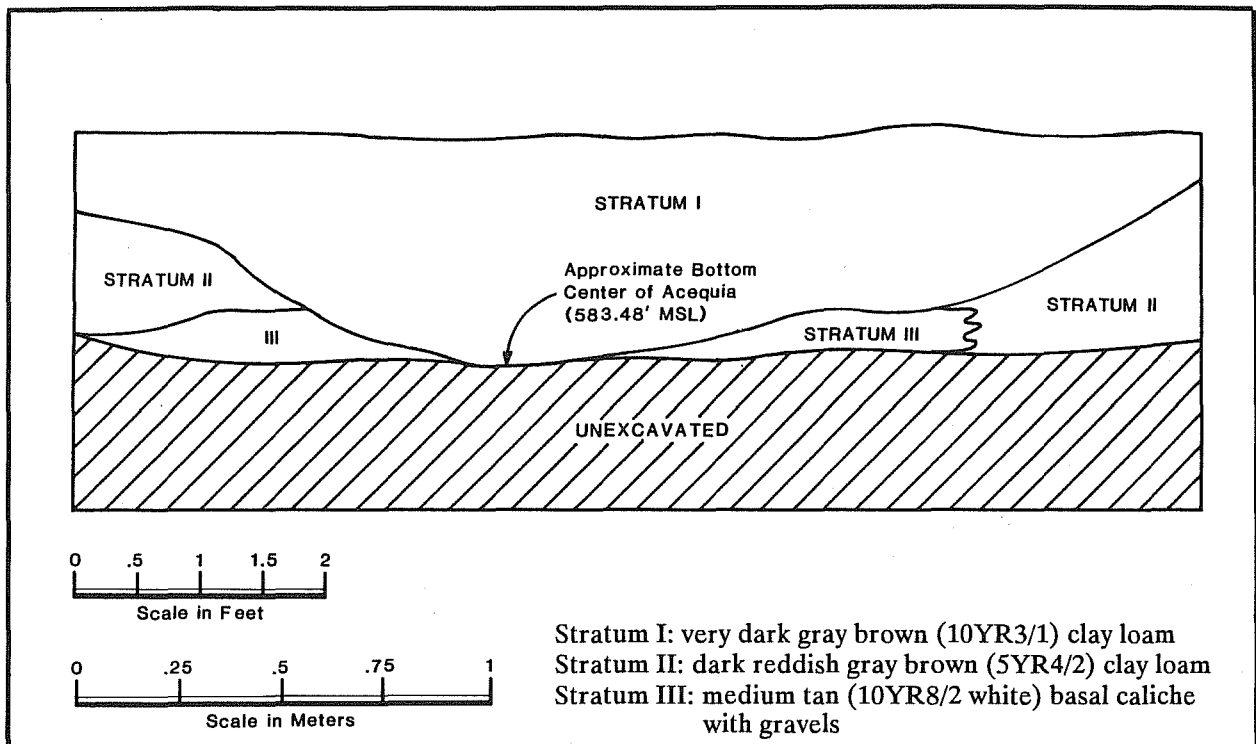
Figure 5. Profile of North Wall of Test Trench 2.

Trench 2 was located ca. 70 feet (21.3 m) north of Trench 1. The outline of the ditch was clearly visible in the profile of the trench (Fig. 5). The same soil strata were encountered as in Trench 1. At this point, the ditch appeared to be about 10 feet (3 m) wide and 20 inches (51 cm) deep, measured from the present surface.

Comparison of the profiles of Test Trenches 1 and 2 with those recorded by CAR archaeologists on acequias elsewhere in the San Antonio area (Valdez and Eaton 1979:Fig. 5; Frkuska 1981:Figs. 8-10; Cox 1988:Fig. 2) confirm that this is the acequia madre, even without the evidence from the deed records and early plat maps. The second, smaller ditch appears to be a lateral or branch of the main ditch, probably intended to irrigate the field between the main ditch and the east wall of the mission. The artifacts found in the bottom of this feature, both in 1981 and during this project, can be securely dated to the mission
