**Mission San José
Repointing and Underpinning Project,
San Antonio, Texas**

Texas Antiquities Permit No. 1841

Center for Archaeological Research
The University of Texas at San Antonio
Archaeological Survey Report, No. 294

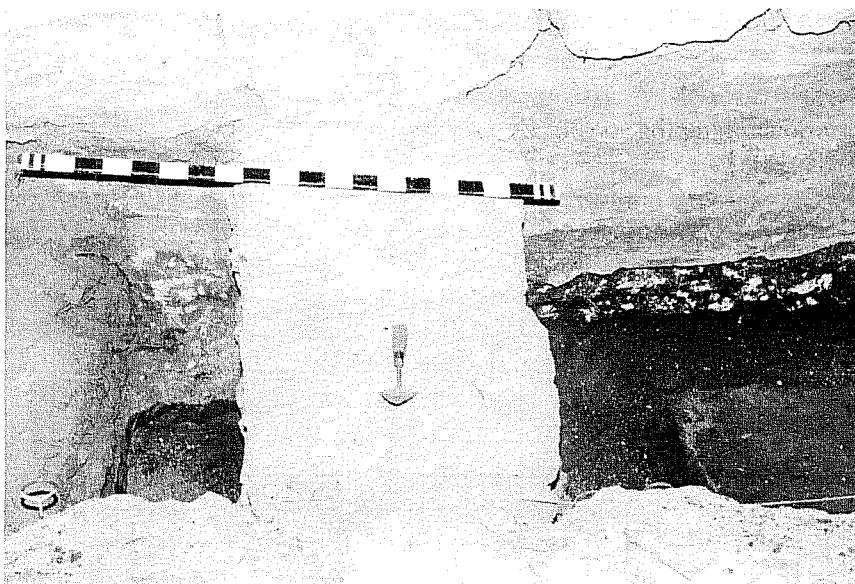
Figure 5. *CWA foundation running perpendicular to south wall of Indian Quarters in Room 54.*

At a depth of 14 inches bs, the excavation of Unit 9 revealed a foundation oriented perpendicular to the back wall of the room (Figure 5). The foundation was

composed of sandstone and limestone cobbles in Portland cement mortar. The base of the wall extended to a depth of 36 inches bs, matching the depth of the colonial foundation of the outside wall (Figure 6). However, it had no colonial foundation at its base and

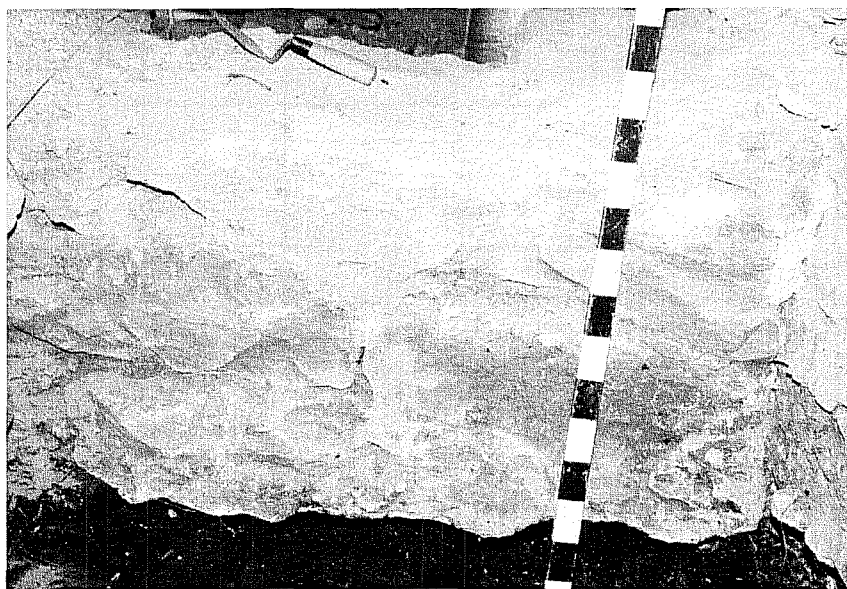
Figure 6. *Base of CWA foundation and south wall of Indian Quarters in Room 54.*

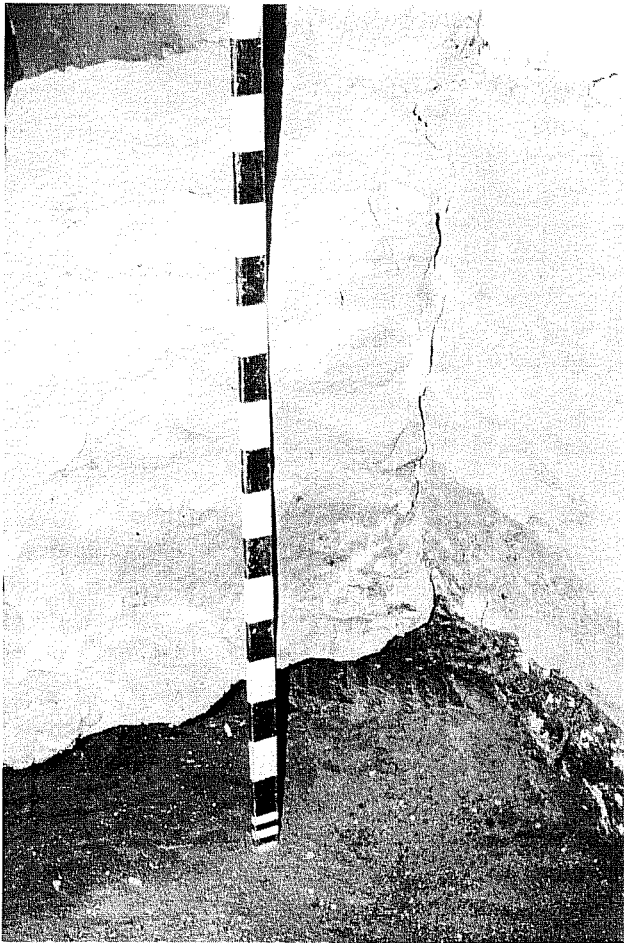
Figure 7. Contact between CWA foundation and south wall of Indian Quarters. Note the lack of jointing between the two.

it abutted the south wall rather than adjoining it (Figure 7). Given these observations, the foundation dates to the time of the CWA reconstruction and may represent an earlier attempt at constructing a gate foundation prior to the existing gate configuration. If so, the previously intended gate walls would have been perpendicular to the south wall rather than tangential, at least based on the three-foot section of the foundation revealed in Unit 9. The foundation is only four feet from the inside corner of the room and the present inside corner of the southeast gate. Alternatively, the foundation may have been intended for an inside wall. However, both its width (21.5 inches) and its height (95 cm) suggest that it would have been much too massive for such a purpose. The three-foot section of the foundation uncovered in Unit 9 was removed prior to the conception of the underpinning work.

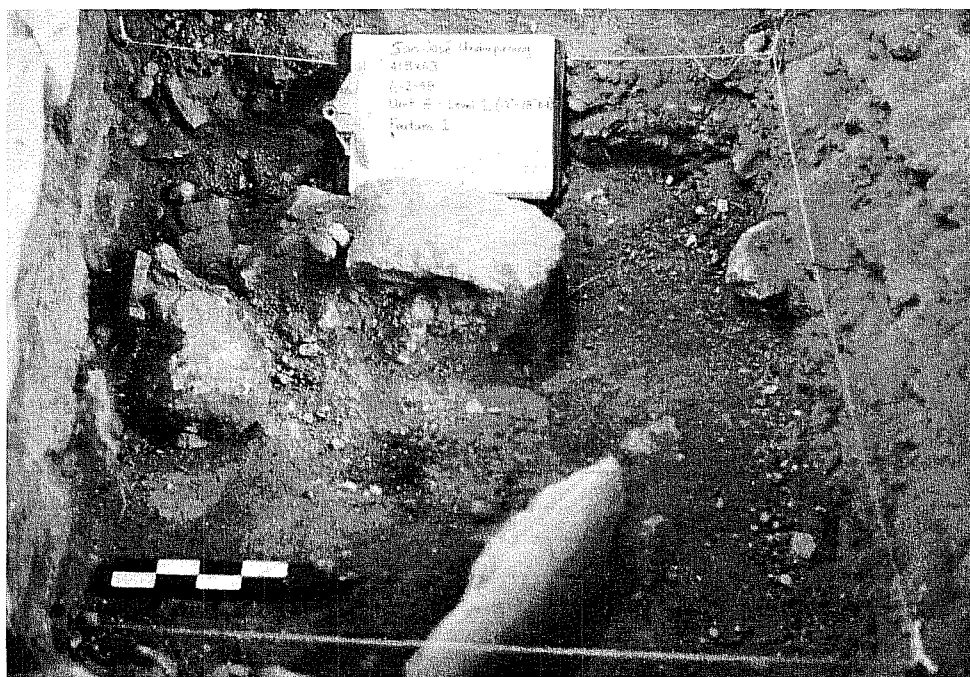
Figure 8. Feature 1, foot support rocks used to stabilize CWA construction scaffolding along inside of Indian Quarters south wall.

cluster of limestone and sandstone cobbles arranged in a circular pattern (Figure 8). One of the larger tabular pieces was set on its edge (see Figure 8, foreground). The soil within this circular cluster was somewhat lighter than the surrounding matrix. A three-inch diameter circular darker stain could be seen in the center of the area. Subsequent excavation showed the hole to be only two inches deep. Based in part on its location within a disturbed context, examinations of historic photographs showing the CWA construction of the mission walls, and the morphology of the feature, it was decided that the feature may have represented the shorings for one of the feet of the scaffoldings erected along the wall.

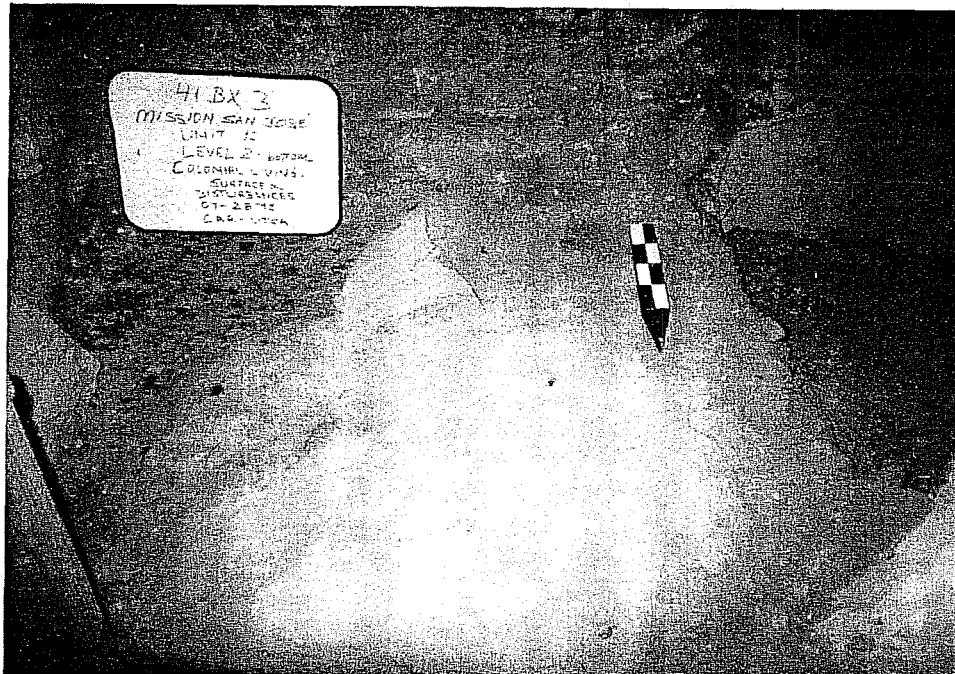
Figure 9. Close-up of colonial living surface remnant in Room 54, Unit 10.

Level 3 (21–23 inches bs) in Unit 10 consisted of the colonial living surface exposed in the northern half of the unit. The excavation consisted of the removal of the hard-packed plaster surface in the center of the area and the collection of soil samples of the fine powdery material underlying this surface. Few charcoal specks and small pieces of burned bone were encountered in the flooring material. Coupled with the orangish-yellow color of the matrix, these traits suggest a possible burning episode. However, the scarcity of the charcoal specks and the absence of large burned roof support pieces suggests that perhaps the charcoal came from a cooking hearth within the structure rather than a roof fire.
