# The Weston Urban Open Space Park CPS Line Project

## San Antonio, Bexar County, Texas

*Prepared by:*  
Center for Archaeological Research  
The University of Texas at San Antonio  
One UTSA Circle  
San Antonio, Texas 78249-1644  
Archaeological Report, No. 498

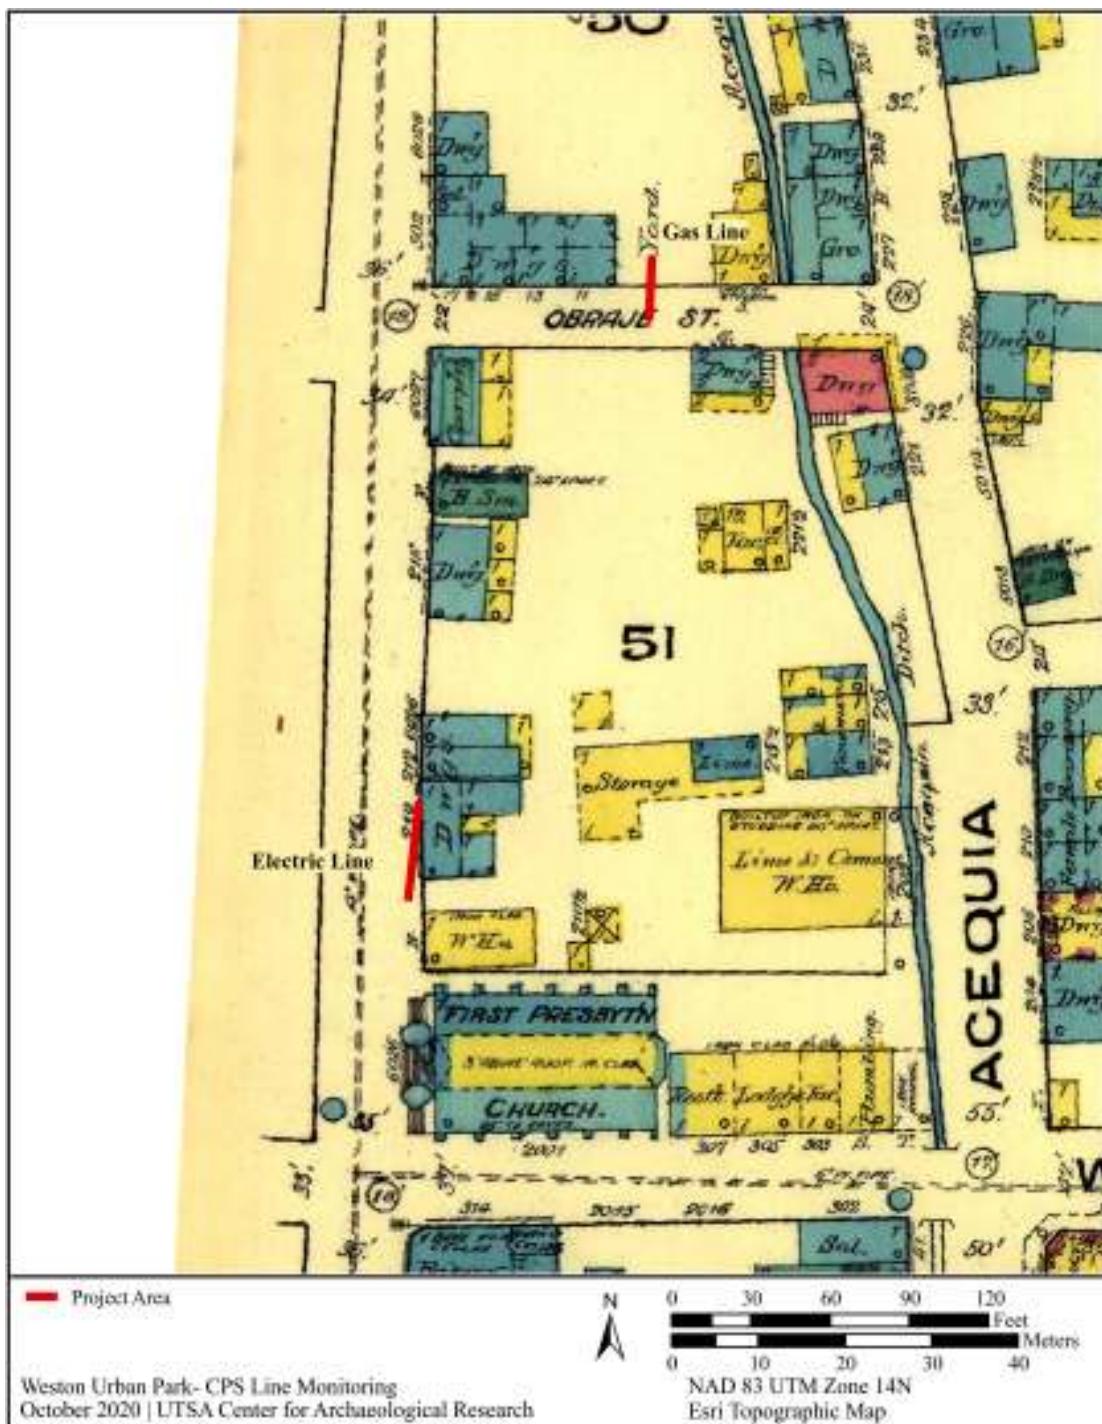
Figure 2-2. 1885 Sanborn Map showing both project areas; note First Presbyterian Church (41BX2348) at bottom left quadrant of City Block 51 (Sanborn 1885).

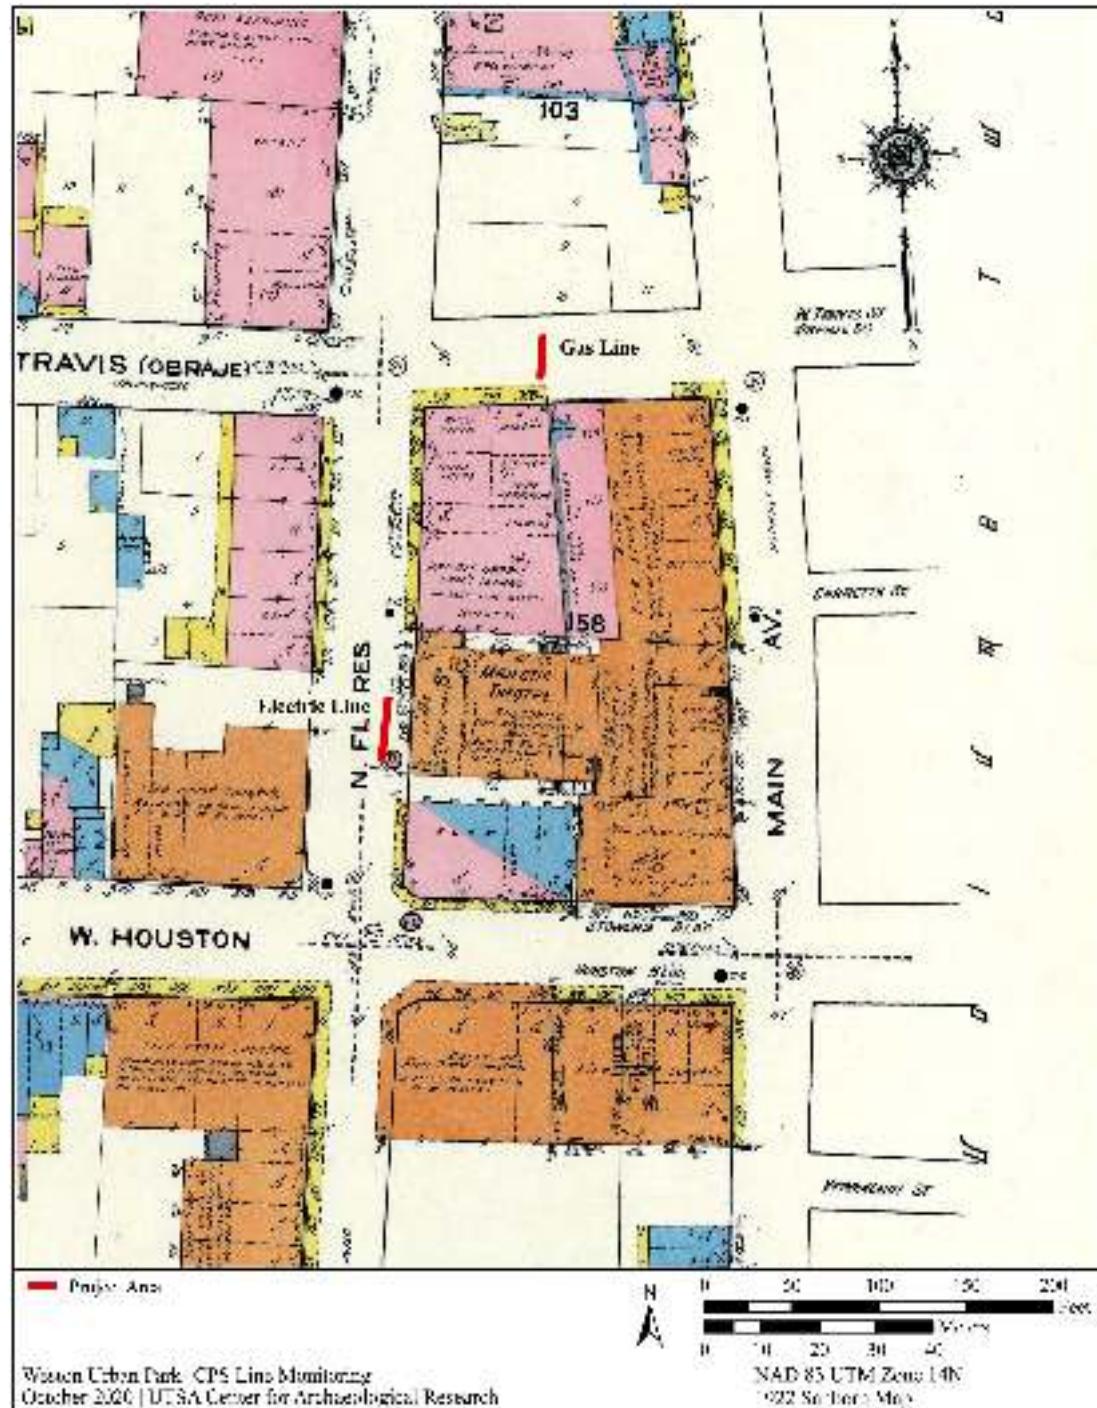
entire block was commercial and the building that had served as the Presbyterian Church was now a boarding house and store (Figure 2-3). Most significant to the current study was the addition of the Majestic Theatre (1913-1929), which extended from the front entrance on Main Avenue, and then across the width of the block, to N. Flores Street (BCDR 440:3; 1129:162).

Figure 2-3. 1922 Sanborn Map adjacent showing both project areas; note the Majestic Theatre (41BX2347) and the First Presbyterian Church (41BX2348) at left quadrant of New City Block (NCB) 158, formerly City Block 51 (Sanborn Maps 1922; see also Figueroa et al. 2022).

1913. The theater is clearly shown on Figure 2-3 and Figure 4-3. Figure 4-3 represents an expanded view of the building as shown on the 1922 Sanborn map (Sanborn 1922:V1:4). The Majestic Theatre extended fully through NCB 158 with the main entrance, lobby and concessions on the Main Avenue side and the theater stage and seating on the western half of the development. The basement encountered and recorded as 41BX2347 was beneath this western portion and most likely housed green rooms, hydraulics for the stage, as well as prop storage.

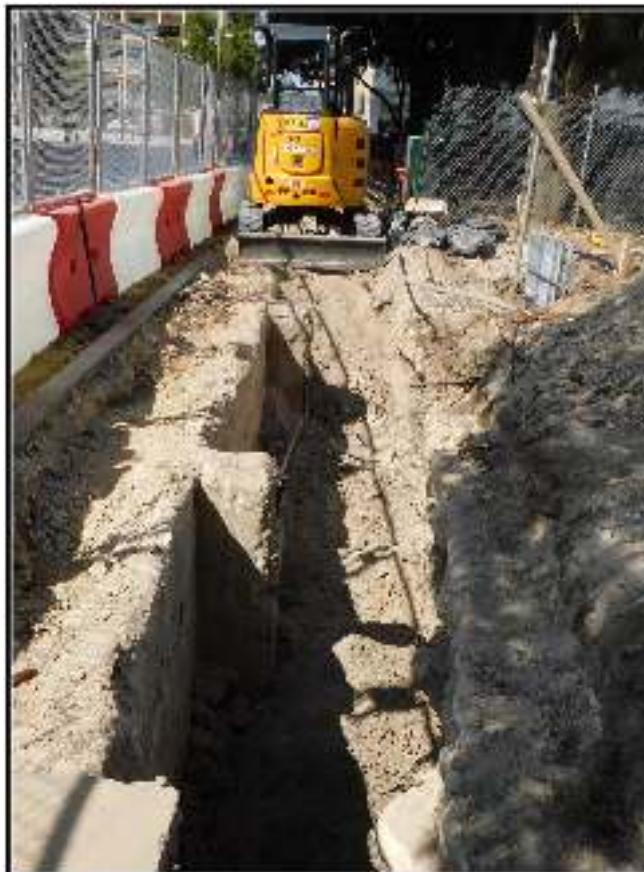
Two views of the excavations are shown in Figures 4-1 and 4-2. A concrete pier and beam footing were encountered along the west side of the trench and extended along the entire

Figure 4-1. Electrical line project area along the east side of N. Flores Street. Note concrete pier and beam footings for the Majestic Theatre, site 41BX2347 (view north).

length. CAR staff determined that this footing relates to the original location of the Majestic Theatre (41BX2347), as discussed in Chapter 3 and shown in Figure 2-3 above and in Figure 4-3. Construction fill was also noted between the exposed footing and the east side of the trench. There were no intact soils in the trench. No prehistoric or historical artifacts were encountered.

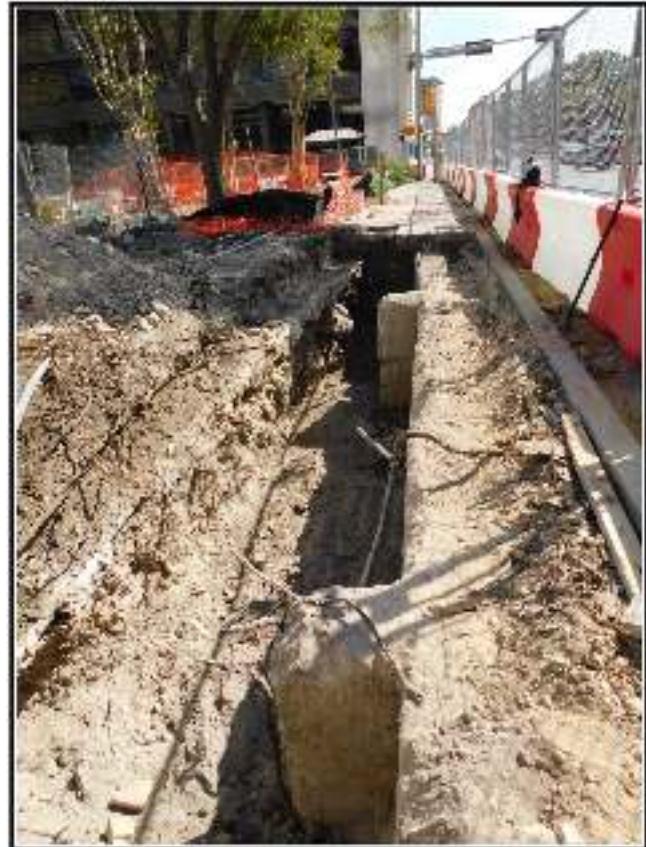
Figure 4-2. Electrical line project area along the east side of N. Flores Street. Note concrete pier and beam footings for the Majestic theatre, site 41BX2347 (view south).

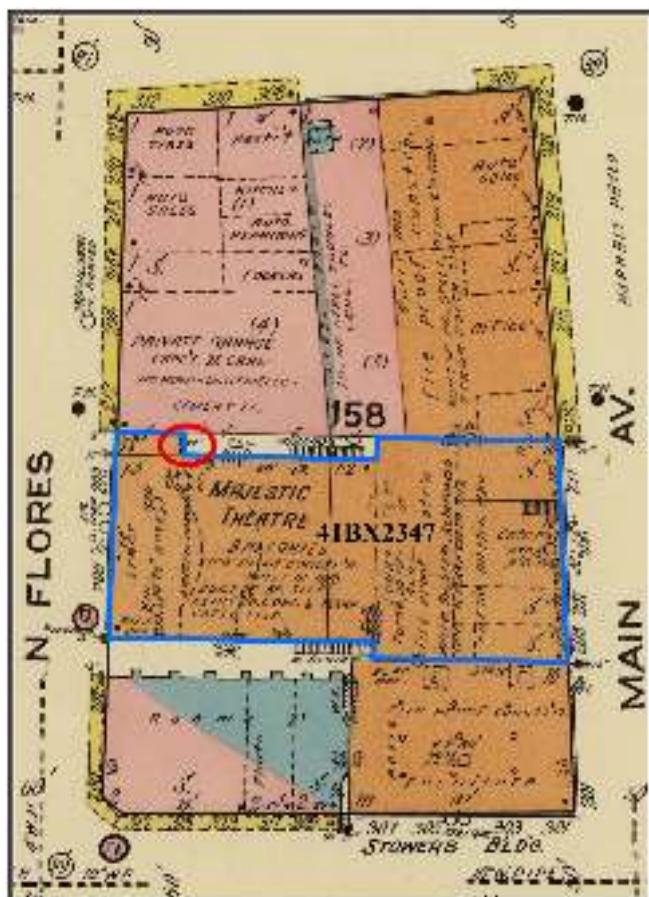
Figure 4-3. Expanded view of the Majestic Theatre (41BX2347), outlined in blue, from the 1922 Sanborn map (Sanborn 1922:V1:4; see also Figueroa et al. 2022). Trash deposits (site 41BX2394) are circled in red.

A separate archaeological monitoring project (NCB 158; Figure 4-3) found a series of trash deposits within the northwest quadrant of the site (Figueroa et al. 2022). The artifacts recovered from these trash features date to between ca. 1830 and 1850, and the site was recorded as the Cardona and Santos-Coy trash deposits (41BX2394). Like 41BX2347, the trash deposits were determined to be ineligible for NRHP or SAL status.

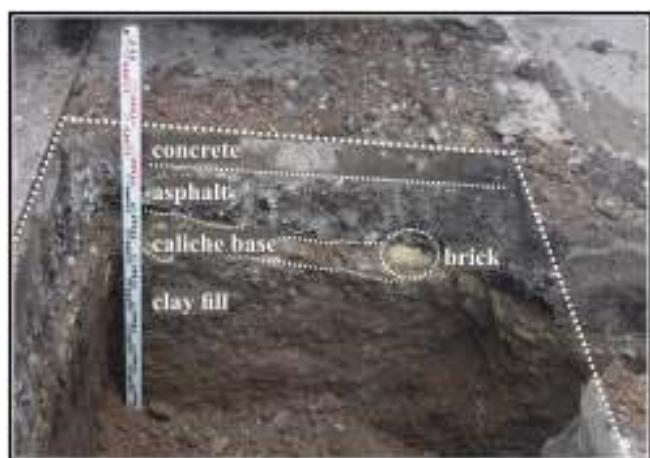
Approximately half of the 10 m long project area was located on the south side of W. Travis Street and the other half on New City Block (NCB) 158. This utility trench was 46 cm wide and 76 cm deep. A 122 cm by 122 cm pit was excavated in the street in order to locate the main gas line. This pit was mechanically excavated and the main line located at 122 cm below surface. A buff-colored brick fragment was embedded in the east wall profile of the pit, and construction fill was noted throughout the 46 cm wide trench (Figures 4-4 and 4-5).

With the exception of a buff-colored brick fragment, no other cultural material was observed in the gas line pit. Trenching into the construction

Figure 4-4. Gas line pit, view east.

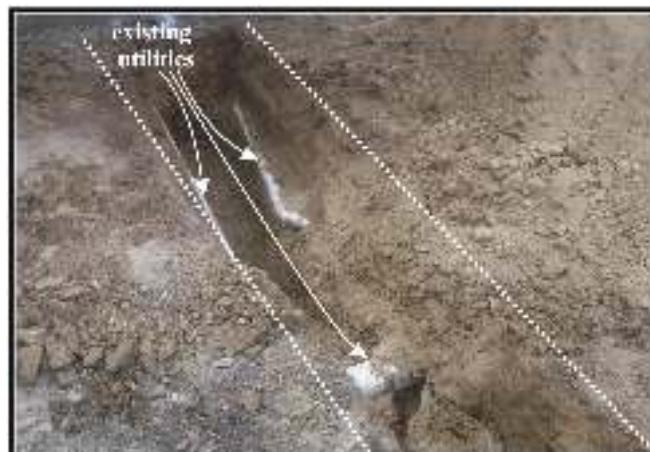
Figure 4-5. Gas line trench, view southwest.

site showed existing utility conduits in a sterile caliche clay matrix. The gas line was installed between and under the exposed conduit.
