Hemisfair Park Area Redevelopment Corporation (HPARC) P3 Project: Testing and Monitoring for the Acequia Lofts Site Development, San Antonio, Bexar County, Texas

Texas Antiquities Permit No. 7852

Prepared by:
Center for Archaeological Research
The University of Texas at San Antonio
One UTSA Circle
San Antonio, Texas 78249-1644
Archaeological Report, No. 464

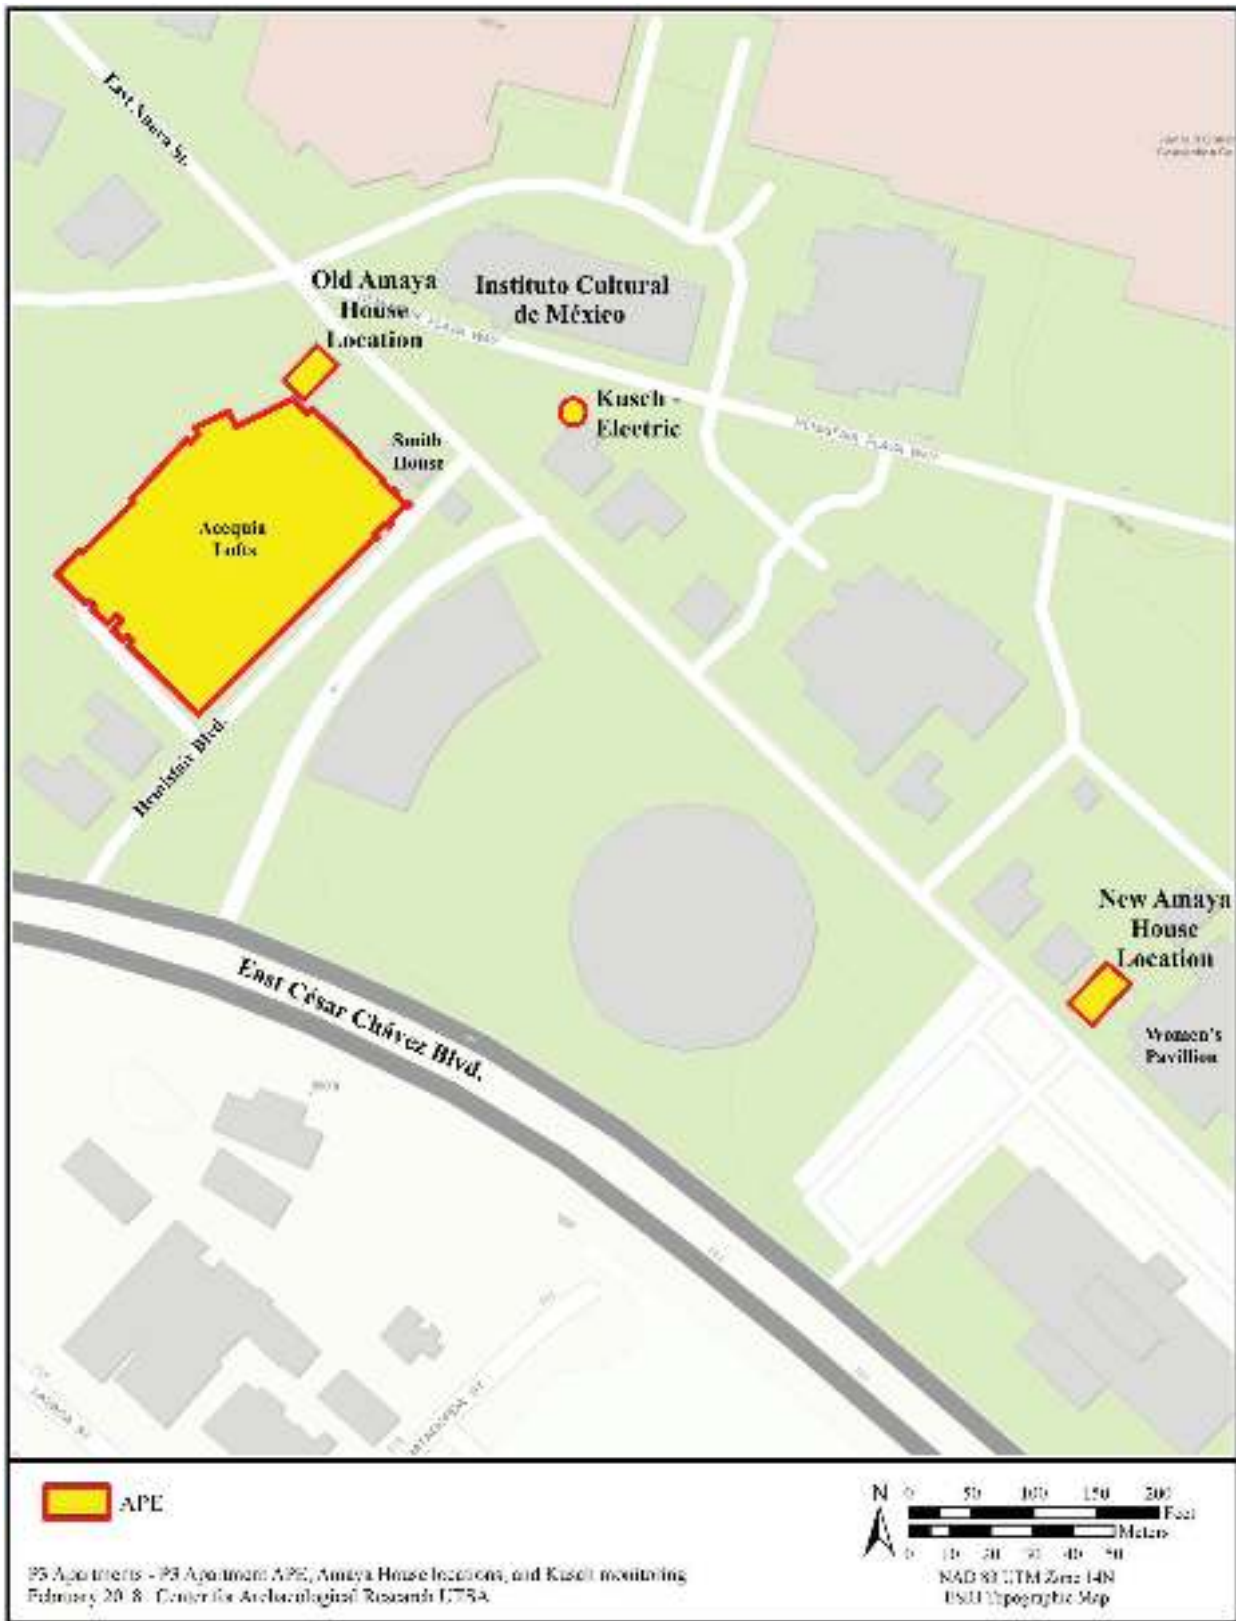
Figure 1-1. Project APE: Acequia Lofts, Old Amaya House location, Kusch House, and New Amaya House location.

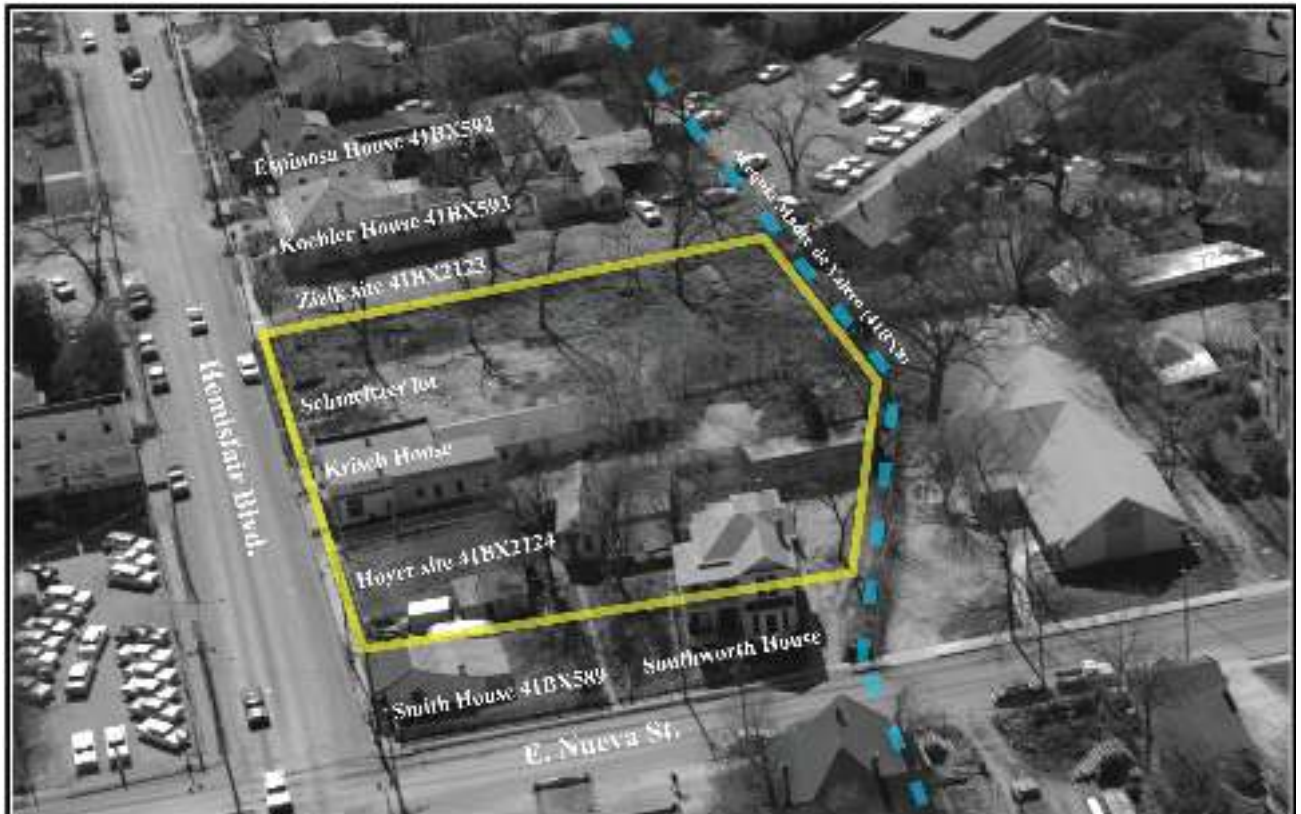
Figure 3-1. Acequia Lofts APE approximation outlined in yellow; course of the acequia outlined in blue dashed line (c.1965 aerial – view south; courtesy of UTSA Institute of Texan Cultures [ITC], H-0746-0348).

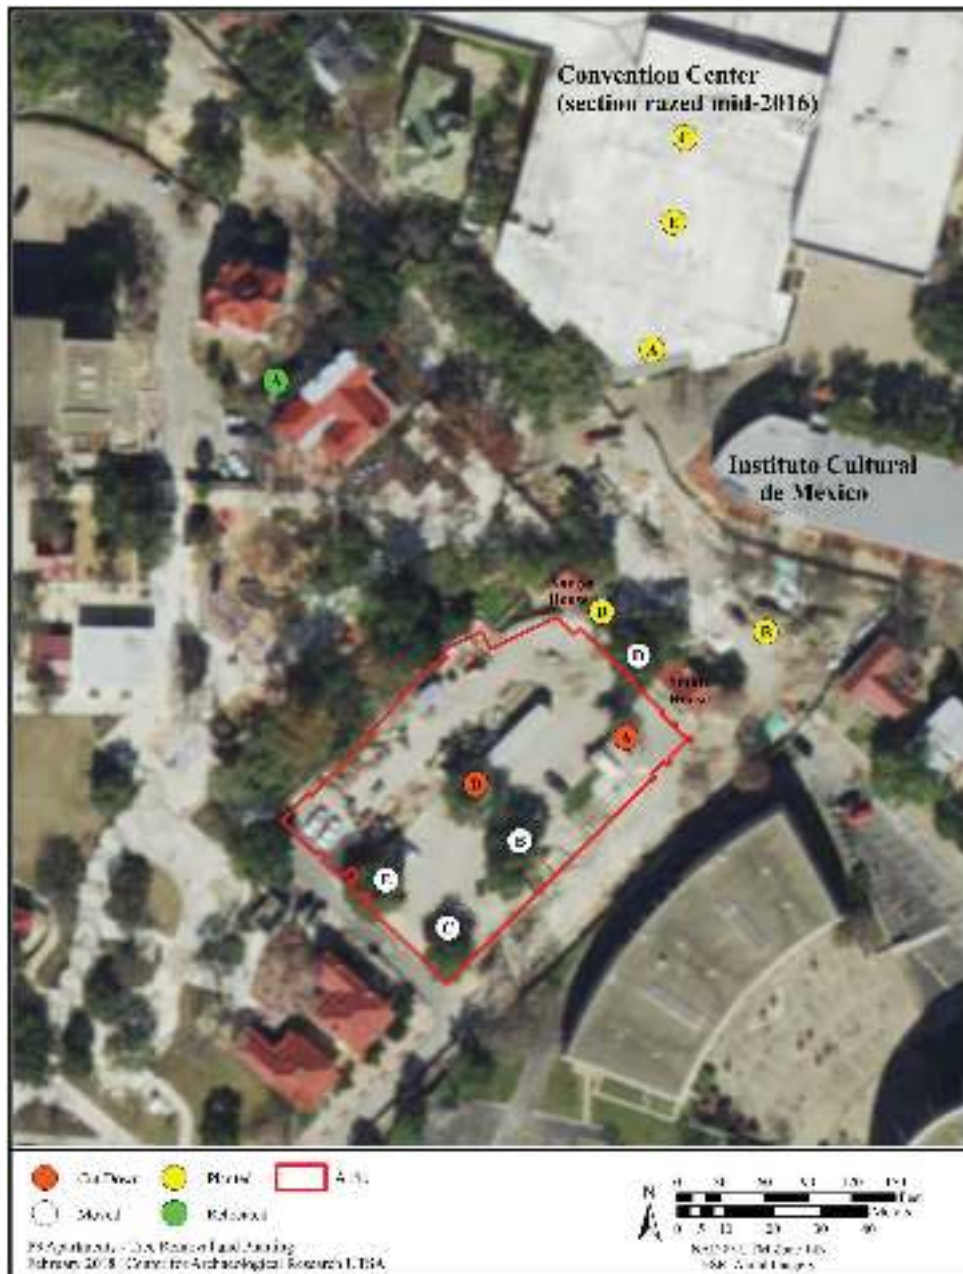
Figure 4-1. Final tree transplantation configuration; note change in Tree A replacement and relocation area, and Tree D replacement tree. Satellite image used for this figure, still shows a convention center building (razed in mid-2016) where Trees A, C, and E were planted.

Trees A and D were not moved, due to the roots being entangled in wall footings (large limestone blocks), and both were consequently cut down. A new tree was donated to replace Tree A, and the oak tree directly behind the Smith House replaced Tree D (Figure 4-1).

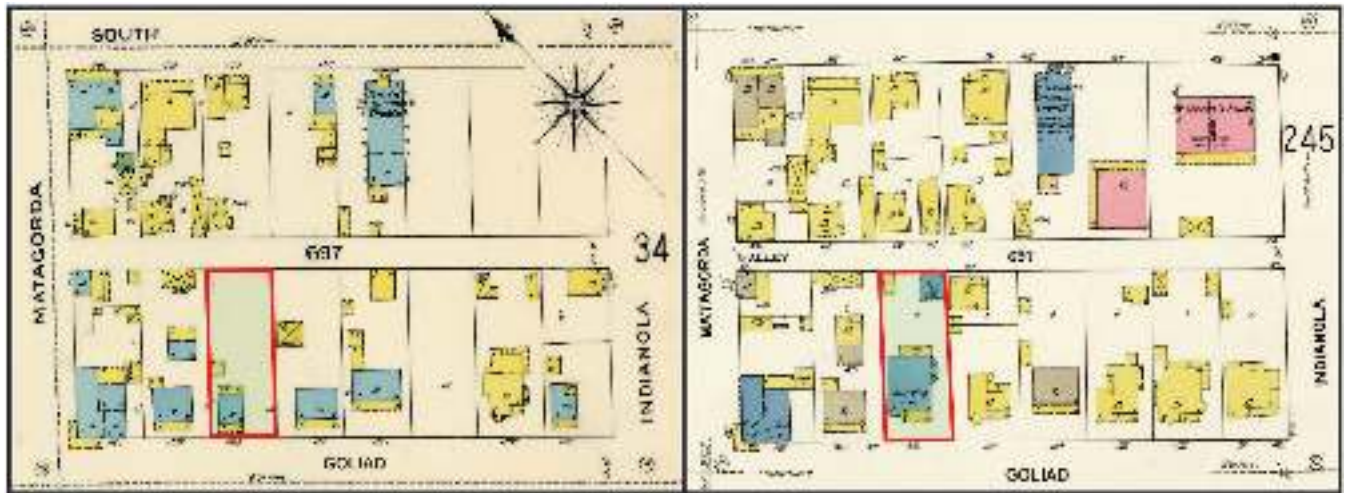
Figure 4-2. Comparison of Lot 3, 409 Goliad Street (box outlined in red), as depicted on the 1896 Sanborn Map (left, cropped) and the 1912 Sanborn Map (right, cropped; 1896 Sanborn Map, Sheet 29, and 1912, Volume 3, Sheet 243; Perry-Castañeda Library Map Collection, The University of Texas at Austin).

In comparing the 1896 and 1912 Sanborn Maps, it was noted that the earlier map showed a rectangular floor plan of a one-story, stone cottage. The 1912 Sanborn Map showed a large rectangular floor plan with a distinct bay window outlined on the left front of a two-story, concrete-block house (see Figure 4-2).

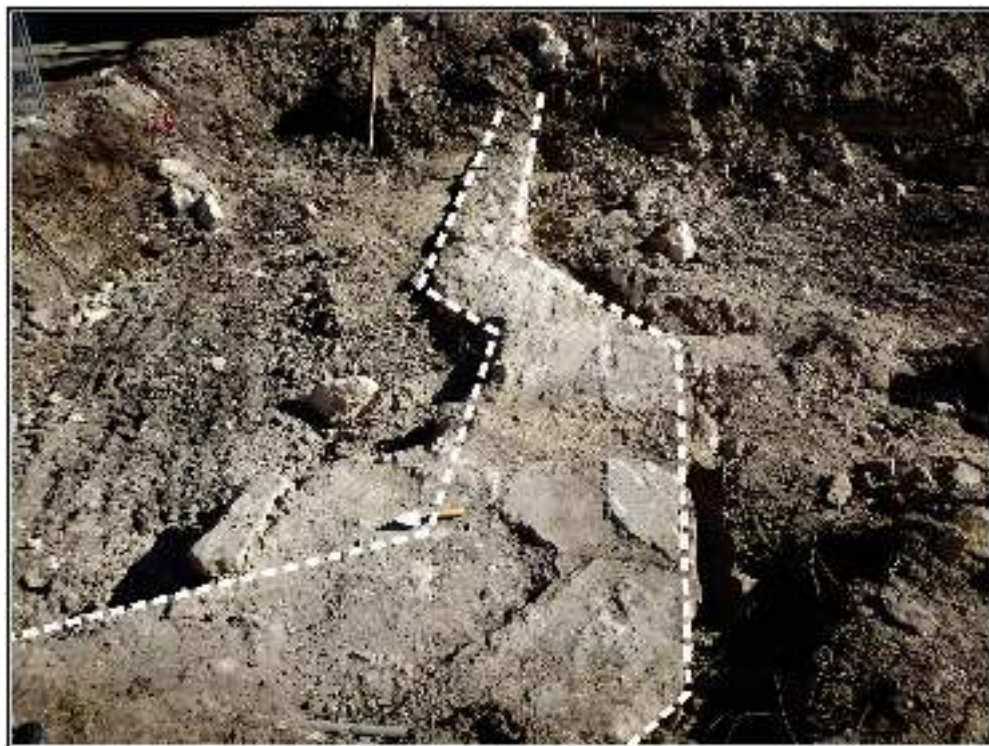
Figure 4-3. Exposed wall footing revealing bay window outline (view east).

At the north end of the APE, the first day of monitoring resulted in the location of wall footings with a north-south orientation. An assortment of bottle glass shards, unidentifiable metal, and whiteware sherds were observed in the excavated soils. These artifacts were noted, but nothing was collected. On the second day of monitoring, mechanical excavation moved to the south end of the APE to the front, or street side, of the property. Excavation in this area continued to expose limestone-block wall footings and included an east-

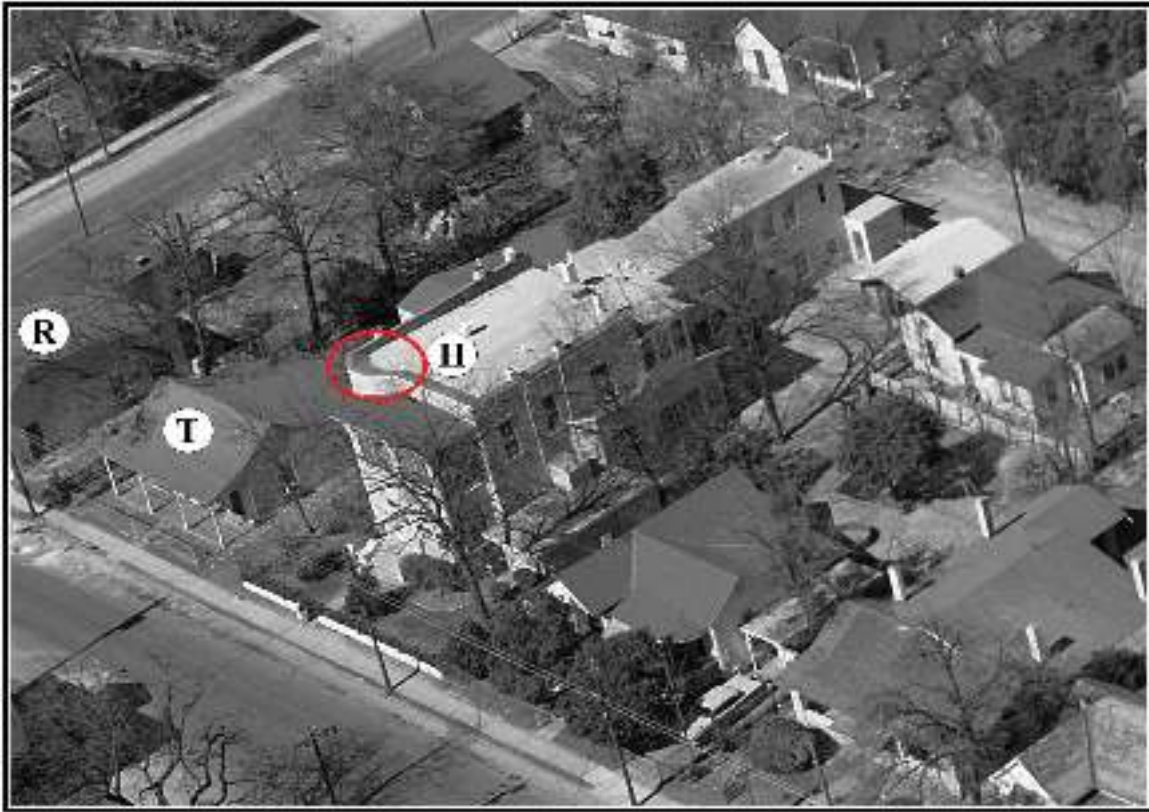
Figure 4-5. Aerial view of the H: Holmgreen House, T: Tynan House (41BX582), and R: Richter House (41BX581). Note distinctive bay window front (red outline) on the Holmgreen House (courtesy of UTSA ITC photo collection, H-0746-0361).

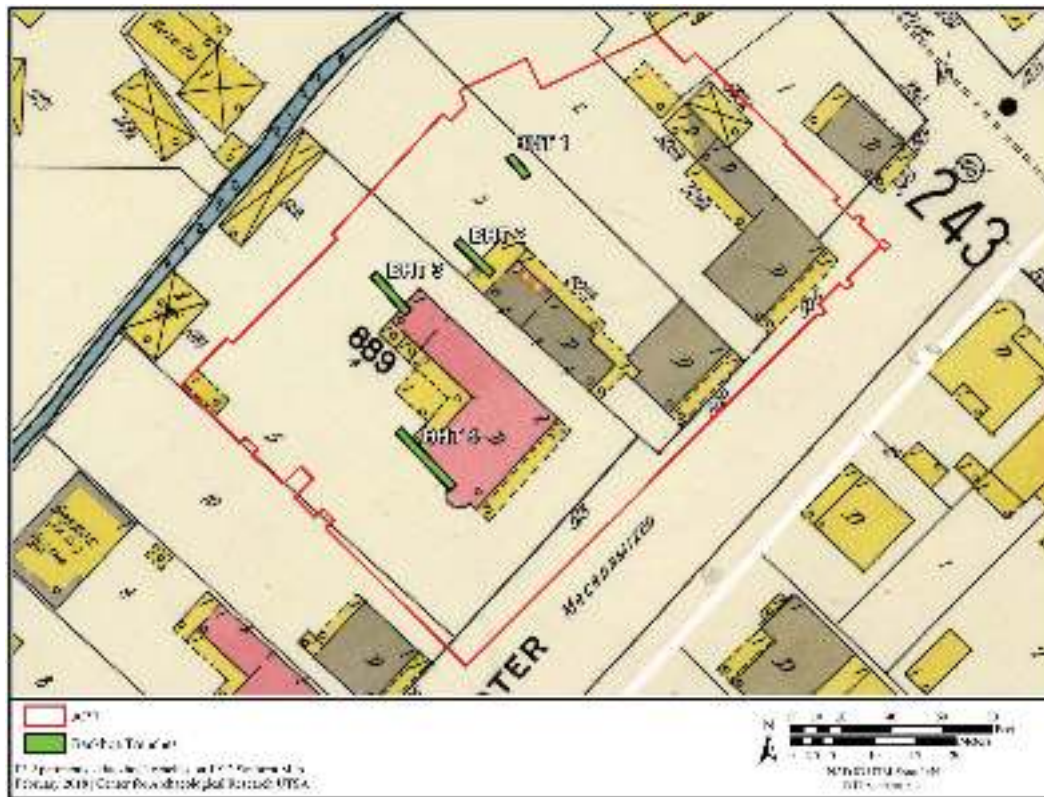
Figure 4-6. 1912 Sanborn Map (cropped) showing the Acequia Lofts construction footprint and BHTs (Volume 3, Sheet 243; Perry-Castañeda Library Map Collection, The University of Texas at Austin).

was then produced, which was used to locate the placement of the BHTs and served as an on-site reference (Figure 4-6). The first two trenches (BHTs 1 and 2) were placed on Lot 3, NCB 889, in an effort to locate features associated with the caliche-block house at 509 Water Street. The next two trenches (BHTs 3 and 4) were placed on Lot 4, NCB 889, in an effort to locate features associated with the brick-house at 513 Water Street. The final trench (BHT 5) was supposed to be placed at the rear of Lot 5, NCB 889, over an outbuilding shown on the 1912 Sanborn Map. However, the planned location of BHT 5 was in an area that had already been improved, so only four BHTs were excavated.

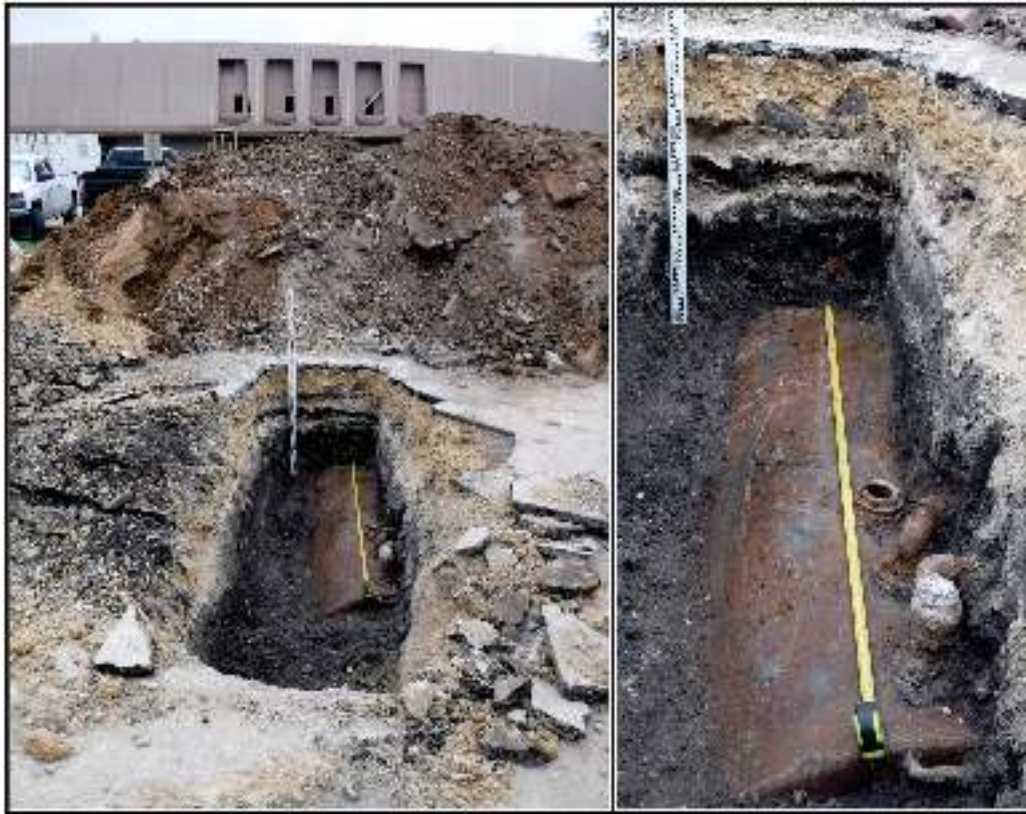
Figure 4-7. Feature 1, fuel tank; close-up at right (view east).

Backhoe Trench 1 was 1.1-m (3.6-ft.) wide, 4-m (13.1-ft.) long, and 0.9-m (2.9-ft.) deep. Excavation of BHT 1 was shallow, as a result of having encountered a fuel storage tank. Although rusty, the storage tank appeared to be intact and in good condition (Figure 4-7). After having probed inside the storage tank through an inlet, CAR staff determined that the fuel storage tank, designated Feature 1, was empty and that there were no toxic smells emitting from the tank (see Figure 4-7). Aside from errant construction debris, no other cultural material was noted.

Based on the GPS data collected on site, Feature 1 was located at 509 Water Street. On November 1, 1945, the City granted the petition of Humble Oil to install a gasoline tank at 509 Water Street (CCM1945:520-521). Schmidt Electric Company was doing business out of 509 Water Street (Ord. 9701; CCM 1949). After consulting with HPARC and 1968 HemisFair LP, it was decided to mark and backfill the feature so that a qualified hazardous material contractor could remove the storage tank during site preparation work scheduled for August 2017. Even though the trench was shallow, CAR staff identified six distinct layers of soil (Table 4-1). It is likely that the fill identified as Strata 3, 4, and 5 relate to the installation of the storage tank.

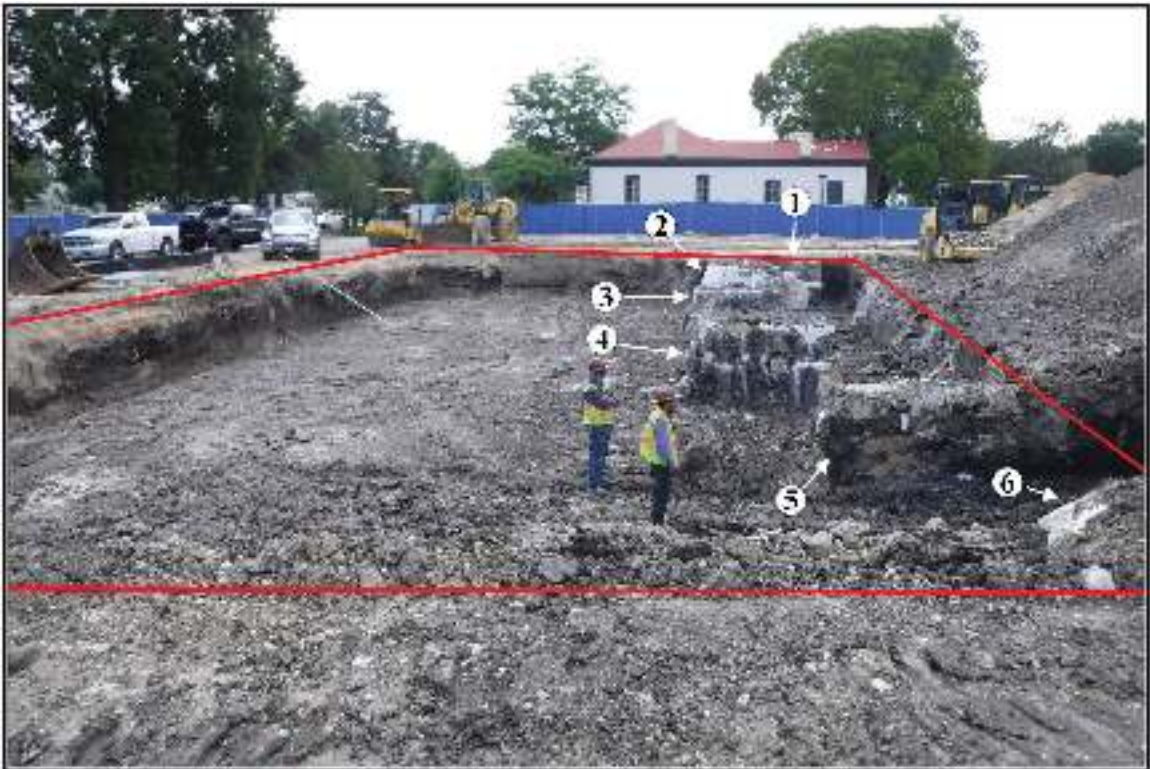
Figure 4-8. Excavated pit, outlined in red; note series of six concrete support piers. Koehler House (41BX592) in background, (view south).
