**Archaeological Investigations of Sections of the  
San Pedro (41BX337) and Upper Labor (41BX1273) Acequias in  
San Antonio, Bexar County, Texas**

Texas Antiquities Permit No. 9229

*Prepared by:*  
Center for Archaeological Research  
The University of Texas at San Antonio  
One UTSA Circle  
San Antonio, Texas 78249  
Archaeological Report, No. 481

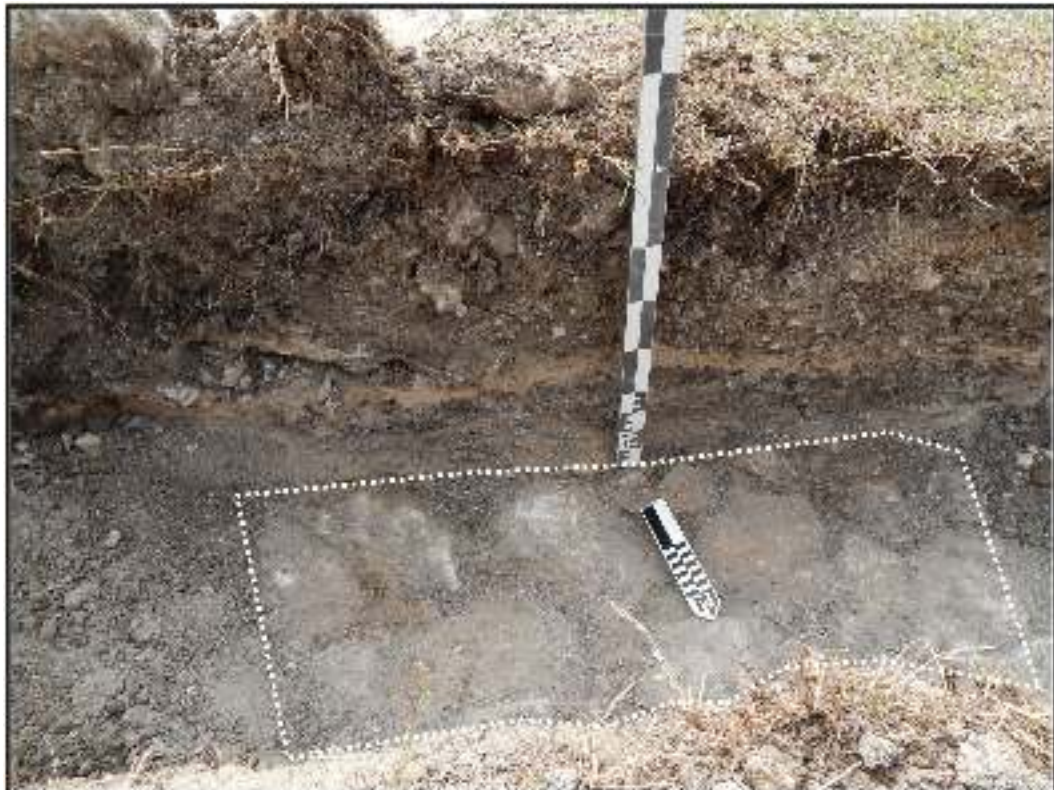
*Figure 4-4. South profile of BHT 1. Feature 1 in foreground in dashed white outline.*

silty clay containing gravels and, in the south profile, cobbles (Figure 4-5). Below this layer, the south profile contained evidence of multiple fill episodes with distinct layers of sand and gravel (see Figure 4-4). Layer 2 of the north profile contained a blocky black (10YR 2/1) clay with carbonates and limestone cobbles from 35-75 cm (13.8-29.5 in.). A 1-2 cm (0.39-0.79 in.) wide intrusion of very pale brown (10YR 8/4) sand was noted in the north profile from 40-75 cm (15.75-29.5 in) below the surface. No artifacts were observed in either the backdirt or the profiles. The feature is discussed in the subsequent section.

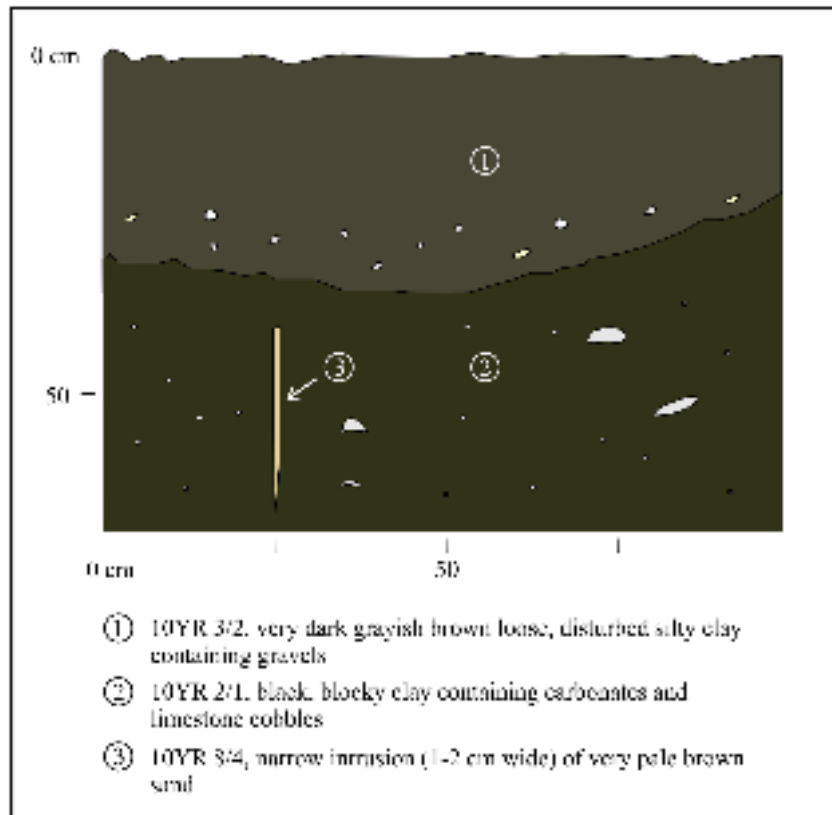
Figure 4-5. North profile drawing of BHT 1, 1 m segment.

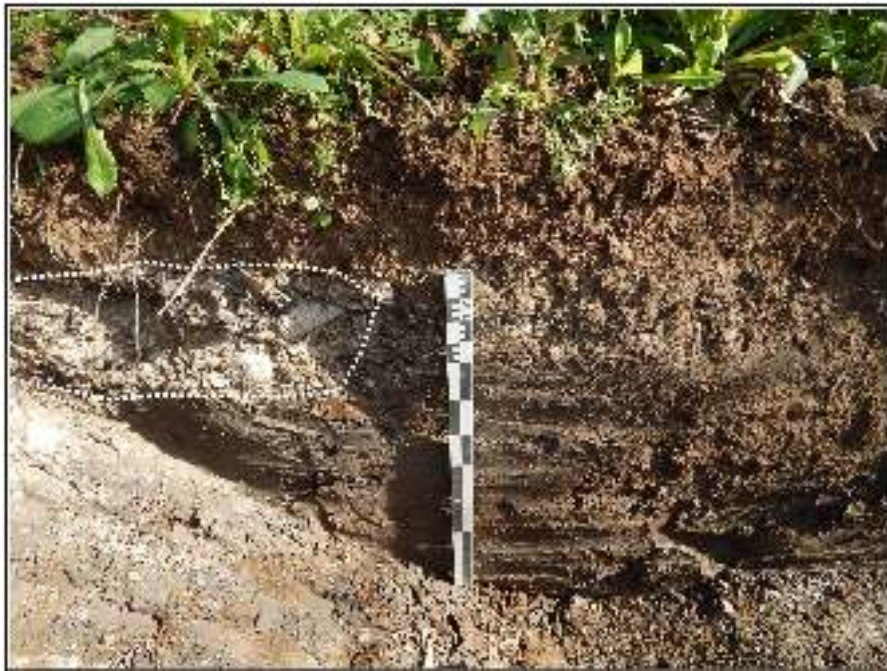
Figure 4-6. East profile of BHT 2. Feature 2 (left) demarcated by dashed white outline.

BHT 2 extended 4.3 m (14.1 ft.) and was terminated at 1.45 m (4.76 ft.) below the surface. In both trench profiles, Feature 2, a shallow, basin-shaped concentration of concrete,

tile, and large amounts of rock and gravel, was documented from 30-60 cm (11.8-23.6 in.) below the surface near the northern edge of the trench. The feature spanned more than 1 m (3.3 ft.) in the eastern profile but narrowed in the west, disappearing into the northwest corner (Figure 4-6). The feature, dominated by construction material, is likely recent. Four layers were recorded in the trench profile (Figure 4-7). Layer 1 was similar to Layer 1 in BHT 1 and contained loose, dark brown (10YR 3/3) silty clay with roots. This layer appeared disturbed and extended from 30-35 cm (11.8-13.8 in.) below the surface. Layer 2 extended from 30-50 cm (11.8-19.7 in.) below the surface and contained dark brown (10YR 3/3) gravelly clay. Layer 3, from 50-110 cm (19.7-43.3 in.) below the surface, contained blocky, very dark gray (10YR 3/1) clay. Below 110 cm (43.3 in.) to the trench floor, Layer 4 was distinguished from Layer 3 by a significant increase in carbonates. One piece of debitage and one fragment of clear glass were observed in the backdirt but not collected. No artifacts, aside from the construction debris in Feature 2, were observed in either profile.

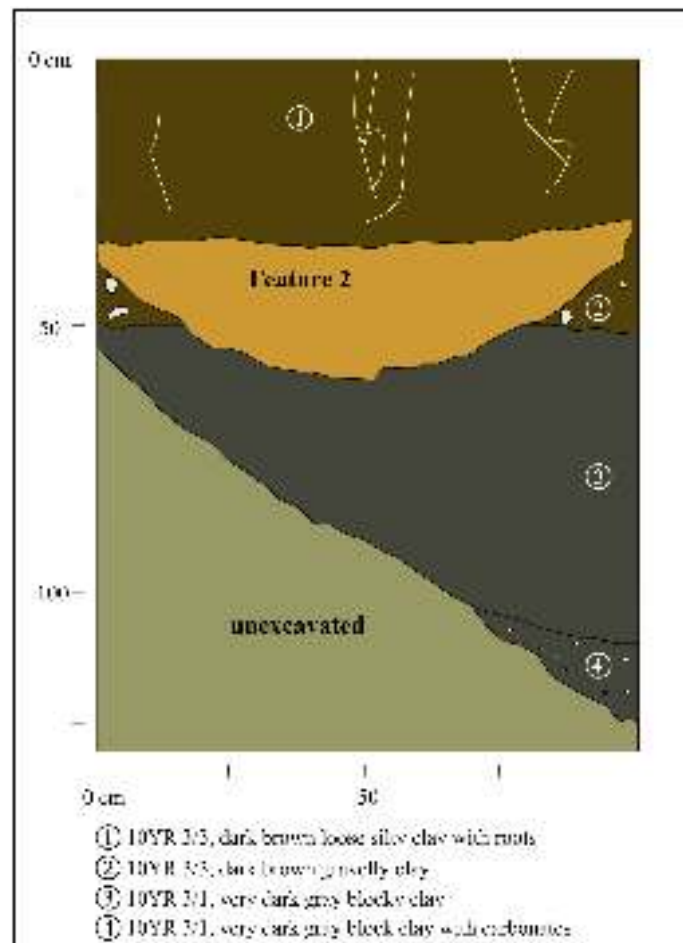
Figure 4-7. East profile of BHT 2, 1 m segment. Roots are shown as yellow lines.

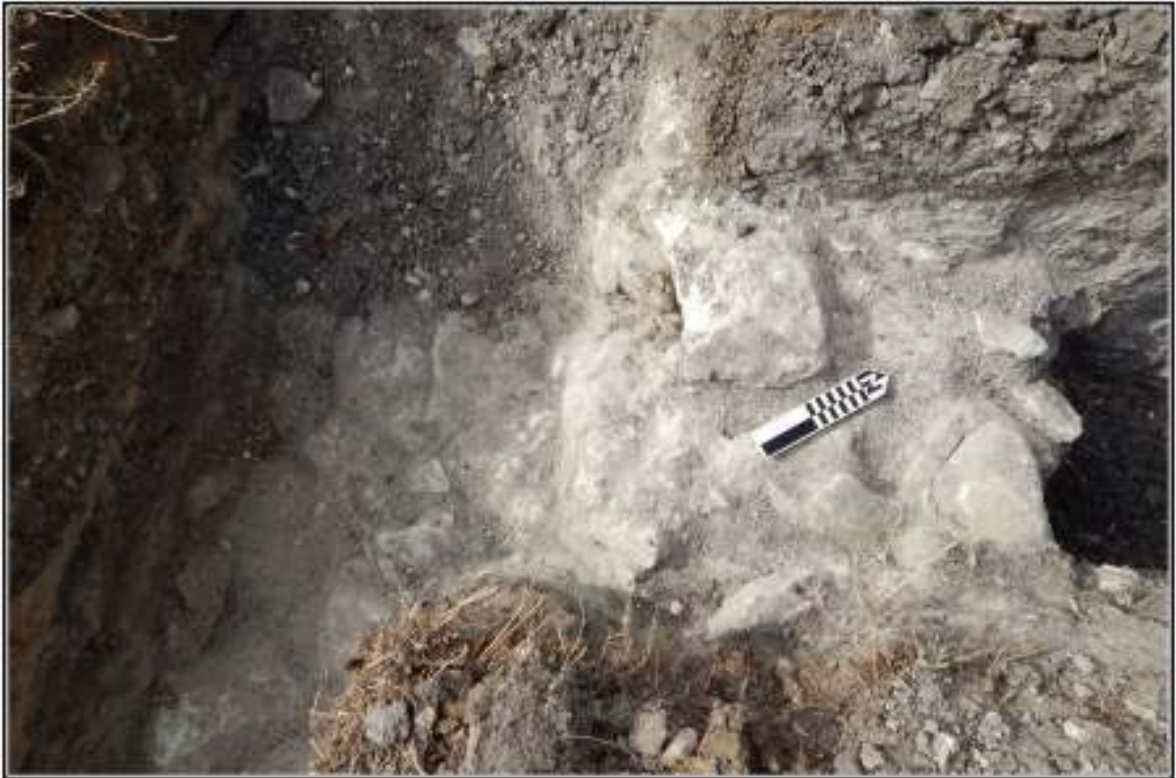
Figure 4-9. Feature 1 facing west. Wall to the right and cobble floor to the left.

Feature 1 was documented in BHTs 1 and 3, spanning the entirety of BHT 1. The feature consisted of a relatively flat floor of rough limestone cobbles, articulated with a wall constructed of rough-cut limestone blocks (Figures 4-9 and 4-10). A layer of sandy soil above the floor was noted (Figure 4-11). To the south, the layers of the soil profile indicate

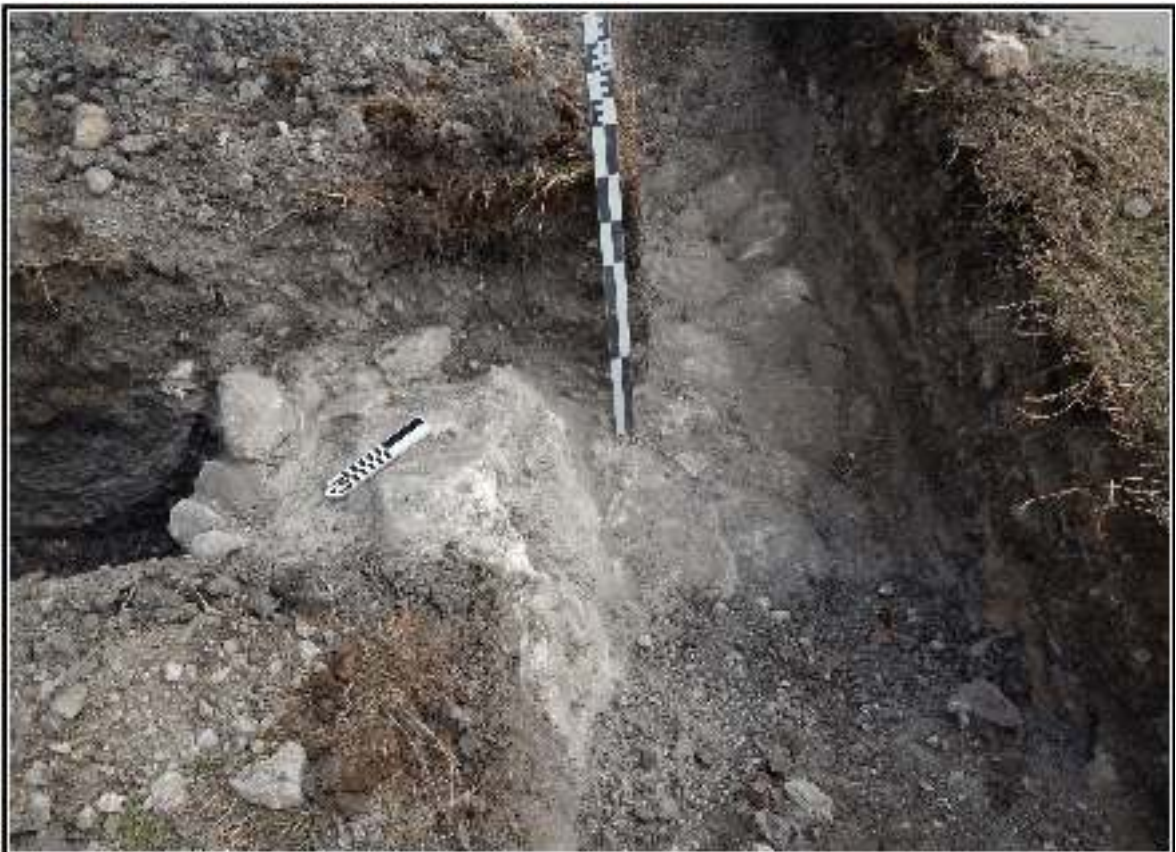
Figure 4-10. Feature 1 facing east. Wall to the left and cobble floor to the right.

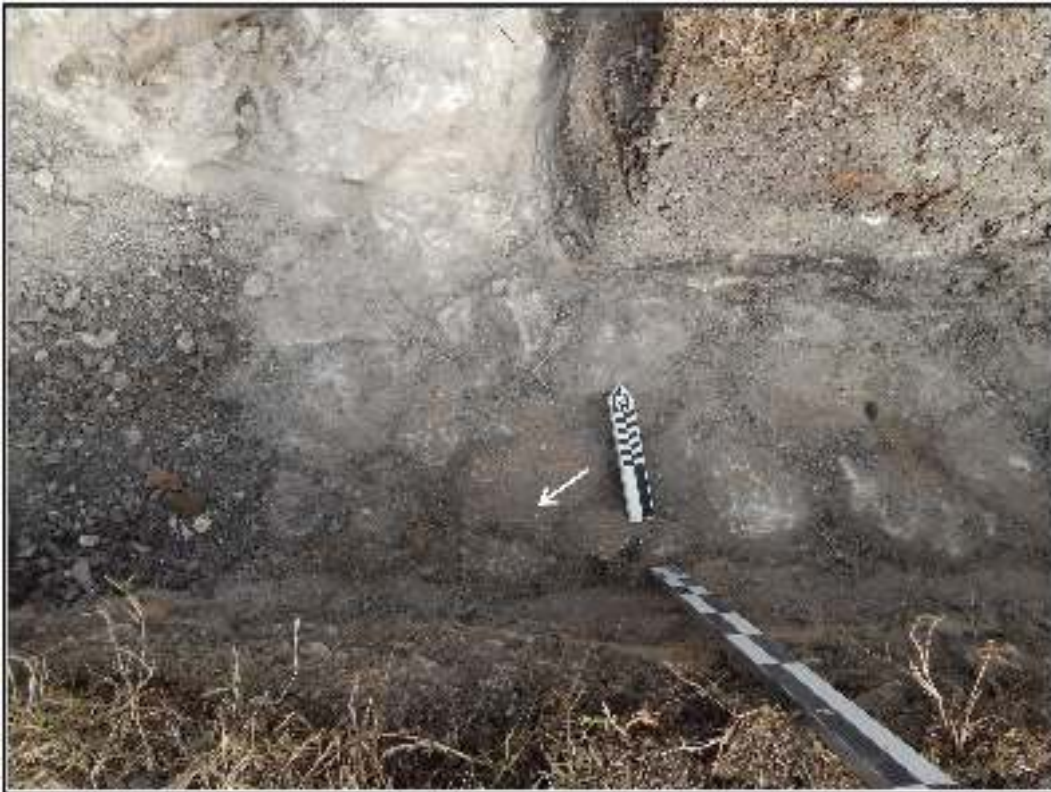
Figure 4-11. Feature 1. Note sandy layer above cobble floor.

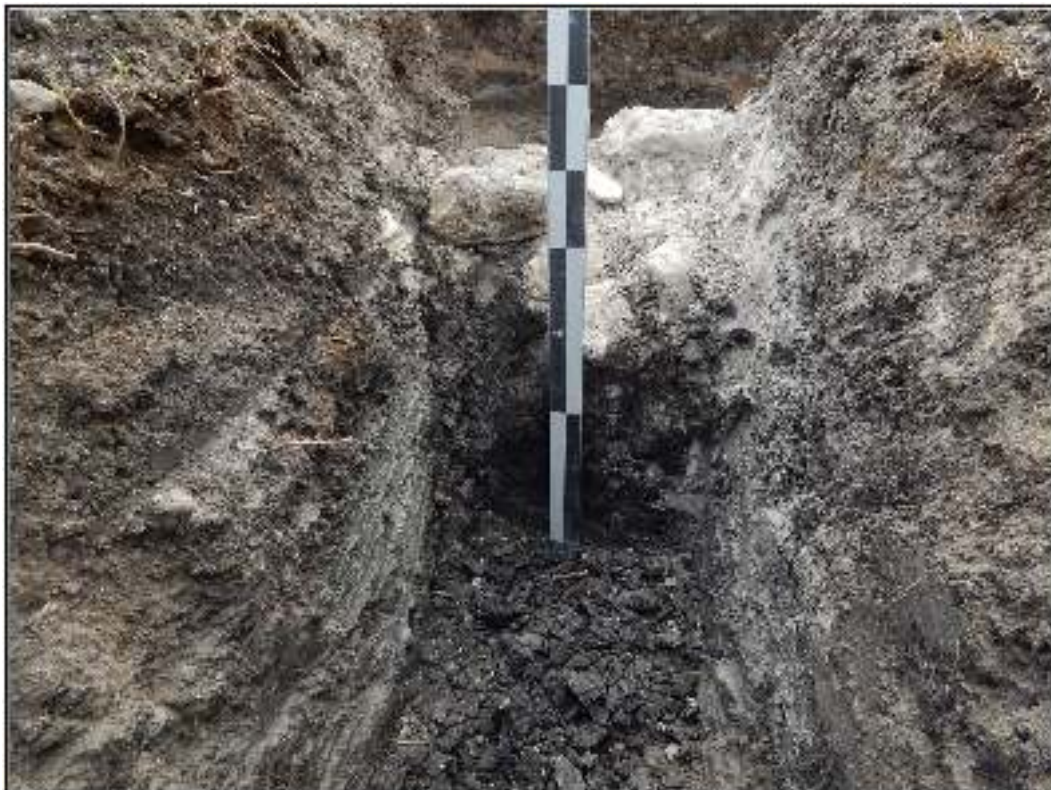
Figure 4-12. Northern profile of Feature 1 within BHT 3 (facing south). Note partial wall collapse.

top of the wall, encountered at 27 cm (10.6 in.) below the surface, appeared to be disturbed. Several loose stones were in the soil above it, and the northern edge was obscured by collapse. The soil profile was similar to the northern profile of BHT 1, and additional profiles were not drawn due to the proximity of the trenches. One possible ox or mule shoe was observed in the backdirt, but it was not collected (see Appendix A).

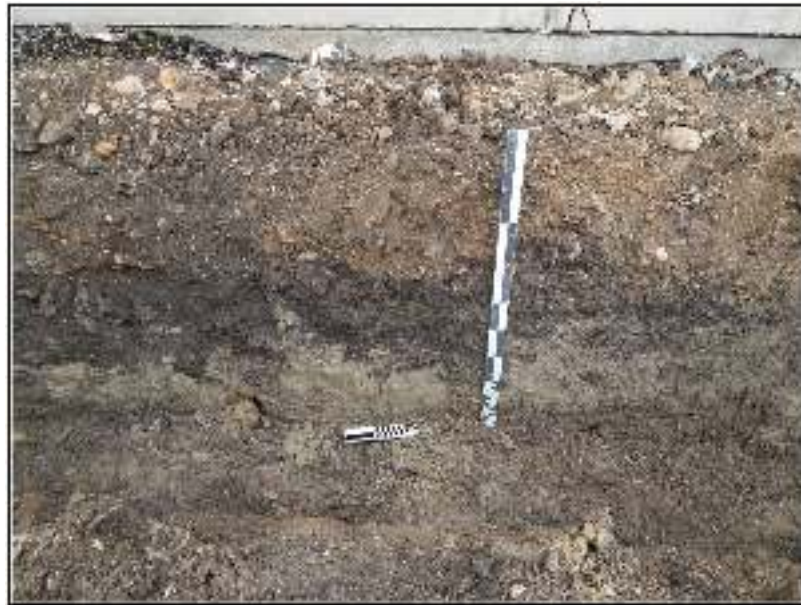
Figure 4-15. Western profile of BHT 4.

The soil profile documented within the trench included three layers with borders that were somewhat irregular (Figures 4-15, 4-16, and 4-17). Layer 1 was 0-47 cm (0-18.5 in.) below the surface and consisted of gravelly clay mottled very dark grayish brown (10YR 3/2) and yellowish brown (10YR 5/6). Layer 2 was 47-75 cm (18.5-29.5 in.) below the surface and consisted of very dark grayish brown (10YR 3/2) blocky clay. Layer 3 was 75-105 cm (29.5-41.3 in.) below

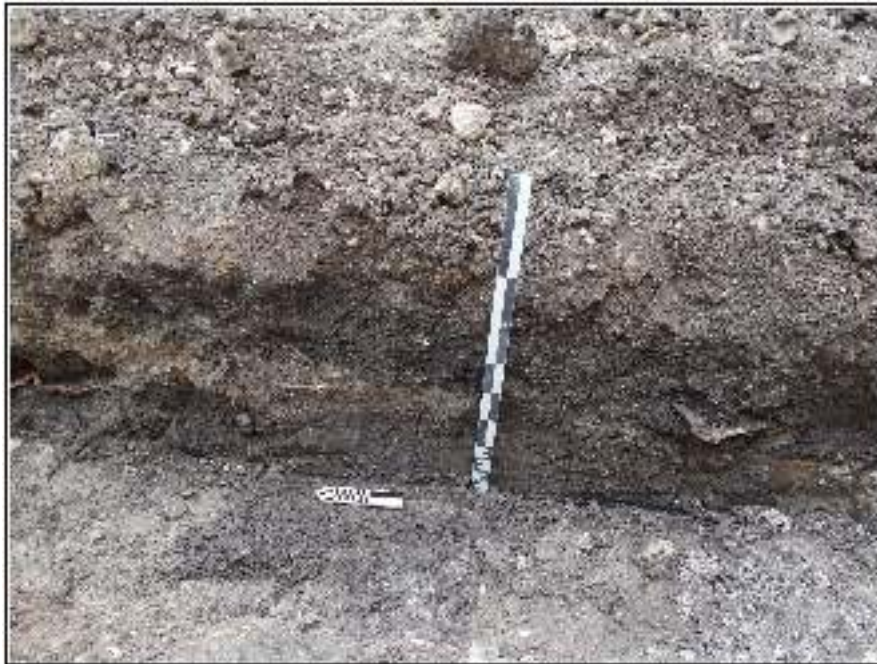
Figure 4-17. Eastern profile of BHT 4.

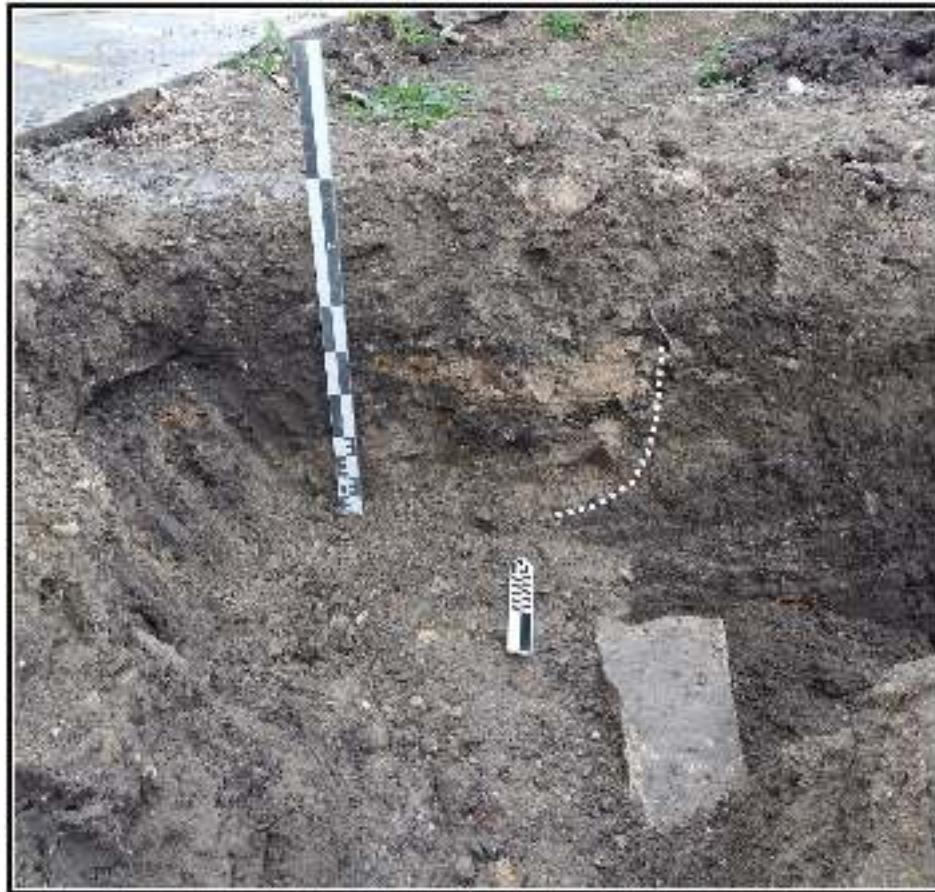
*Figure 4-18. Northern profile of BHT 5. Dashed white line demarcates soil change associated with Feature 3.*

This feature was initially documented within BHT 5, but it was determined to be present within the whole of BHT 4 as well (see Figure 4-20). Feature 3 was originally defined by the presence of a smooth, finely cut limestone block encountered within BHT 5, with a thin layer of small limestone cobbles below the block. Examination of the area below the stone in BHT 5 made it clear that only one course of stone is present. In the northern profile of BHT 5, a basin-shaped channel west of the limestone block was present (Figure 4-21). The soil profile within the channel was similar in appearance to the soil profile documented within BHT 4, while soil profile east of the limestone block showed less stratification (see Figures 4-18, 4-19, and 4-21). The defined basin-shaped feature in the profile is present at 30 cm (11.8 in.) below the surface, but the stone was not encountered until 88 cm (34.65 in.) below the surface. The bottom of the stone extends to 110 cm (43.3 in.) below the surface. The documented extent of the feature was 1.1 m (3.6 ft.) extending north-south and 90 cm (35.4 in.) east-west. However, the feature extends north, south, and west of the section documented within BHTs 4 and 5. The nature, alignment, and location of the feature along the property line suggest it is a segment of the San Pedro Acequia (41BX337). The soil profile resembles the description of the unlined ditch recorded by CAR just north of the project area in 1986, with the exception of the asphalt fill noted during that project (Cox 1993). The west wall of the *acequia*, if still

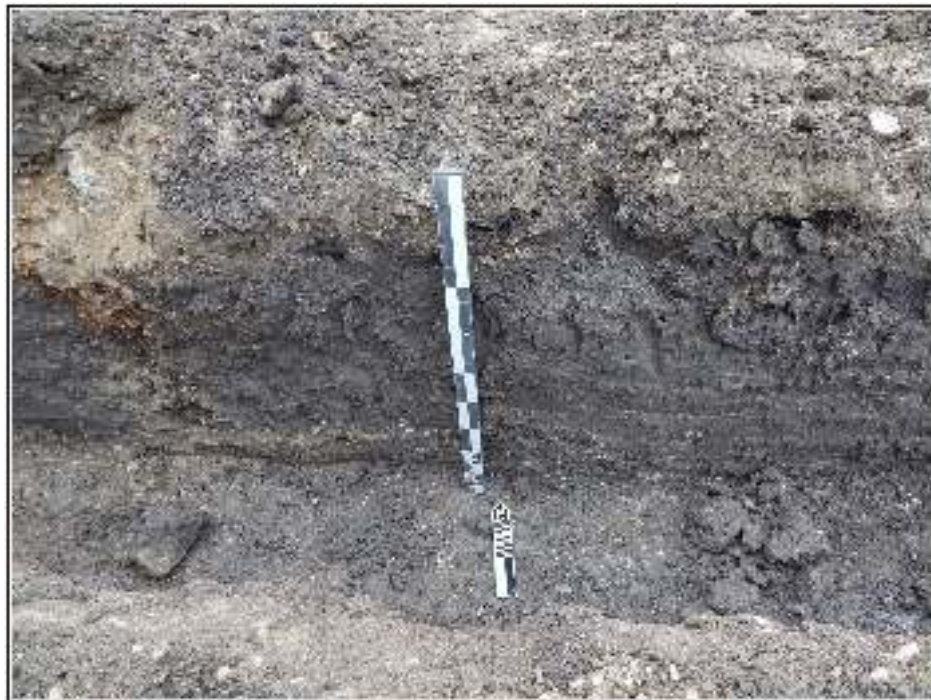
*Figure 4-19. Northern profile of BHT 5, east of Feature 3.*

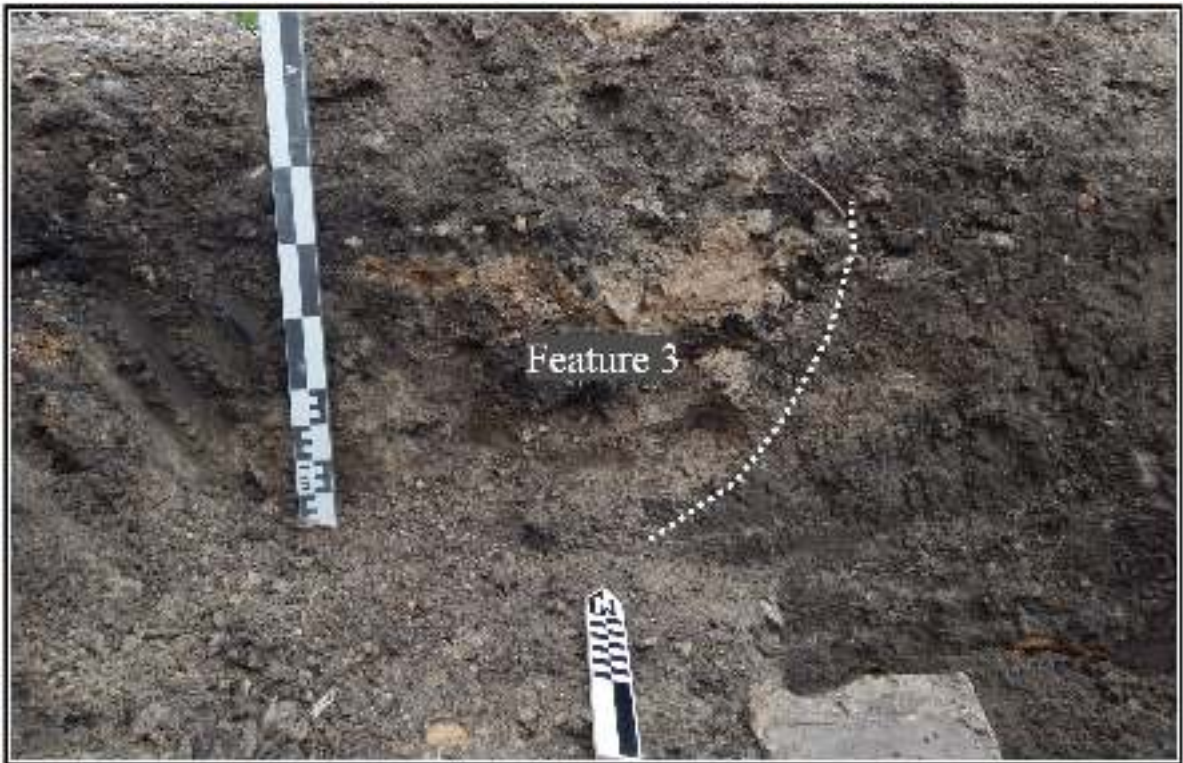
*Figure 4-21. Feature 3. Note soil change west of limestone block (facing north). Dashed white line demarcates shift in soil profile.*

present, is likely west of the Project Area 2 on VIA-MTA property. The highly finished nature of the stone (see Figures 4-21, 4-22, and Appendix A) suggests that it may have been a later modification, prior to the closing of the *acequia* in 1912 (Cox 2005). If this is the case, it is likely that this segment of the *acequia* was originally unlined. The construction of Feature 3 is significantly different than the limestone cobble construction of Feature 1 in Project Area 1.

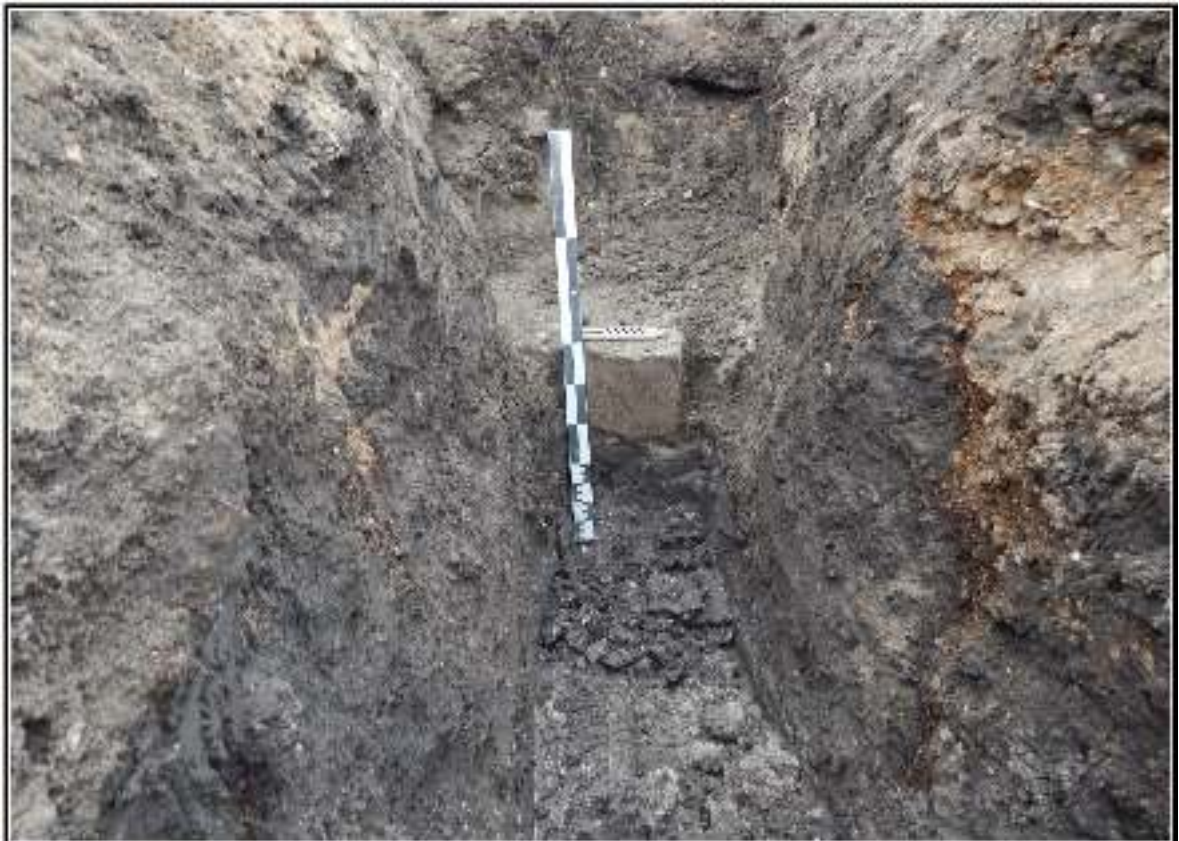
*Figure 4-22. East profile of Feature 3. Note single course of stone.*

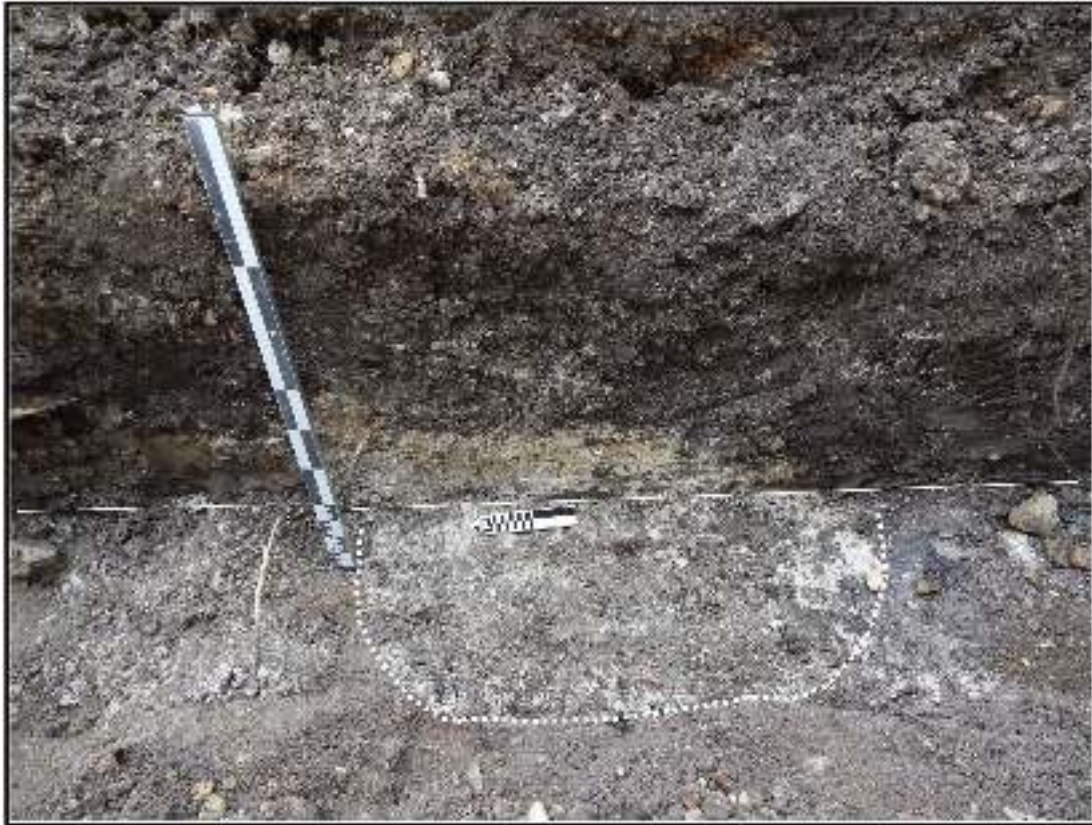
Figure 4-24. Feature 4 within BHT 4 (facing east). Dashed white line demarcates feature boundary, and solid white line separates trench wall from trench floor.

Feature 4 is a white clay stain documented within the *acequia* channel (Feature 3) near the bottom of BHT 4 (Figure 4-24; see also Figure 4-20). This may represent the use of the area as some sort of dump before the *acequia* was closed. The feature was irregular in shape with defined edges. It was defined at 70 cm (27.6 in.) below the surface and reached a depth of at least 115 cm (45.3 in.) below the surface. The feature was 118 cm (46.5 in.) in length and 55 cm (21.65 in.) in width. The feature contained no artifacts.

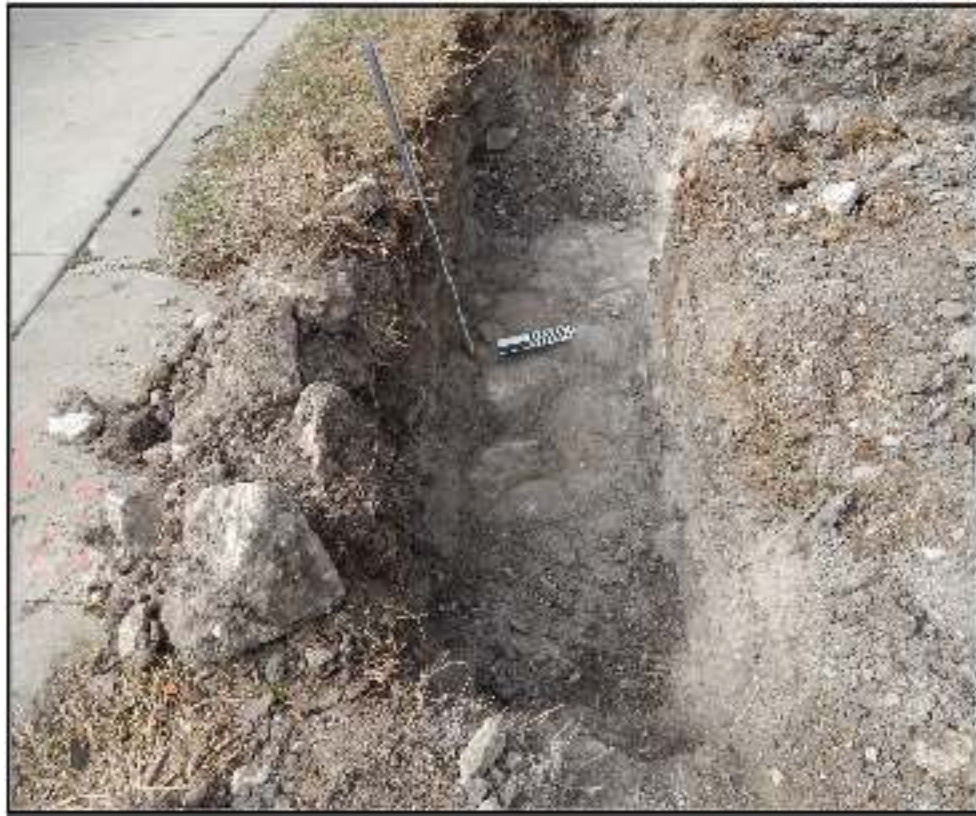
*Figure A-1. Feature 1, floor, in BHT 1.*

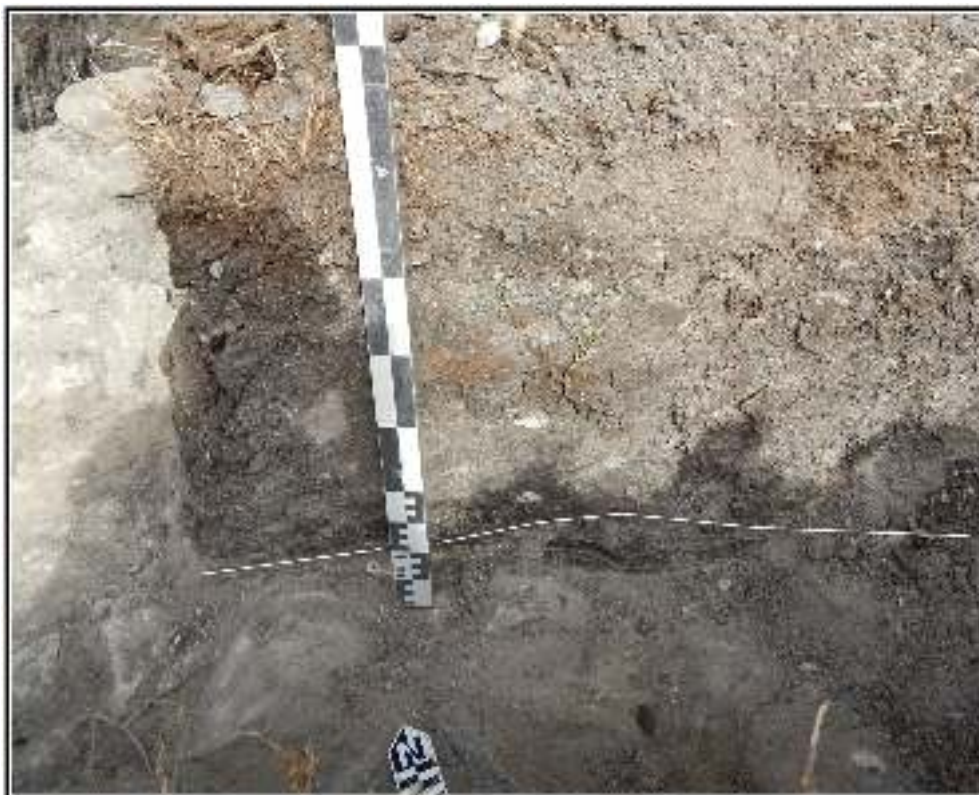
*Figure A-2. North profile of BHT 1, Feature 1 to the left and foreground. Solid white line demarcates trench wall from floor.*

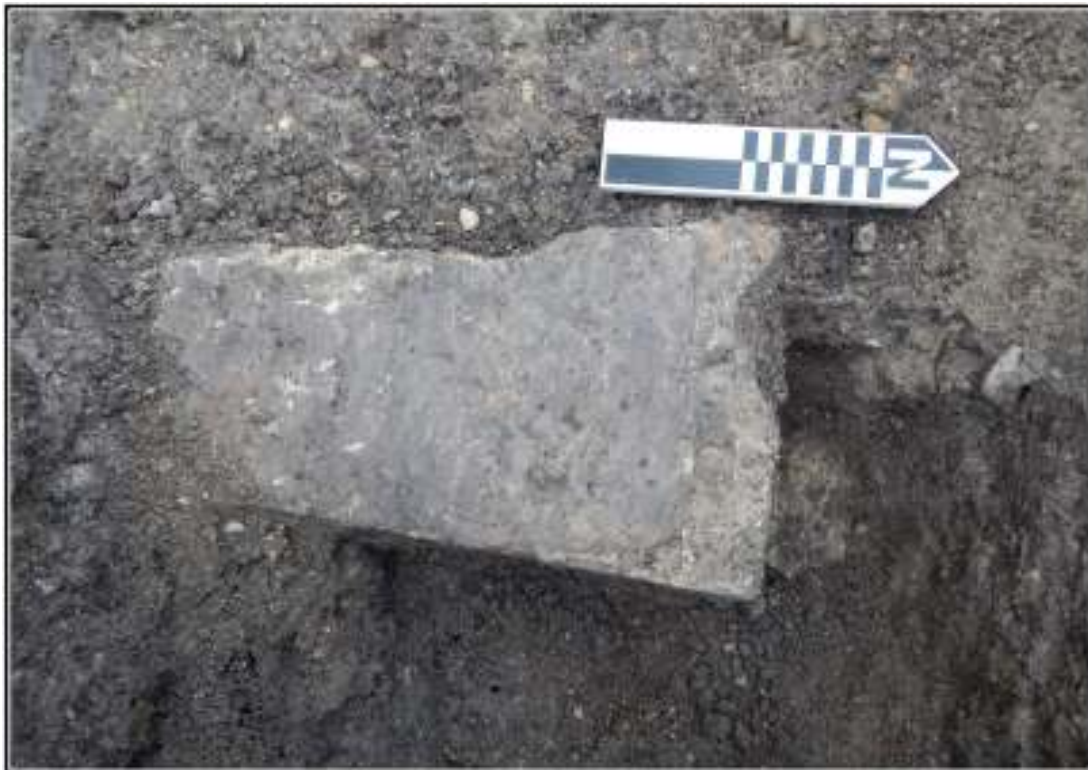
*Figure A-4. Limestone block in Feature 3.*
