Archaeological Monitoring for the Buena Vista Corridor Project, San Antonio, Bexar County, Texas

Prepared by:
Center for Archaeological Research
The University of Texas at San Antonio
One UTSA Circle
San Antonio, Texas 78249
Archaeological Report, No. 483

Between July 11, 2018, and February 28, 2020, The University of Texas at San Antonio (UTSA) Center for Archaeological Research (CAR), in response to a request from the City of San Antonio (COSA), intermittently conducted archaeological monitoring for the Buena Vista (BV) Corridor project in San Antonio, Bexar County, Texas. The project goal was to foster pedestrian traffic by sidewalk, lighting, and aesthetic improvements on Buena Vista Street between S. Leona and S. Santa Rosa streets. The COSA department of Transportation and Capital Improvements (TCI; now Public Works Department) administered the BV Corridor project with the COSA Office of Historic Preservation (OHP) having regulatory control of the archaeological component. The project required review by the Texas Historical Commission (THC) under the Antiquities Code of Texas (Texas Natural Resource Code, Title 9, Chapter 191, Sections 191.003(4) and 191.052(5) as amended)

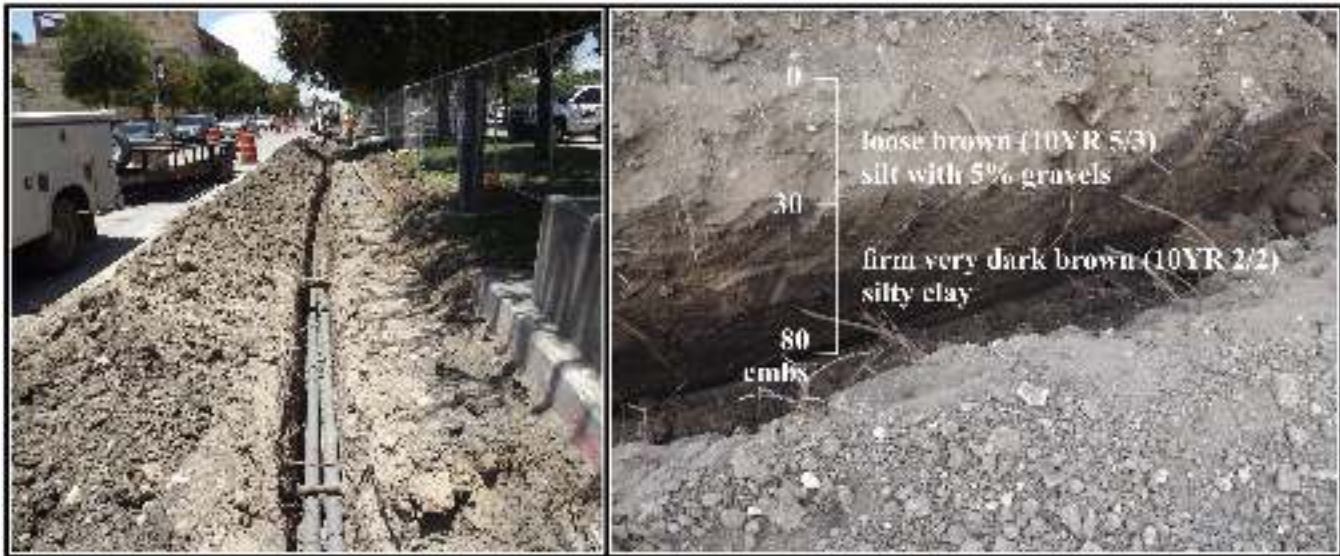
Figure 6-2. Trench 1 excavated on the north side of Buena Vista Street (left). Profile of the southern trench wall (right).

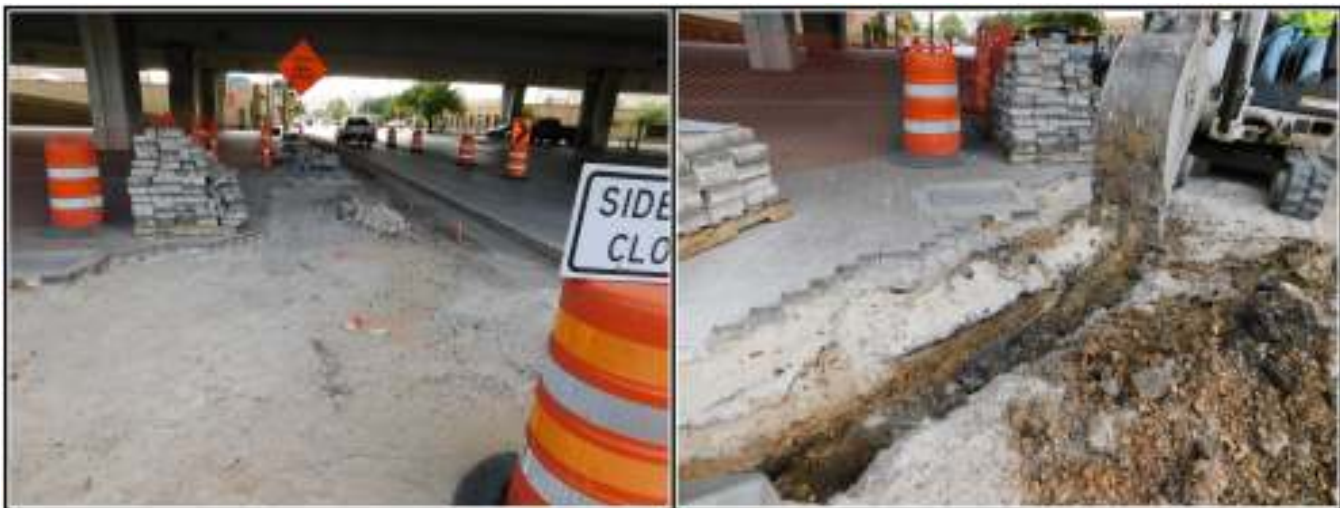
Trench 2 was excavated on the north side of Dolorosa Street under the Pan Am Expressway overpass to the Framers Market Building entrance on August 21 and September 9, 2019 (Figure 6-3, left). The trench was excavated to connect existing utilities from Buena Vista and Dolorosa streets. The trench were 37 m (121.3 ft.) long, 50 cm (19.6 in.) wide, and 30 cm (11.8 in.) deep. The trench matrix consisted of construction fill with the bottom 5 cm (1.9 in.) revealing a dark brown clay (Figure 6-3, right). No artifacts or features were observed in the profiles or backfill.

Figure 6-3. The image on the left shows the layout of the trench under the Pan Am Expressway. The image on the right shows the profile of the northern trench wall.

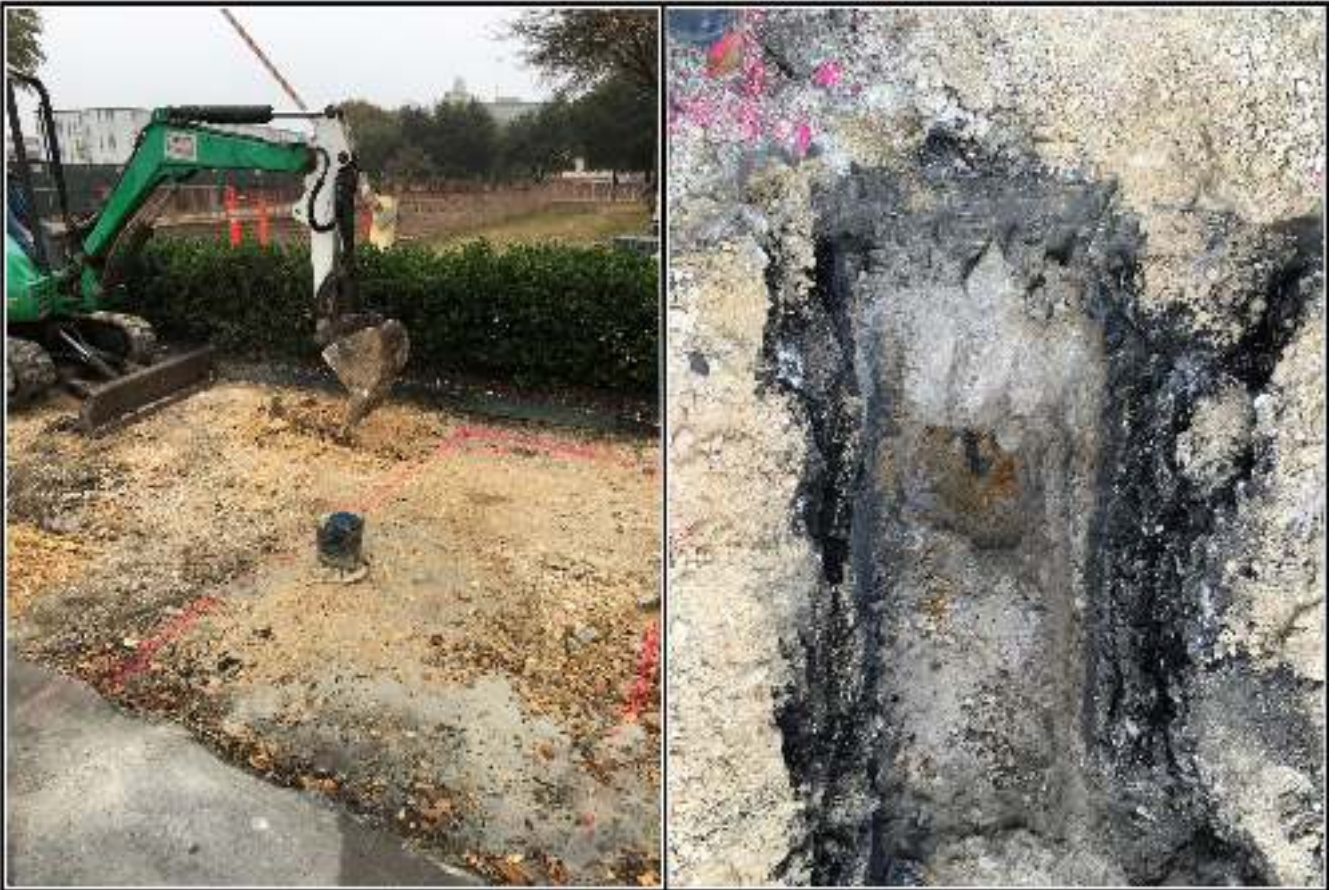
Trench 3 for a crossing walk signal was excavated on December 5, 2019, on the south portion of Buena Vista Street across from its intersection with S. Leona Street (Figure 6-4). The trench measured 3 m (9.8 ft.) long, 70 cm (27.5 in.) wide, and 1.82 m (5.9 ft.) deep. The trench contained asphalt to 60.9 cm (24 in.) below the grade followed by flowable fill. A cast iron pipe was found at 1.82 m (5.9 ft.) deep. No artifacts or features were observed in the profiles or backfill.

Figure 6-4. Excavation of Trench 3 on the south side of Buena Vista and S. Leona streets (left). The right image shows the trench with asphalt and flowable fill over an existing cast iron pipe.

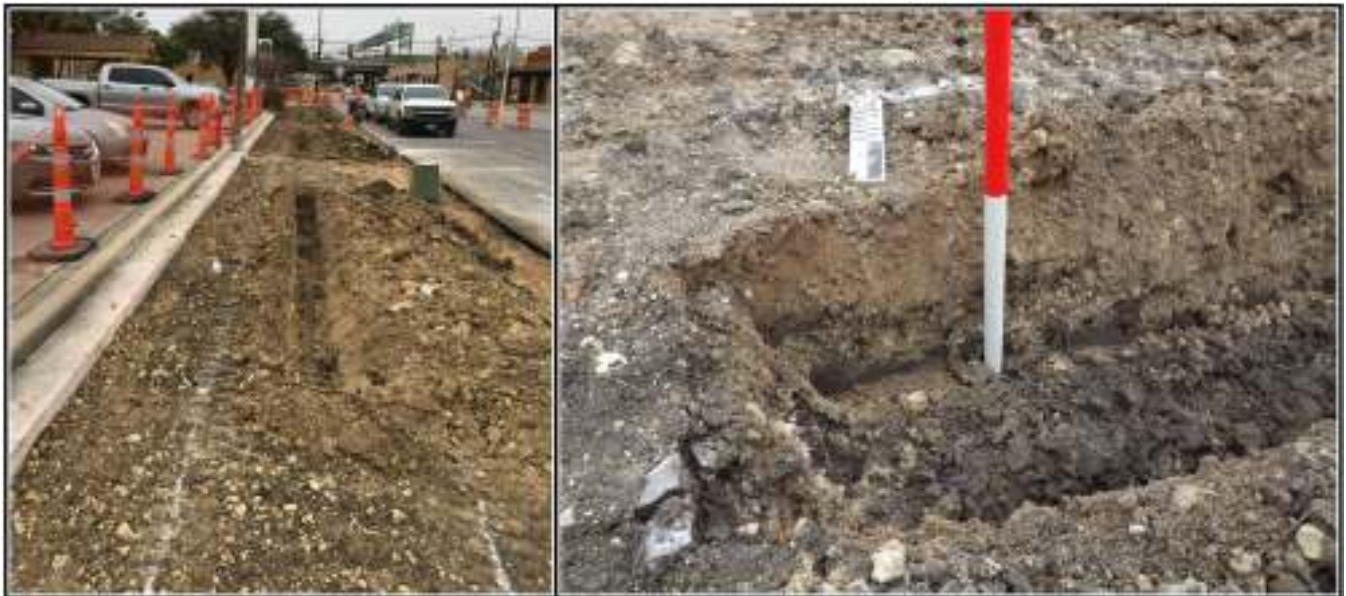
Trench 4 was excavated on February 19, 2020, on the south side of Dolorosa Street between San Saba and Santa Rosa streets for an irrigation line (Figure 6-5, left). The trench is 140 m (459.3 ft.) in long, 30 cm (11.8 in.) wide, and 30 cm (11.8 in.) deep. The top 25 cm (9.8 in.) of the trench consisted of construction fill and asphalt over a dark brown silty clay (Figure 6-5, right). No artifacts or features were observed in the profiles or backfill.

Figure 6-5. View to the west of the irrigation trench excavation with layout for planter boxes painted in white (left). Typical profile of irrigation wall view with construction fill to 25 cm (9.8 in.) below the grade followed by 5 cm (1.9 in.) of silty clay (right).

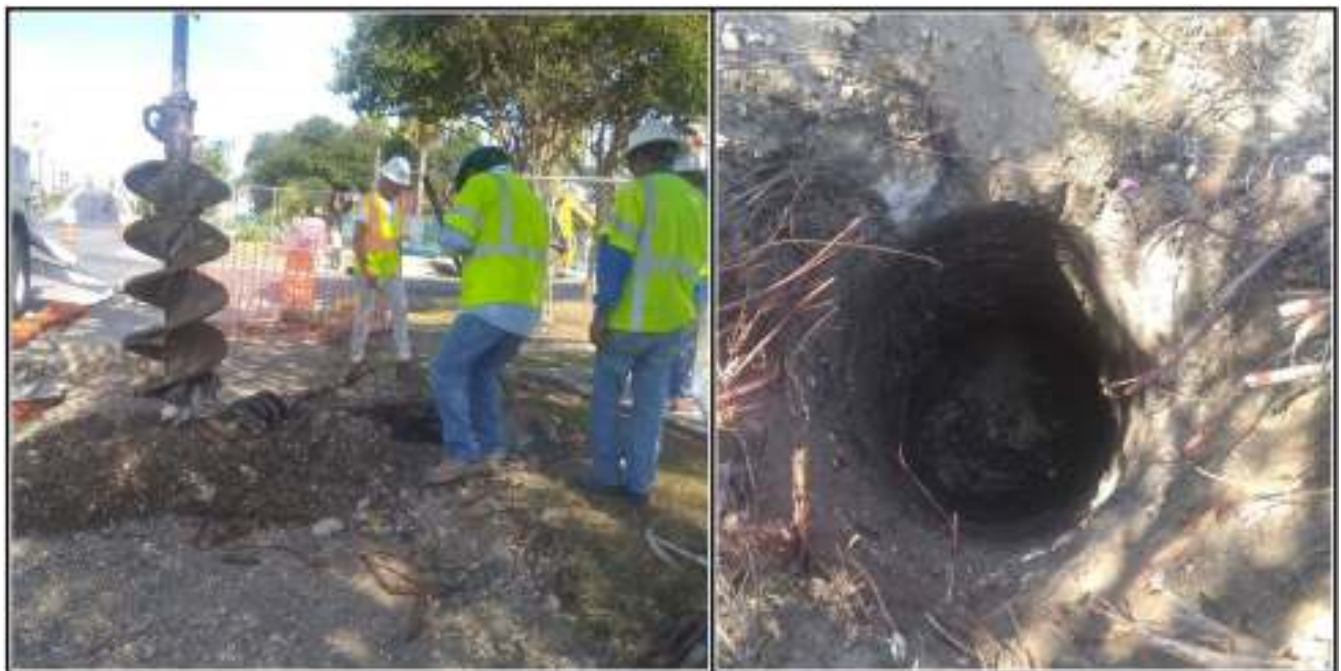
Auger excavations in Areas 1 revealed past construction activities with construction fill and concrete. The auger location at S. Leona and Buena Vista streets contained rebar and unidentifiable metal at 1.2 m (4 ft.) and concrete at 1.52 cm (5 ft.) below the surface (Figure 6-7). The auger excavation at Buena Vista and Pecos streets encountered concrete 60.96 cm (2 ft.) below the surface followed by soils. The final auger

Figure 6-7. Auger excavation at S. Leona and Buena Vista streets (left). The image of the right shows concrete at 152.4 cm (5 ft.) below the surface.

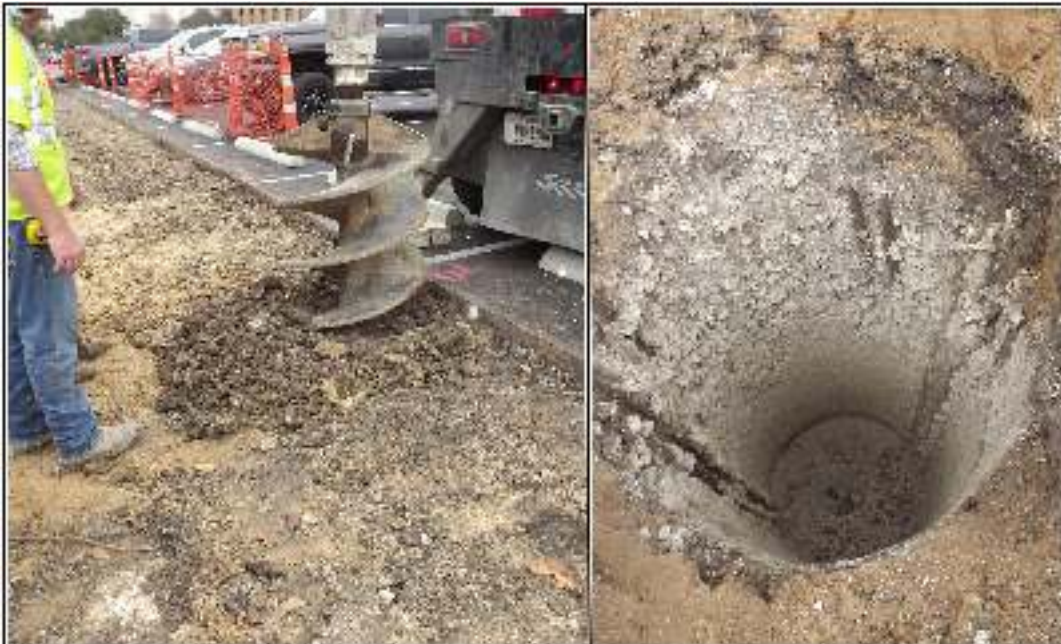
Figure 6-9. Image on the right shows location of Area 5 view to the southeast. Profile view of auger in Area 5.

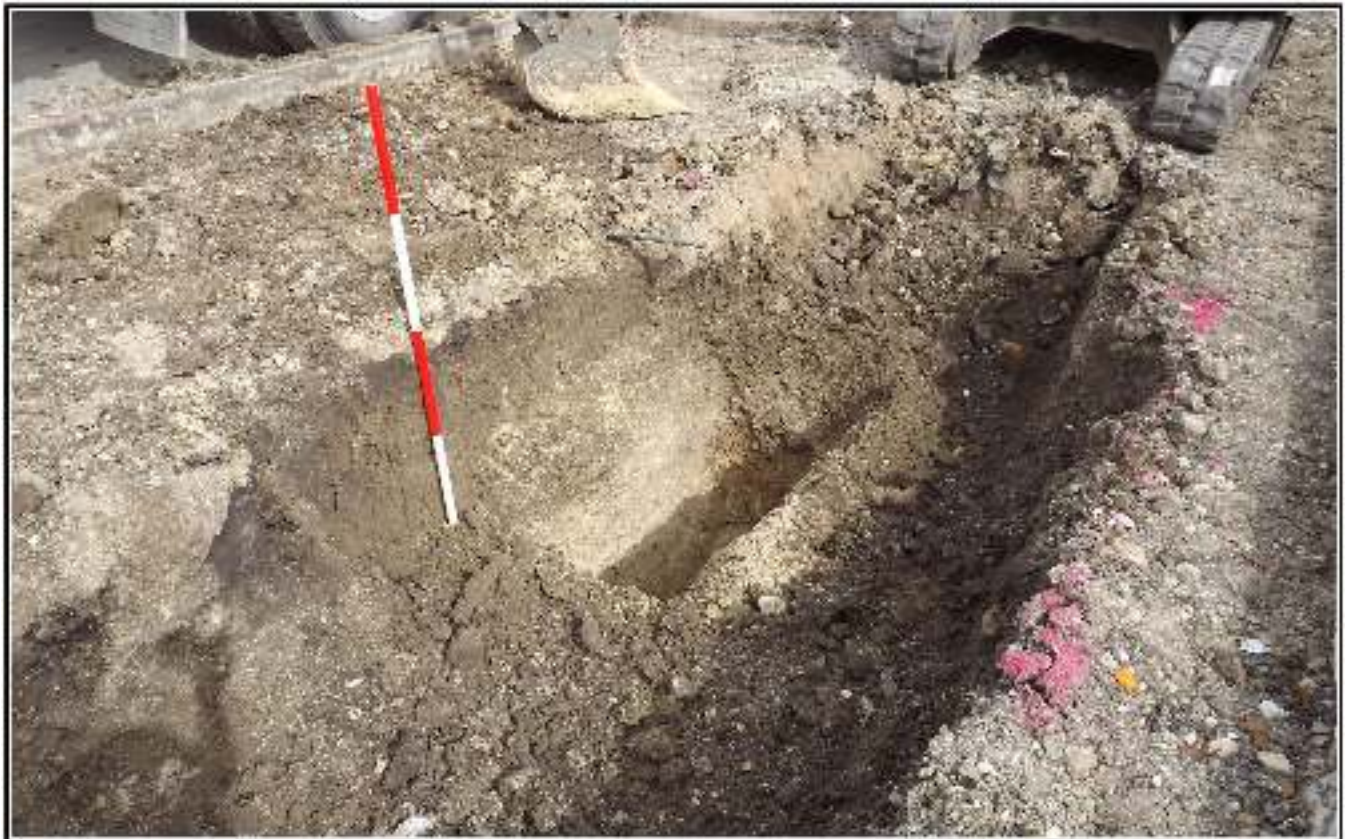
Figure 6-11. Typical pit excavation with deeper drainage pit against the wall and soil profile.

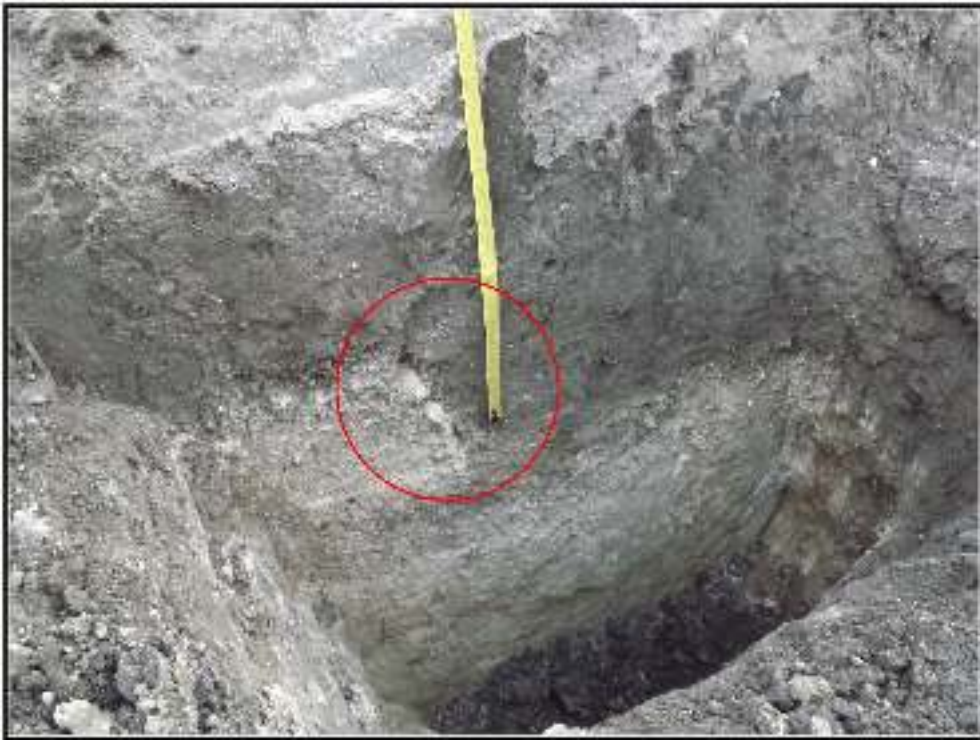
Figure 6-14. Detail of the east portion of the north profile highlight the stones.

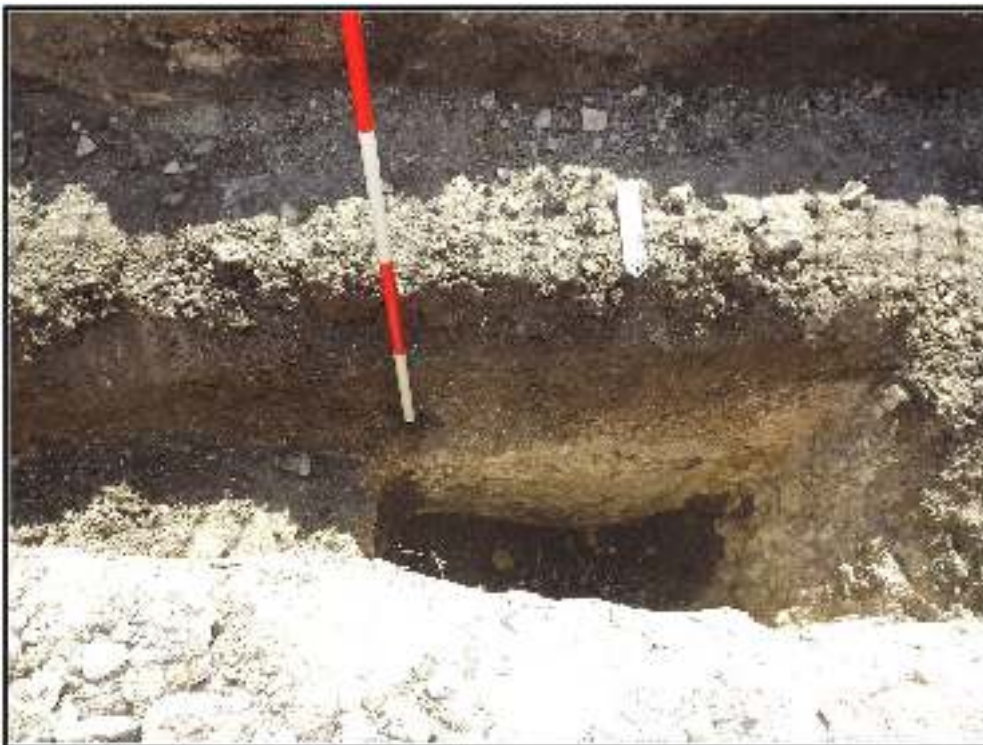
Figure 6-15. South profile of 41BX2345.

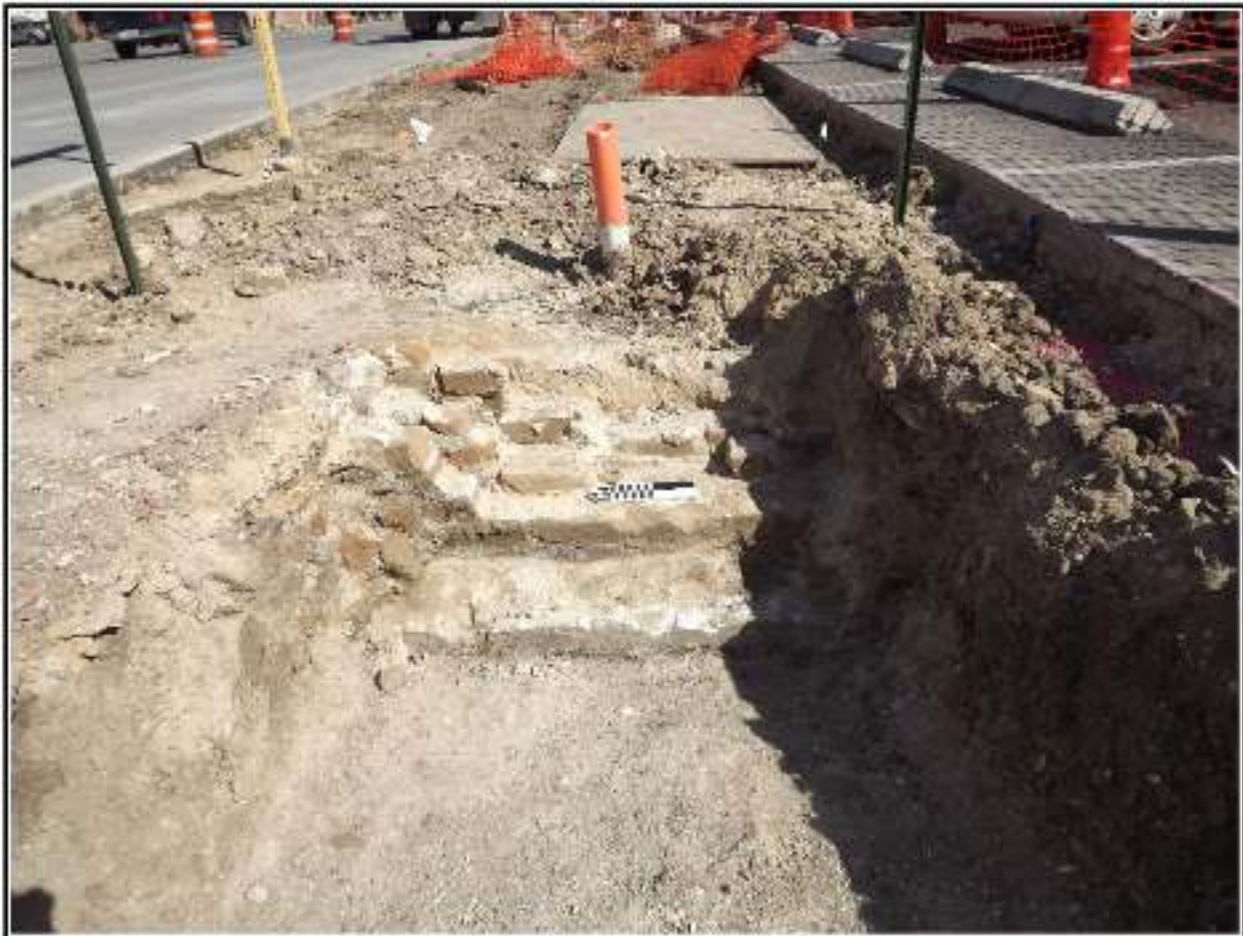
Figure 6-18. A view to the east of the brick foundation comprising 41BX2346.

Site 41BX2346 was documented in the field and with archival research. Following field documentation, the portion of the foundation within the excavation footprint was removed. The THC and COSA-OHP approved of this action during

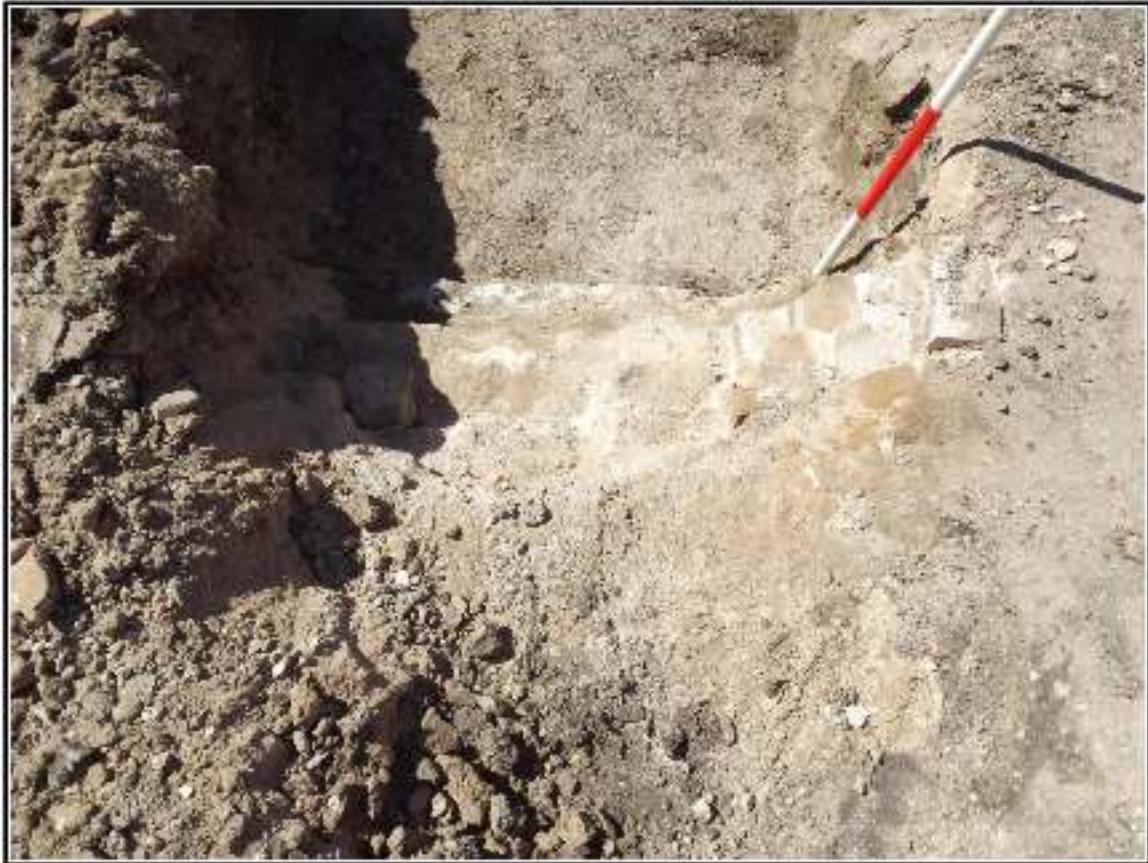
Figure 6-19. An overhead view of the brick foundation comprising 41BX2346.
