EXCAVATIONS AT THE ALAMO SHRINE

(MISSION SAN ANTONIO DE VALERO)

Center for Archaeological Research
The University of Texas at San Antonio
Special Report No. 10
1980

1. Archaeological testing in front of Alamo Shrine;
2. Excavations at the Alamo Shrine (San Antonio de Valero);
3. Bexar County, Texas;
4. Thomas R. Hester, Principal Investigator; Jack D. Eaton, Field Director and Author;
5. City of San Antonio;
6. Texas Historical Commission Antiquities Permit No. 139;
7. Published by the Center for Archaeological Research, The University of Texas at San Antonio, San Antonio, Texas 78285; December 1980.

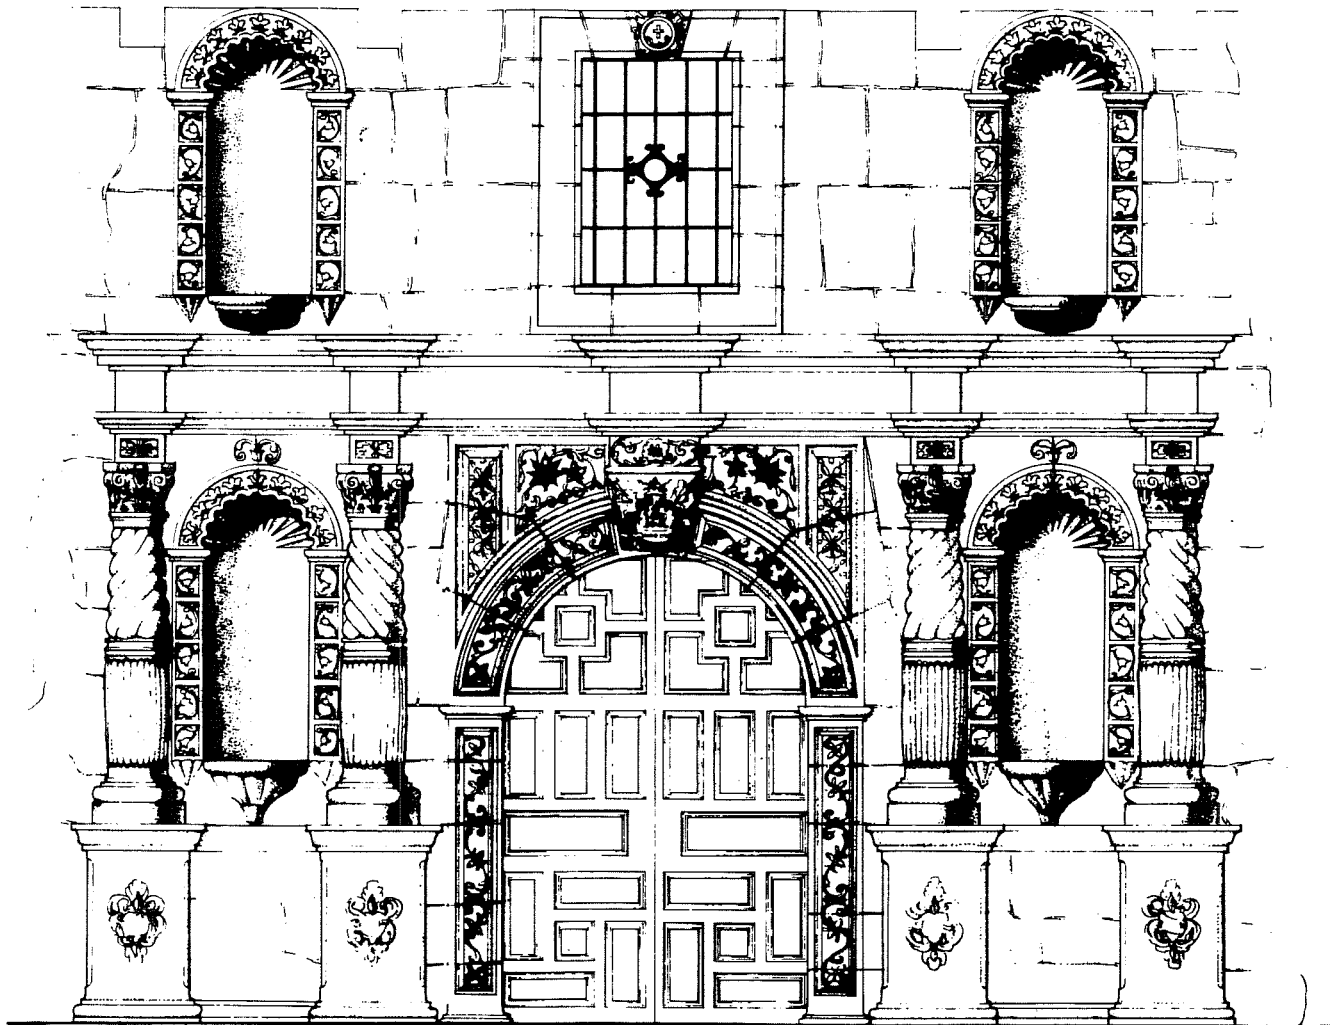
Figure 4. *Alamo Shrine Facade*. An elevation view of the current facade. This is the lower portion of a planned larger church facade never completed. Courtesy of Eugene George, AIA Architect and the Texas Historical Commission.

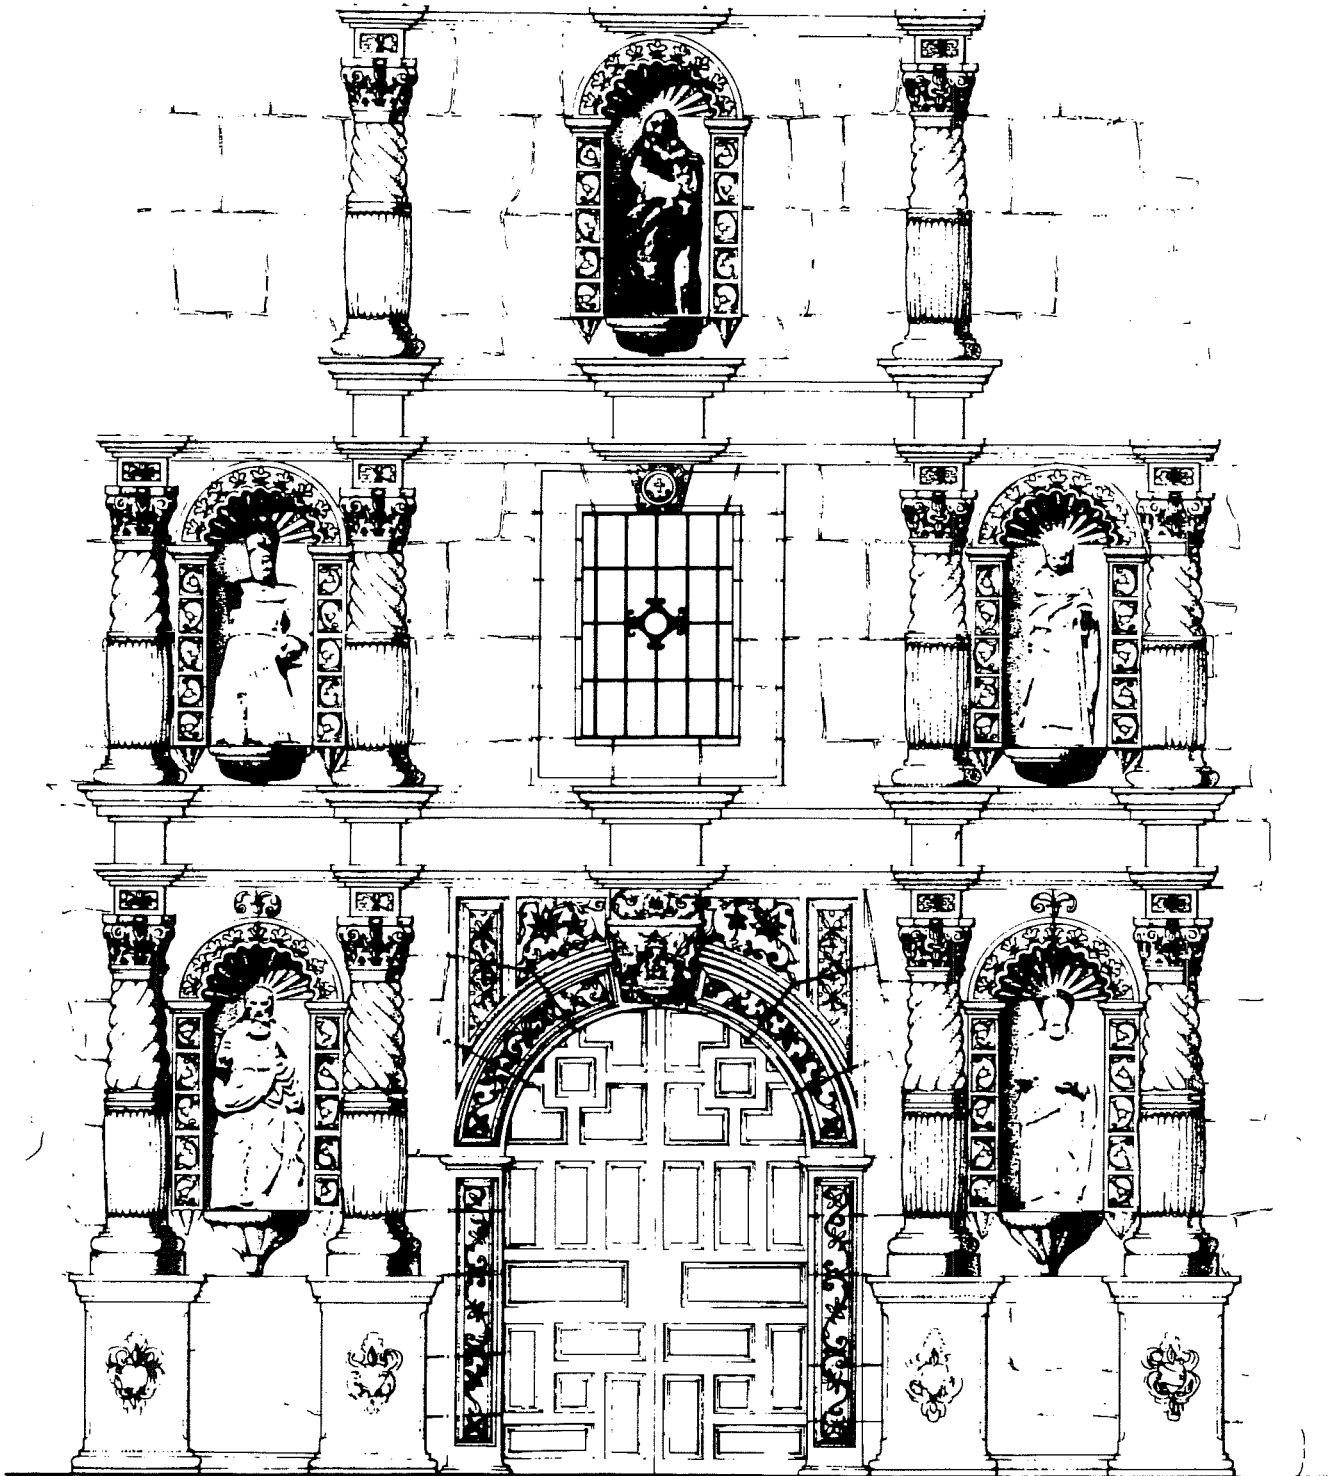
Figure 5. *San Antonio de Valero Mission Church Facade*. A reconstruction of the planned (but not completed) design as described in 1772 inventory. A 17th century Early Baroque retablo facade.

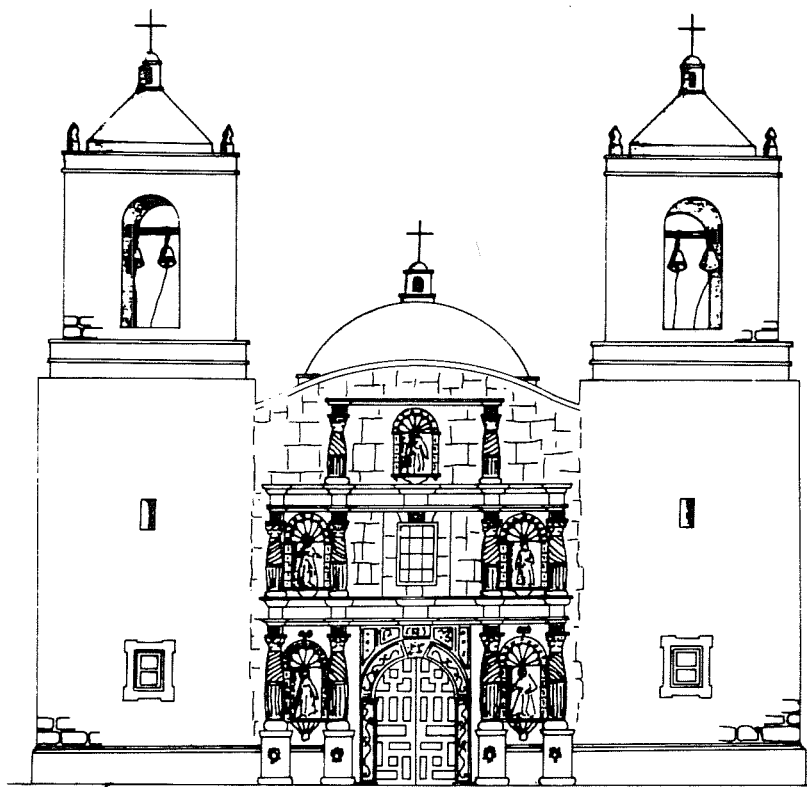
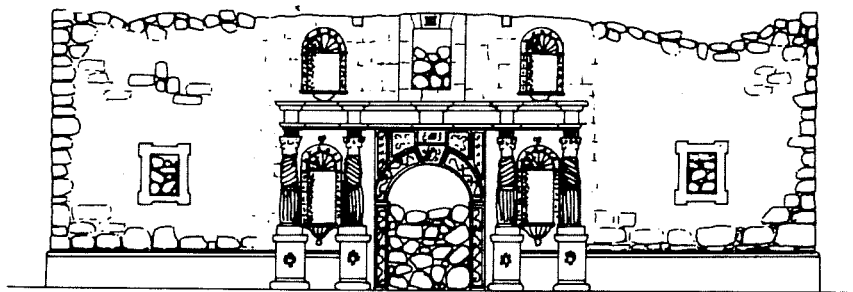
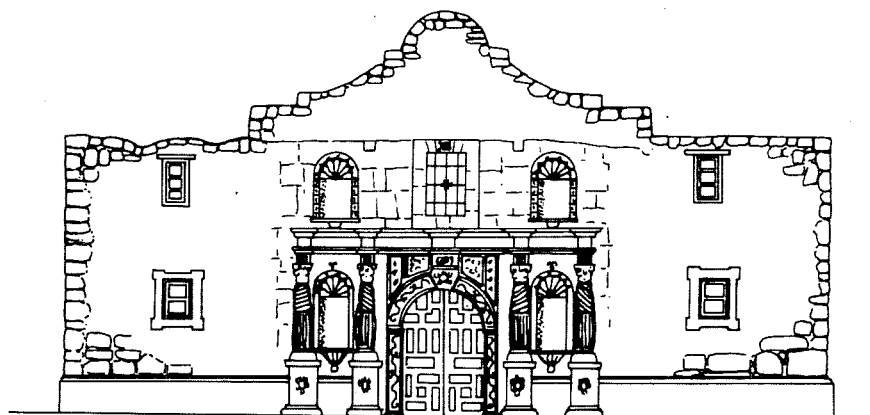
Figure 6. *San Antonio de Valero Mission Church (The Alamo)*. a, suggested original elevation view of mission church, planned but not completed; b, the Alamo at the time of the 1836 battle; c, the Alamo as seen today, with added gable and upper windows.

In the meantime, the Texans began to appreciate the seriousness of the situation and to realize that a Mexican army under General Santa Anna was indeed advancing on San Antonio. Although a great deal of confusion clouded decisions of what to do, it was finally decided that the Alamo complex, the only sturdy structures available which could withstand an attack, would be repaired and put back into fort fashion as best as time and materials would allow. William Travis and James Bowie were to be joint commanders of the fortifications. Green B. Jameson was appointed garrison engineer and was responsible for fortifying the Alamo (Turner 1972:122; Williams 1933:18; Smith 1967:18-22). The quadrangle and building walls were repaired, and parapets of earth and wood were erected for cannon and riflemen. Men would also take the prone position on rooftops. In the old church, scaffolding was constructed to serve as a catwalk for riflemen; and the door and window openings were blocked off (Fig. 6,b).

During 1821 to 1835, when the Mexican Army occupied the old mission complex, little was done to improve the church structure (Fig. 6,b). During the reoccupation of the Alamo by the Texans in 1835, and through the siege of 1836, no repairs were made to the old chapel other than to block up door and window openings and to construct an interior scaffold for riflemen (Smith 1967). It was not until the U.S. Army occupation in 1849 that a frame gable roof was installed, along with repairing the upper walls, adding the top center gable, cutting new upper windows, and installing upper flooring (Fig. 6,c). In 1920, a new timber-framed gable roof with shingles was constructed by the Daughters of the Republic of Texas after acquiring the famous structure. Then, in 1934, concrete vaults covered with lead-coated galvanized metal with standing-seam roof replaced the frame structure. The flat roofs over the tower bases and adjacent rooms are covered with the same material in a flat-locked seam. This roofing is still in use.

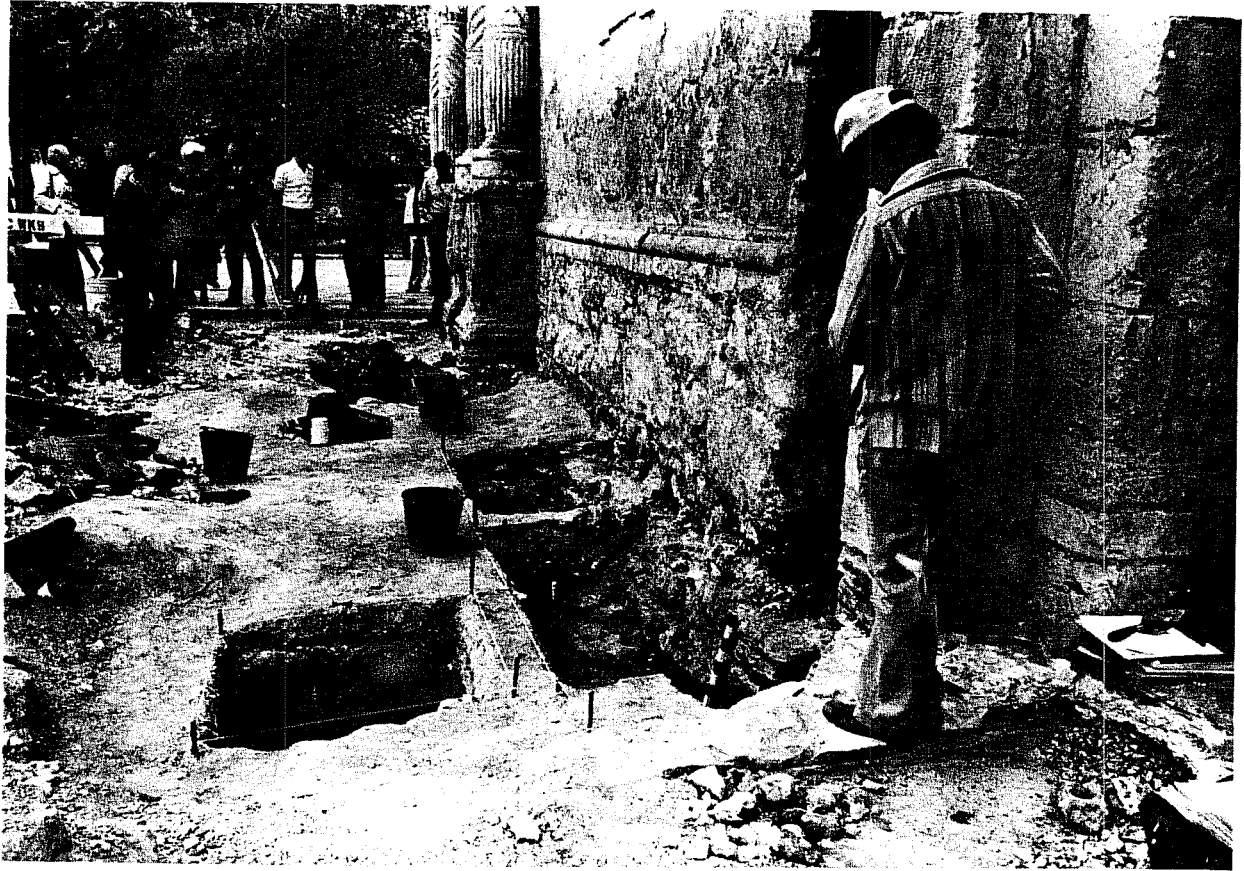
Figure 8. *Excavations in Front of Alamo Shrine.* a, view of initial excavation units, looking north; b, elevation of building's southwest corner and basic soil profile.

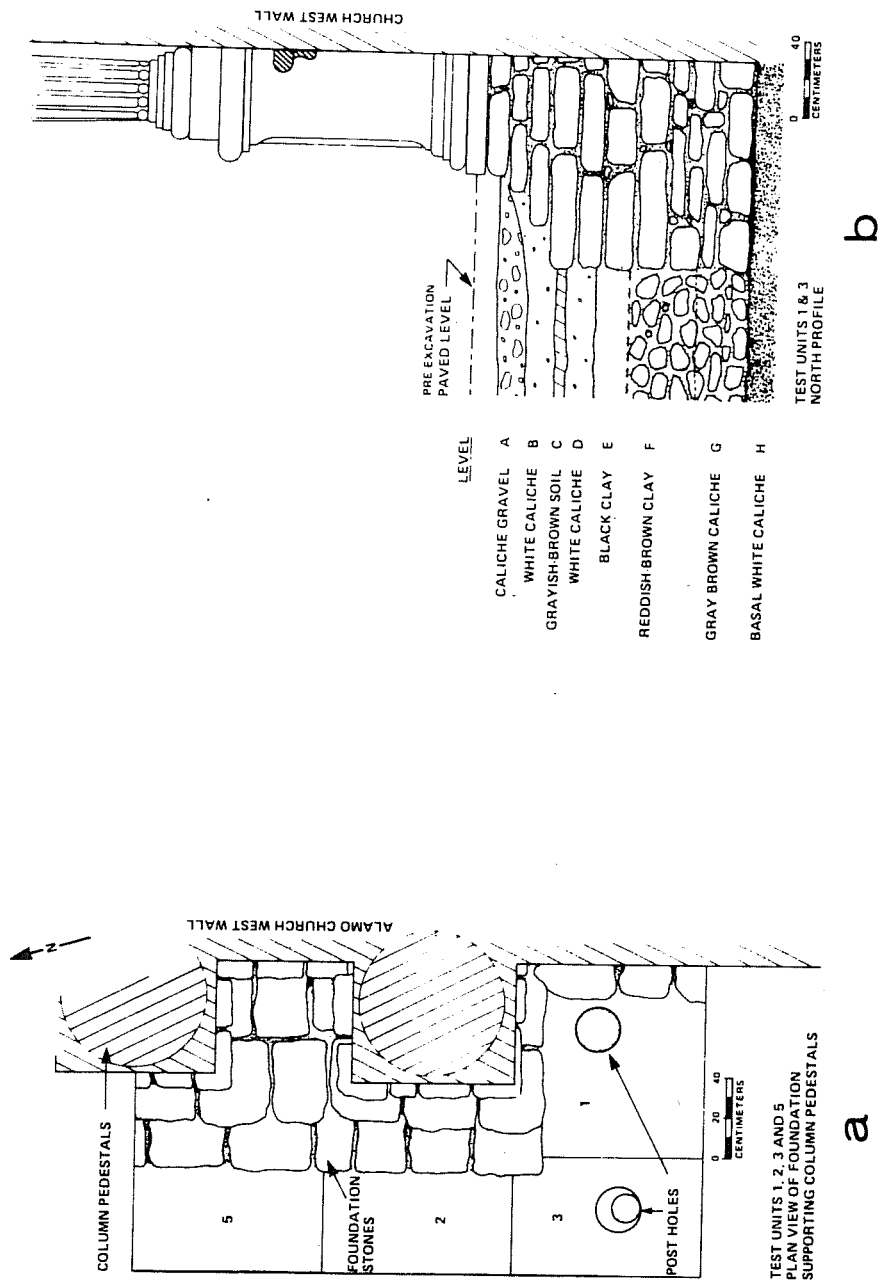
Figure 9. Alamo Shrine Excavations at the Front Column Pedestals. Shown are foundation construction and soil levels. a, plan view; b, elevation view.

Post holes were noted in Units 1, 3, and 12 (Fig. 9). In Unit 1, the outline of a post hole of 23 cm diameter filled with brown soil was exposed at the top of the level. It is located 24 cm away from the building wall and was found to penetrate to a depth of 50 cm. The post hole in Unit 3 was basically of the same description and was located 1.16 m from the building. The post hole found in Unit 12 was located 1 m from the building, off the southwest corner and in line with the hole in Unit 3. These holes possibly had been dug by the U.S. Army under the direction of Major E. B. Babbitt, Acting Quartermaster U.S.A., in 1849 to install scaffolding posts for the repair of the building.

Excavations against the building wall exposed sections of the foundation which provided a view of the construction and its condition. The foundation wall which supports the large church structure is nearly four feet in width and is very sturdy. The foundation, at least in our limited tests, was found to be dry and in excellent condition, and is the reason the building stands firm today.

The base of the church wall, which rests upon the foundation, is 24 cm below the present flagstone paved surface. At this level, there appears to have been older flagstone paving possibly dating to the mission period. Some flagstone fragments were found to butt against the wall base. These earlier flagstones were possibly either part of an old walkway extending along the building wall or remnants of church courtyard paving.

The building foundation wall is thicker by several centimeters than the church wall it supports, and it extends down 60 cm to where it rests upon a wall footing of the same thickness. This level is coincidental with the top of the dark brown clay, which evidently was the original construction-period ground surface. The foundation wall is constructed of large, load-bearing irregular stones and slabs which are roughly dressed on the facings and maintain fairly even coursing and alignment (Figs. 8, 9, 10). These stones, which are generally around 10 to 20 cm in height and roughly 20 to 40 cm in length, are laid in rough horizontal coursing, using gray to occasionally pink sandlime mortar and many spalls to fill the larger mortar joints and to aid in setting the stones.

The footing upon which the foundation wall rests is not as carefully built, and uses rubble stones and slabs set without coursing in yellowish sandlime mortar. It appears that the footing trench had been dug through the dark brown clay to the underlying base caliche, a depth of more than a meter. Stones and mortar had been placed into the trench to provide the footing. These were not merely dumped into the trench but were carefully set to bear the load. It seems possible that

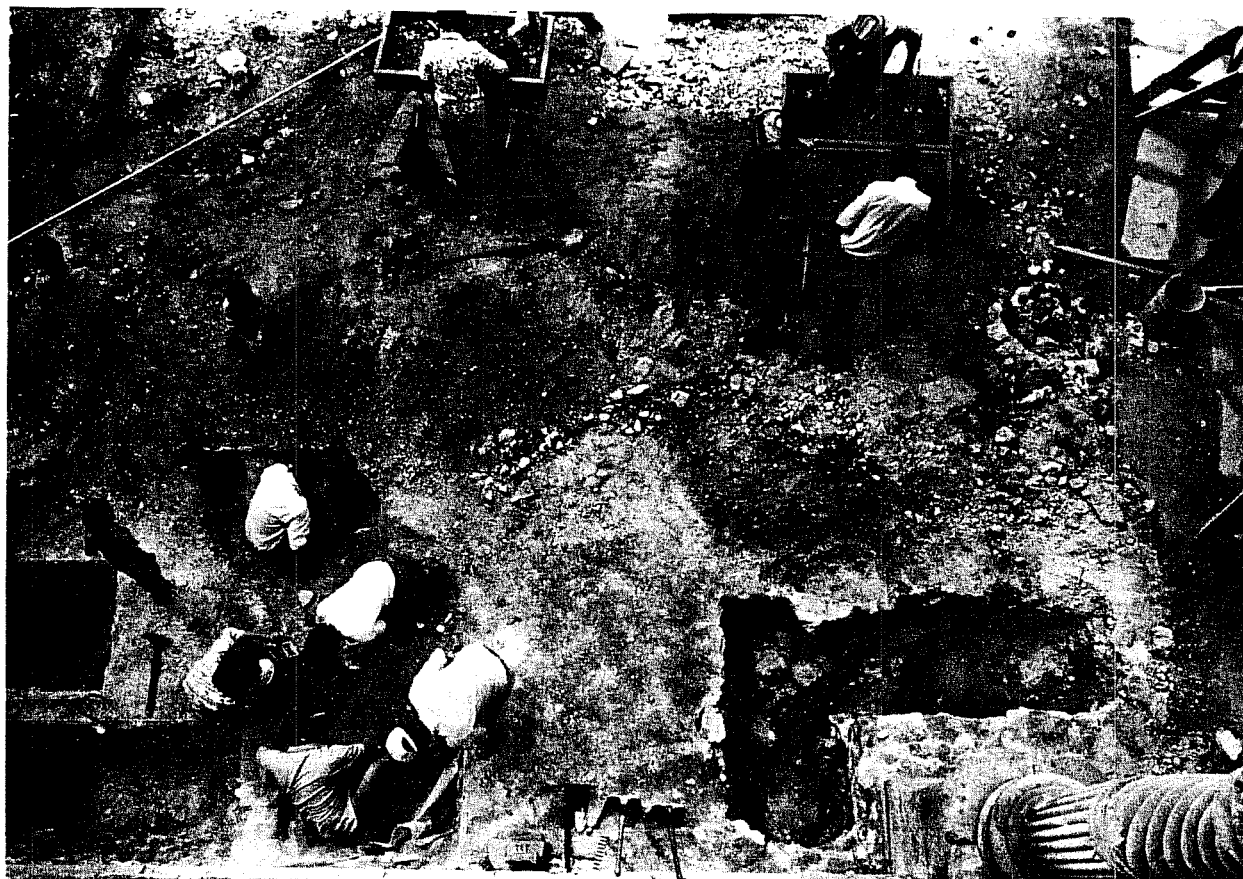
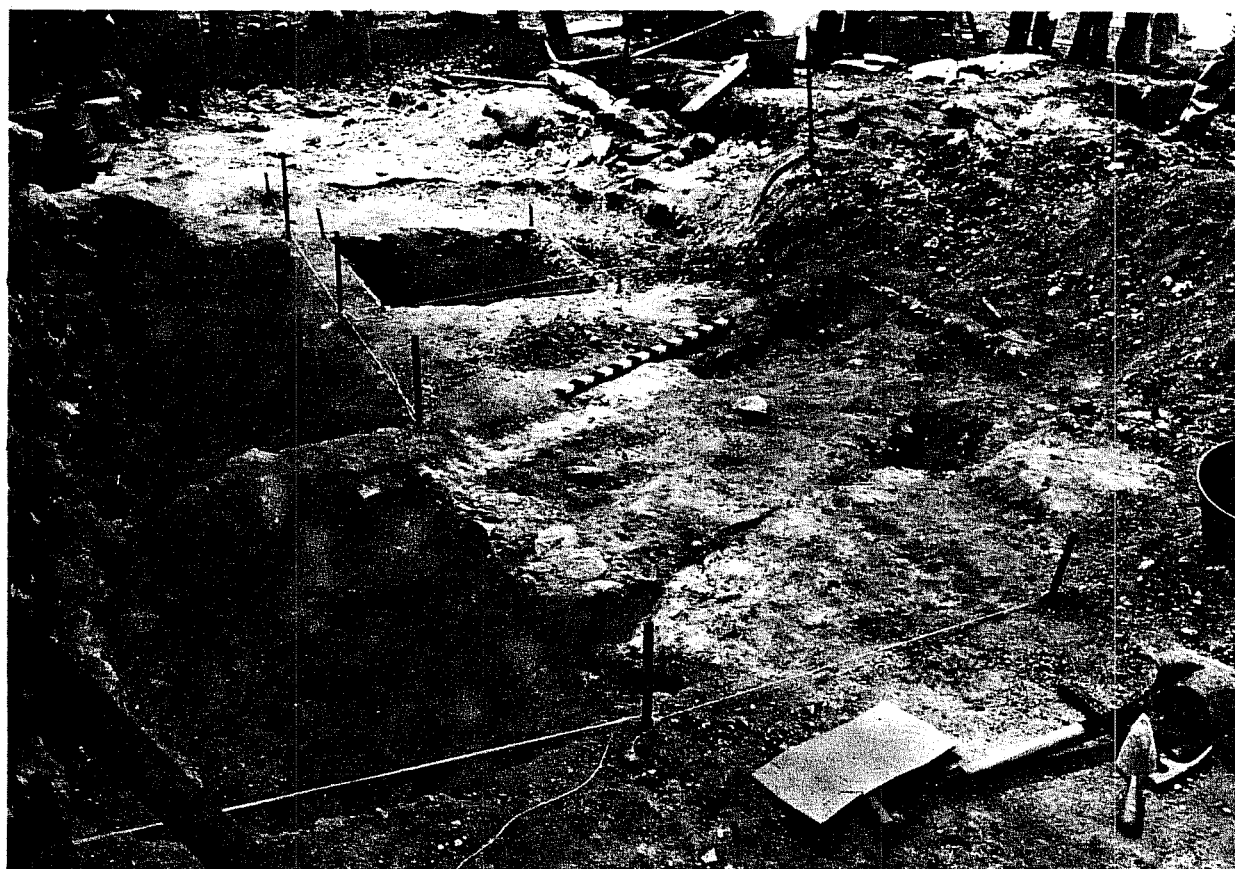
Figure 10. *Alamo Shrine Excavations*. a, view from Alamo roof showing location of excavations and palisade trench; b, palisade trench during excavation.

The old backfilled trench was first noted as a slight depression and soil color change within the upper level white caliche. The trench began about 65 cm out from the building wall and extended southwest (250° magnetic) to as far as the old sidewalk curb, located three meters from the wall (Figs. 3, 11). The trench did not follow beyond the curb since that was the area of the old street and was very much disturbed. The trench averaged ca. 70 cm in width and ca. 45 cm in

depth. The fill consisted of mixed soil types including caliche, but generally dark gray to brown in color with inclusions of artifacts and many animal bones. The artifacts included a variety of lead and bronze balls, ranging from pistol and musket balls to large canister shot. Two large fragments of 8-inch howitzer spherical shells (bronze), one exhibiting part of a fuse hole, were also found. Other artifacts include metal and bone buttons, square nails and other objects of metal, fragments of bottle and window glass, and a variety of pottery sherds. These and other objects collected will be discussed in more detail in the chapter on artifacts.

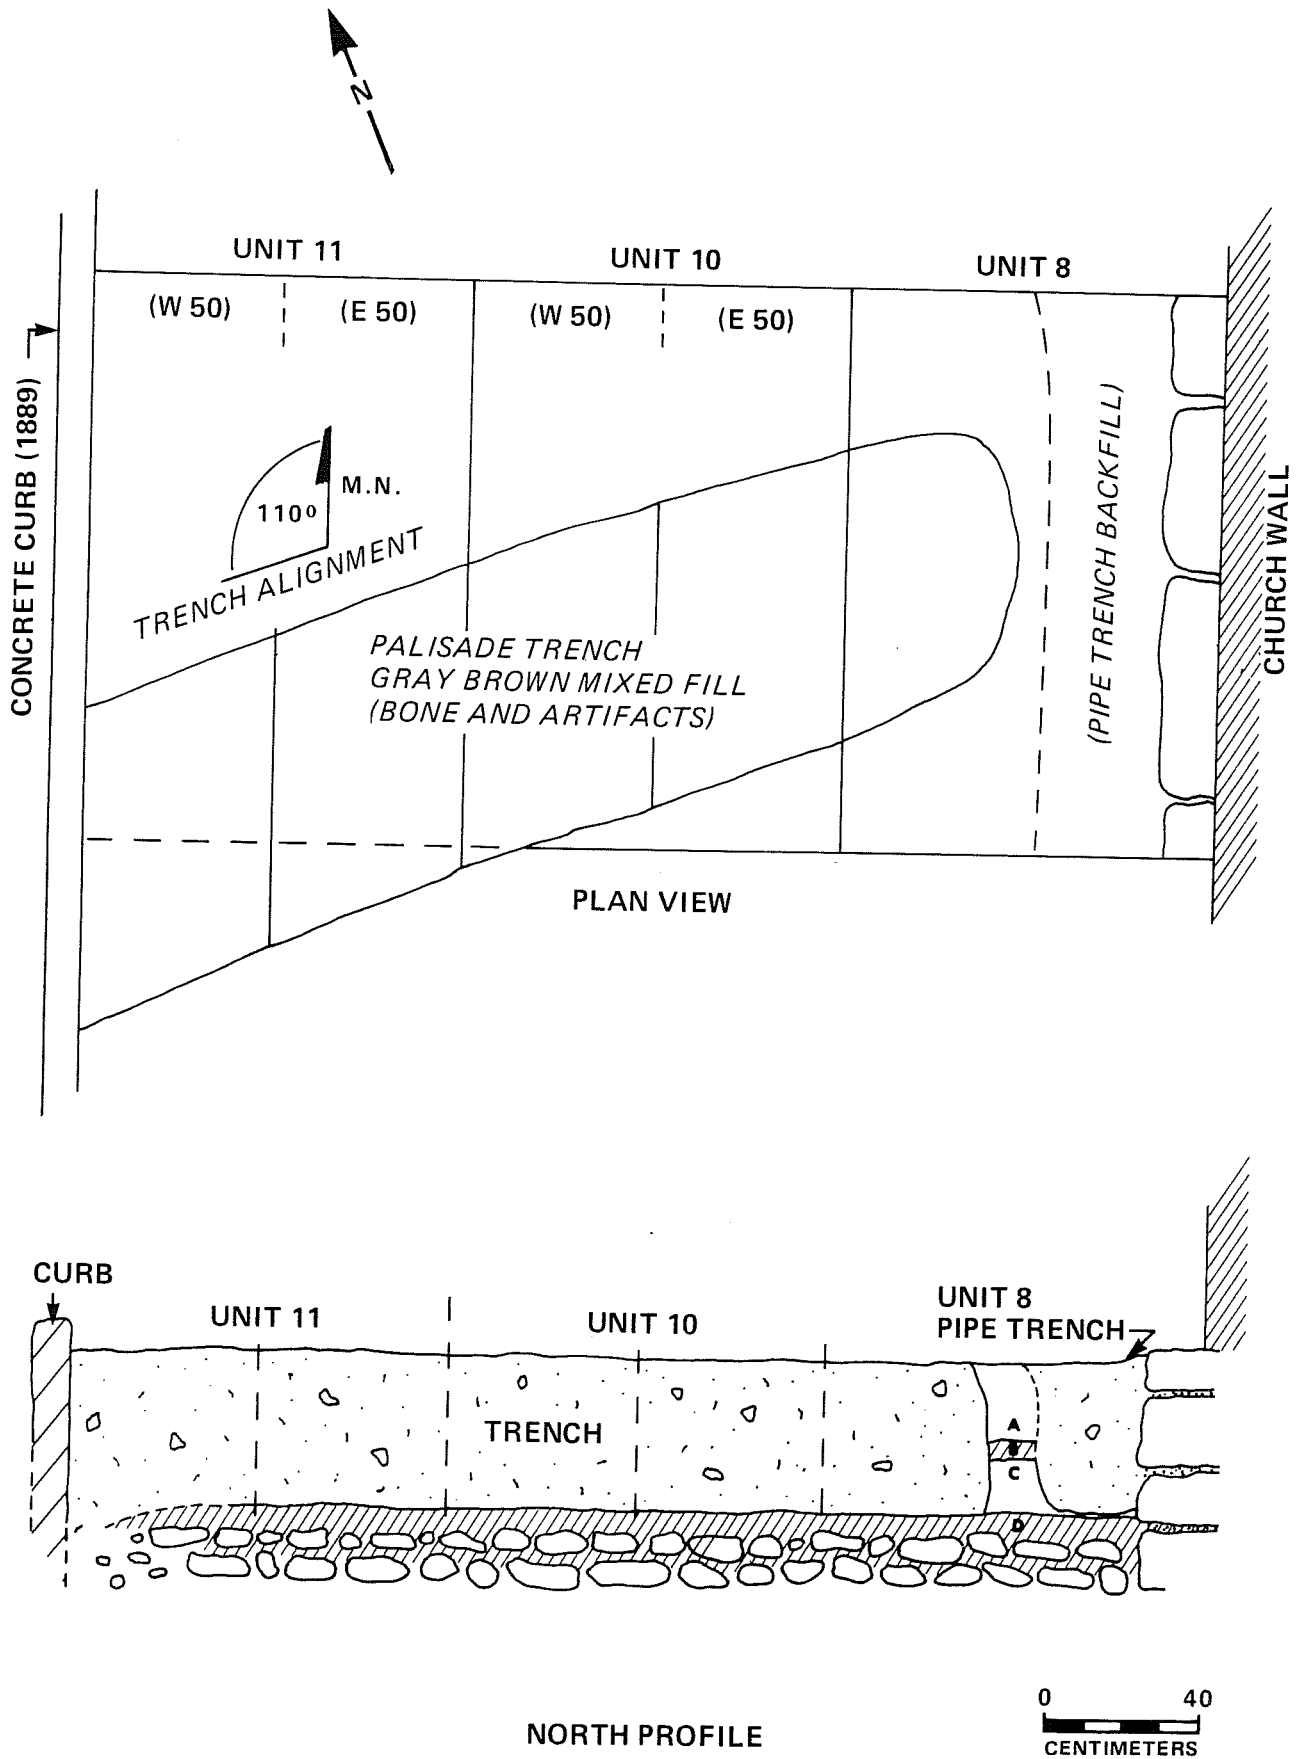
Figure 11. *Palisade Trench*. Located at southwest corner of Alamo Shrine. Shown are plan and profile views as determined by excavation.

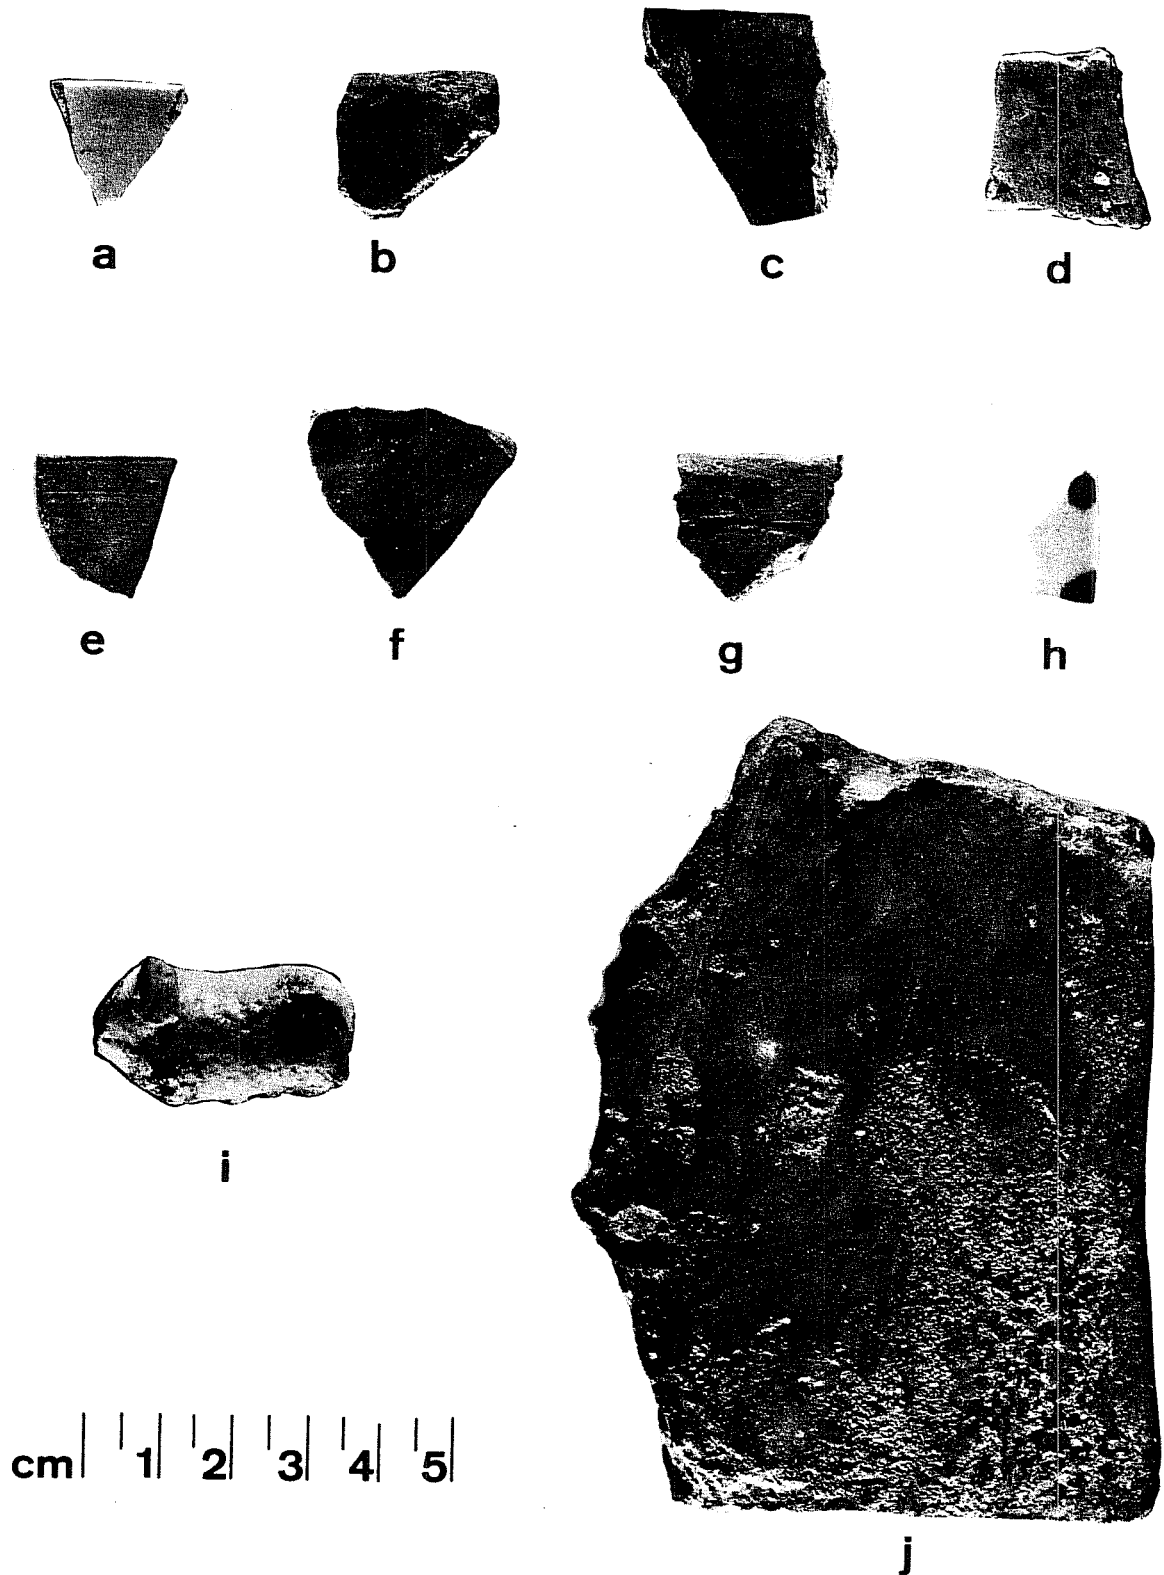
Figure 13. *Ceramic Artifacts*. a, creamware; b, sandy-paste glazeware; c, *Tonalá* ware; d, plain unslipped utility ware (buff paste); e, plain unslipped utility ware (pink paste); f, red-painted utility ware; g, red-painted and incised utility ware; h, oriental porcelain; i, glazed animal figure; j, pink ceramic tile.

A thin pottery with medium brown burnished slip inside and outside. It has a gray to tan fine paste (Fig. 13,c). This ware was made during the mission period and probably also until the middle or late 1800s.

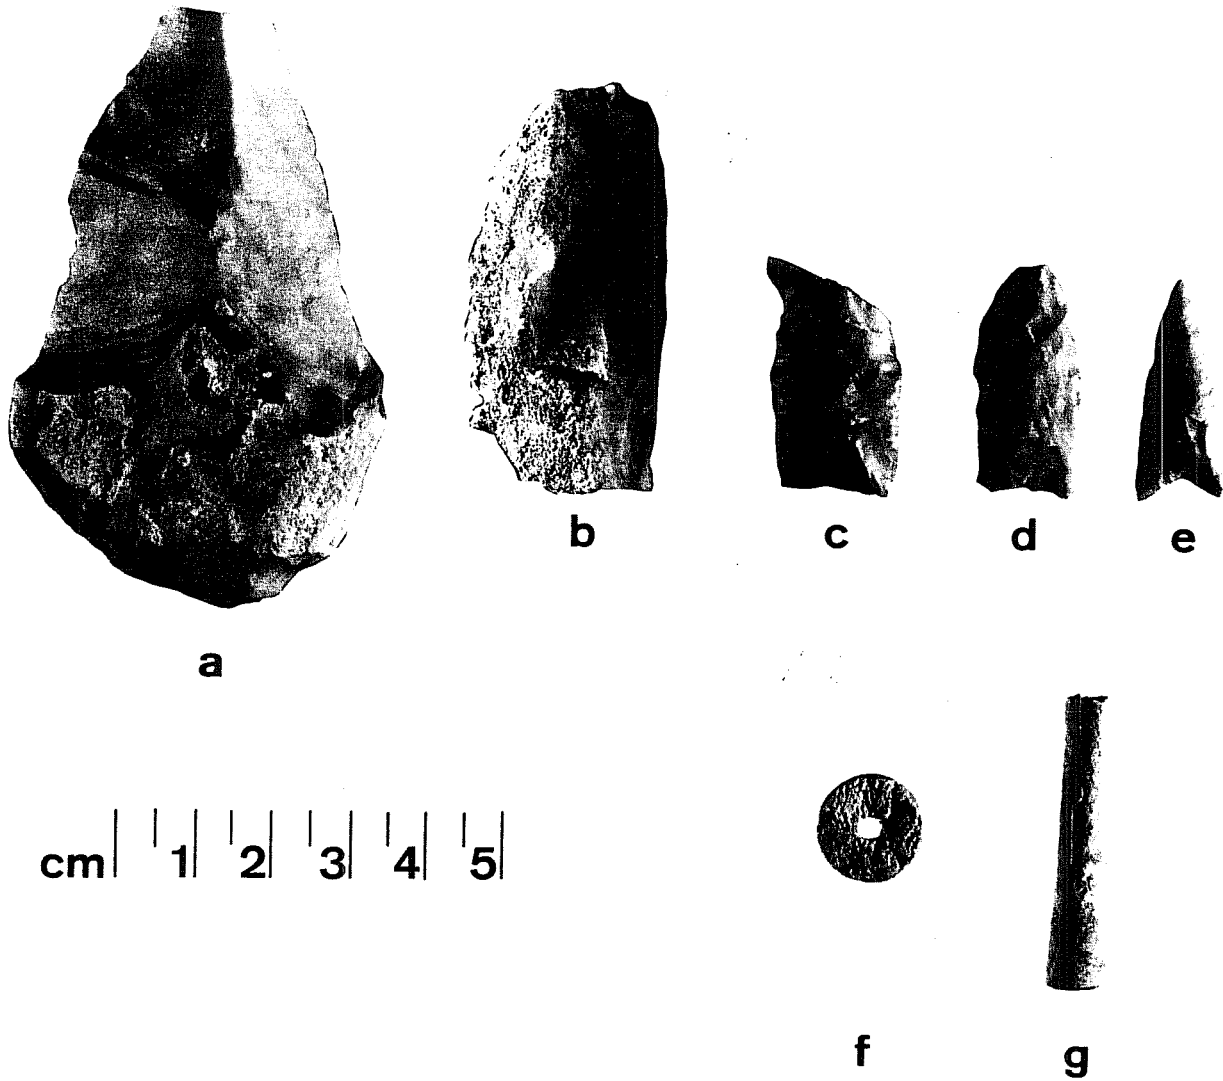
Figure 14. *Chert and Bone Artifacts.* a, chert end scraper; b, chert side scraper; c-e, chert "mission" points; f, bone button; g, bone tubular bead.

Three arrow points were collected. These are types characterized as "mission points" since they are found at Spanish Colonial missions in south Texas and northern Coahuila (Hester 1977; Fox 1979). Hester (1977) has applied the type name *Guerrero* to these points. There are two forms represented in the collection. One of the points has a deeply notched base, while the other two have slightly concave bases. One specimen is a basal fragment of an unfinished point, apparently broken during knapping (Fig. 13,c-e).

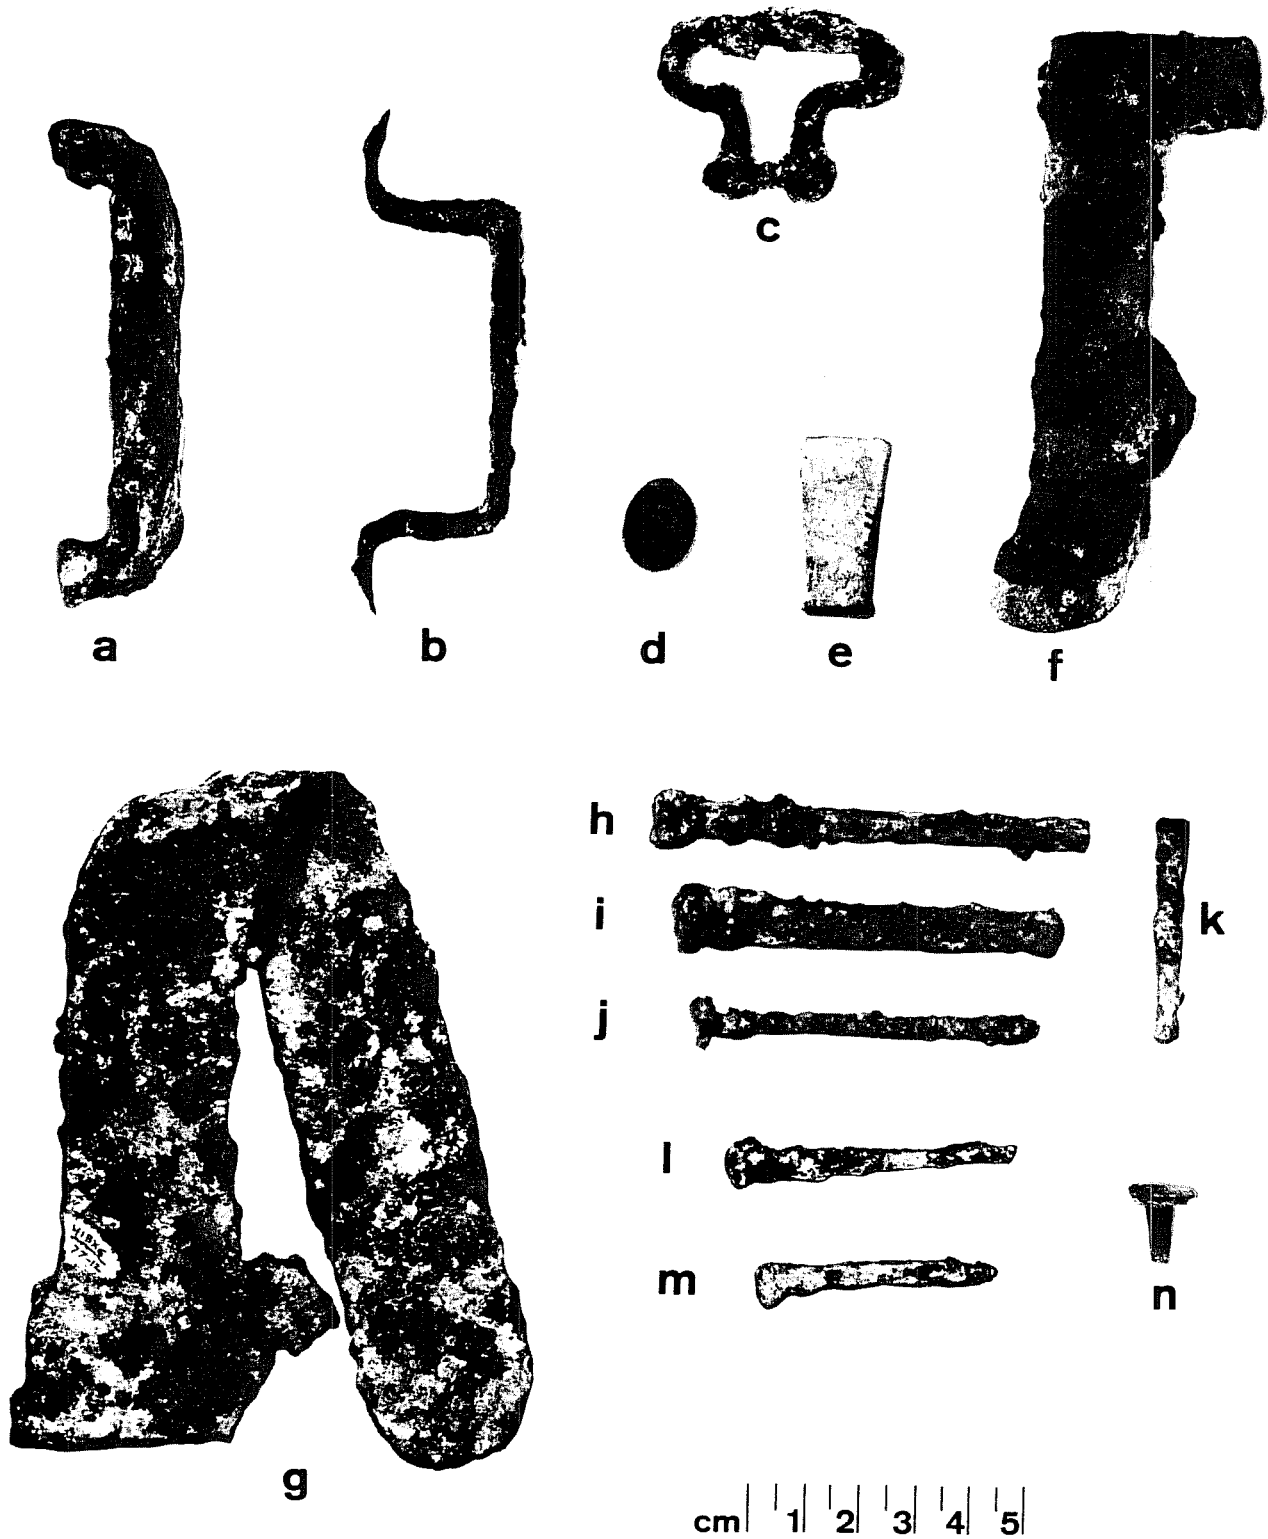
Figure 15. *Metal Artifacts*. a, iron handle; b, iron bracket; c, sling swivel for musket; d, brass button; e, .44 or .45 caliber center-fire cartridge; f, iron tool; g, iron strap; h-m, square iron nails; n, square tack.

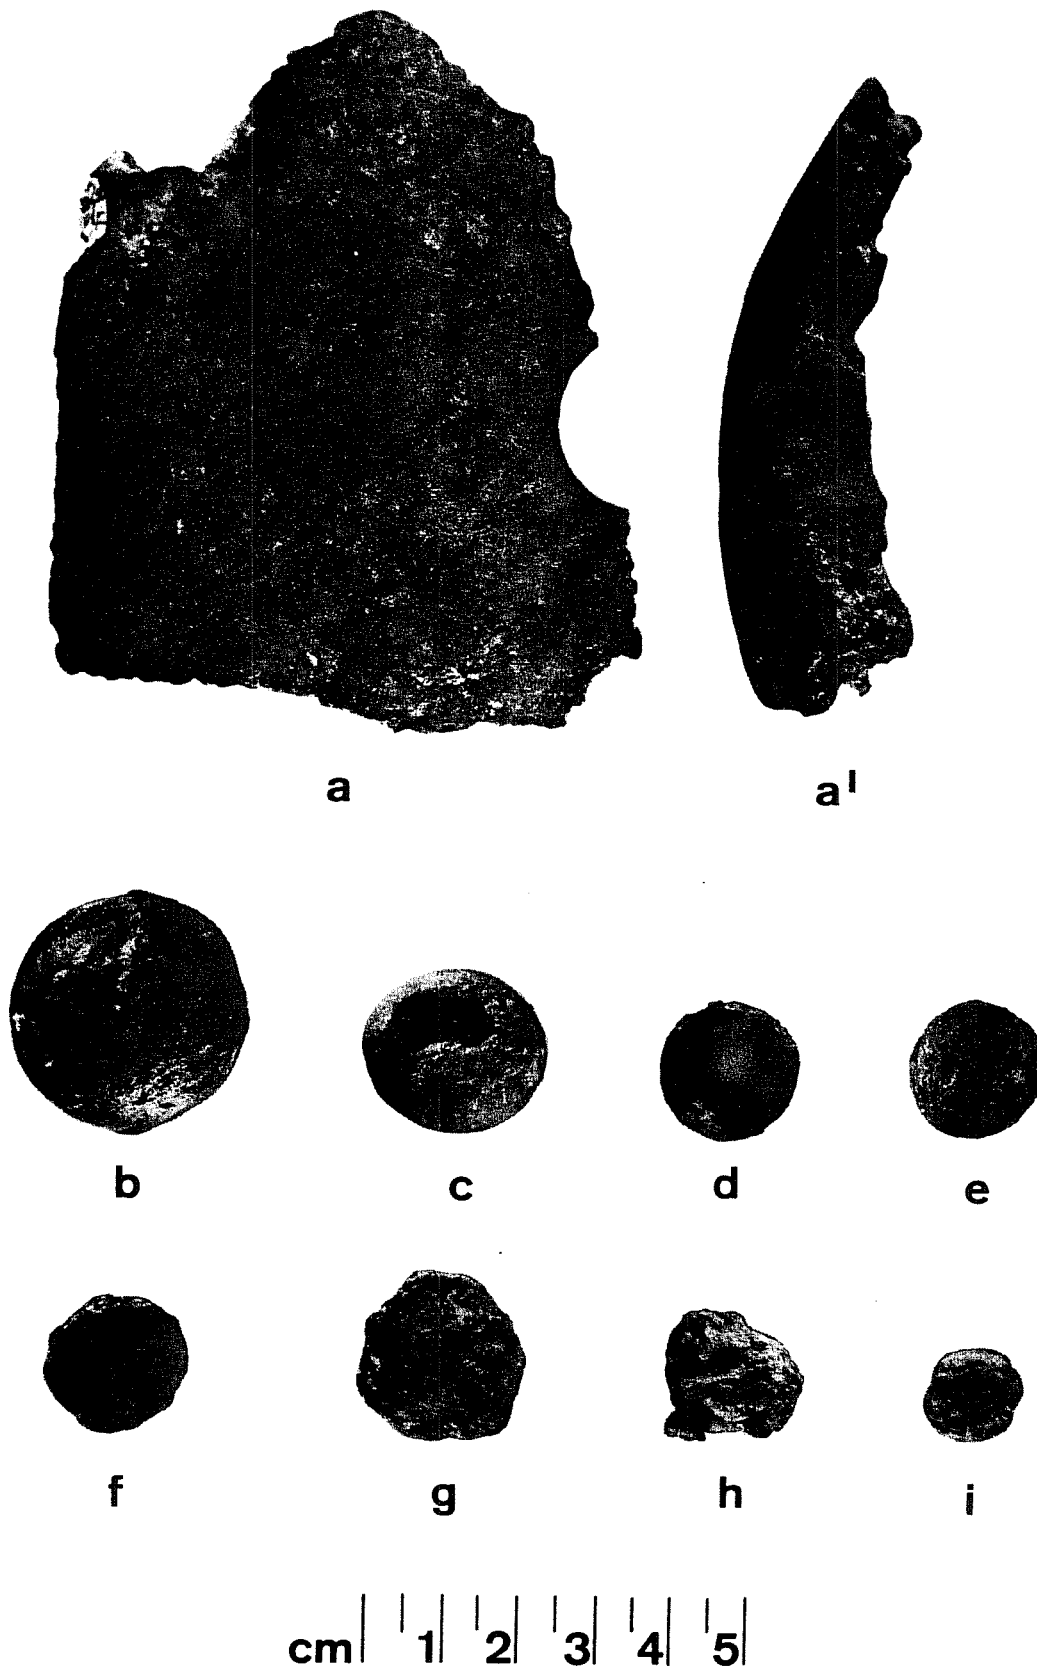
Figure 16. *Metal Artifacts*. a-a', fragment of 8-in. bronze spherical shell with fuse hole; b, bronze spherical canister or grape shot; c, bronze spherical canister shot; d, .70 cal. lead musket ball; e-f, .69 cal. lead musket ball; g-h, impacted lead musket ball; i, .48 cal. musket or pistol lead ball.

Solid spherical shot for musket. Two .69 caliber balls weighing 31.2 grams and 31.7 grams, one .70 caliber ball weighing 32.7 grams, and a .46 caliber ball weighing 9.7 grams. Two impacted lead balls, probably .69 to .70 caliber, were also found (Fig. 16,d-i).

One solid shot of cast bronze, slightly flattened, with a deep hole in one side evidently caused by intense heat during firing. It is roughly 1.15 inch (2.8 cm) in diameter and weighs 56.4 grams. Possibly this is a canister shot from a 6-pounder cannon (Fig. 16,c). Also in the collection is a larger solid shot of cast bronze, 1.3 inch (3.3 cm) in diameter and weighing 147.2 grams. Possibly this is a canister or grape shot from a Mexican 24-pounder (6-inch) howitzer (Fig. 16,b).
